AIRWORTHINESS DIRECTIVE GLIDERS/POWERED SAILPLANES

GFA/AD 219

TYPE AFFECTED: Jantar series, all SZD-42, SZD-42-1, ("Jantar-2" and "Jantar-2A") as well as SZD-42-2 "Jantar 2B", up to Serial No. B-1074 inclusive.

SUBJECT: Retention of the "Tarnamid" bearing sleeve fitted into the bottom rudder hinge.

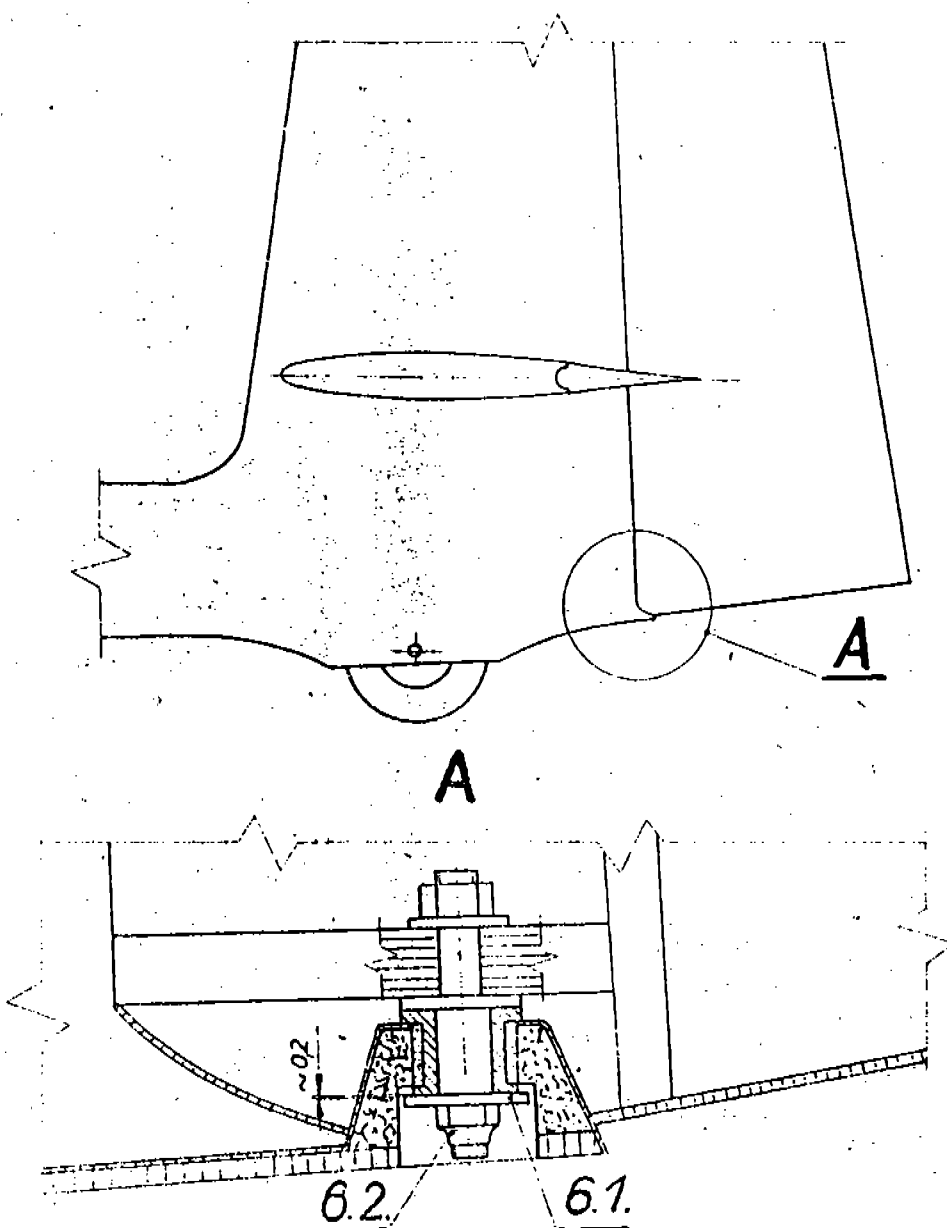
Fig. 1.

BACKGROUND: Impact during takeoff, landing, and manoeuvring on rough ground can cause looseness of the bearing, possibly allowing vertical freedom of the rudder.

REQUIRED ACTION: (1) A washer, either factory supplied through the Australian distributor, or made from mild steel to Fig 2 is to be fitted to the bottom rudder hinge assembly to Fig 1, replacing the existing washer.
(2) Modification details to be entered into log book.
