7
GFA/AD 220
SZD 23
24.11.1981
Issue 1
Sheet 1 of 2

AIRWORTHINESS DIRECTIVE

Jantar 2B gliders, S/Nos. X131, B-858 to B-875, B-908,

Modification to prevent the undercarriage retraction assist

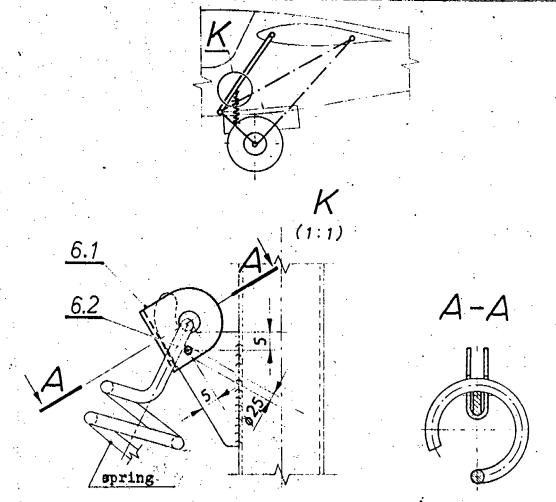
Fig.1.

Ing. 6.1. /68-00-66/
material: 20-k /1x20x44/
protective cost - zinc plate

- (1) If a factory supplied lug is not available through the Australian distributor, a lug made to Fig. 1 from commercial mild steel sheet, approx. lmm thick, etch primed will be acceptable.
- (2) Remove seat pan & disconnect the spring from its top hook, with the undercarriage retracted.
- (3) Thread the lug onto the end of the spring.
- (4) Fit the spring & lug onto the hook, ref. Fig 2. and mark the small split pin hole from the lug onto the fixed hook. Remove the spring and lug.
- (5) Drill the split pin hole through the lug.
- (6) Assemble the spring & lug, back onto the hook, fitting a split pin, bending the legs.
- (7) Enter modification details into the glider's log book.
