AIRWORTHINESS DIRECTIVE. GLIDER/POWERED SAILPLANE

GFA/AD 233

ROLLADEN SCHNEIDER
19

SUBJECT: Undercarriage serviceability.

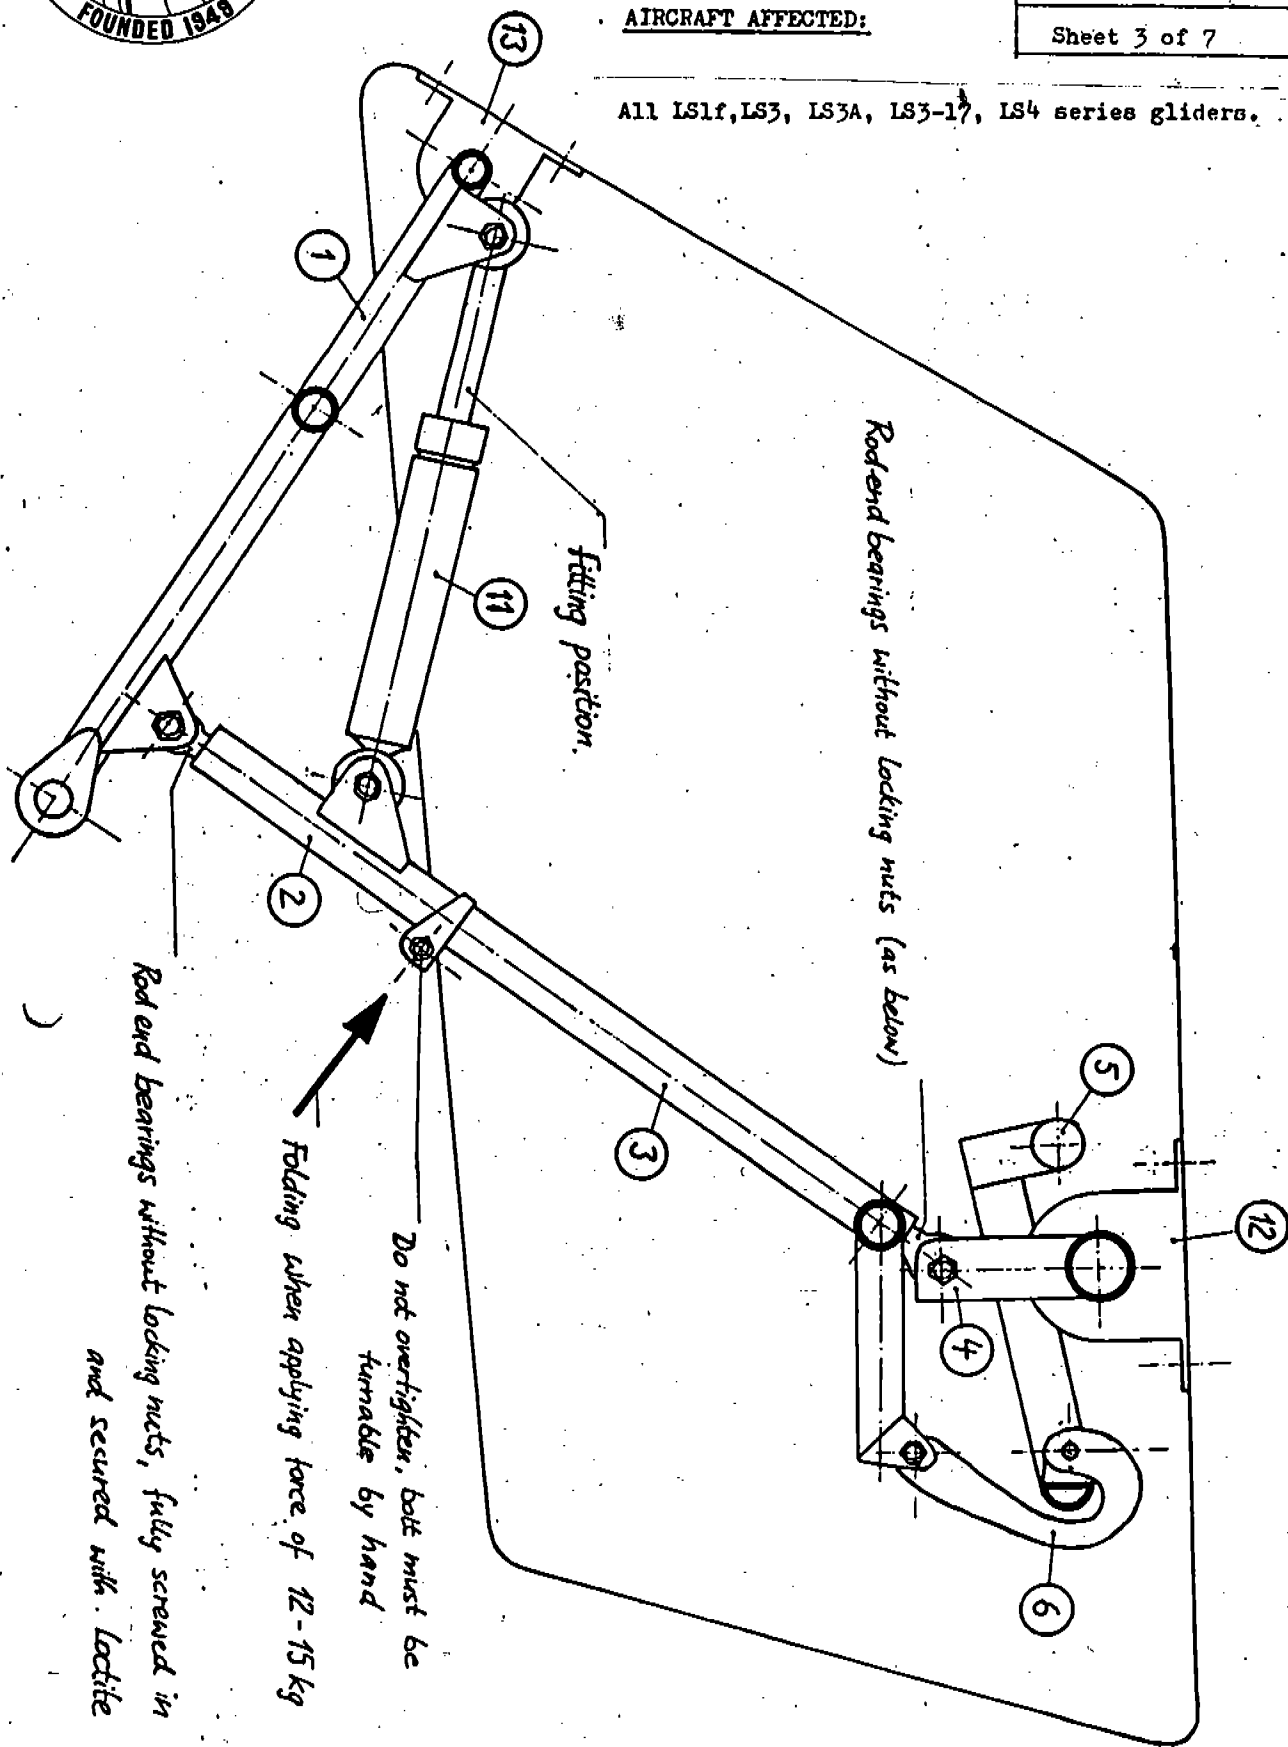
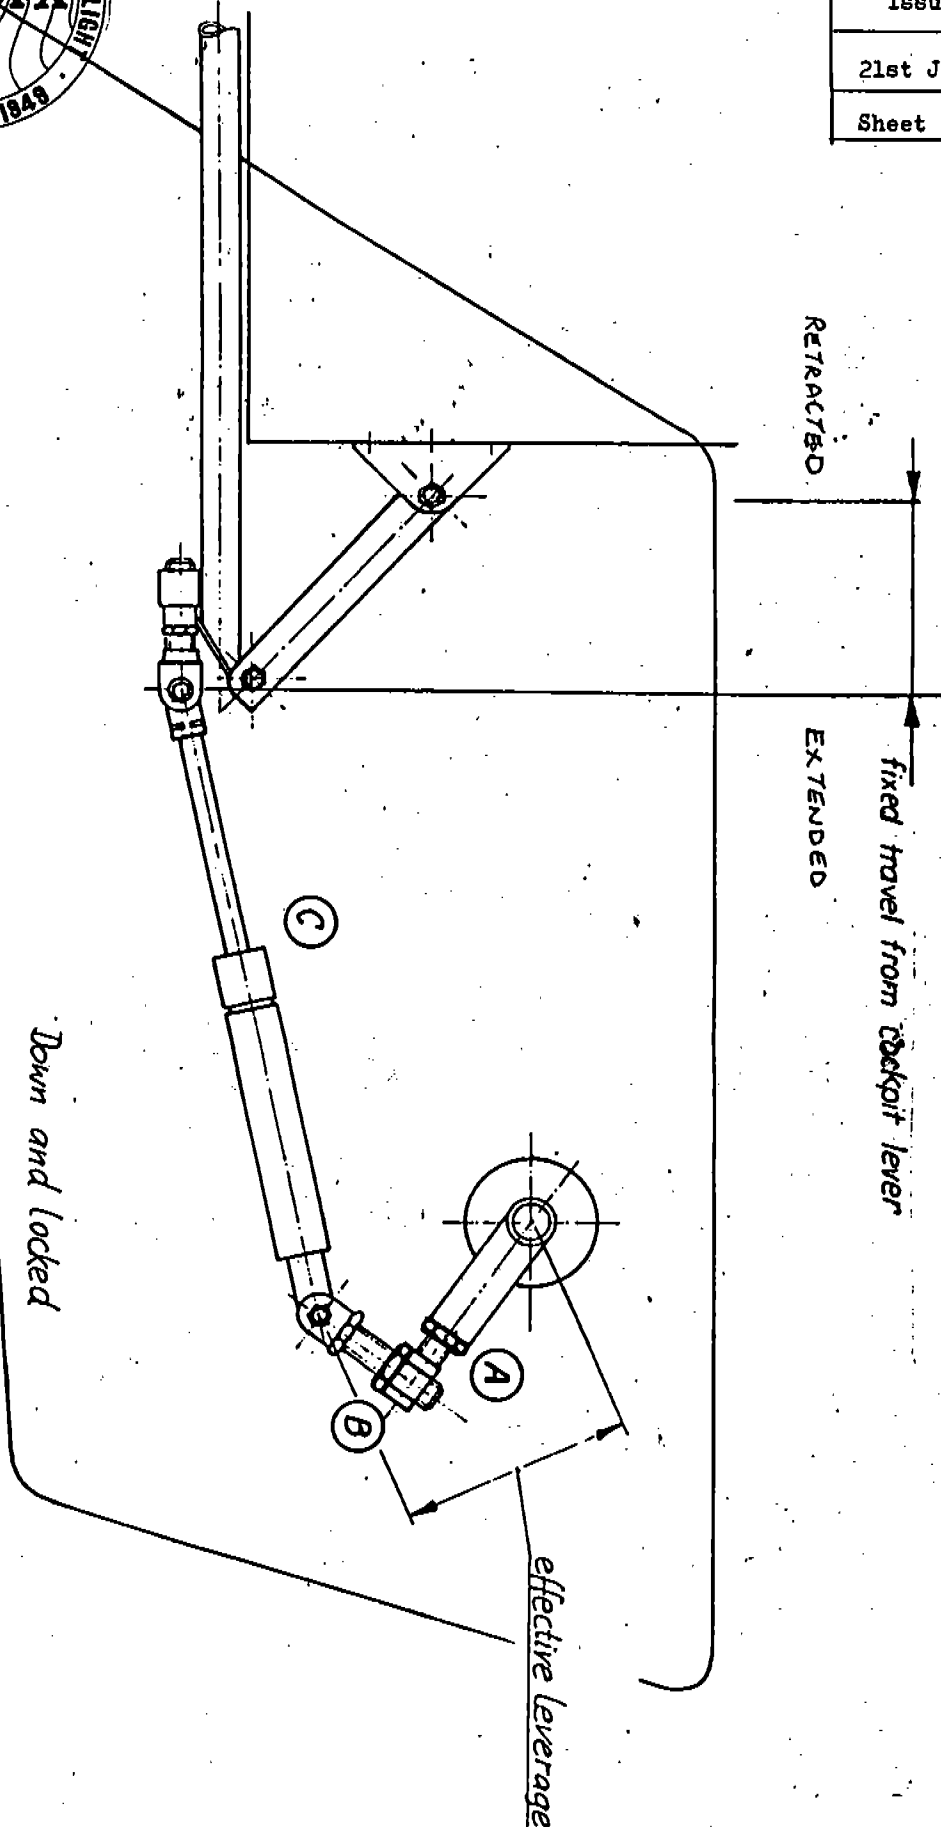
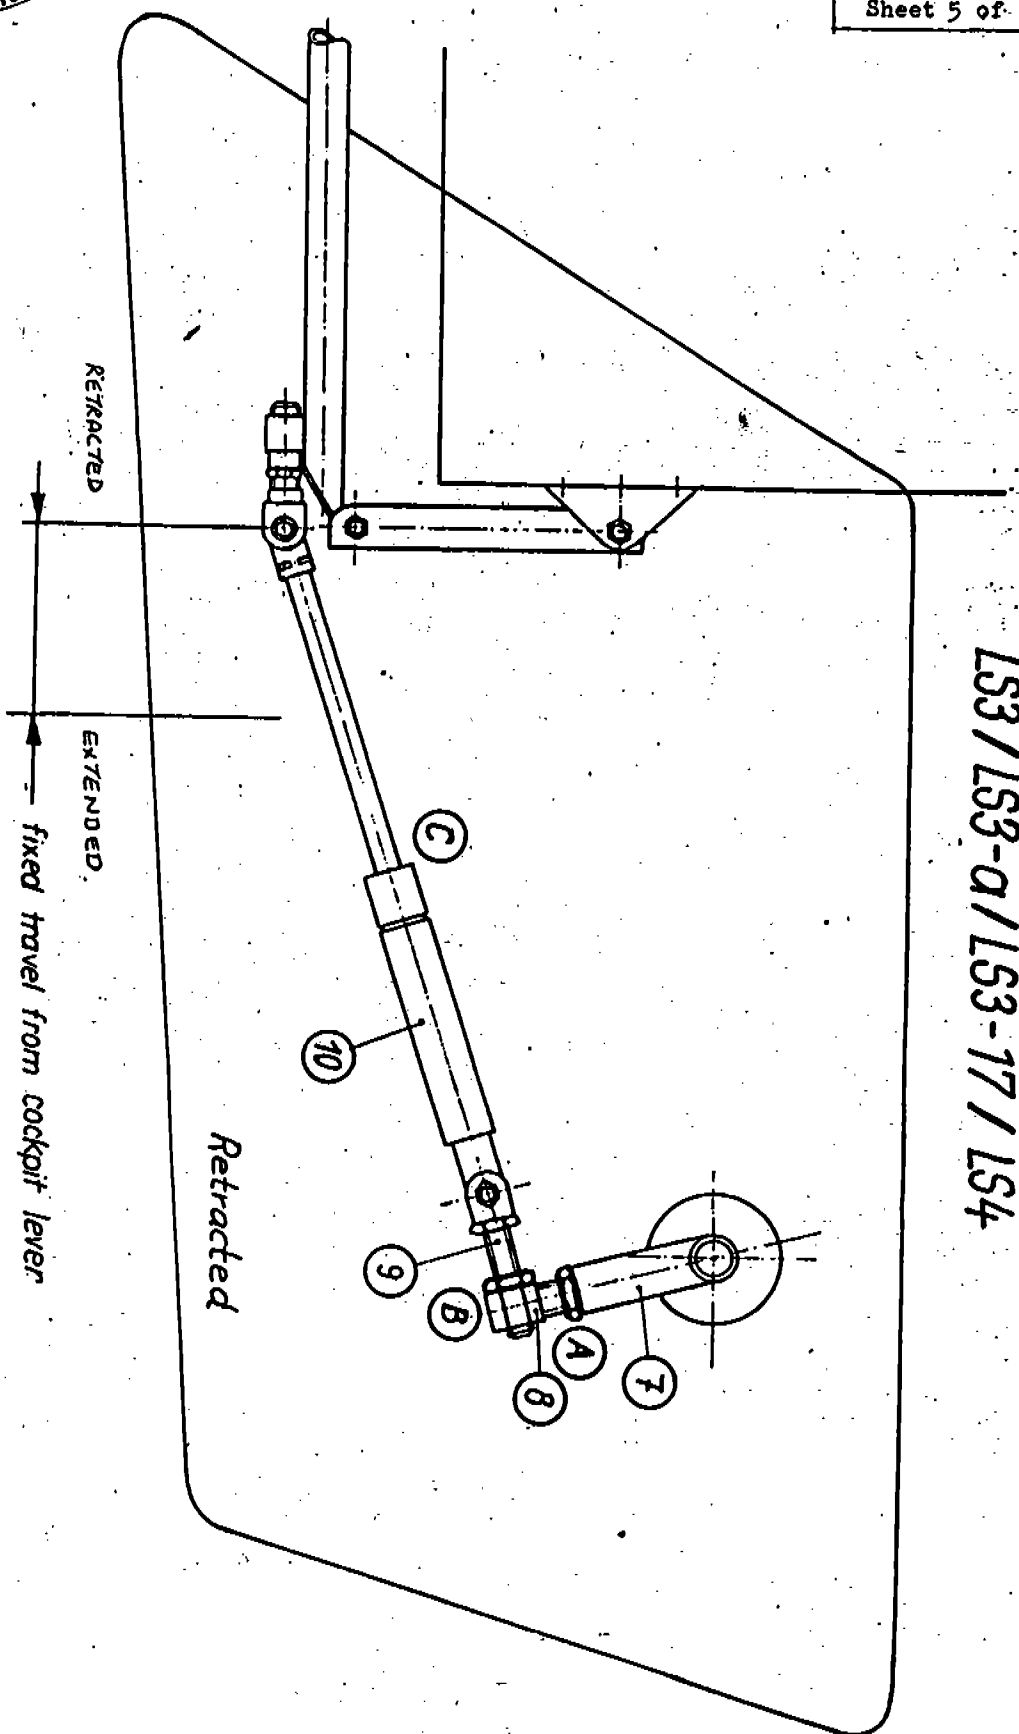
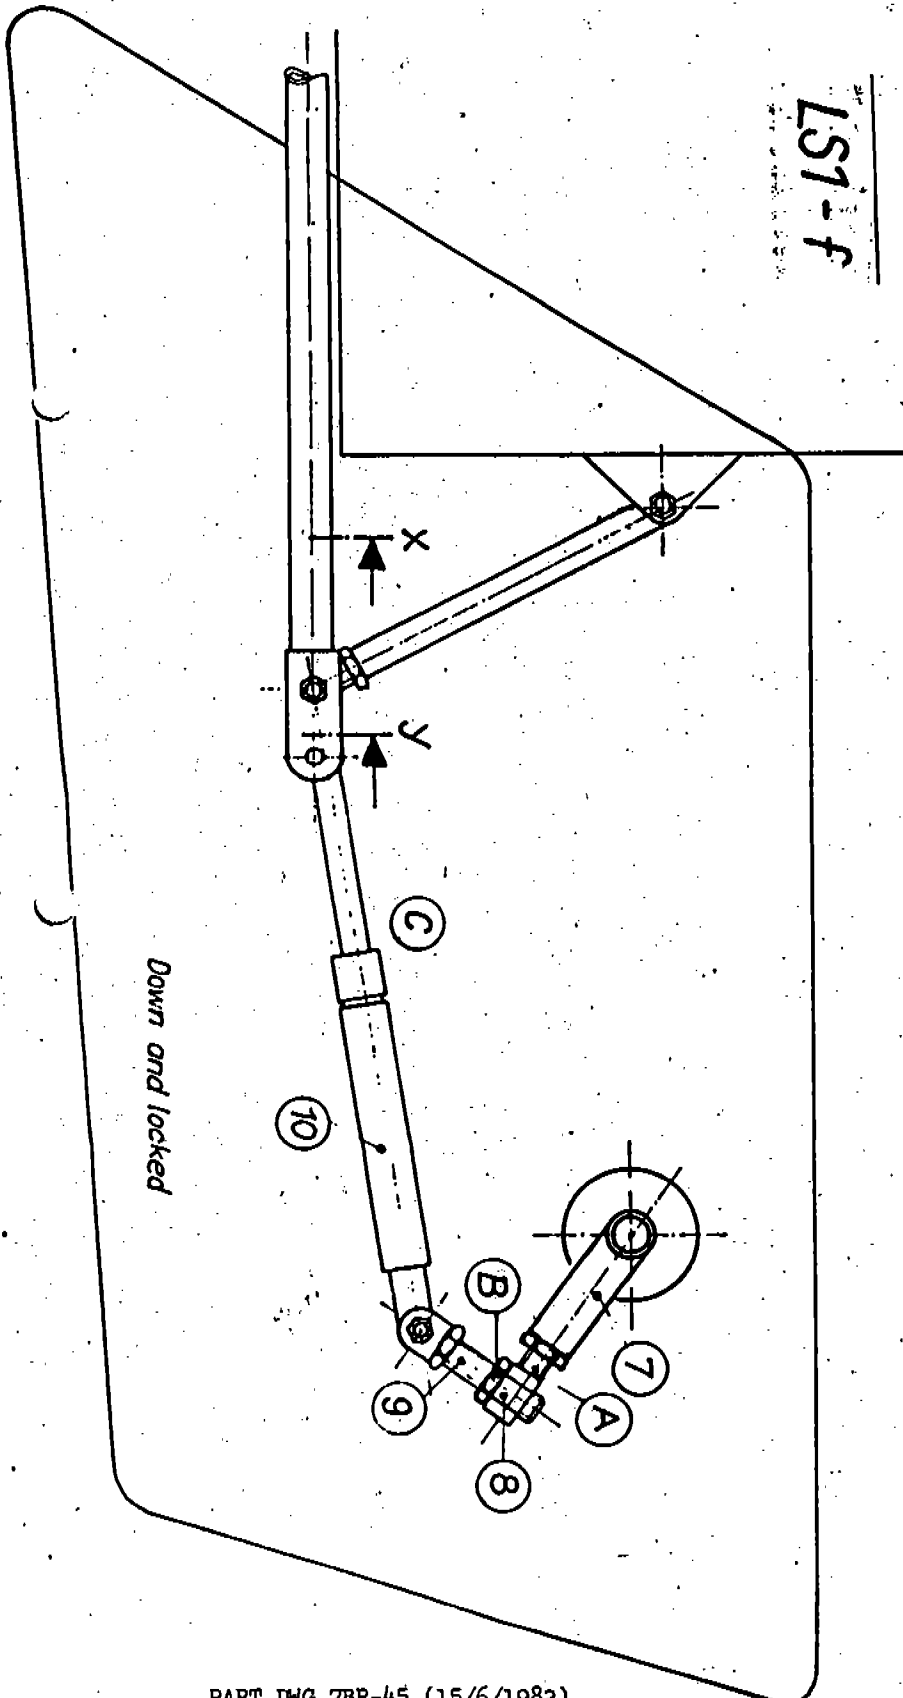
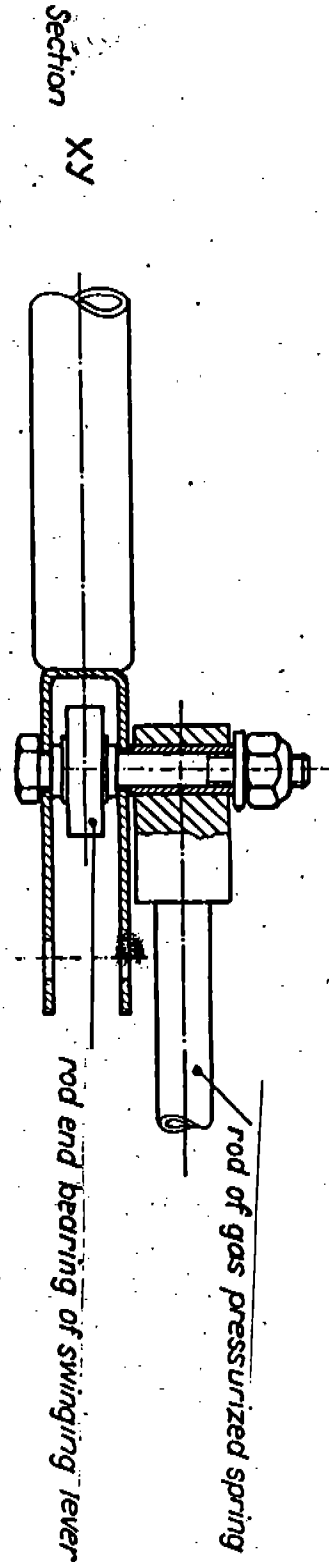
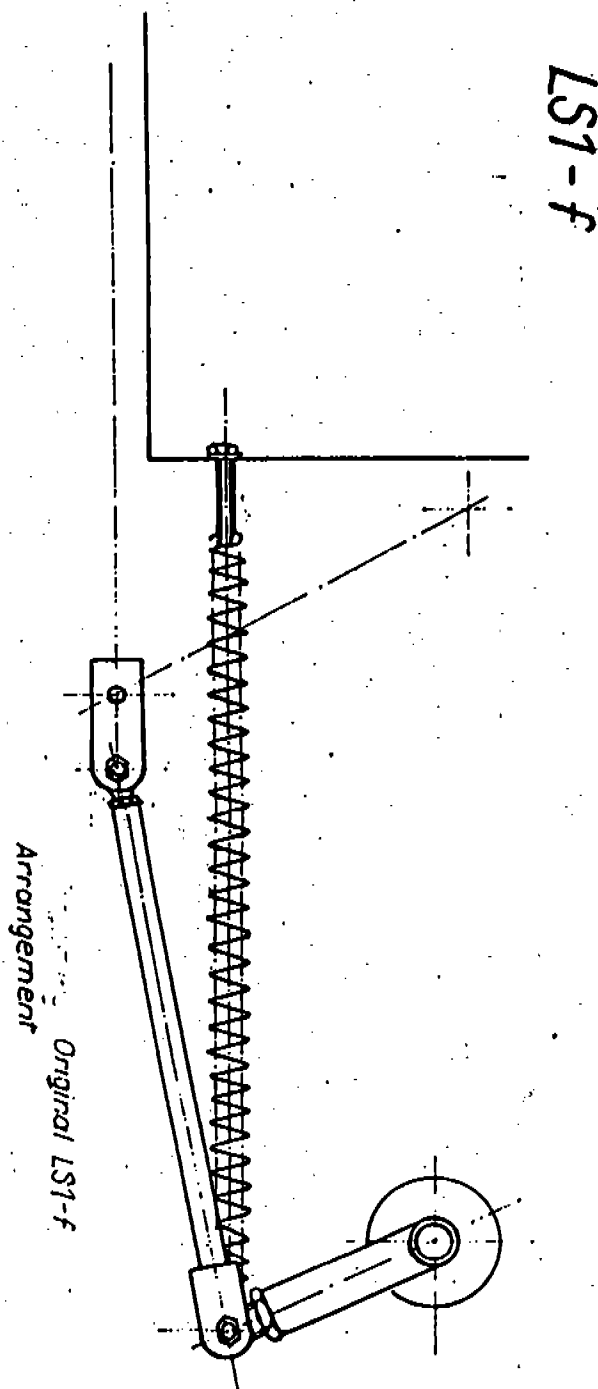
BACKGROUND: AN 51 discussed reports concerning premature undercarriage retraction on LS series gliders, following which GFA requested that Rolladen-Schneider supply drawings and data on the under-carriage systems to allow proper inspection and maintenance to be carried out.

Effective leverage too short: Hand forces increase considerably
Wheel "bottoms" on landing gear housing when retracted.

Effective leverage too long: Insufficient locking when extended, because gas pressurized spring not or not enough compressed.
Insufficient retraction, doors stay partly open.

With correct effective leverage the connection point (C) for the gas pressurized spring may be too much forward or aft, symptoms are the same ones as for wrong length.

During Form 2 inspection and inspections following ground loops or heavy landings, drawing No. 7BR-45 is to be used as a reference for determining system serviceability.

- Start adjustment at (A) with 2 turns out, tighten locking nut.
- Adjust at (B) such that gas pressurized spring is compressed 5 to 8 mm at down and locked position, tighten locking nut.
- Retract gear. If wheel "bottoms" on housing screw 1 turn out at (A), half a turn out at (B). If doors stay partly open screw 1 turn in at (A), half a turn in at (B).
- Check again compression of gas pressurized spring as under b).
- Check according to c).
- Check hand force for retraction: maximum 20 kg.
