# THE GLIDING FEDERATION OF AUSTRALIA

GFA/AD 248

## AIRWORTHINESS DIRECTIVE GLIDERS/POWERED SAILPLANES

Subject: Forward trim weight attachment bracket

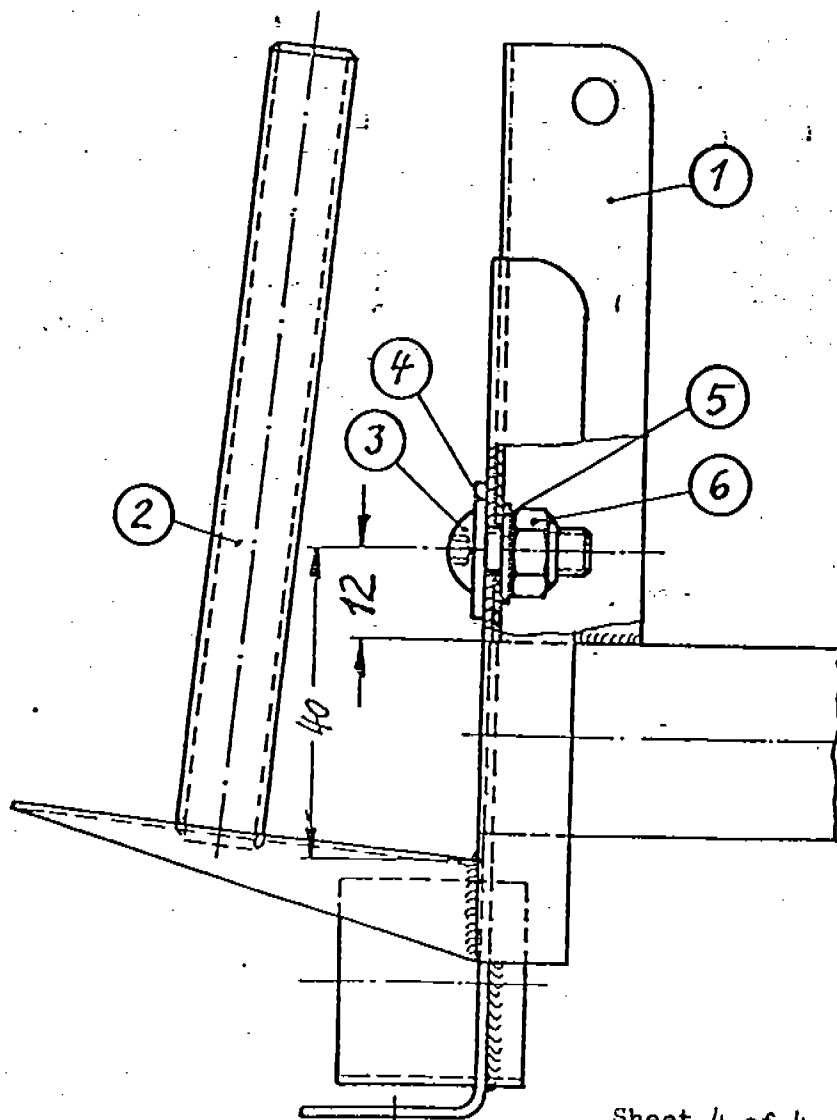
| Bea. | 6.04.82 | | Leuschke | | Montage Trimmbleihalterung | | | 4 BR - 43 | |

Reason: At trim weight attachment bracket cracks around fitting  
hole occurred in one case.

Material and  
Instructions: Disassemble bracket and check for cracks. (4 mm hex key).  
Case 1: No cracks detectable and fitting hole is 40 to 52 mm  
(1.57 to 2 in) above trim weight support - reassemble  
bracket using large washer according to drawing  
4BR-48.  
Case 2: Cracks could be found or fitting hole is above given  
range - proceed as detailed in Fitting Instruction  
for 4BR-48.

- a) Take canopy off.
- b) Dismount canopy gas strut at forward end.
- c) Fit bracket provisionally using existing hole.
- d) Drill new hole of 6.1 mm in diameter (o.24 in, use drill of drill number size C) 12 mm (o.5 in) above square tube of pedal guide.
- e) Mount bracket according to drawing 4BR-48 using large washer, connect gas strut.

- a) Set circular cutout of new bracket onto tube of pedal guide.
- b) Mark hole on bracket.
- c) Drill hole, see above under d)
- d) Mount bracket according to drawing 4BR-48 using large washer.
