AIRWORTHINESS DIRECTIVE

SALTO H101, SAILPLANE

Inspection, modification of control column base bearing.

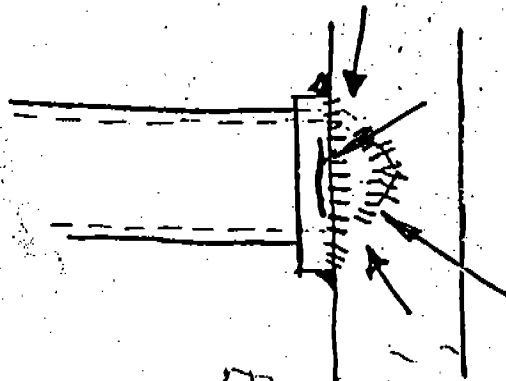
2

The cracking of this component is due to very poor detail design of the welded joints.

Cracks may be found in the welds or in the parent metal adjacent to the welds. Use magnifying glass (x10), dye check or Magnaflux

Inspect the base bearing for cracks in the welds.

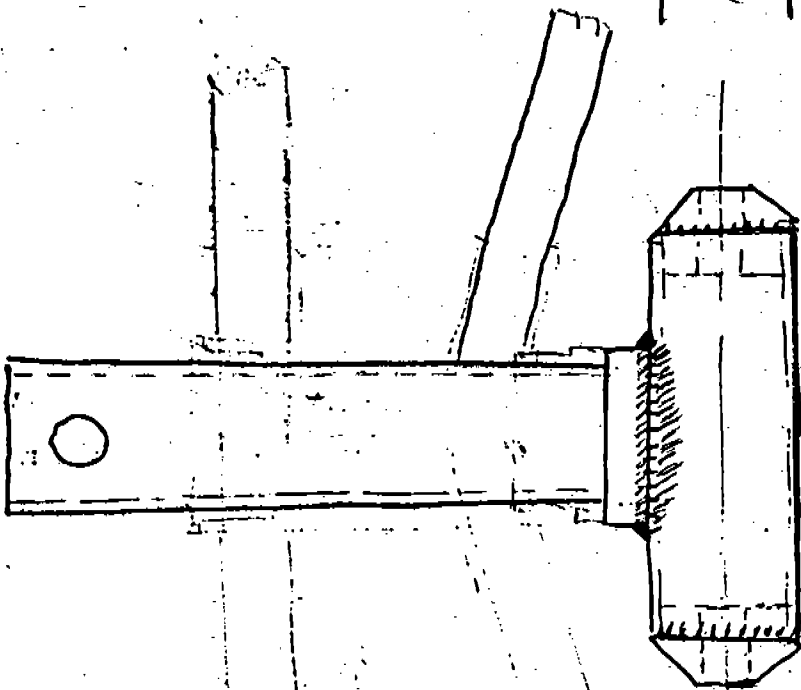
1

Base bearing, suspected of cracking in service.
