AIRWORTHINESS DIRECTIVE

Centrair 101, 101A, 101 AP, 101P

Centrair Service Bulletin # 101-4 asks for immediate inspection of the top rudder hinge, for cracking or failure in some form.

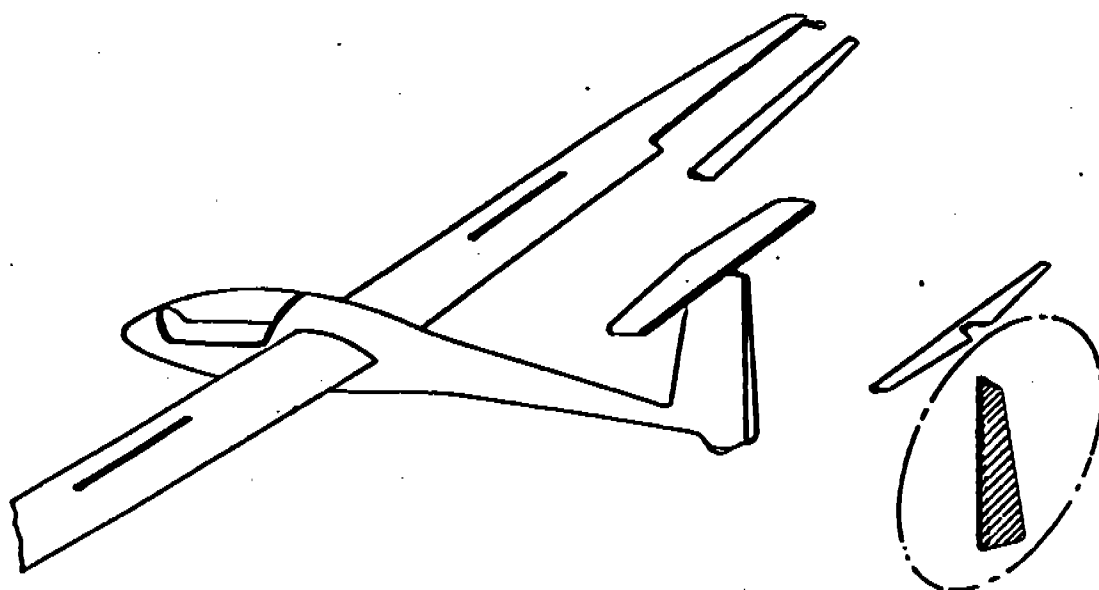
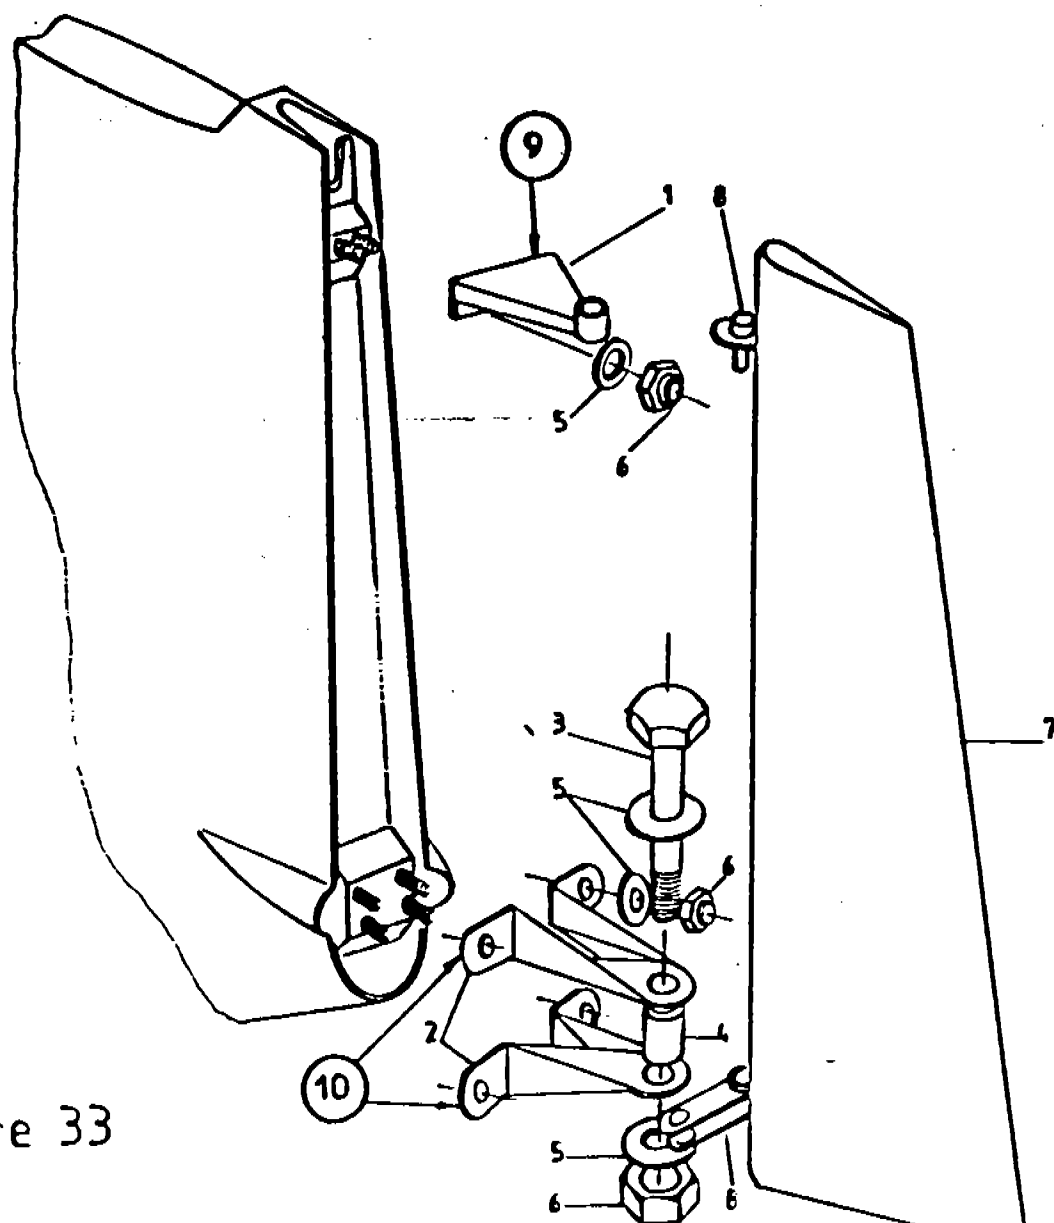
Figure 33

Following the discovery of two failures of the upper rudder hinge pivot, it is imperative to immediately check the upper rudder hinge pivot by disassembling the rudder :

1. Remove the rudder control cables (rep.15 fig.22)
2. Remove the bottom rudder hinge retaining bolt (rep.3 fig.33)
3. Pull the rudder back slightly (to clear the bottom rudder hinge) then lift rudder to disengage it from the vertical fin.

In the case of a failed pivot or seized pivot the aircraft must be grounded until repair kit number one (1) is installed. This repair kit consisting of upgraded parts must be ordered from the manufacturer CENTRAIR immediately.
