GFA AD 290
(ISSUE 2)

GFA AIRWORTHINESS DIRECTIVE

Flight controls. Inspection and/or replacement of bearings in the
control sticks.

Subject: Bearings in the control stick

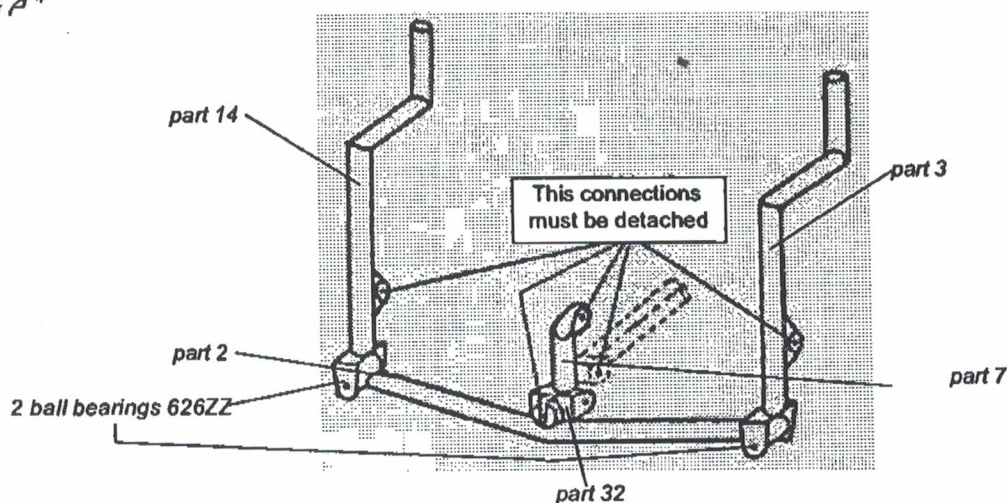
Urgency: a) Before the next flight, if a double-row self aligning ball bearing 14 C 6 is to be found in the control column parts 2, 3, 7 and/or 14 (see below sketch) or
b) when the spheric slide bearings GE 8 E installed in accordance with TM 653-47 are worn out and must be replaced.

Reason: The spheric slide bearings GE 8 E according to TM 653-47 wear out very soon and are no longer obtainable.
If these spheric slide bearings must be replaced, the complete control column (Parts 2, 3, 7 and 14 according to 653E-41-S10 and part 32 according to 653E-41-S10E1) must be modified according to 653E-41-S10 change d.

Actions: New slide bearing supports must be welded to the parts 2, 3, 7 und 14 (see below sketch) according to 653E-41-S10 change d and 653E-41-S10E1.
The old Part 33 of 653E-41-S10 located between part 2 and 7 is to be replaced by the new part 32 according to 653E-41-S10E1.
With the exception of the spheric ball bearing 14 C 8 at part 2 of 653-41-S10E1 all the other bearings are spheric slide bearings (1x SSCP 8 IH und 2x SSCP 6 IH). All the slide bearings are fixed with Loctite 270. Apply 2 new chime rings at each bearing.
Replace the additional 4 ball bearings 626 ZZ at part 2 of 653E-41-S10.

FOR "CHIME RING"
READ "CARELIP"
