AIRWORTHINESS DIRECTIVE

ASW 19 ASW19B

Inspection to verify that the release knob has 12mm of freeplay with the release in the fully locked position.

ASW 19 / 19 B
Technical Note
No. 18

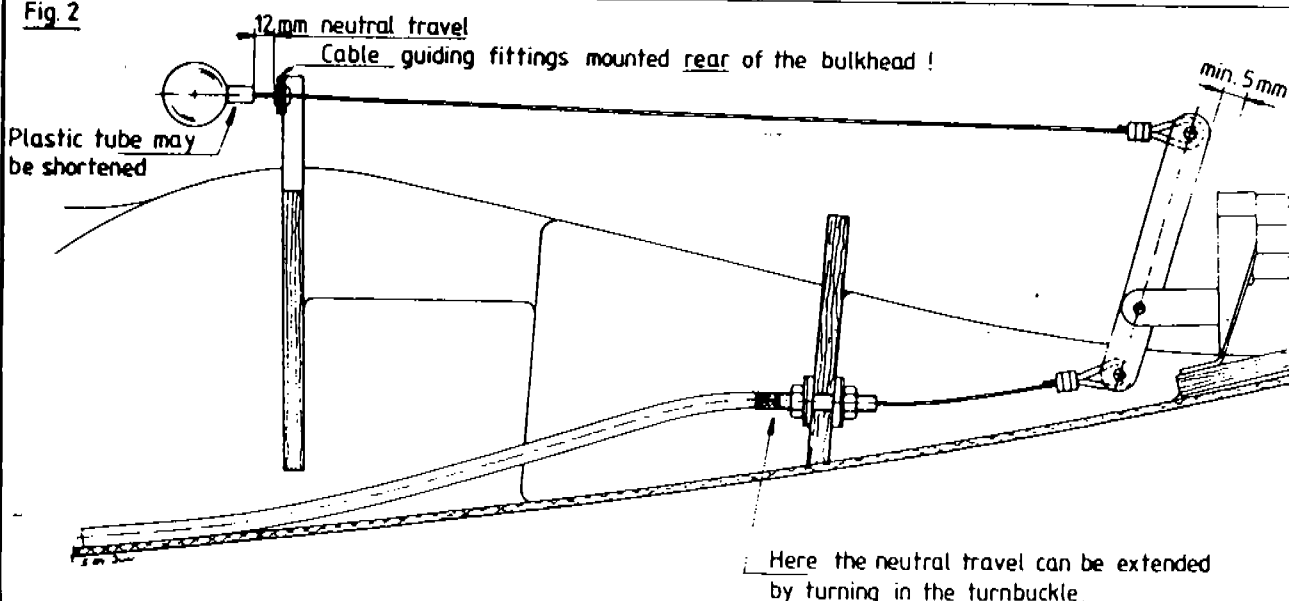
Fig. 2

Background: With older ASW 19 and ASW 19 B the cable guiding fittings were mounted in front of the control bulkhead (as shown in Fig. 1), while with newer gliders the fittings were mounted as standard rear of the control bulkhead (See Fig. 2).

If the cable guiding fittings are mounted in front of the control bulkhead with sufficient neutral travel, the neutral travel disappears in case that the fittings are mounted by mistake rear of the control bulkhead.

12 mm neutral travel
Cable guiding fittings mounted rear of the bulkhead!

Therefore, all ASW 19 and ASW 19 B must be changed as standard to the mounting of the cable guiding fittings to the rear of the control bulkhead, with sufficient neutral travel (Fig. 2).

1. Check whether the cable guiding fittings are mounted in front of the bulkhead (Fig. 1) or rear of it (Fig. 2).
2. If the fittings are mounted in front of the bulkhead, they must be remounted to the rear!
3. Now you have to check whether sufficient neutral travel is left, as indicated in Fig. 2. With too little neutral travel the plastic tube at the ball grip may be shortened accordingly and/or the neutral travel may be extended by turning in the turnbuckle (Fig. 2).
