## AIRWORTHINESS DIRECTIVE

ASTIR CS from Serial No. 1001 to 1536 inclusive  
ASTIR CS77 from Serial No. 1601 to 1844 inclusive  
ASTIR CS Jeans from Serial No. 2001 to 2248 inclusive  
CLUB ASTIR 11 and STD ASTIR 11 from Serial No. 5001 to 5061 incl.

Inspection/replacement of divebrake system cast bellcranks

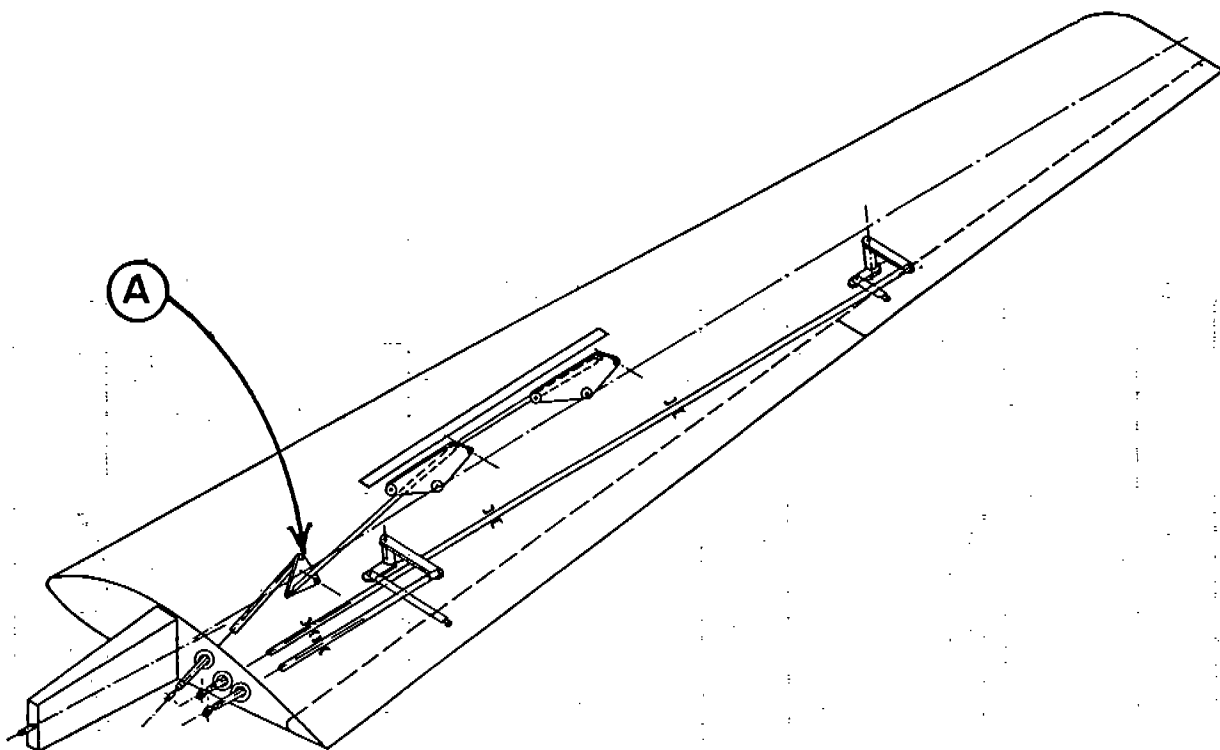
These documents request the inspection and replacement of the cast bellcrank marked (a) in the sketch below.

Anchor nuts have been added to the bellcrank pivots to allow inservice removal of the new bellcranks without the need for re-cutting access holes at a later date.

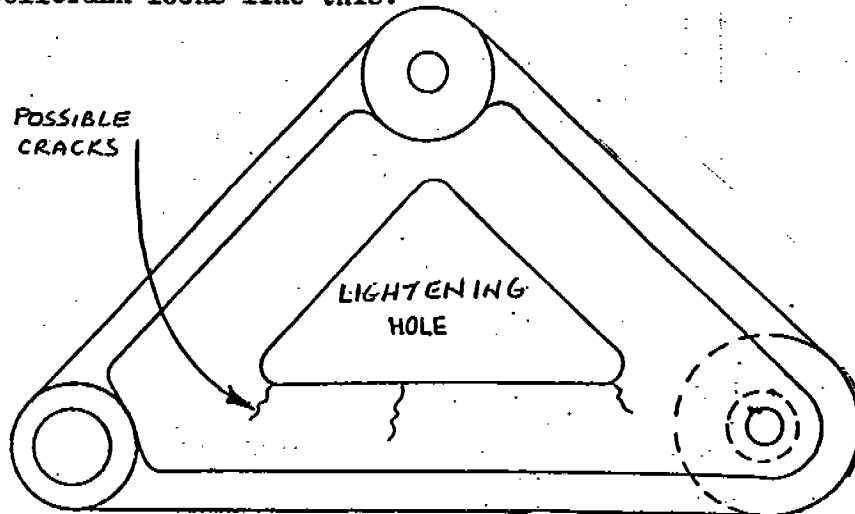
Cut an inspection hole in both wing root ribs and determine if the bellcrank looks like this:

- (a) If the inspection shows no hole in the casting, then you are not required to replace the bellcrank until the 3000 hr life extension inspection.
- (b) If the inspection shows no hole, but the sailplane has passed 3000 hrs then replacement of the bellcrank must be made on or before June 30th 1987.

(c) If the bellcrank has a hole, then the following is required:

1. Order both mod kits on the attached forms (Before 31st August 85)
2. Cut a 40mm inspection hole as shown on the attached sheets (Dimensions supplied by Grob).
3. Through the hole, determine whether or not the bellcrank is cracked.
4. If the bellcrank is cracked it must be replaced before further operations. (The sailplane is grounded).
5. If no cracks can be seen (they will show as a black line), the sailplane can return to service on the condition that the bellcrank is visually inspected for cracks at each Daily Inspection.  
This must be endorsed on both Parts 1 and 2 of the Maintenance Release.
6. Bellcranks to be replaced on or before 30th June 1987.

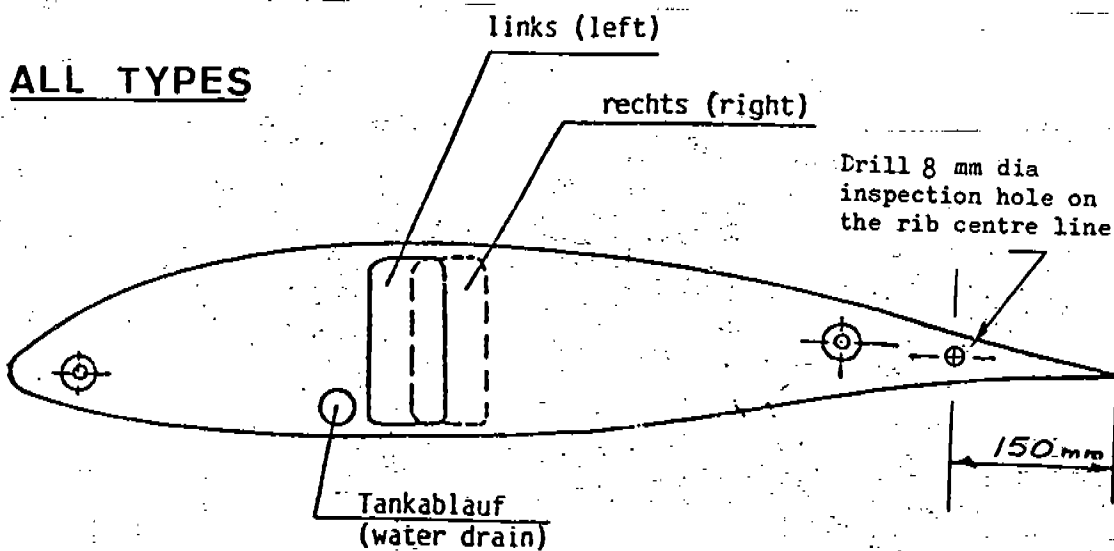
Locate the inspection holes as shown in the following diagram.

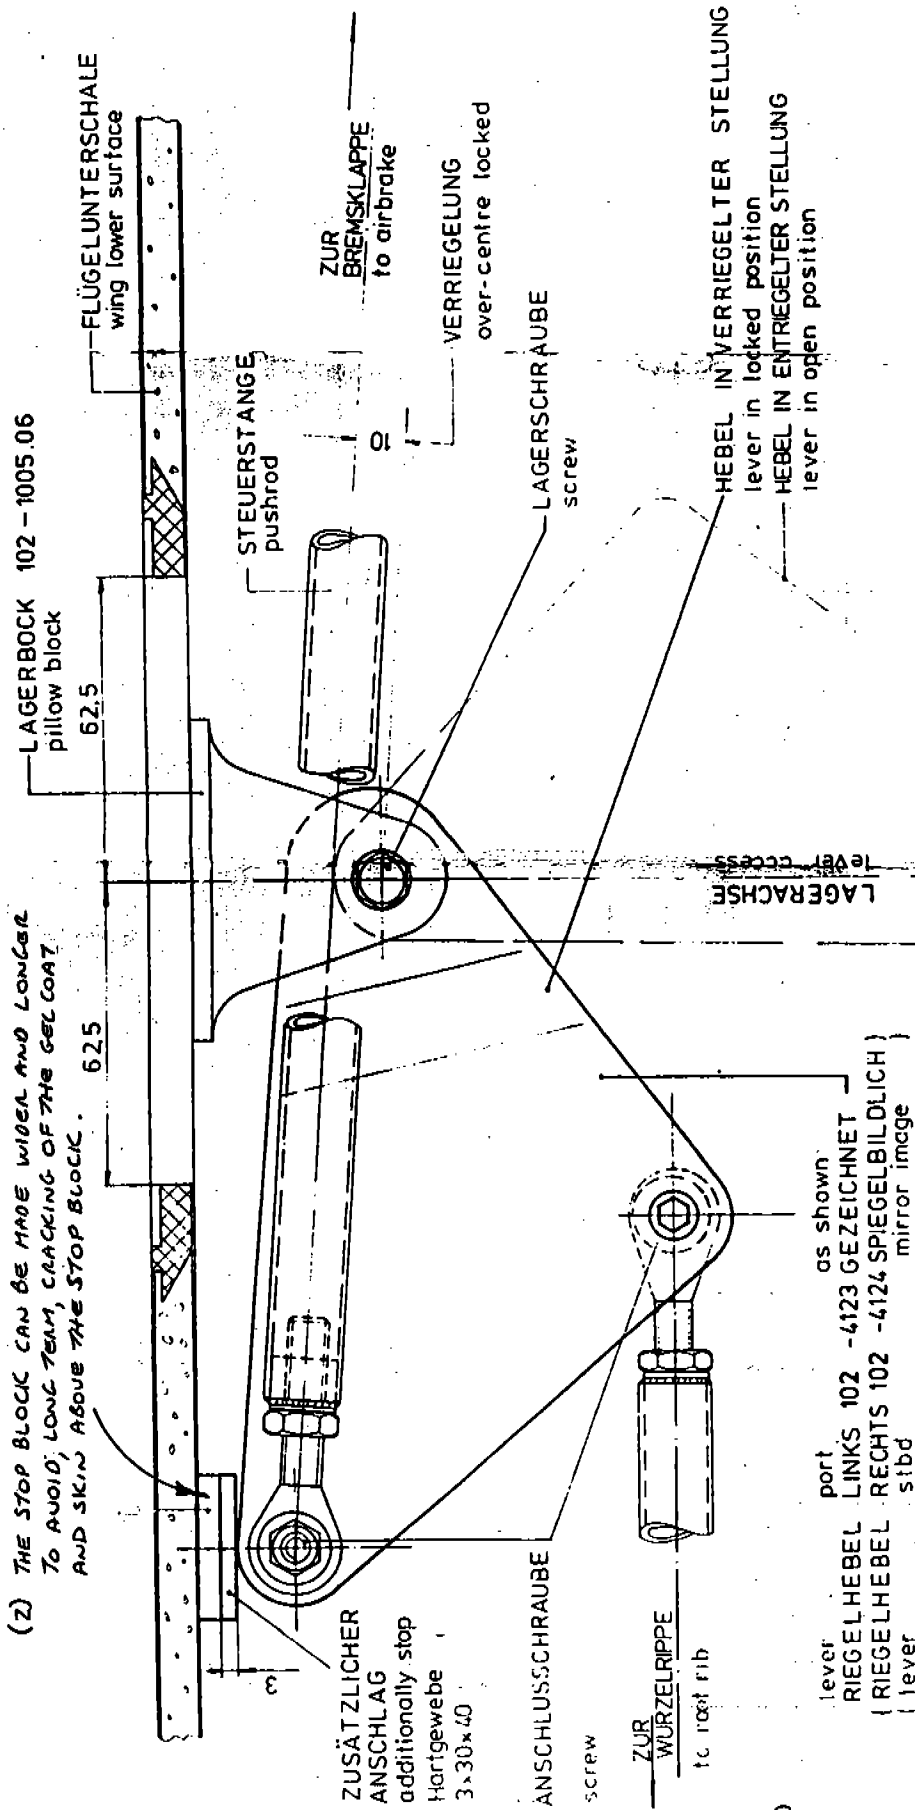
ZEICHNUNG 3  
DRAWING 3  
ZU TM 306-26

(2) THE STOP BLOCK CAN BE MADE WIDER AND LONGER TO AVOID LONG TERM CRACKING OF THE GEL COAT AND SKIN ABOVE THE STOP BLOCK. FIVE

NOTE! (1) ON COMPLETION ENSURE THAT THE BELL CLANK AND PUSH RODS FUNCTION FREELY WITHOUT INTERFERENCE.

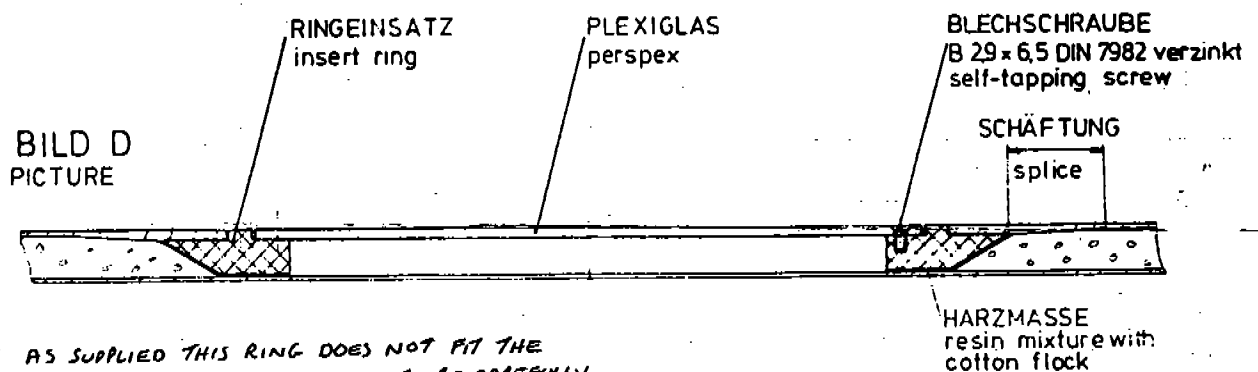
DARSTELLUNG ZU ARBEITSANLEITUNG NR. 306-26/1  
ILLUSTRATION TO REPAIR INSTRUCTION

**NOTE!** AS SUPPLIED THIS RING DOES NOT FIT THE WING CONTOUR REQUIRING IT TO BE CAREFULLY SHAPED TO FIT.
