AIRWORTHINESS DIRECTIVE

TYPE: DG400, 200, 100 - All series and serial Nos.

SUBJECT: Cracking of bottom fin mounted rudder hinge bracket.

GFA/AD 295	Issue 1
14/11/85	Sheet 2 of 2

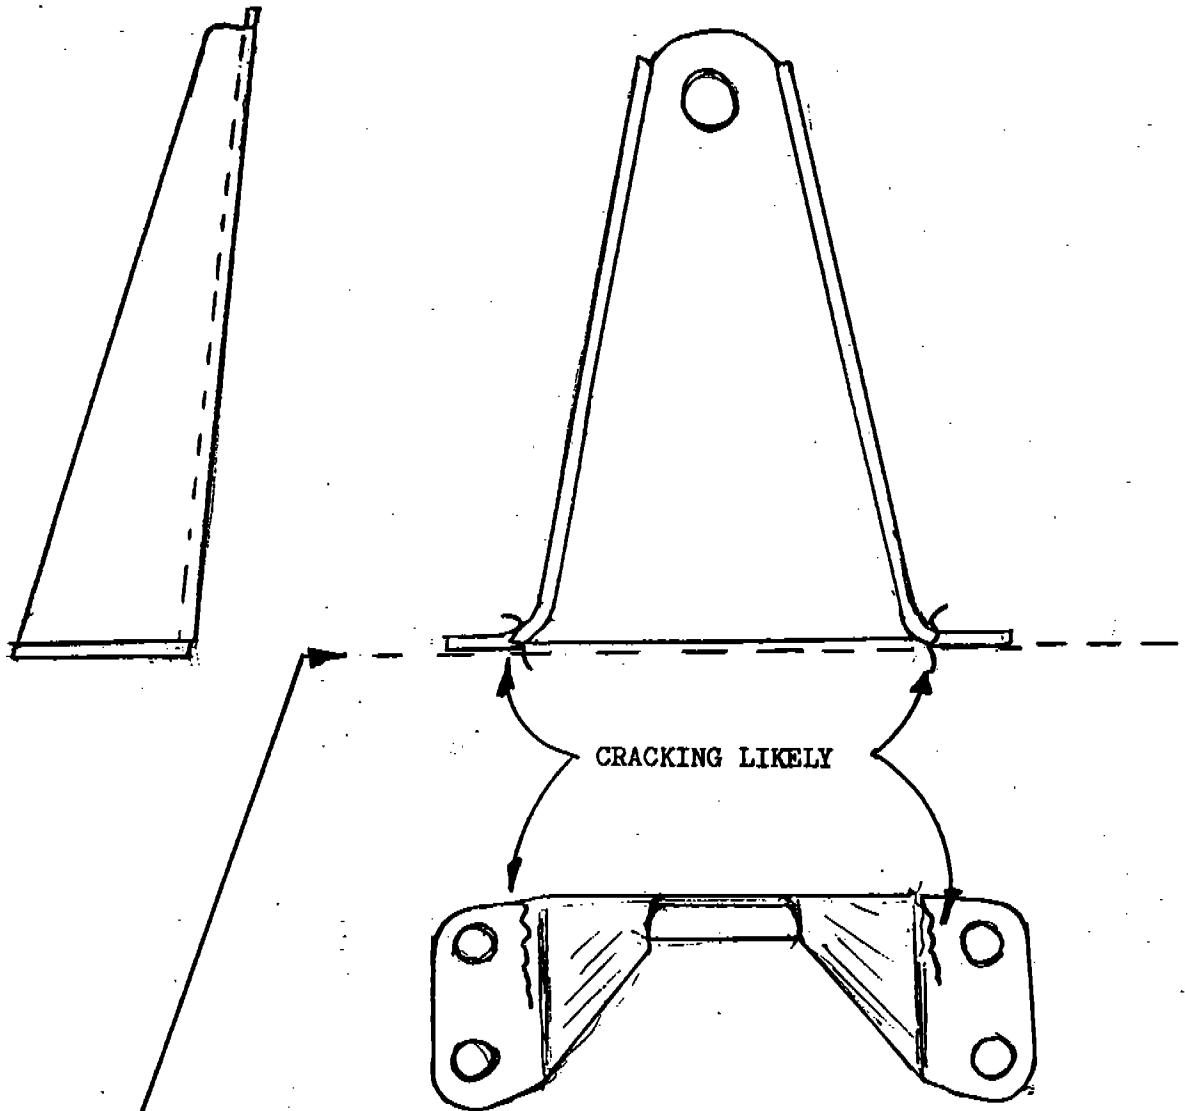
BOTTOM HINGE BRACKET

One reported case of bracket fatigue cracking found in a DG 200 in Australia.

Cracking is most likely to be the result of the two feet of the bracket not being in line with each other, causing pre-loading as the mounting bolts are done up. Also the spar surface may not be flat.

Within the next 25 hours of flight remove the rudder and inspect all rudder hinge brackets for cracks. (Refer illustration Sheet 2).

If a crack is found, the glider is unserviceable until a new bracket is fitted or the cracked bracket repaired by welding.
