CIRCULAR ATTACHED TO AD 364 (issue 1)

AIRWORTHINESS DIRECTIVE

SUBJECT: Modification of Gadringer FB19 Harness Buckle, Tongue Half, to prevent failure to release under emergency conditions.

GFA AD 364	Issue 1	4/8/1989	Sheet 2 of 6
------------	---------	----------	--------------

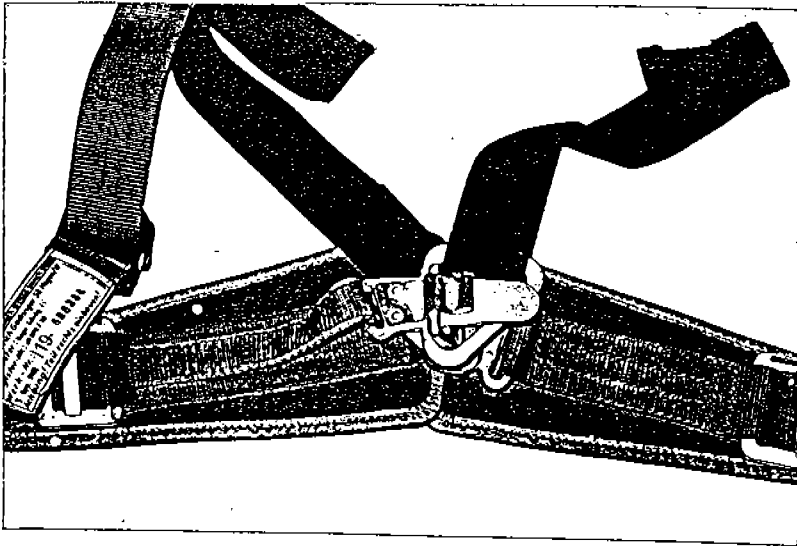
Figure 1

- * Over recent years, many pilot harness assemblies have been subject to renewal of harness straps, replacement of abdominal pads and other repairs and miscellaneous modifications, dictated by age, condition and the high cost of new harness assemblies.
- * Repair and refurbish work has been completed by a wide range of organizations and individuals not all of whom have followed G.F.A. harness repair guidelines, or requested G.F.A. design approval for non standard repairs and modifications.
- * The original Gadringer harness system, fitted with the FB 19 Buckle was fitted with two, large, abdominal support pads which are shown in Figure 1.

These two pads not only provided good abdominal support THEY ALSO PREVENTED THE TWO BUCKLE HALVES ENGAGING TOO FAR, THEREBY PREVENTING THE TWO HALVES JAMMING TOGETHER.

Original Gadringer FB19 harness system with large abdominal pads which overlap in the centre. The pad overlap keeps the buckle halves properly aligned ensuring immediate disengagement when the peg is withdrawn.

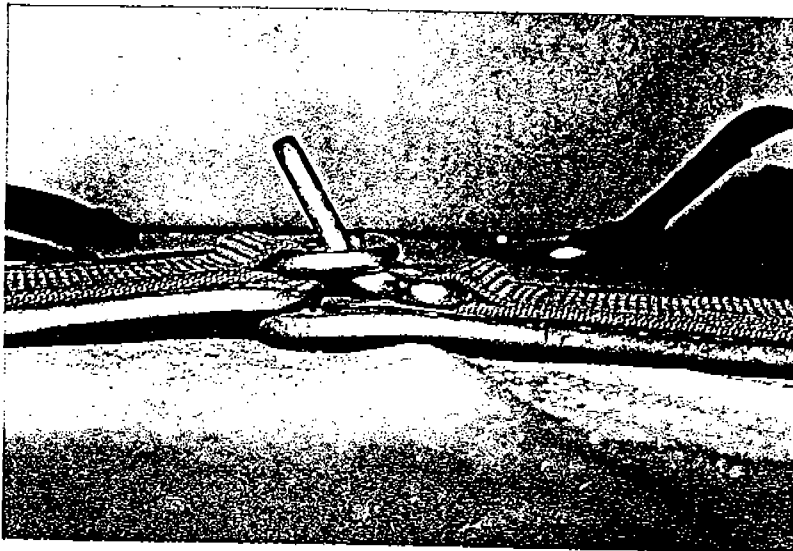
Figure 2

Shows the pad overlap and the correct fit of the two buckle halves. The "bend up" angle of the tongue is obviously important

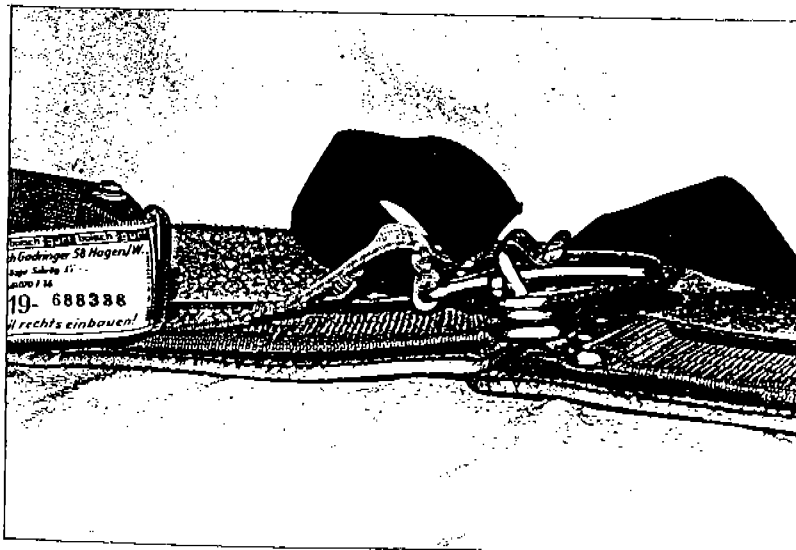
Figure 3

Shows pad overlap and all four straps correctly assembled with proper alignment controlled by the pads.

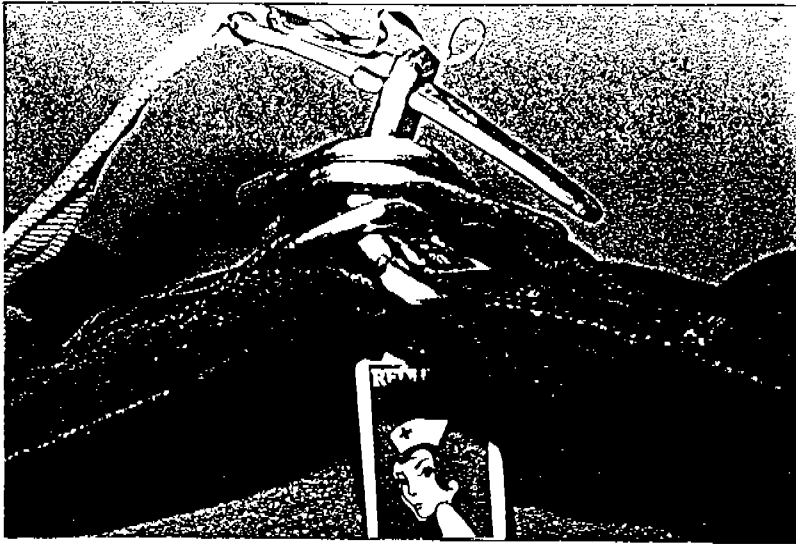
- * The fit of the buckle halves with the correct, original pads is shown in figures 2 and 3. The pad overlap and their stiffness ensuring correct buckle alignment
- * Some refurbished harnesses have no abdominal pads at all. Some have small pads as shown in Figure 4 which do not support or align the buckle halves correctly.
- * Some original Gadringer harness assemblies may be in service with no abdominal pads, the original pads being removed because of deteriorated condition .

These 2 illustrations show that without correct pad support the two lap strap buckle halves can engage too far and hook by jamming together at an angle that prevents self disengagement

The modification to Gadringer Buckle Tongue Half (ident. FB19), fully detailed in APPENDIX A will prevent jamming of the two buckle halves irrespective of the condition or existence of abdominal support pads, provided the following actions are taken.

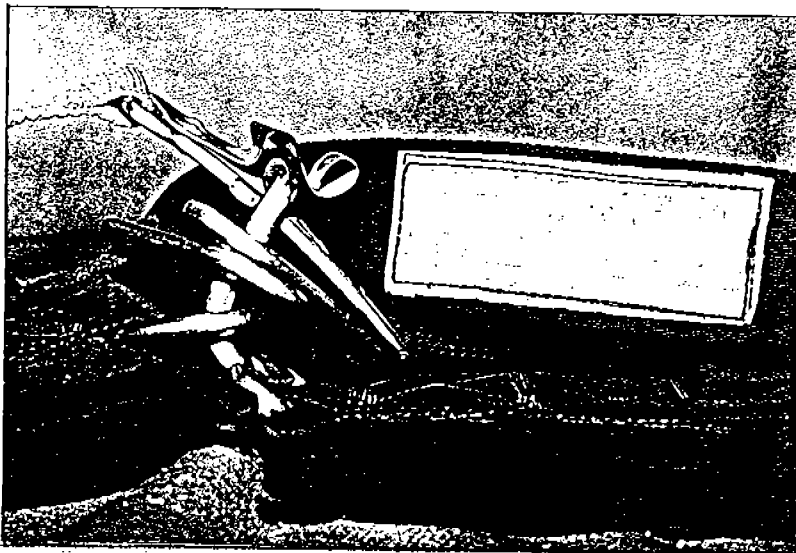
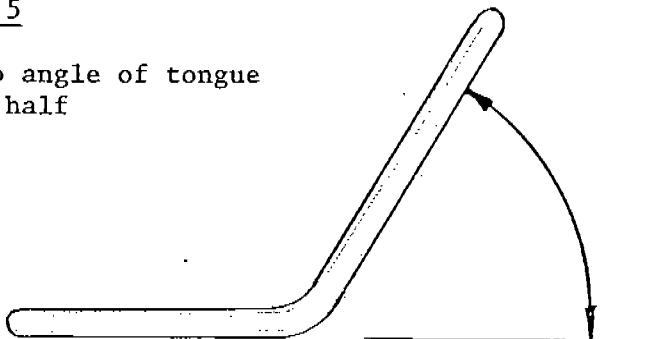
Figure 5

- * Some ORIGINAL Gadringer harnesses still in service may have ORIGINAL abdominal pads which are in such poor condition they may no longer prevent jamming of the two buckle halves.
- * The harness involved in the above incident displayed a considerable change in the bendup angle of the buckle tongue. This may have been damage incurred during the accident or may have been man made at sometime in the past.

ANY CHANGE IN THIS ANGLE WILL AFFECT THE EASE OF DISENGAGEMENT OF THE TWO BUCKLE HALVES.

Bend up angle of tongue buckle half

Bend up angle $57^\circ \pm 2^\circ$ measured at 90° to the tongue fold line.

- (1) Inspect all pilot harness assemblies for the presence of Gadringer buckle tongue half FB19. ALL buckle halves found to then be subject to the following inspection and modification.
- (2) Inspect the FB19 buckle tongue half for condition and the correctness of the bendup angle (reference Figure 5)
- (3) If either the condition of the buckle tongue half is unacceptable or the bendup angle is outside the tolerance stated, the component is to be removed and destroyed.
