## GFA AIRWORTHINESS DIRECTIVE

- SUBJECT:** Cracking of front mounting brackets of C of G (winch) release.
- BACKGROUND:** See attached Grob Service Bulletin MSB 315-62
- DOCUMENTATION:** Luftfahrt-Bundesamt (LBA) Airworthiness Directive No 2002-067 and Grob Service Bulletin No MSB 315-62 form part of this AD.

**Airworthiness  
Directive  
2002-067**

## SERVICE BULLETIN NO. MSB315-62

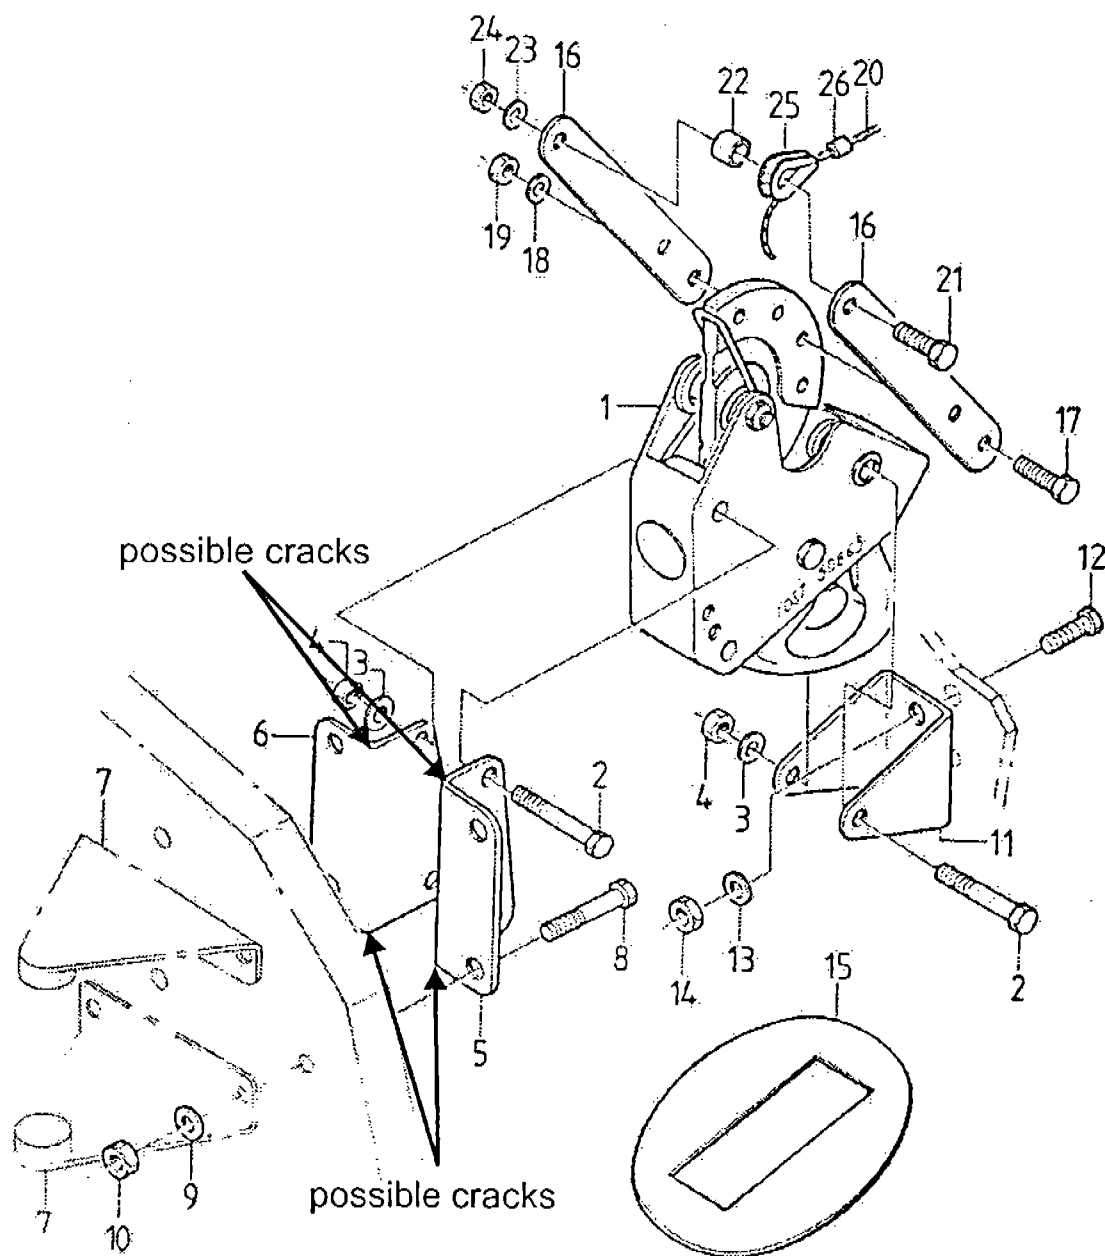
After long time of operation (i.e. towing using the C of G release hook) cracks at the forward C of G release hook attachment brackets might occur.

**Caution:** Illustration below is only for G 103A TWIN II ACRO ! For other models a different arrangement is possible !

- remove rear seat
- check the brackets for possible cracks, refer to illustration on page 2 (if necessary use mirror and pocket lamp)

- remove rear seat
- remove L/H and R/H instrument panel cover
- remove **front** attachment of the C of G hook (item 2, 3, 4), loosen rear attachment (item 12, 13, 14)
- remove attachment brackets (page 2, item 5 and 6)
- install new brackets P/N 103B-2360.01/2 and 103B-2360.02/2
