Occurrence Summaries 01/01/2017 to 31/12/2017 Region(s): All Club:

Christopher Thorpe Executive Manager, Operations The Gliding Federation of Australia Inc.

The Gliding SOAR Accident	The Gliding Federation of Australia Inc SOAR Accident and Incident Occurrences								
General Statistics									
Date From:	Date From: 01/01/2017								
Date to:	31/12/2017

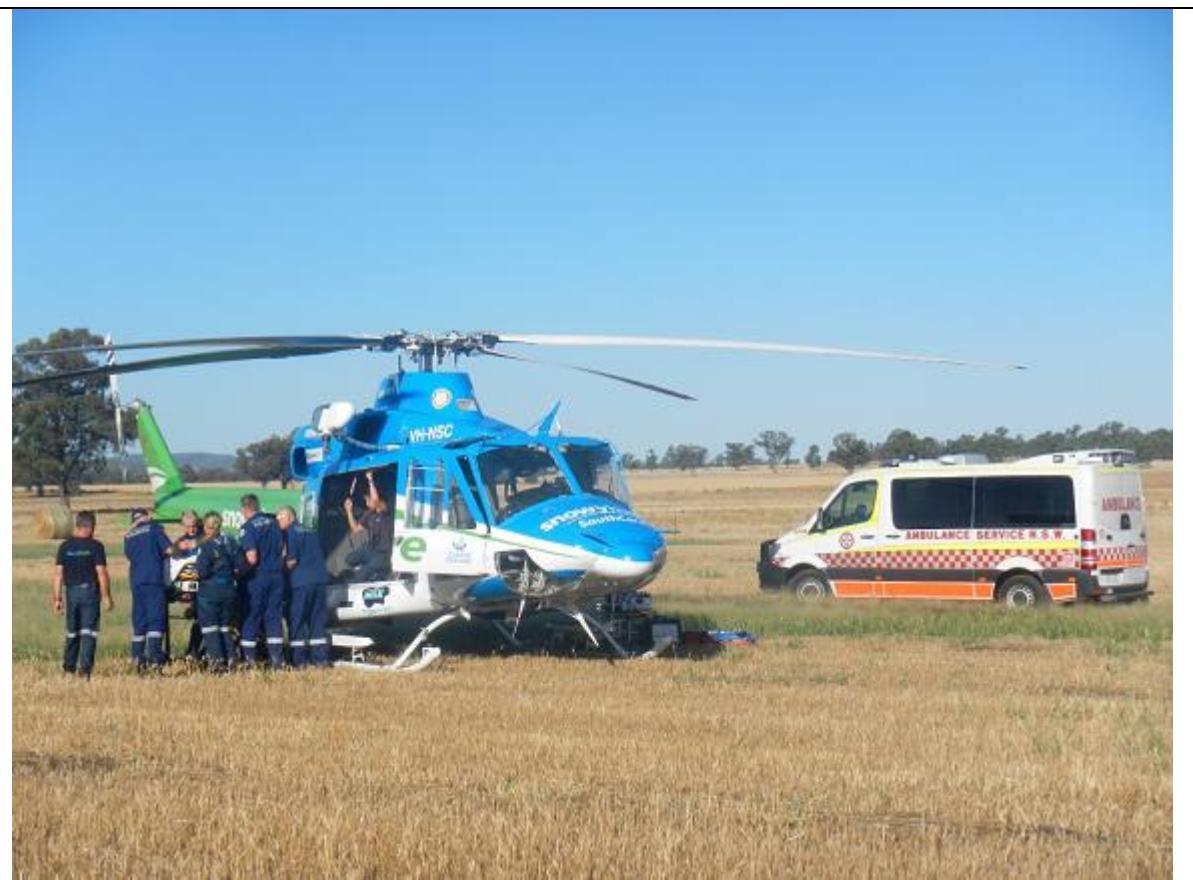
Fig. 2 Emergency services on site (Victoria Police Photo).

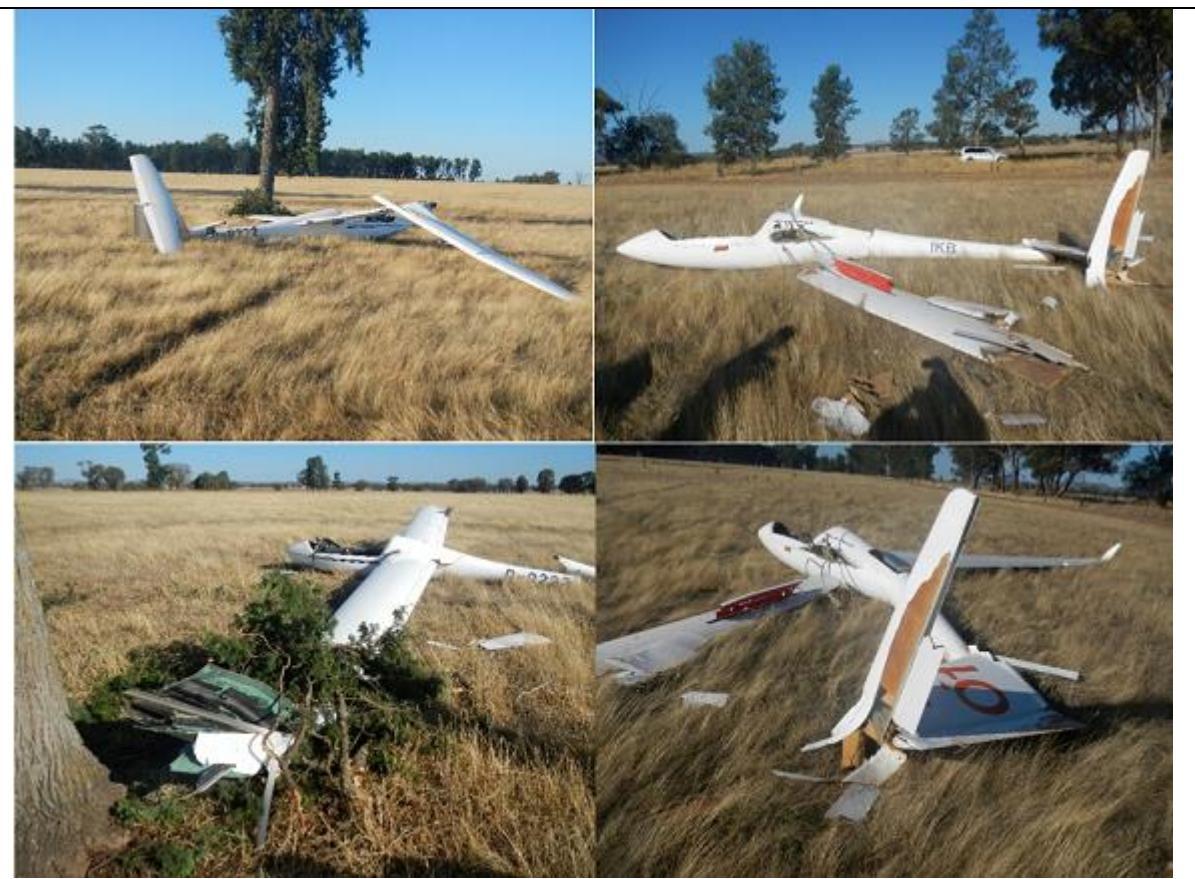
At impact glider O1 suffered catastrophic damage; the pilot's head smashed the Perspex canopy, the fuselage broke behind the engine bay, and half the tailplane broke away together with 2 metres of the outboard port wing. Glider DE appears to have suffered only minor damage from the collision. While under parachute descent the pilot of DE observed their glider to be complete and in a stable flat spin until it hit terrain. The pilot of O1 stated: *"In an instant I heard and felt a violent unseen impact, was aware of broken perspex, strong airflow and that my glider was immediately unflyable. My perception was that the glider pitched down steeply at impact and started spinning to the left in a violent unnatural action. The broken perspex was from my head breaking through the canopy, caused by the impact that took off most of the tailplane, broke the fuselage at the engine bay and took 6ft off the left wing." When under parachute descent after a low-level egress, the pilot of glider O1 observed their glider falling vertically, with its port wing low, without oscillating. They observed damage to the tail and fuselage and heard a loud impact as the glider struck the ground. Both aircraft were substantially destroyed on impact and have been written off by their respective insurers. Glider DE was repatriated to Germany.*

Fig 3. Damaged aircraft (Victoria Police photos).

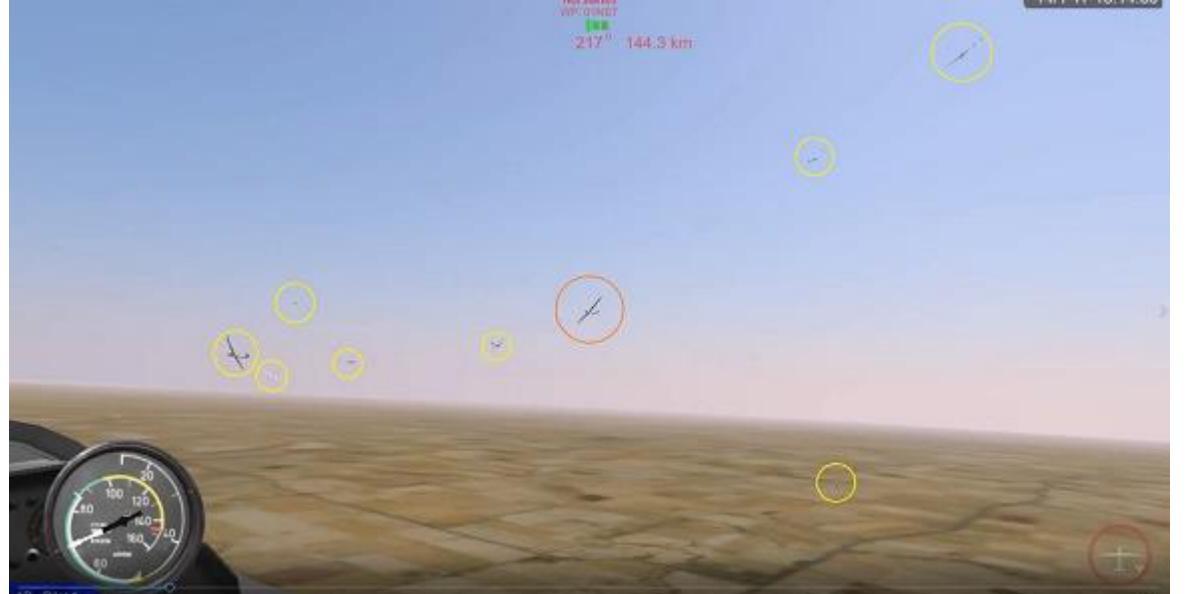
Flarm and logger records for all aircraft in the 15 metres class were made available. Analysis of these records revealed that glider O1 approached glider DE from the rear, flying about 160 ft below. From 1614:17 to 1614:20 hours, glider O1 was below glider DE, with a very small elevation difference, before the collision occurred. Glider O1 and glider DE collided when O1 slowed down and climbed in lift at the edge of the thermal and the pilot of DE lowered the nose to increase speed on exiting the thermal. An evaluation of the logger records suggests that the pilot of glider DE did not have an opportunity to recognise the approach of glider O1, which was approaching from behind and below. In contrast, the pilot of the glider O1 had glider DE in front of them most of the time and should have been able to see it. However, as there were several gliders in the immediate vicinity of glider O1, the pilot's focus may have been on other gliders they deemed more of a threat.

Fig.5: Simulated view (The IGC logger files for all aircraft in 15-metre class were loaded into the 'Silent Wings' flight simulator program in order to review the pilot's view just prior to the collision) from glider O1 as the pilot manoeuvres slightly left on entering the edge of the thermal approximately 20 seconds before impact. Gliders in thermal are circled. Glider DE is circled orange. Another glider (G1) is out of frame to the pilot's right.

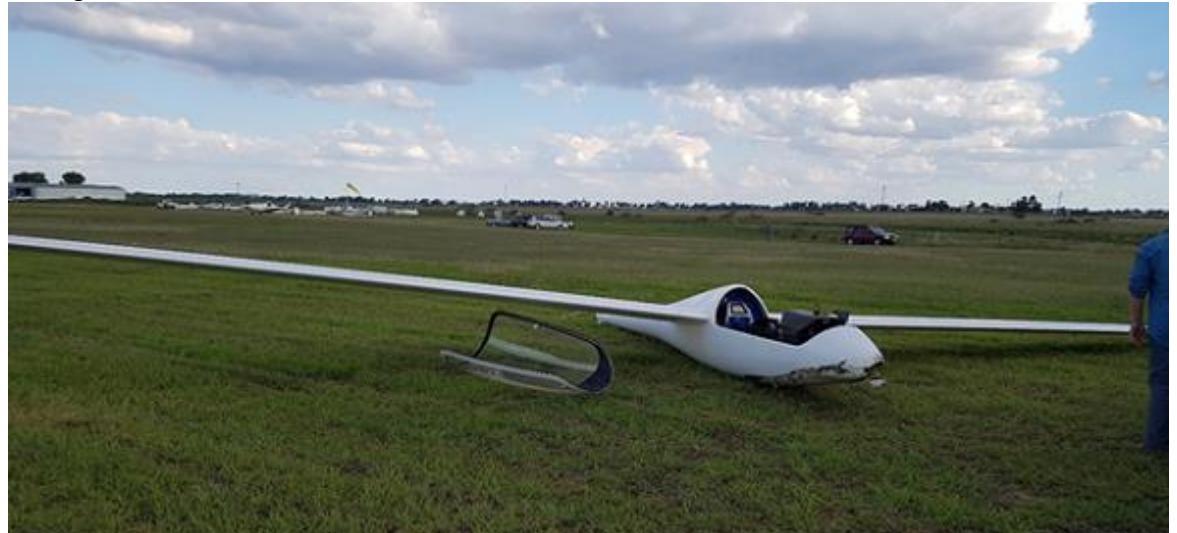
At about 1539 Eastern Standard Time on 15 April 2017, while conducting a low-level and high-speed circuit onto runway 12 at McCaffrey's Field Qld, the pilot flew into the ground during the final approach. The aircraft impacted forcefully on its nose and came to rest about 100 metres from the point of impact. The aircraft suffered substantial damage, with the vertical and horizontal stabilisers separating from the fuselage.

Figure 1: Damaged aircraft.

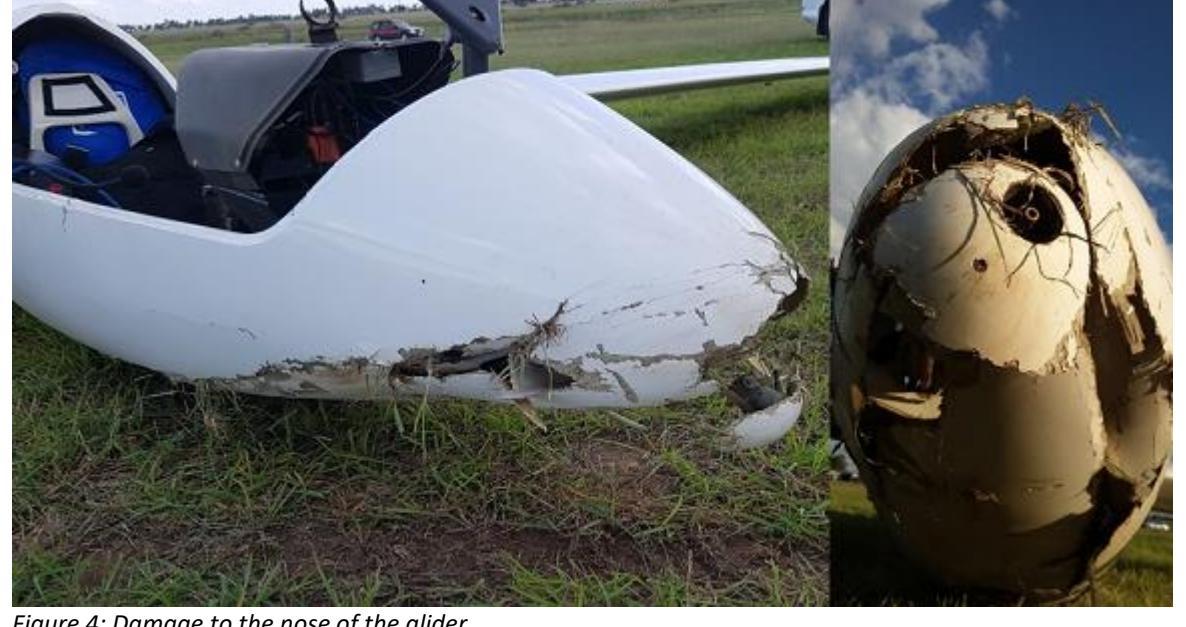
Figure 4: Damage to the nose of the glider. Pilot

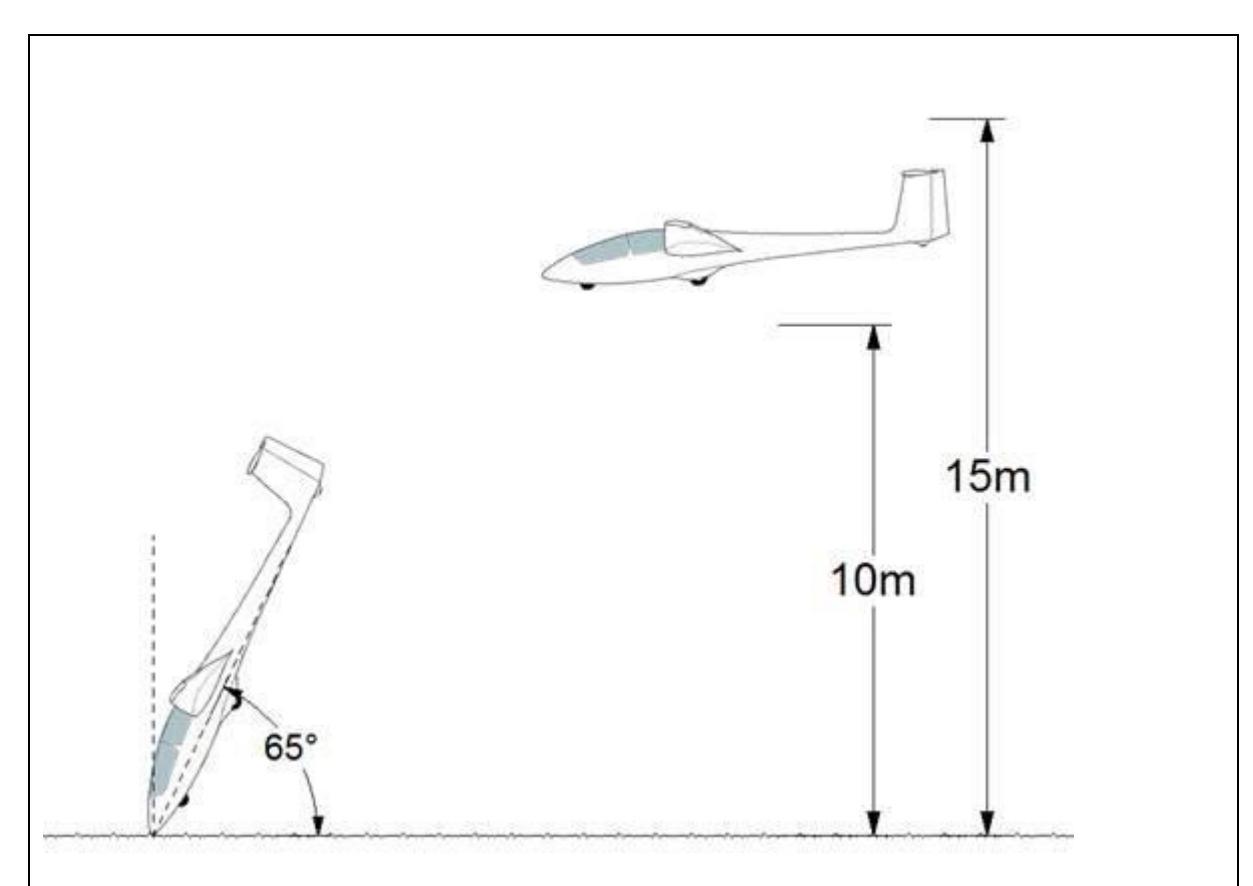
Figure 2: Impact profile

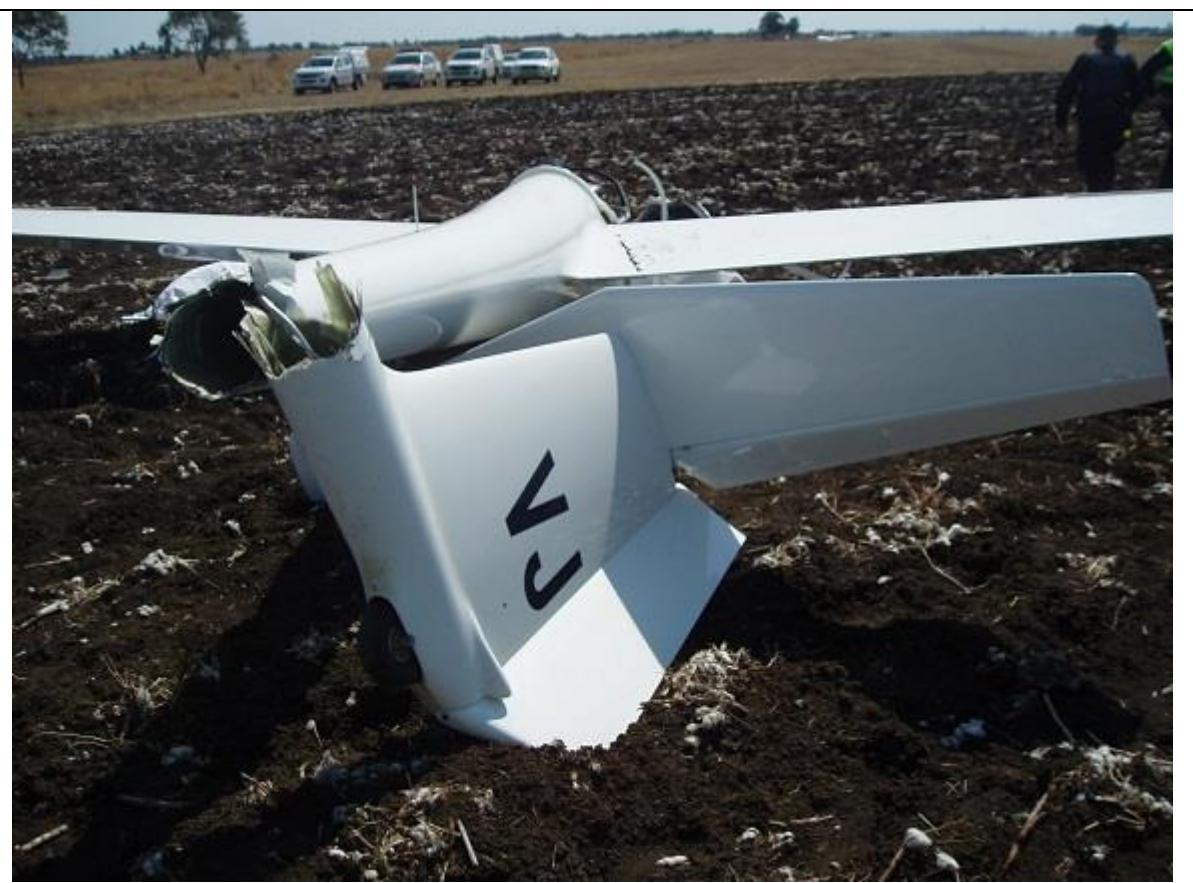
Figure 5: Tail boom, rudder and elevator.

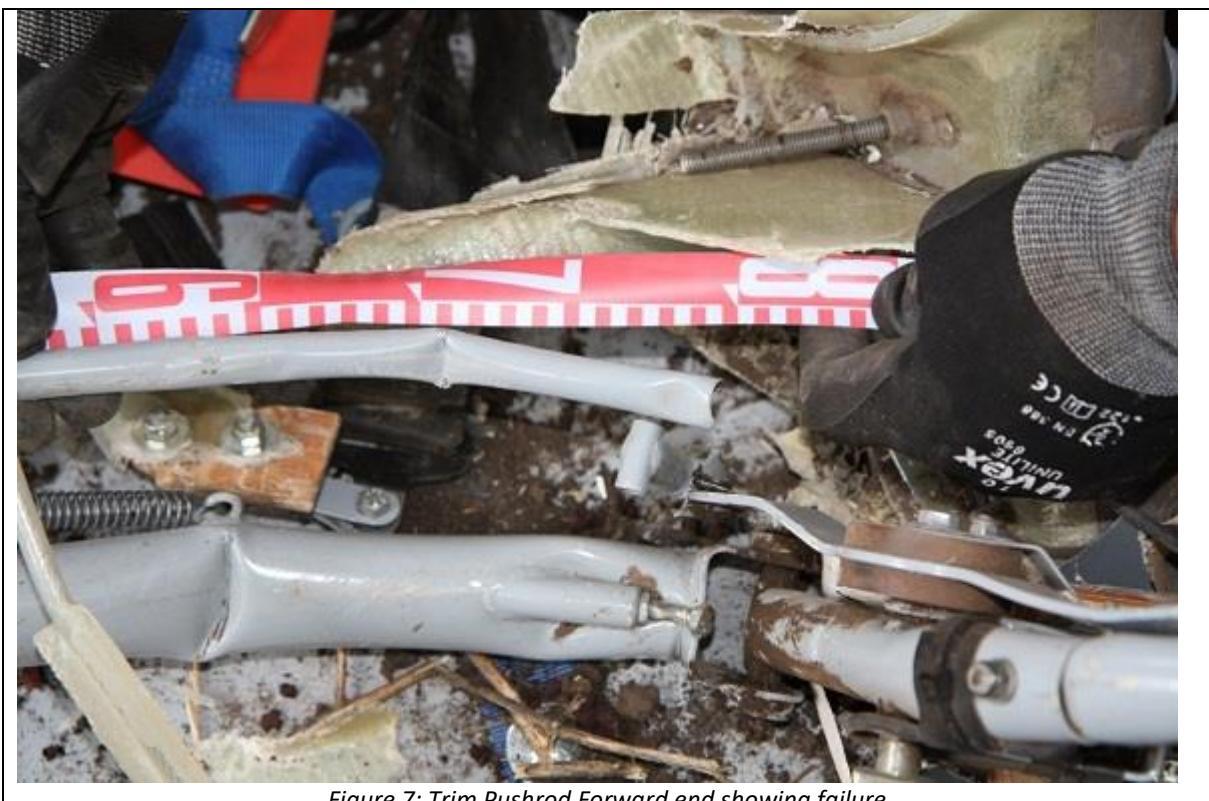
Figure 7: Trim Pushrod Forward end showing failure

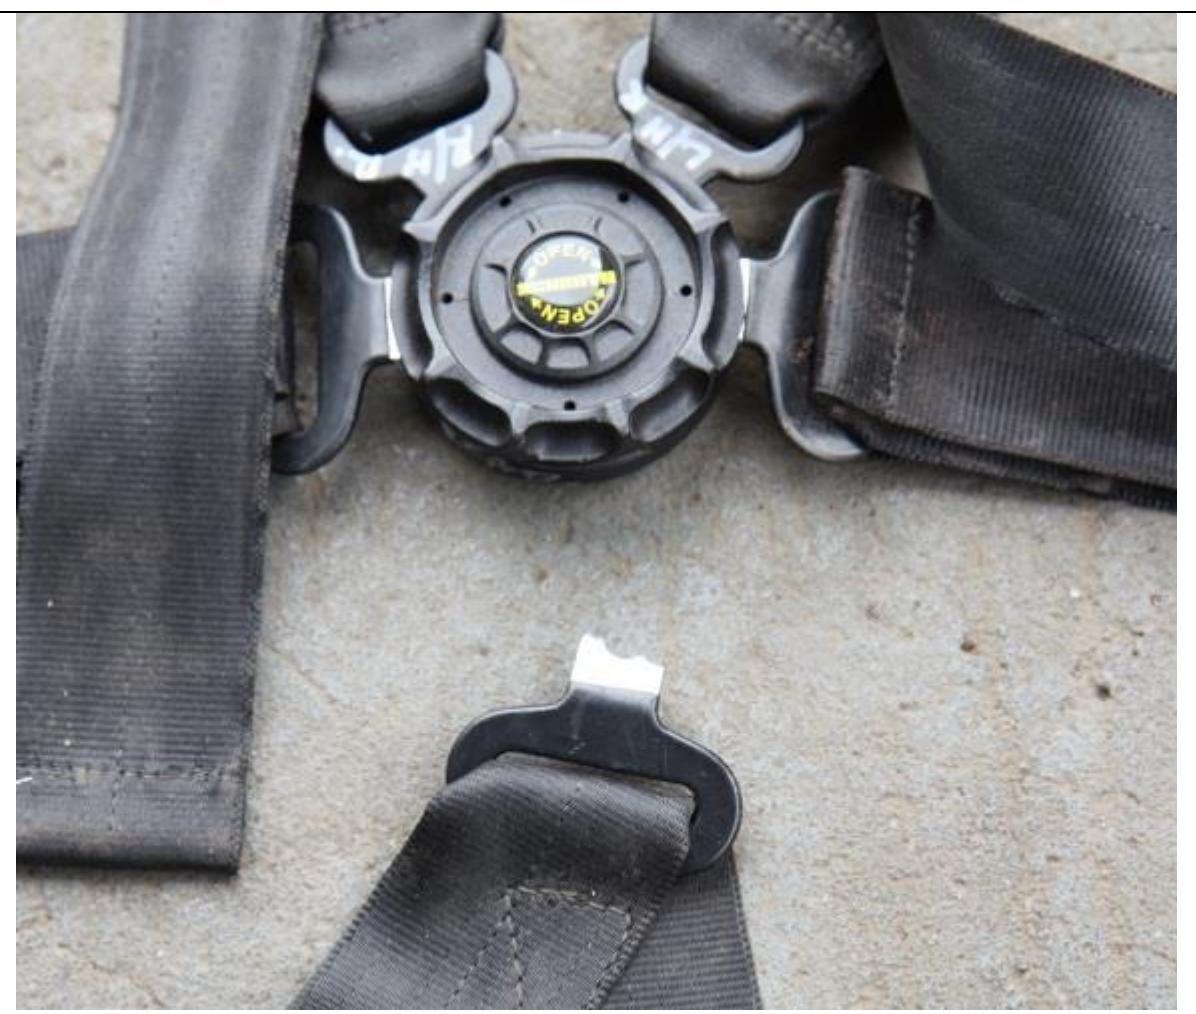
Figure 11: Rear Harness with failed crotch strap tang

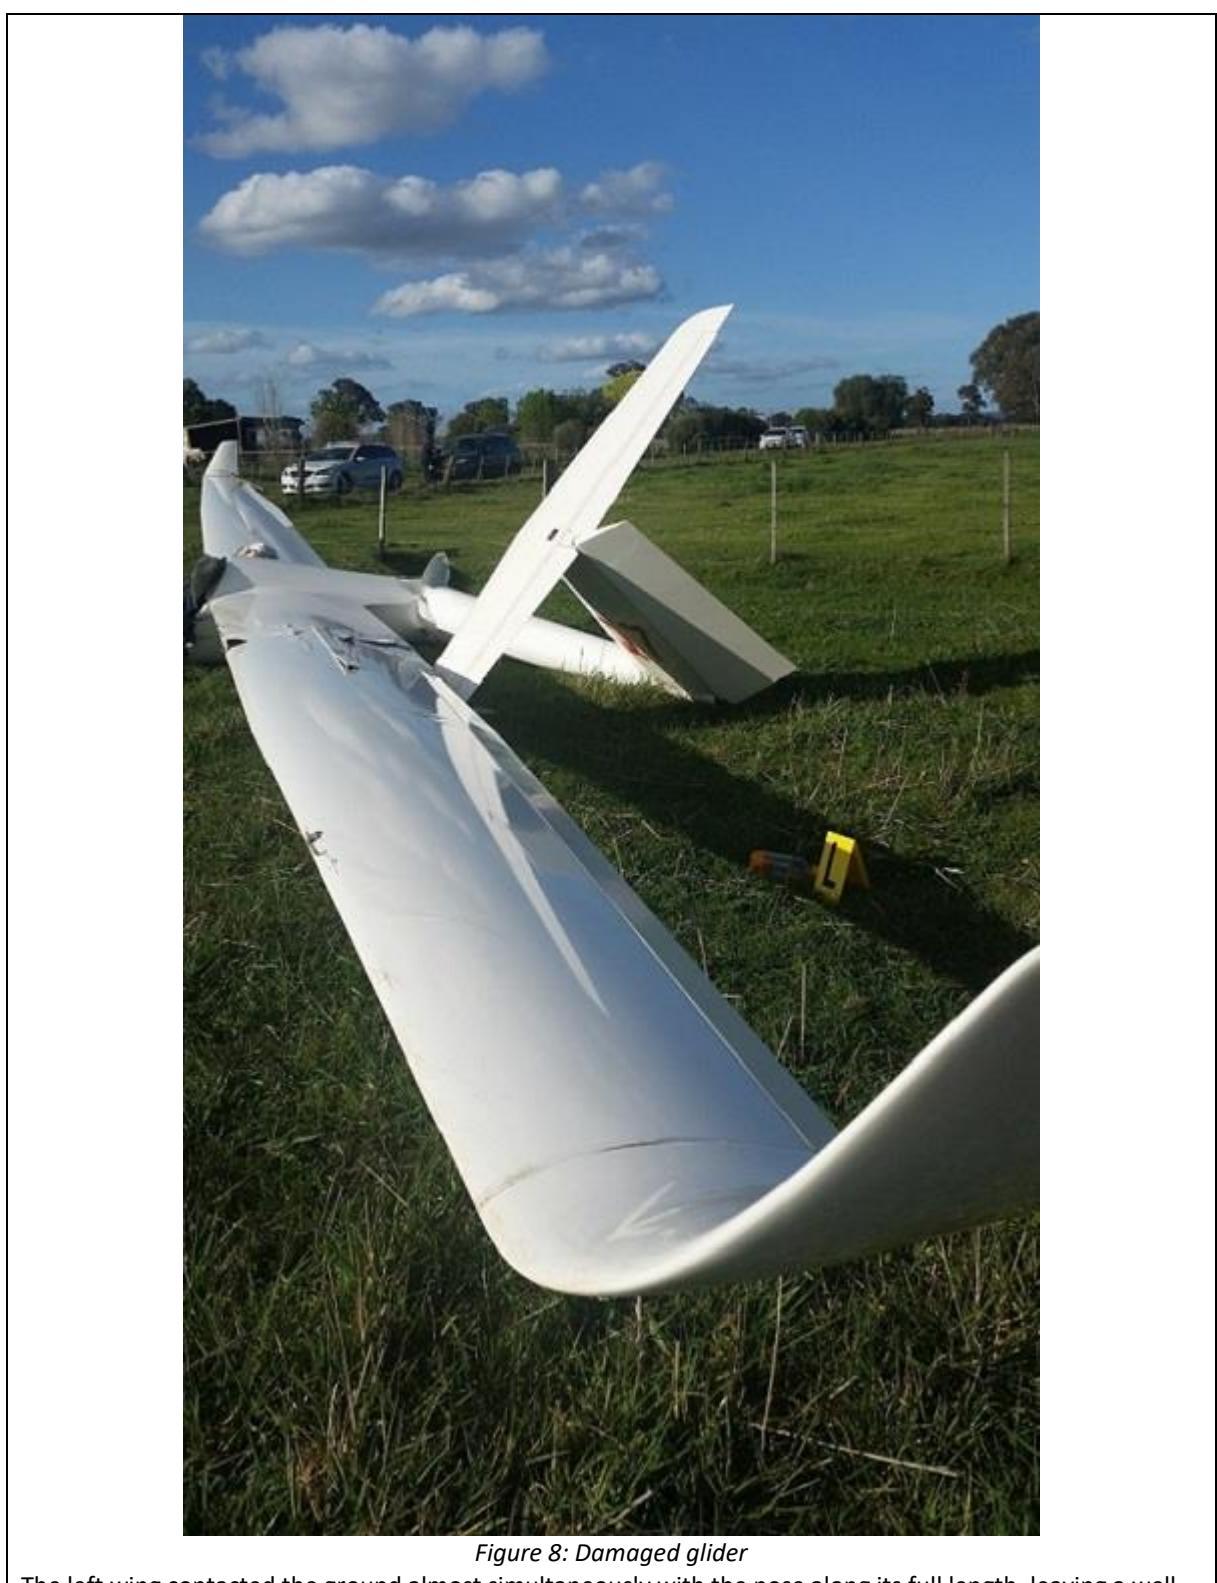
The left wing contacted the ground almost simultaneously with the nose along its full length, leaving a welldefined depression in the ground. The left-hand wing suffered significant damage.

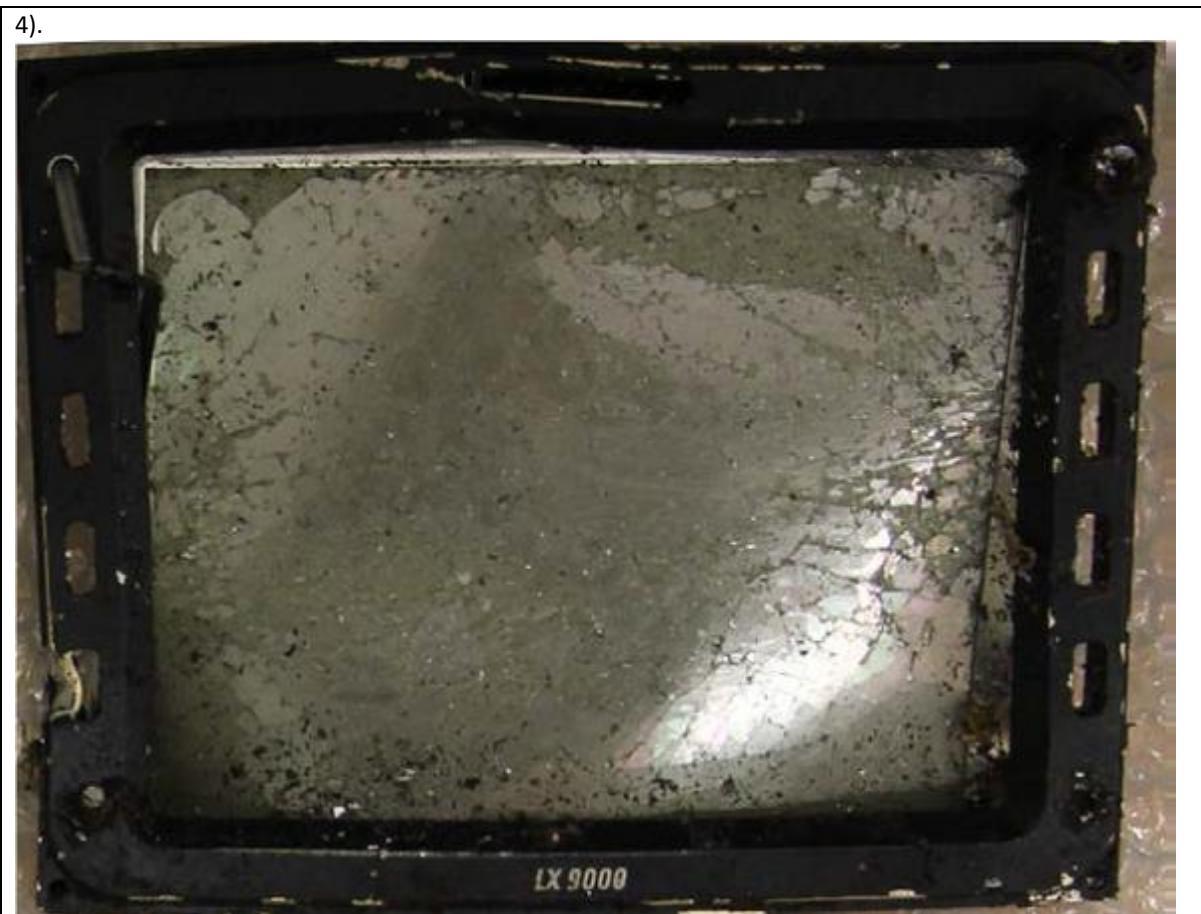
Figure 4: The damaged LXNAV LX 9000 taken from VH-IBS

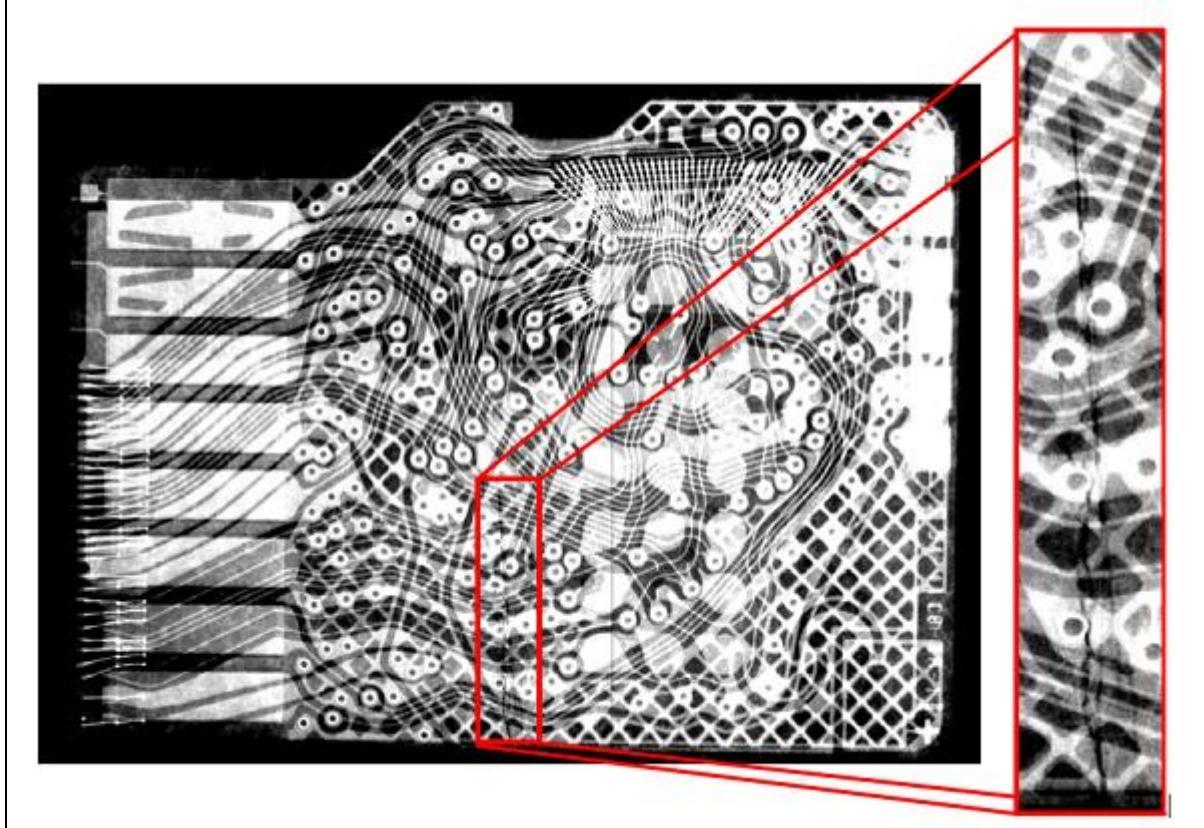
*Figure 7: X-ray of micro-SD card*The following conclusions were made with respect to the examination of the avionics unit provided to the ATSB:

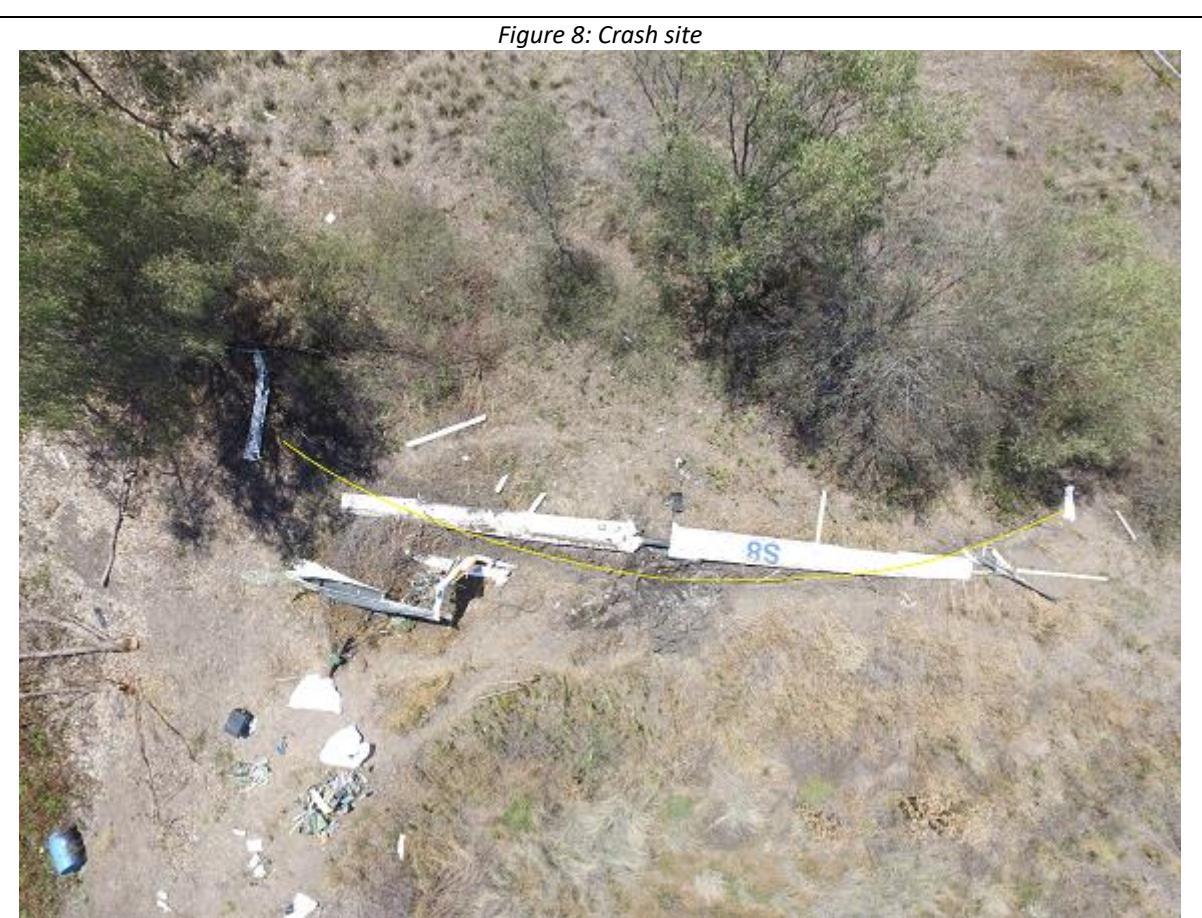
Figure 9: Aerial photograph of crash site showing the ground scar left by the wing (yellow)

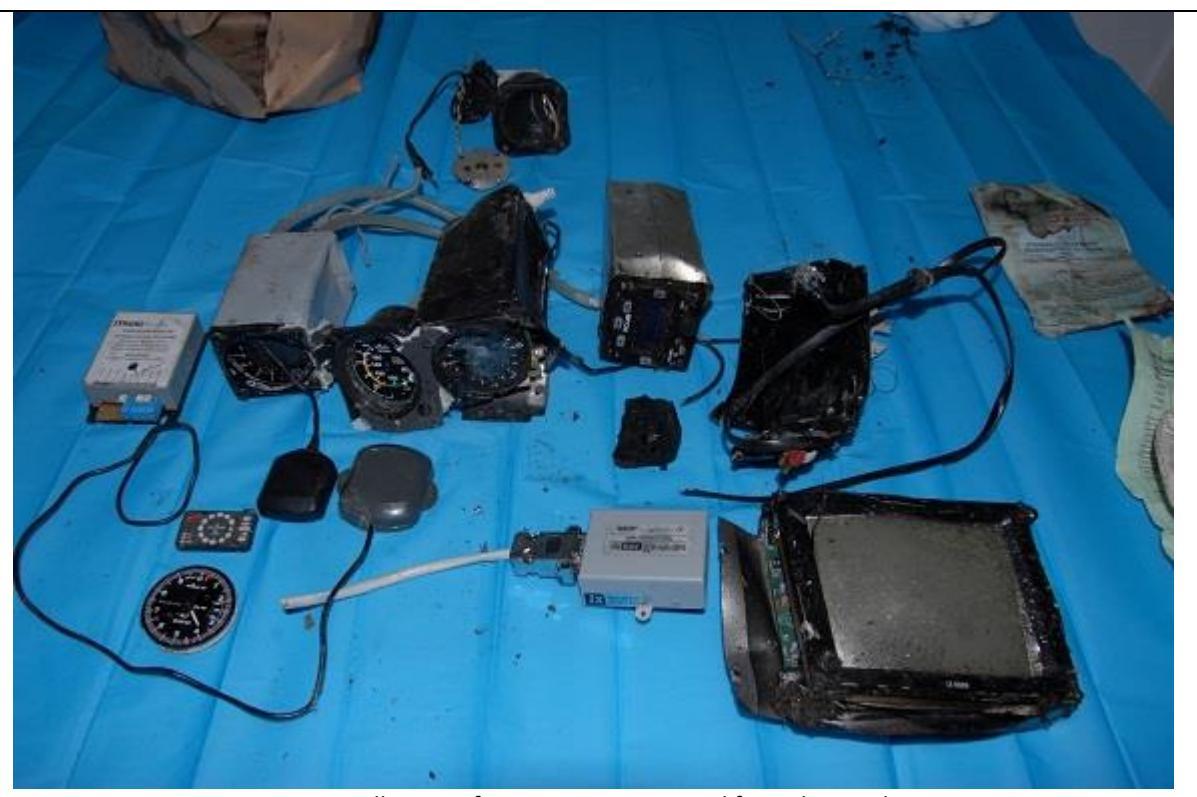
Figure 10: collection of instruments recovered from the accident site.
