AIRWORTHINESS DIRECTIVE

THE GLIDING FEDERATION OF AUSTRALIA Inc.

C4/1-13 THE GATEWAY, BROADMEADOWS VICTORIA 3047 PHONE +61 (0) 3 9359 9865 FAX +61 (0) 3 9359 1613. ABN: 82 433 264 489	GFAAD 684 Issue 2 Date: December 5 th 2018 Fully replaces Issue 1 dated February 2017, clarifying inspection procedures and specifying replacement valves must comply with CS22.695
Subject	Inspection, replacement and life limitations of ON / OFF fuel valves fitted to powered sailplanes.
Background	There have been reported cases of Fuel Shut Off Valves failing, resulting in in-flight engine power loss. In most cases the valve partially restricts flow when selected in the "ON" position, causing a reduction of power. Subsequent ground runs may not reveal the problem. On returning the powered sailplane to service; the power loss in flight is repeated. Additionally, there have also been reports of external fuel leaks from the valve spindle. See "Defects." Photo (1) The valve is identified as a Truma, Type V Male / Male ¼ It may have an identification number displayed, depending on the supplier. Example: DE 21G D237

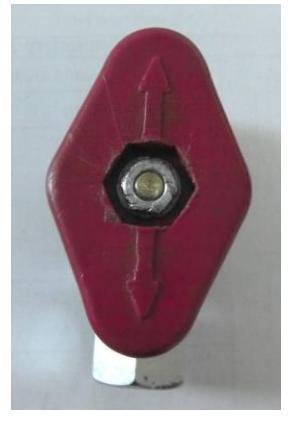
Photo (2)

The securing nut is plain, no locking provided. If this nut loosens even slightly the shaft will damage the rectangular slot. Removing the knob from the shaft shows the rectangular slot needed to drive the shaft. Any wear in the slot causes free play and loss of shaft movement

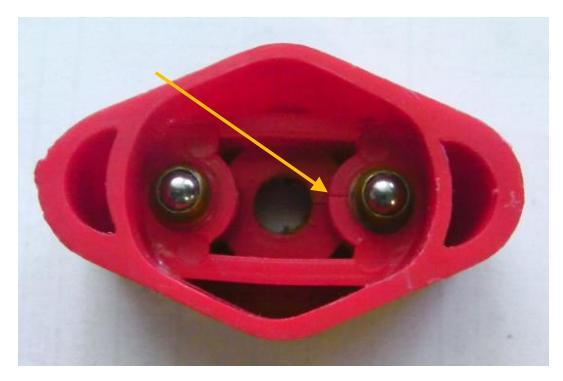
The restriction of fuel flow has been found to be caused by failure of the control knob to turn the shaft through full travel in the ON direction. The result of the rectangular slot in the knob, (engaging over the rectangular shoulder on the top of the shaft) becoming rounded as illustrated in Photo (4).

Photo (4) shows a knob with a rectangular slot which has become rounded causing loss of shaft motion, resulting in fuel flow restriction when the knob is turned in the ON direction. The small, single crack on the inside of the knob may have been there from production, or induced by the stress developed while turning the knob against the loading created by the internal compression spring.

There are 4 options for valve / knob replacement:
	 If a valve has not reached 5 years in service and inspection shows a faulty knob, it may be replaced with a serviceable knob or a new knob from the valve manufacturer. That replacement knob is to be inspected for cracks and slot shape before installation, the securing nut fully tightened, the use of a star washer or thread lock recommended. Replace a time expired valve with a new Truma valve with a life limitation of 5 years and subject to knob inspection both before installation and periodic at Form2 inspections. Install a replacement valve which complies with:
	CS22. 695 (d) Each fuel tank selector must: (1) Require a separate and distinct action to place the selector in the OFF position.
	REPLACEMENT RECOMMENDATION
	Use of any alternative valve, not recommended in this AD, will require individual engineering approval. Consult the GFA CAD for directions.

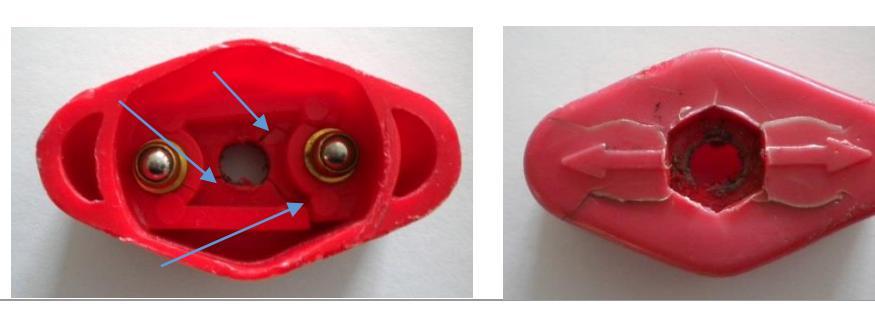
. Photo (5)

It has been suggested the knob failure is due to Ultra Violet Light exposure, however, cracks are seen in knobs with little or no UV damage. It is possible that knobs could be cracked prior to delivery. Photo (6) shows UV damage.

This internal damage is NOT detectable from the top of the knob as shown in Photo (6) It is only apparent when the knob is removed. The cracking in Photo (5) is most likely the result of the stress caused by the rectangular section of the shaft, "reaming" the hole in the knob from rectangular to round.
GFA ACTION	VALVE LIFE LIMITATIONS The Truma fuel valve is limited by this AD to 5 years service, in all powered sailplanes from the date of installation. This limitation is based on deterioration of the internal sealing.
Operator Actions	BEFORE NEXT FLIGHT and EACH ANNUAL INSPECTION:
Valve Replacement	 Remove the plastic plug covering the nut. Undo the nut and remove the knob, checking for damage to the rectangular slot. If damage is found the knob / valve is deemed unserviceable. If no damage, re-fit the knob. Fitment of a star washer and or thread lock is recommended. Place the knob in the OFF position and gently check for free play as the knob is turned to the ON position. No free play allows the valve to return to service. If the knob passes the free play check, identify from logbook records the time in service / date fitted. If no records can be found, or if the date fitted is over 5 years, and the valve deemed serviceable, return the powered sailplane to service for a period of 3 months and endorse the MR accordingly. This provides time to organise a replacement valve. If the knob fails the free play inspection, showing loss of motion, remove the valve from service and replace before next flight.
