# THE GLIDING FEDERATION OF AUSTRALIA INC

# Incident Report IS-28B2 Wing Rigging Failure

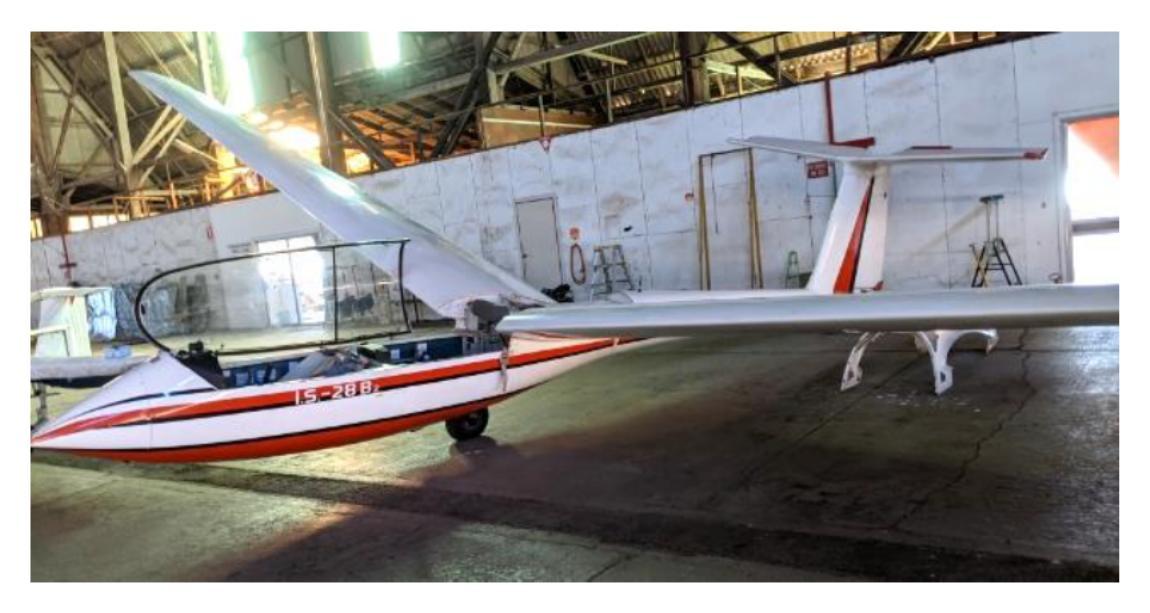
IS-28B2 had recently completed an annual inspection for the issue of a maintenance release and was performing a post maintenance evaluation flight with two pilots onboard. The glider was conducting an aerotow launch. The aircraft had just separated from the ground when a loud cracking noise was heard behind the rear cockpit. The flight was terminated and a landing straight ahead was successfully carried out. After landing, the glider wings exhibited an exaggerated dihedral. On inspection, the connection between the lower wing spar attachment fittings had failed.

# Photo 1 – Post Incident Showing Exaggerated Dihedral

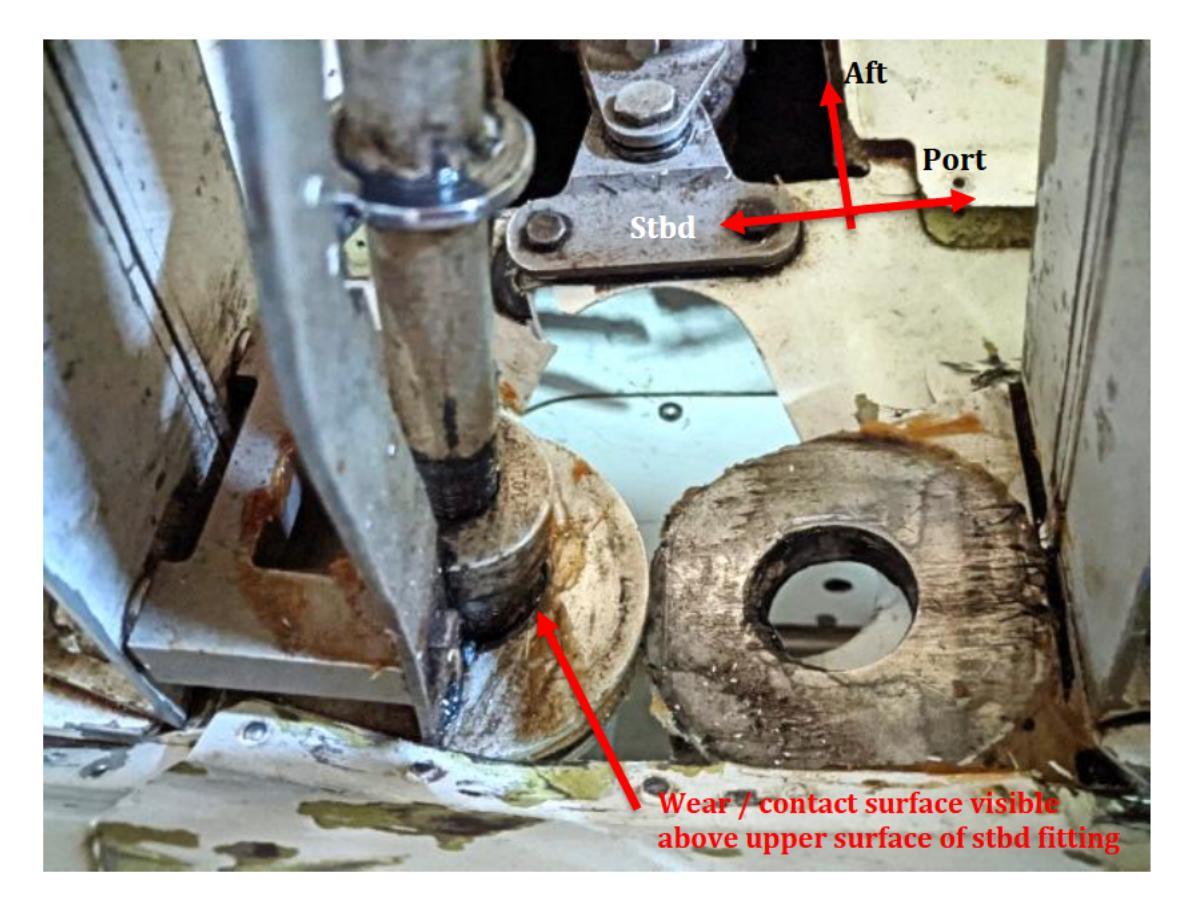
Photo 2 - Lower Spar Connection Post Incident Showing Disconnection of Fittings

The sailplane was inspected by an airworthiness inspector with over 21 years of experience. Visual inspection of the spar fittings showed the upper tapered bolt had engaged in the spar fittings, but lower tapered bolt had not. It was noted that the guide plates that retains the collar of the threaded spindle were deformed and the retaining slots worn. The centre locating collar on the spindle had broken loose from the retaining slots and was well above its normal position.

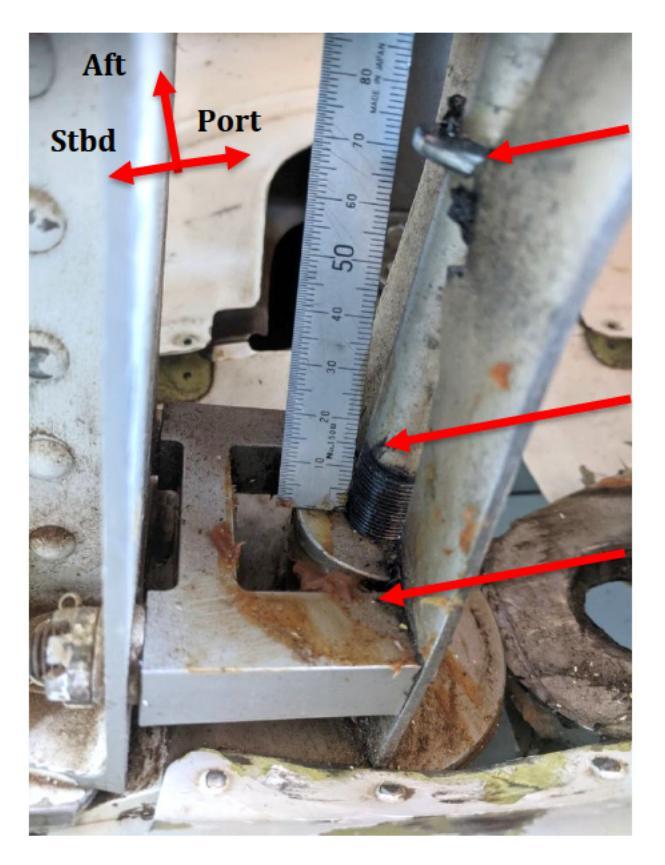
Witnesses during the fitting of the wings state an extension tool was used during the rigging process, which is against the manufacturers' recommendation and explicitly stated not to do in the Flight Manual. Using an extension tool when rigging would give added torque on the spindle and could apply excessive force if either of the tapered bolts were jammed.

The initial inspection suggested the upper tapered bolt had engaged correctly during rigging, but the lower tapered bolt had not engaged correctly. There were less than 14 mm of thread exposed on both the lower and upper tapered bolt. A comparison with another IS-28B2 revealed that both correctly engaged tapered bolts had approximately 25 mm of threads exposed on upper and lower threads when the tapered bolts were fully engaged.

Collar above retaining slots

13 mm thread exposed

Wear / contact surface visible above upper surface of stbd fitting

Photo 3 - Incorrect rigging of - 13 mm thread exposed and wear / contact surfaces visible above upper surface of stbd fitting on lower tapered bolt. Centre collar is above retaining slot in guide plates.

1. Prior to rigging, the slot in the guide plates for the collar should be inspected for undue wear.

2. Prior to rigging, the tapered bolt assembly must be inspected and confirmed to be in good condition, fully functional and serviceable. Worn bolt assemblies must be replaced.

3. The tapered bolts and collar should be visually inspected after rigging (including using a torch and mirror) to ensure upper and lower tapered bolts are fully engaged and collar is retained correctly in slot. Check the exposed threads are roughly equal on the upper and lower surface and approximately 25 mm of thread is exposed. Wear / contact surfaces on both tapered bolts should not be visible.

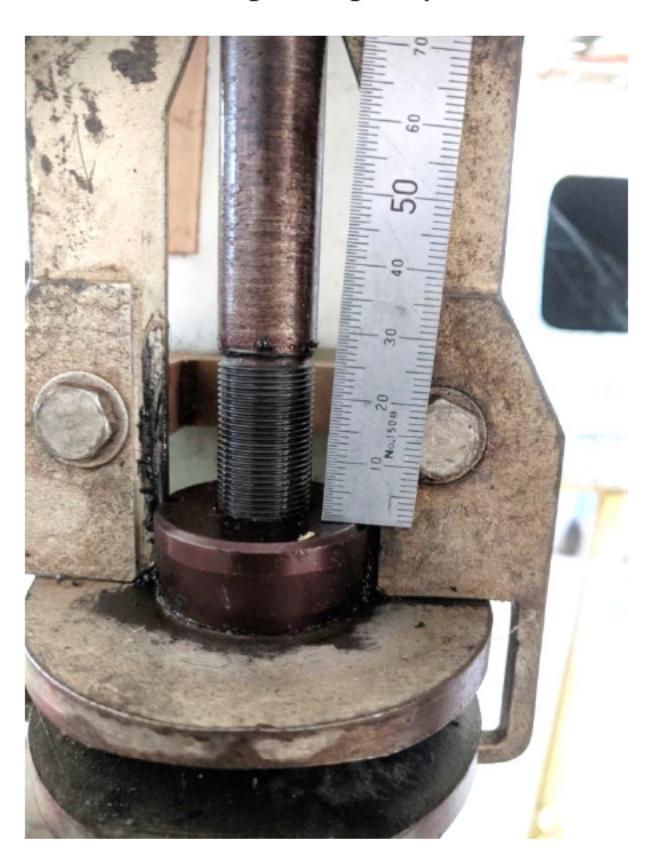
Photo 4 - Correctly engaged lower tapered bolt - 25 mm thread exposed, no wear / contact surfaces of tapered bolt exposed above upper surface of fitting, centre collar housed in retainer.

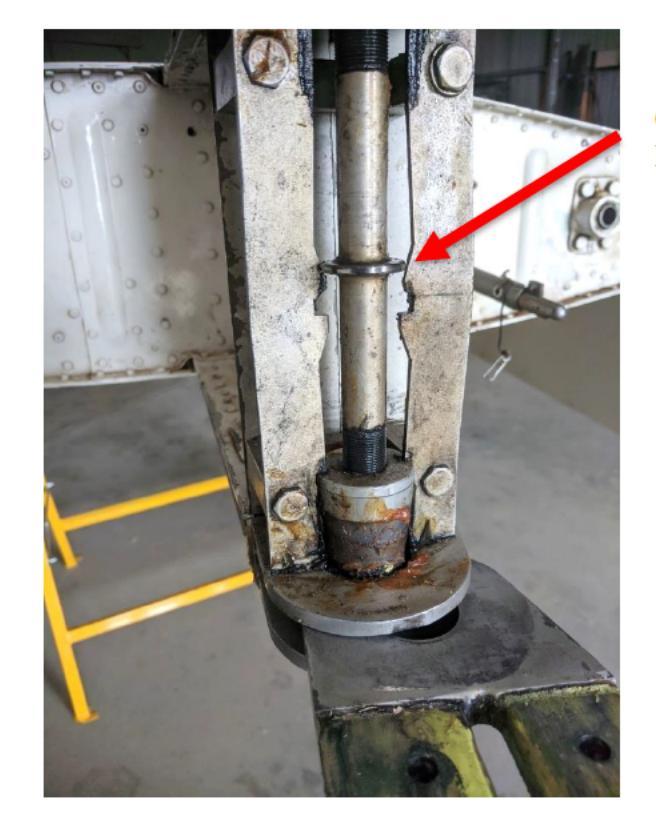
During the assembly of the wings to the fuselage, the lower spar fittings were mis-aligned whilst the upper fittings were aligned. As the spindle was turned, the upper and lower tapered bolts extended. The lower tapered bolt jammed when it encountered the misalignment.

An extension handle was being used on the T handle rigging tool used to rotate the threaded spindle. With the lower tapered bolt jammed and the additional torque provided by the extension to the Tee handle, caused the spindle collar to force itself free of the retaining slots.

The upper tapered bolt was then free to extend into the upper fitting. The lower tapered bolt was still jammed and winding the T handle simply moved the spindle and upper pin upwards. The rigging procedure was concluded when the upper tapered bolt was identified as being fully engaged. The lower retaining bolt had not engaged the port wing fitting at all.

Collar free of slots. Retaining plates deformed.

Photo 5 - Recreation of event. The port lower spar tongue (removed from wing) is jamming the lower tapered bolt with wear / contact surfaces exposed, the collar is 10-15mm above the retaining slots. The collar retaining slots are worn and rounded. The upper tapered bolt is fully engaged.
