THE GLIDING FEDERATION OF AUSTRALIA INC

Airworthiness Alert 2019-2 Austro Engine-Broken Studs

RM-TR-MDC-E1-188a

Stud repair

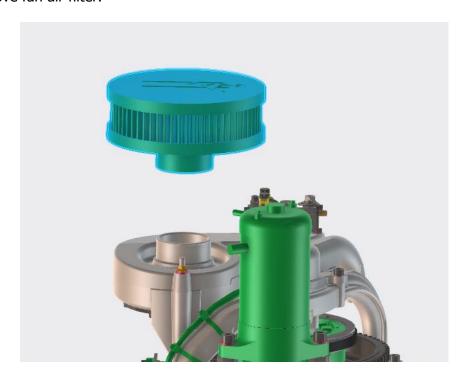
1. Remove fan air filter.

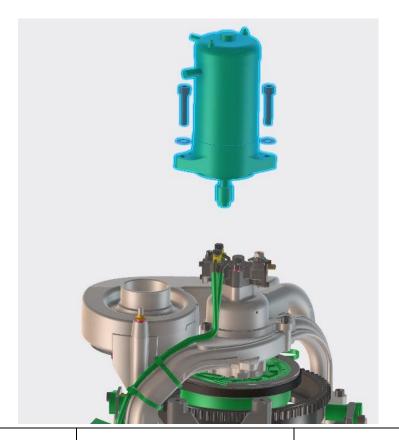
2. Remove starter motor.

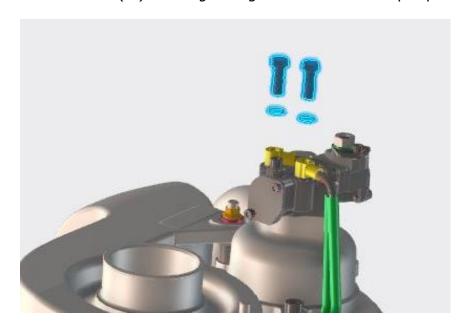
3. Remove oil line screws (2x) including sealing washers from the oil pump.

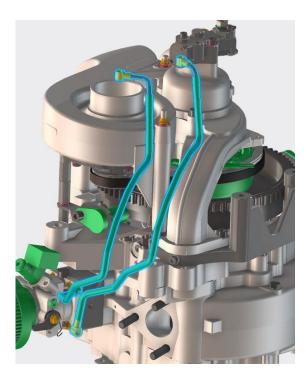
5. Cut cable ties and remove oil lines (2x). Remove all sealing washers from the oil lines from the engine!

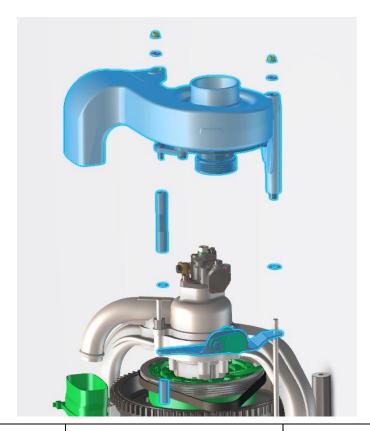
6. Cut cable tie and remove fan assy. Note position and number of washers for reinstallation. Remove distance sleeves and speed sensor assy.

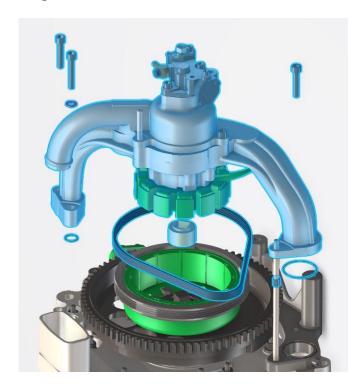
7. Remove water pump housing assy. Remove fan belt and shaft coupling. Remove all Orings and positioning sleeves.

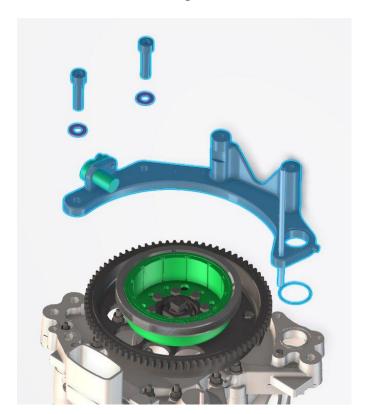
8. Remove starter bracket. Remove all O-rings from the starter bracket from the engine!

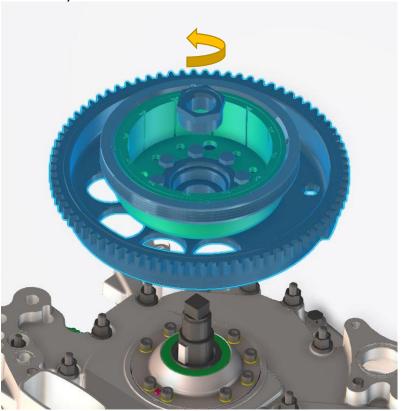
9. Remove flywheel assy

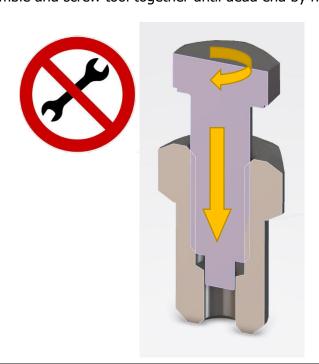
- 4. Unscrew removal tool and stud using hex drive on lower part of the tool. Pull tool and stud out of the screw hole.
- 5. Untighten and remove tool from stud.
- 6. Reassemble and screw tool together until dead end by hand.

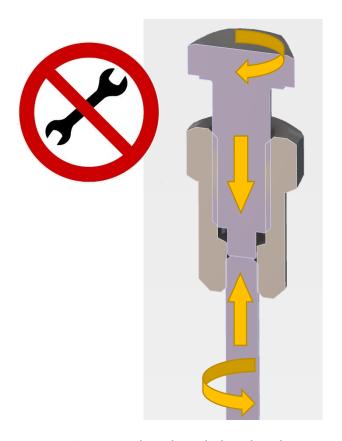
7. Screw assembled removal tool onto new stud

- 8. Apply Loctite 2701 onto other threaded end and screw into front plate by hand until dead stop. DO NOT USE WRENCH OR PLIERS FOR TIGHTENING!
- 9. Unscrew removal tool by untightening upper part while locking lower part with wrench.
- 10. Put washer back onto stud.
- 11. Apply Loctite 243 on freestanding thread of new stud screw down housing nut.
- 12. Pre-tighten housing nut by 12Nm.
- 13. Tighten nut with 16Nm (12 lbft).
- 14. Proceed with step 1 replacing one stud after another for all 13 studs.
