**Subject: Sailplane Rigging – Procedures, Inspections and Training**

All sailplanes and powered sailplanes, subject to rigging.

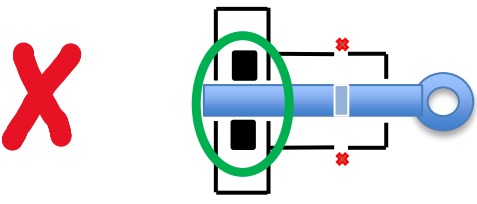
| Engaged but <u>not</u> secured. | The bolt moved away from its engaged position, and the control is unconnected. |

To engage means e.g. that a bolt is inserted into a bushing. In this condition, the connection is able to transmit forces, but the bolt can move out of the bushing again, therefore the connection is not secure. All connections need to be engaged and secured.

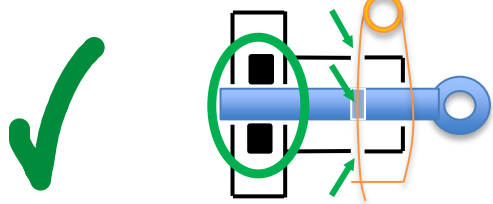
| | The Fokker-needle needs to be pushed through both holes of the cage and the hole of the bolt. |
| Engaged and secured. | |

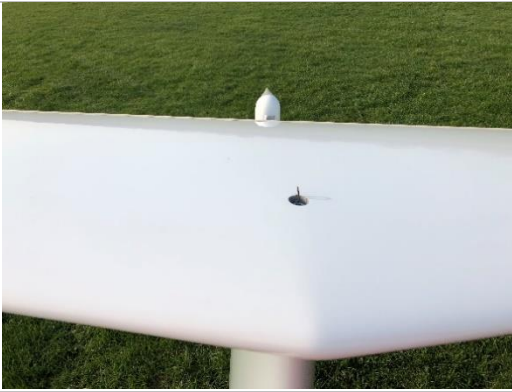
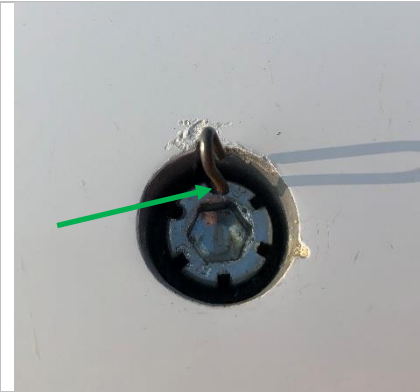
Some connections need to be secured against rotation. In most of the cases, this is achieved by the use of a castellated nut and a Fokker-needle. The pin of the needle has to be pushed through two castells and a hole inside the screw.

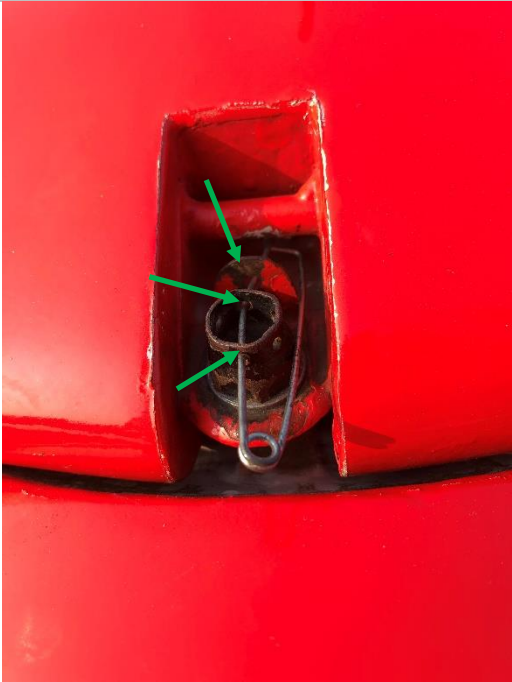
| | | <p>The bolt needs to be engaged and secured against rotation.</p> | |

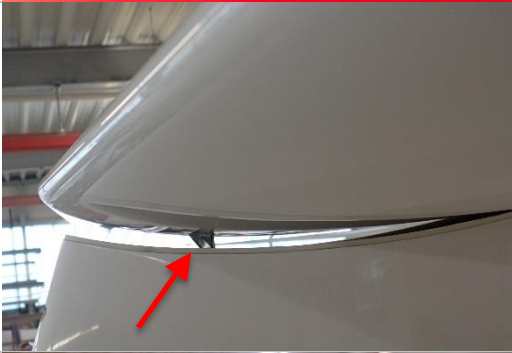
| | | <p>Horizontal stabilizer engaged in its aft fitting but forward fitting not engaged.</p> | |

*Note: All cases of unconnected controls and unconnected horizontal stabilizers can be detected by performing a positive control check. Non-interruption during the rigging helps to prevent forgetting the connections in the first place. The checking of proper securing can be done by a visual inspection only.*

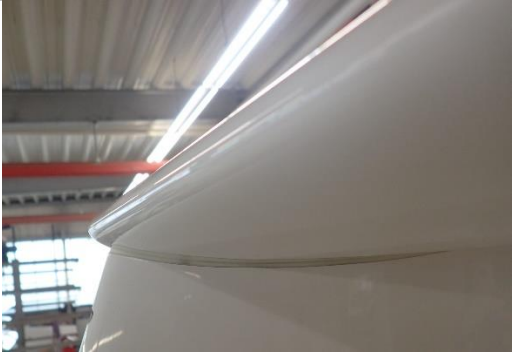
| | | <p>Horizontal stabilizer properly engaged.</p> | |

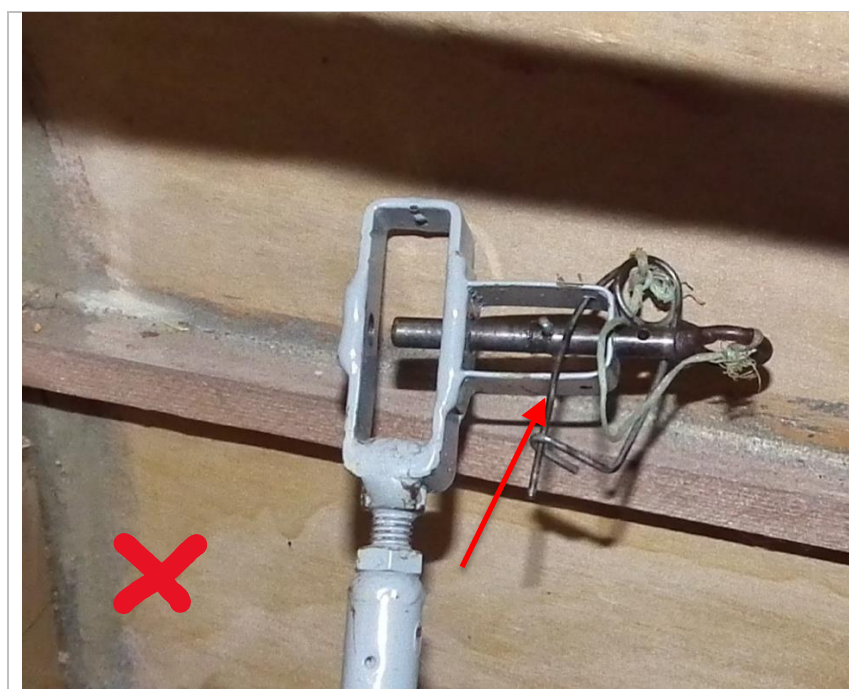
The example below shows an aileron connection, which is typical for old sailplanes with manual control connections. In this case, the connection was engaged during rigging, but not correctly secured. After three flights of short duration, the bolt moved away from its engaged position. The pilot lost control and crashed fatally.

The connection was not secured. The Fokker-needle was put through one hole of the cage only, but not through the bolt and the lower hole of the cage, as well. By this, the bolt could move freely and the control connection could become unconnected.

The bolt is secured by pushing the Fokker-needle through all three holes.

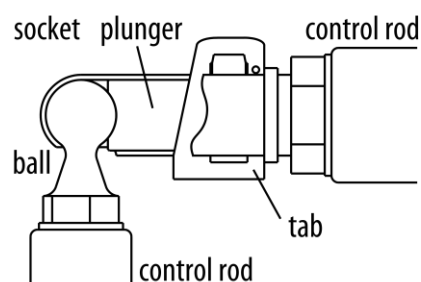
(a) Correct: cut-away shows how tab holds plunger in place

L'Hotellier connections rely upon proper engagement of a ball and socket, which are secured by a spring-loaded tab that must be pressed out of the way to make the connection. With the tab in position, a witness hole is exposed, allowing a locking pin/clip to be fitted to secure the connection. The controls can become disconnected in flight, if the pin is not fitted.

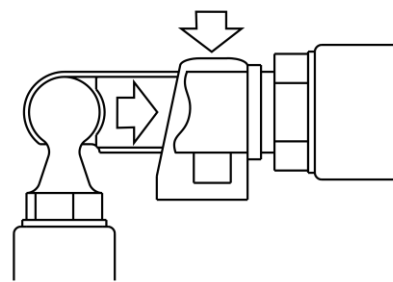
(b) Open: with tab depressed, plunger allows ball to be inserted or removed

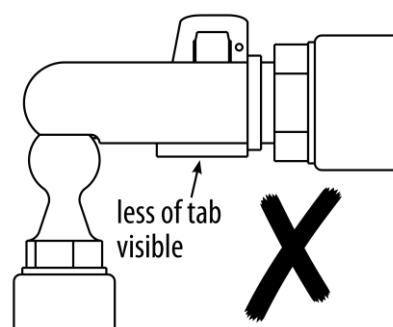
(d) Incorrect: ball not engaged, but locking pin may still be inserted

Unfortunately, the tab adopts a similar position when the ball and socket are completely disconnected and, although the ball is then locked out of the socket, it may in some cases engage sufficiently for the controls to seem connected. Being able to insert the locking pin does not guarantee that the connection has been properly made.

It is crucial to check that the ball and socket are correctly engaged. This can be difficult, if access is tight or illumination poor; a torch and mirror, or telephone camera, can help.

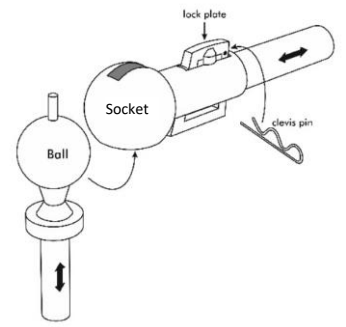
| | Newer l'Hotellier connectors come with a pin on the top of the ball that becomes visible outside the socket, once the ball and socket are properly engaged. The pin allows also for a tactile inspection. The connection still needs to be secured. |

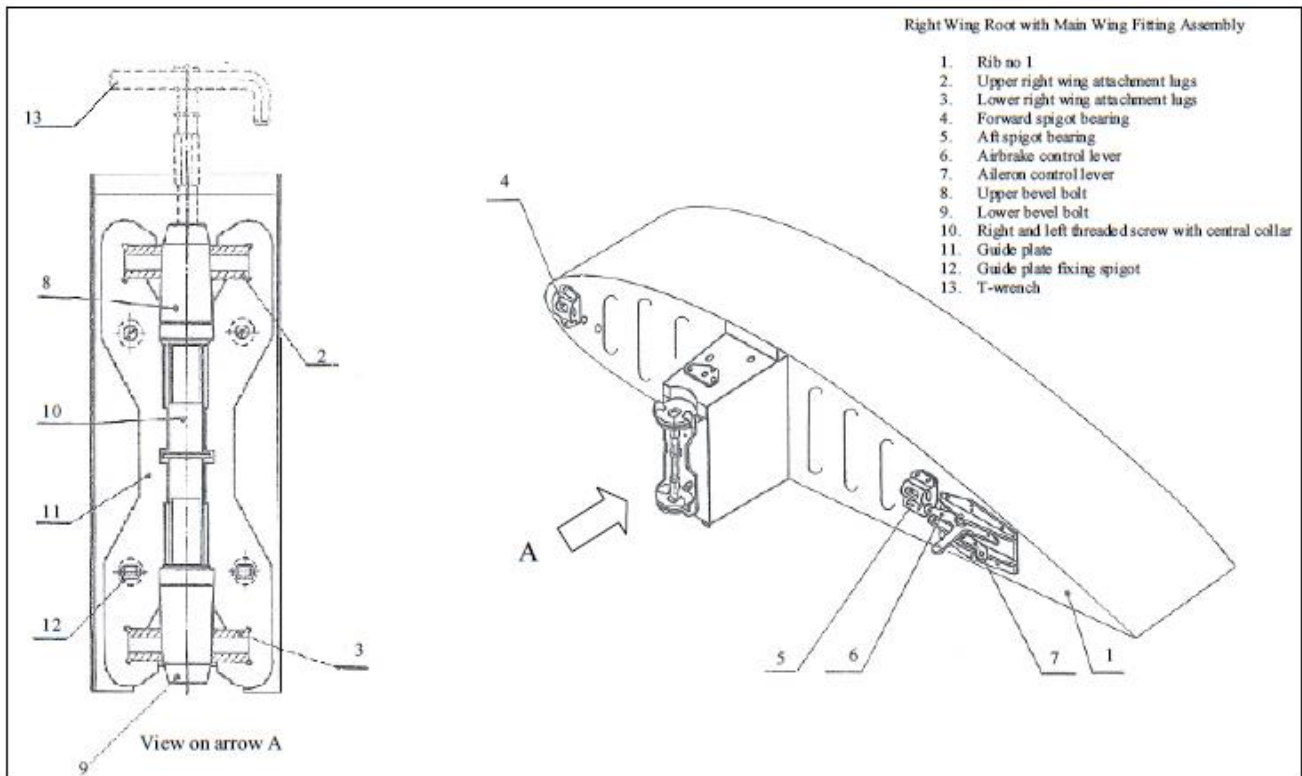
Example of an expanding main pin wing connection.

The wing rigging pins for most gliders are smooth cylinders, but those for e.g. the Foka, Cobra, Bocian, Jaskółka, Schempp-Hirth SHK and Austria, consist of expanding pins/cones, which must be fitted exactly in accordance with the instructions of the flight manual. If the pin/cone is not correctly located, the wings can fold up and detach from the fuselage. Unless inspection holes have been cut for the purpose, it can be very difficult in some gliders to see whether the fitting has been assembled correctly.

*Note: In case of sailplanes with expanding main pin wing connections, practice rigging should be carried out under the supervision of someone who is familiar with the sailplane type.*
