Propellor Departure During Engine Run

14 Feb 2022

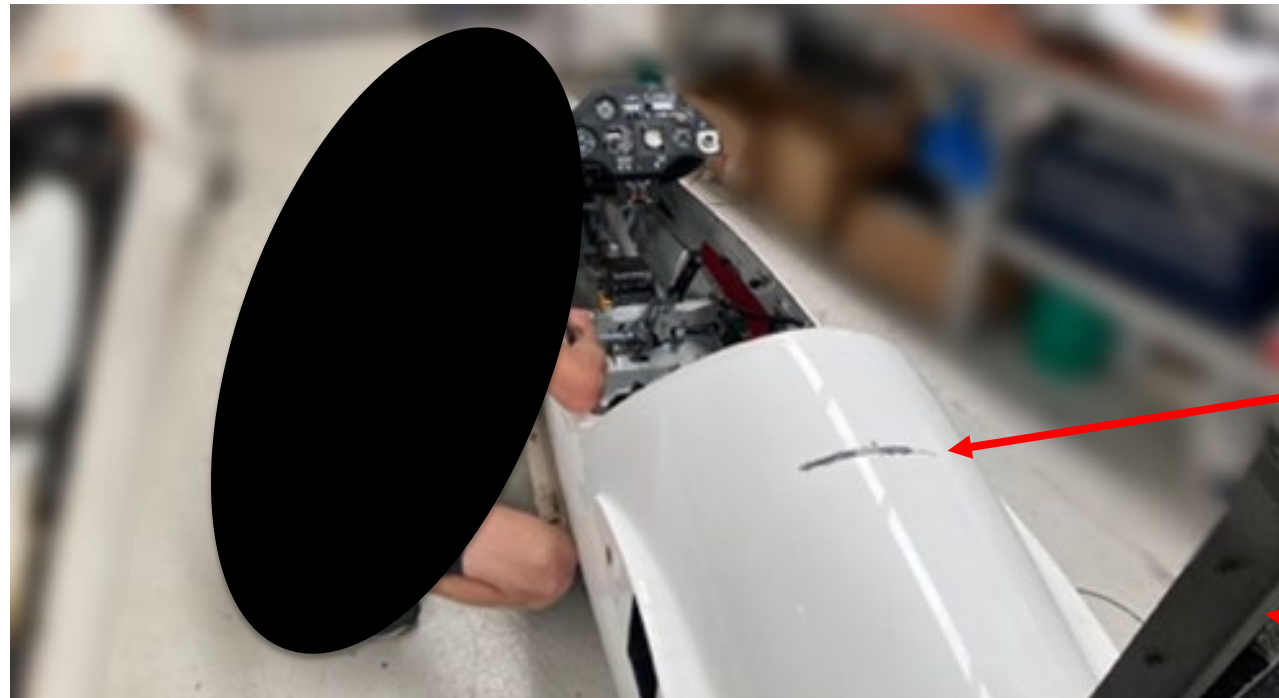
Propellor Strike

Pylon

Recreation of engine operator position post incident. Sailplane has been moved into a workshop. Propellor strike on upper fuselage. Propellor pylon visible at bottom right.

- During a post maintenance engine run, the propellor assembly separated from the pylon at approx 4500 rpm.
- The propellor travelled forward and down and struck the upper fuselage between the pylon and the rear edge of the cockpit.
- The propellor then travelled forward and left and struck the person operating the engine from outside the cockpit.
- The propellor continued a further 30 meters, narrowly missing the safety observer, and eventually stopped after colliding with parked trailers.
- The engine operator required 15 staples to the back of the head.

M10 mounting bolt that secured prop + pulley to spindle (hub) was not fitted. Thrust from prop was sufficient to pull prop + pulley off the spindle.

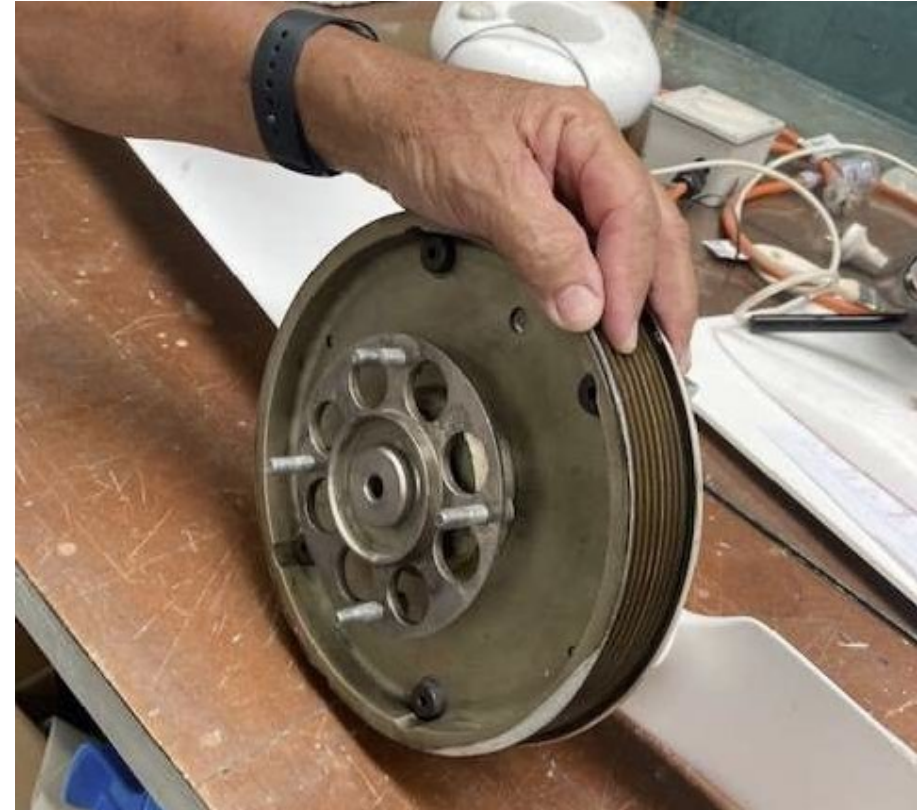
- Propellor removed by people who did not have appropriate airworthiness rating. Breach of MOSP 3 Section 10.
- People removing prop followed the maintenance manual - mostly. Steps at the end were missed.
- Poor use of the word 'hub' in the maintenance manual caused confusion over what was to be removed and not removed.
- M10 bolt was 'bagged and tagged' and put into plastic lunch box.

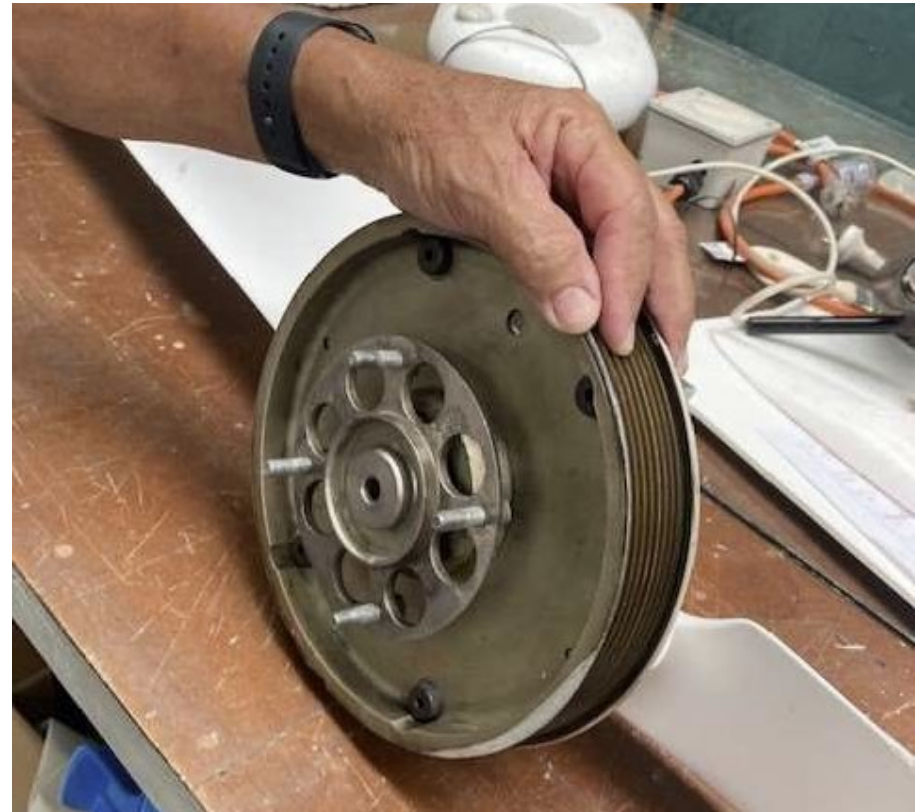
- Maintenance manual probably translated from German to English.
- Maintenance manual uses the words: Prop, pulley and hub.
- Poor use of the word 'hub' in reference to spindle. Conventional use would have 'hub' as the assembly that the blades attach to.
- Prop manufacturer wanted prop hub and pulley together for O/H. Created confusion on what was needed to be removed.
- If in doubt, ask!
