AIRWORTHINESS ALERT 2022-3

Stemme S10-VT Engine Coolant Blockage

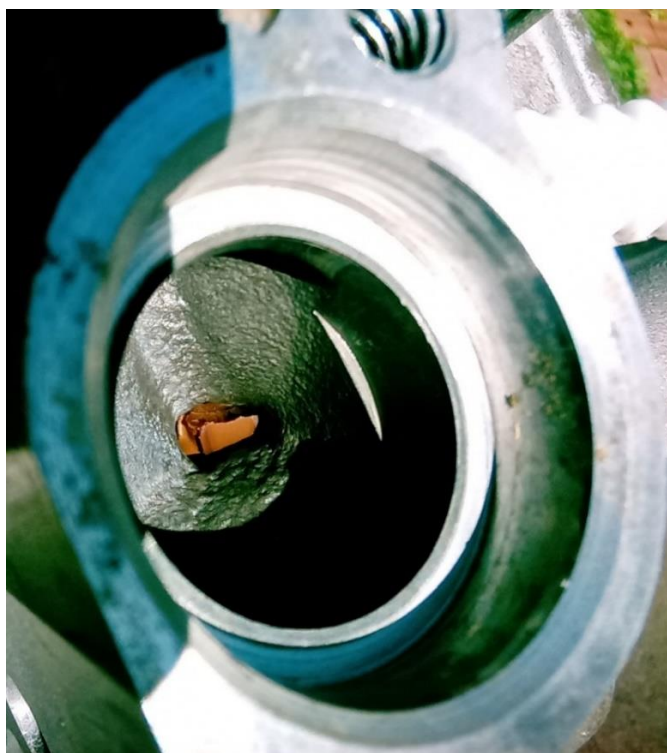
Figure 1: Blockage of cylinder head coolant port.

Figure 1 above is looking down into the main cylinder head coolant port. The brown material is the blockage as found. The pieces were too large to pass through the hole. Smaller pieces packed in around the larger piece compounded the problem. The blockage had to be broken into smaller pieces to back flush clean.

The GFA recommends Stemme S10-VT owners to remove the heat exchanger and back flush the system looking for any signs of solid glue loose in the system at the next periodic maintenance. It is possible to flush all four cylinder heads in-situ satisfactorily without head removal by removing the cylinder bottom coolant hose and applying water under pressure back flushing each cylinder. The inspector should then be satisfied any loose material is flushed free.

The heat exchanger should also be back flushed using a similar method. Remove the heat exchanger from the airframe and apply water pressure at the heat exchanger outlet, flushing to the top of the reservoir. Ensure the heat exchanger is shaken and rotated to ensure any loose pieces are flushed.

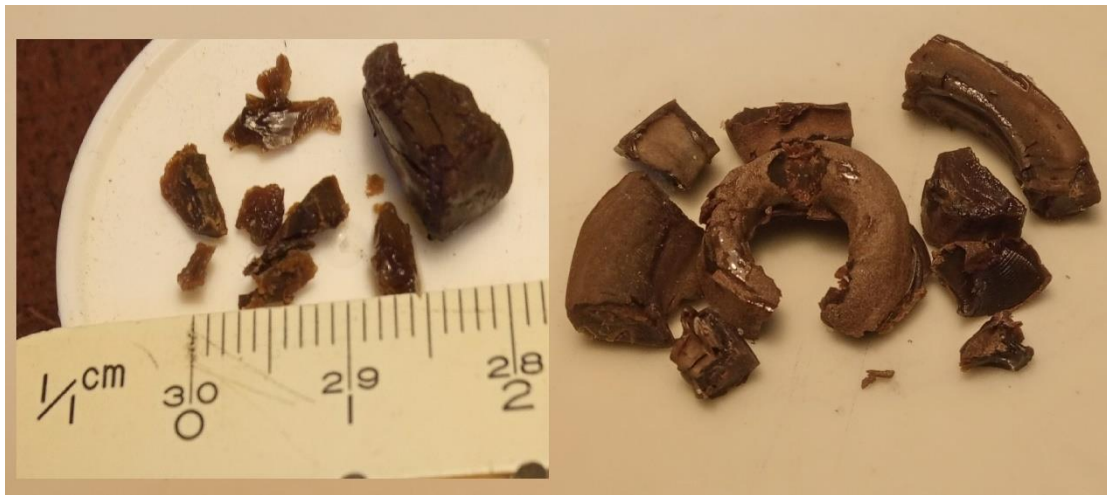
Figure 2: Blockage material.

A sample of the material was sent for chemical analysis. The analysis report stated the material was a glue or form of sealant. The source of the thick glue material was traced to the systems heat exchanger (radiator). The glue identified is used to internally bond three metal fittings in the heat exchanger unit.

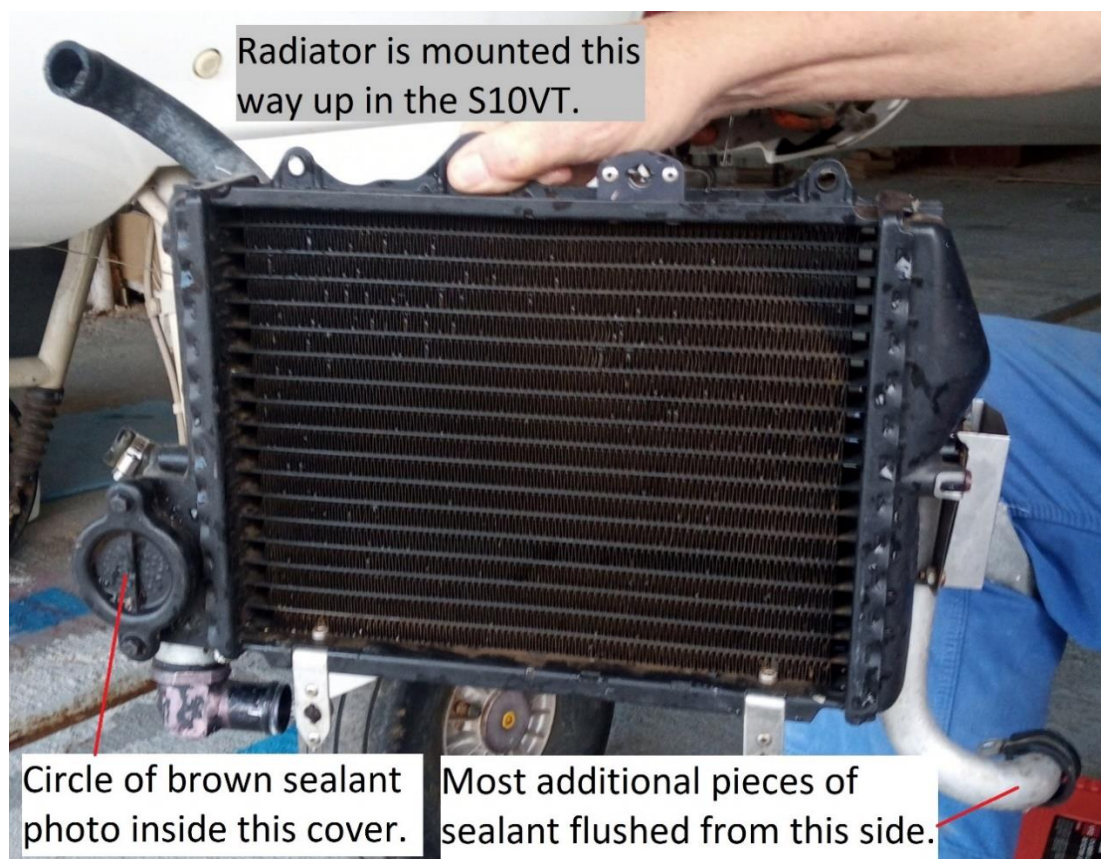
Figure 3: Stemme Heat Exchanger.

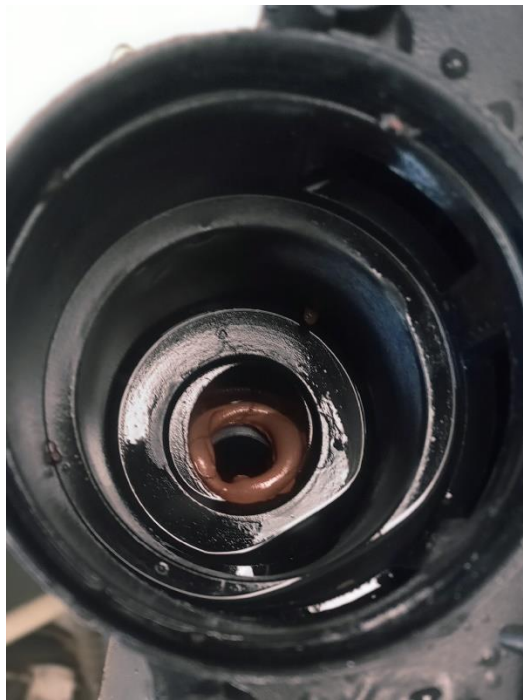
Figure 4: Excess sealant / adhesive squeezed out into inside of heat exchanger.

The excess sealant in the heat exchanger port can easily be pried off. It is recommended that a borescope is used to gain a better view inside.
