# AIRWORTHINESS BULLETIN

## Flexible Hose Assemblies - Maintenance Practices

**AWB** 02-006 **Issue :** 2  
**Date :** 8 May 2015

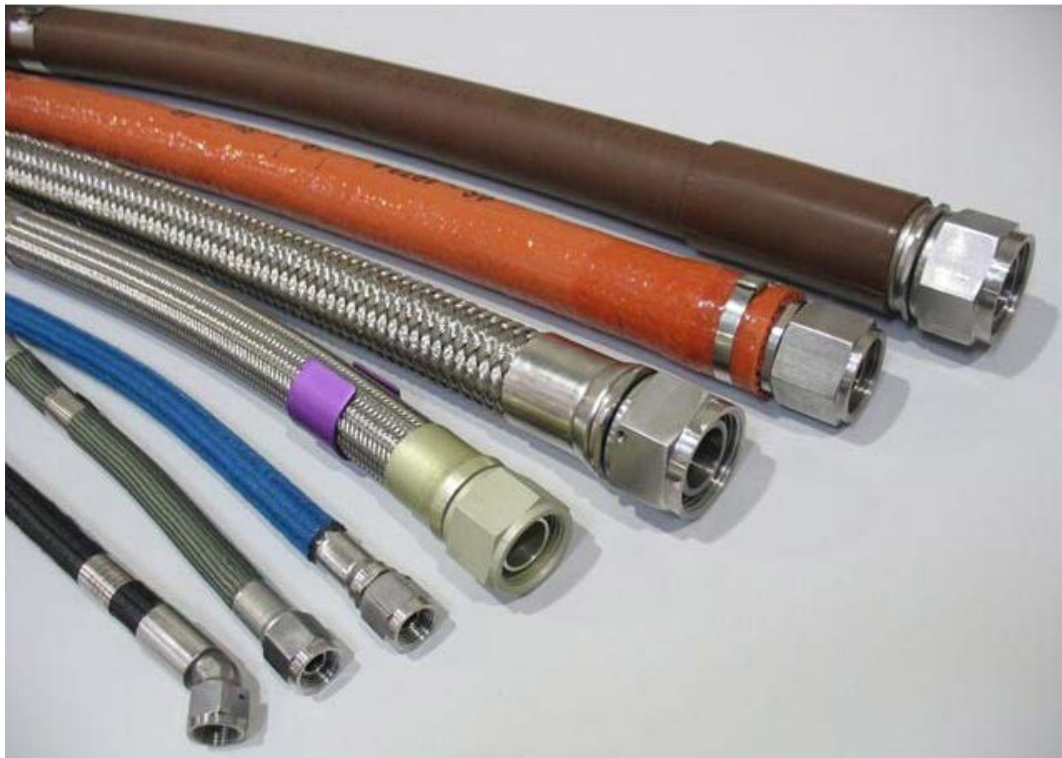
*Figure 1. Aircraft use many different types of flexible hose, and each hose type has specific maintenance requirements. (Picture: Eton Hoses)*

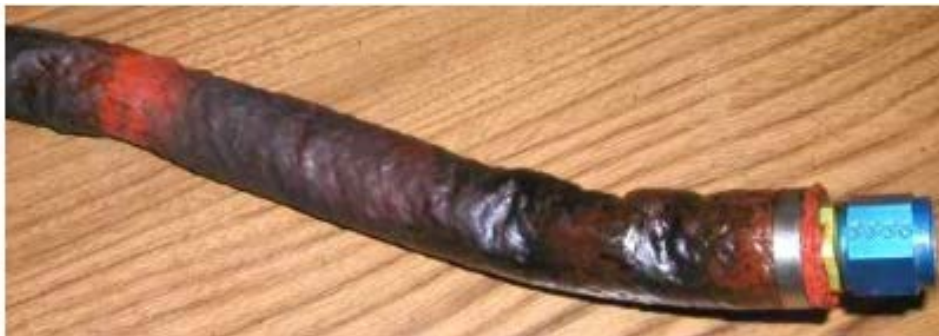
Figure 2. Contaminated fire sleeving

Trapped water could result in corrosion of the hose lay-up wires or braid. Oil or fuel contamination on the inside of the fire sleeve will result in serious deterioration of the fire resistant characteristics of the sleeving.

Any slip-on fire-sleeving, including any sleeving in addition to that specified by the aircraft or aircraft engine manufacturer, should be incorporated only in accordance with approved data including the applicable Technical Service Order (TSO). Fire sleeving must cover the end fitting as shown below. Be aware that slip-on fire sleeves can mask hose defects, and nicks and cuts in the fire sleeve. Unsealed hose sleeve ends can also admit and retain fuel, oil or moisture against the outer braid.

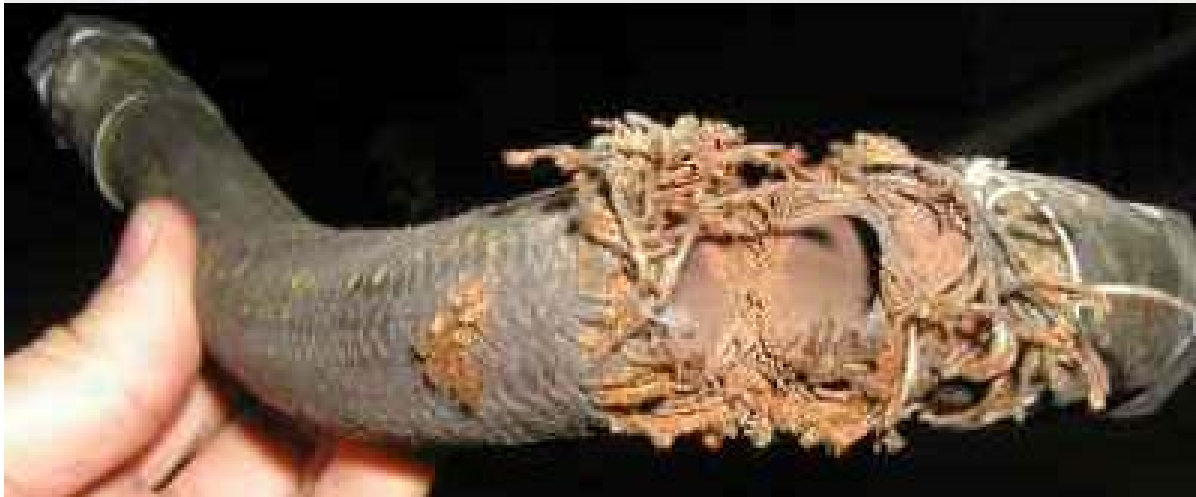
**(a) Brittle**

The typical piston engine oil hose consists of a rubber compound inner liner with a structural carbon steel braid covered with a grey woven fabric cover. Heat from the engine oil and the engine compartment will harden the rubber compound hose. Such a hose may appear to be serviceable and slight defects in the cover may not seem too serious (or be completely hidden under a fire sleeve) until the hose is flexed by hand.

Careful flexing of accessible sections of installed hose by hand to assess hardness or flexibility may well result in 'creaking' noises or a 'crackling' noise and feel. This immediately indicates that the hose rubber liner has failed, is unserviceable and should be removed before further flight. The discovery of a brittle hose before the planned replacement time may also indicate an incorrect type of hose for the application and should be investigated. The carbon steel wire braids in the hose pictured above have also been severely affected by corrosion.

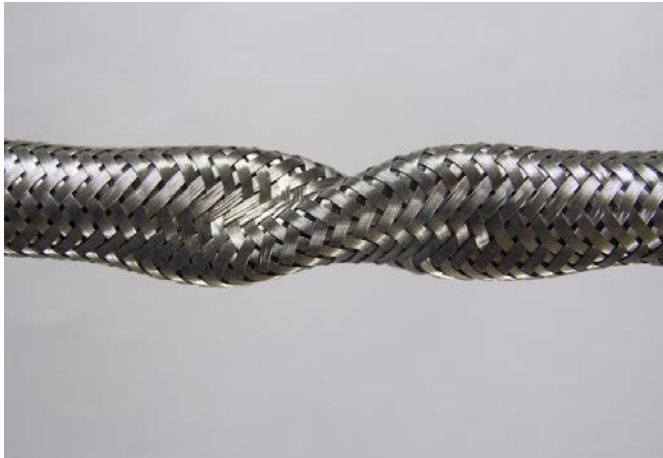
### (b) Twisted

Typically caused by incorrect installation, where, during final torquing of the second union, the nut picks up on the back of the hose nipple fitting, and twists the hose.

Twists cause permanent damage to the structure of the hose, and if undetected, cause restricted flow, local 'hot spots' and rapid deterioration of the inner hose liner or pressure vessel.

A hose which has been kinked during installation, or found kinked or twisted during inspection should be replaced before further flight.

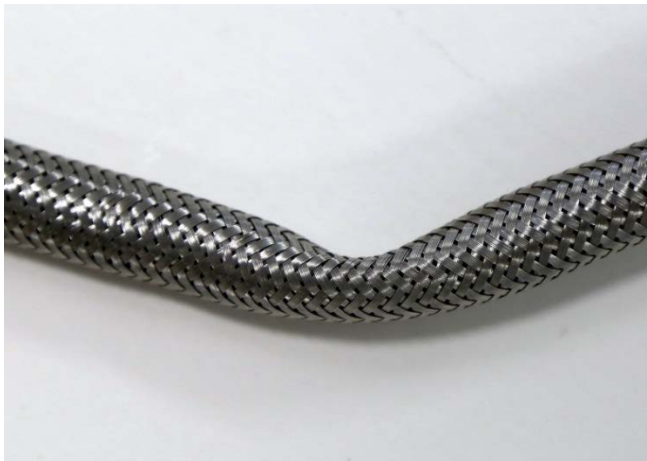
### (c) Kinked

Typically caused by incorrect installation, attempting to bend the hose around a radius too small for the specified installation radius, or hose diameter. A new hose may initially resist kinking, but over time the hose wall may yield and collapse.

PTFE type hoses can fail after being kinked - even temporarily. During component removal and installation for example.

As with twists, kinks restrict flow and frequently result in local 'hot spots' and rapid deterioration of the inner hose liner or pressure vessel. These hoses should be replaced before further flight

Hose failure at or near the edge of the data tag can be an indicator that the hose was kinked at that point at some stage. ([FAA SAIB NE-06-67](#)).

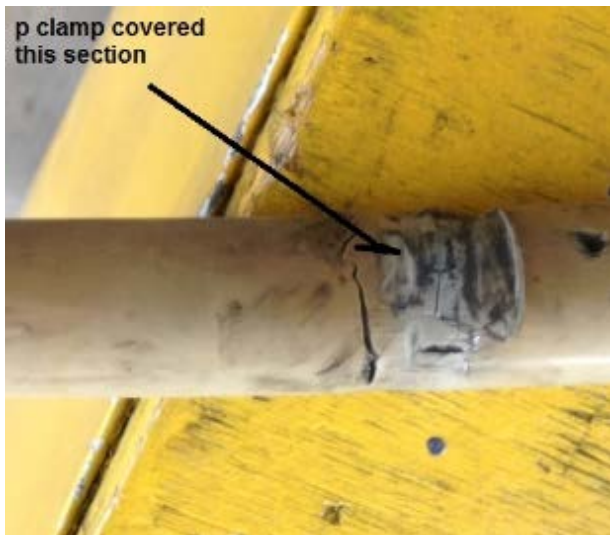
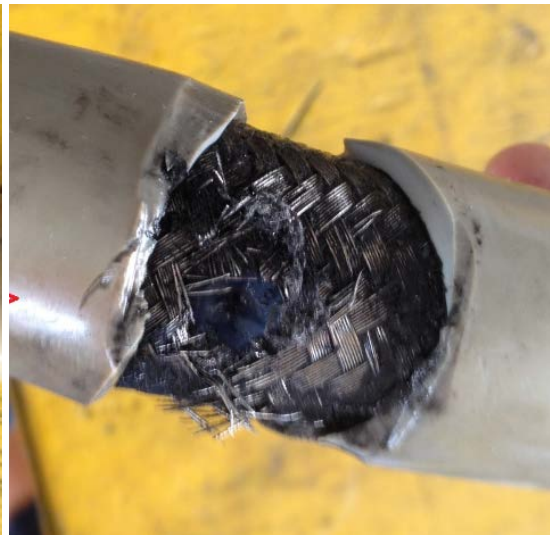
## (e) Chafed

Hose in-flight failure and loss of system fluid due to the hose chafing and flexing under and adjacent to the 'P' clamp.

Chafing damage is usually a cause for rejecting the hose. Ensure the hose routing, clamping and securing scheme is in accordance with approved data.

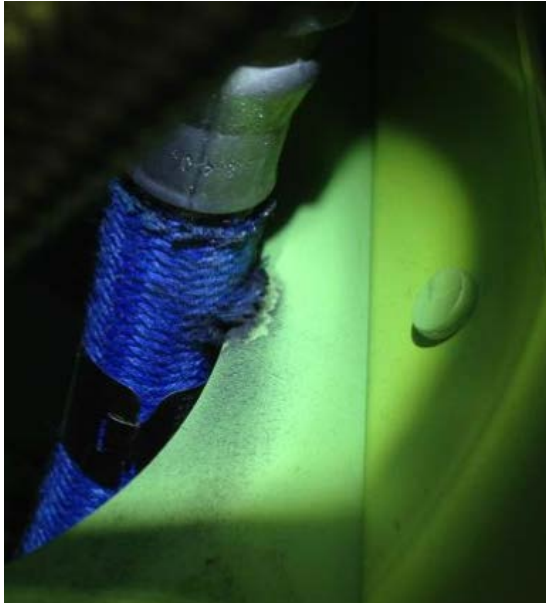
Even slight changes in the way the hose is installed between the clamps and subtle end fitting alignment, fitting angle changes during torqueing and incorrect torqueing procedures etc. can result in loss of clearance between the hose and the aircraft structure and/or other hoses.

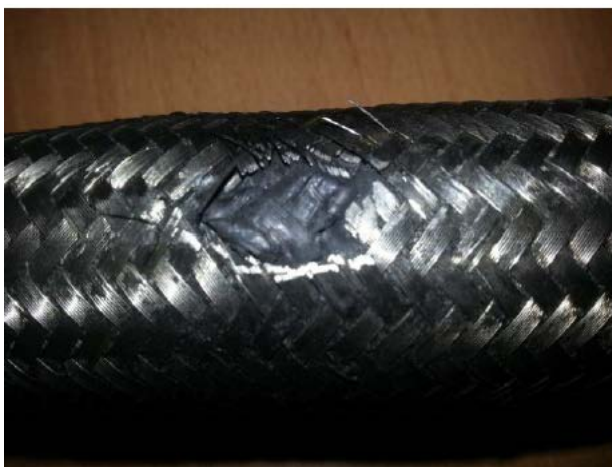
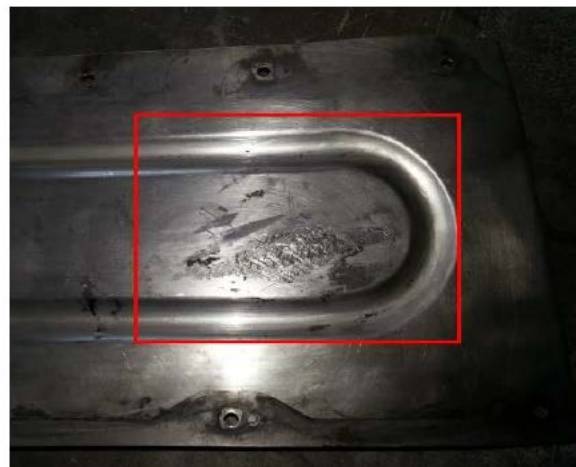
Hose (above) failed due to chafing against the structure (right).

Chafing is frequently difficult to detect before hose failure, because the contact areas are concealed and the aircraft maintenance instructions typically do not state how and where to check for hoses chafing.

Special hose chafing inspections are frequently issued via aircraft manufacturer's Service Bulletins and Service Letters. Chafing damage and failure often occur because the hose has been made too long (or too short).

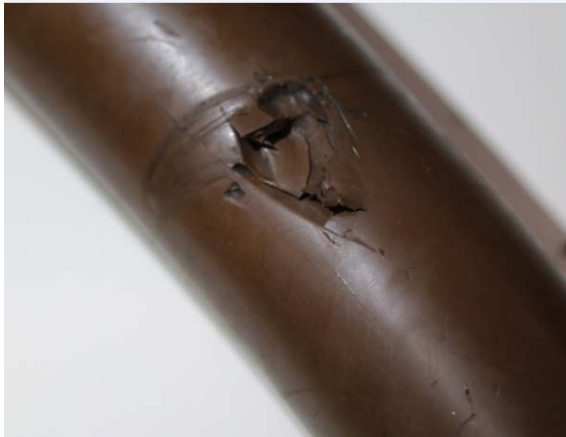
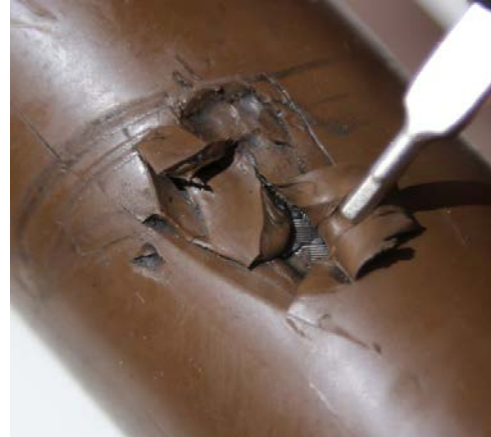
Chafed PTFE/Teflon hose (above) with integral silicone fire sleeve. Damaged sleeve flap folded back (right) to show extent of damage.

Such damage not only severely reduces the Type Design fire resistance requirement, it allows moisture and other fluids to penetrate the stainless steel hose braid under the covering. Stainless steel braid will corrode when exposed to contaminants and denied direct contact with atmospheric oxygen.

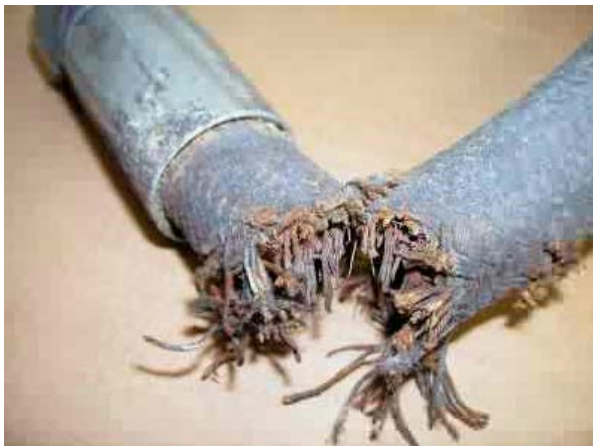
## (f) Corroded

Corrosion and/or staining of the hose ends, particularly with regard to cloth braid covered carbon steel braided hoses, is reason to reject the hose.

End fitting corrosion and bulging cotton weave can be an indication of possible hidden corrosion damage to the steel wire braiding under the cotton cover, even though the cover may look sound. Any hose giving 'creaking' or 'crackling' feel or sounds when flexed should be replaced before further flight. (Picture: ATN-Aircraft Division)

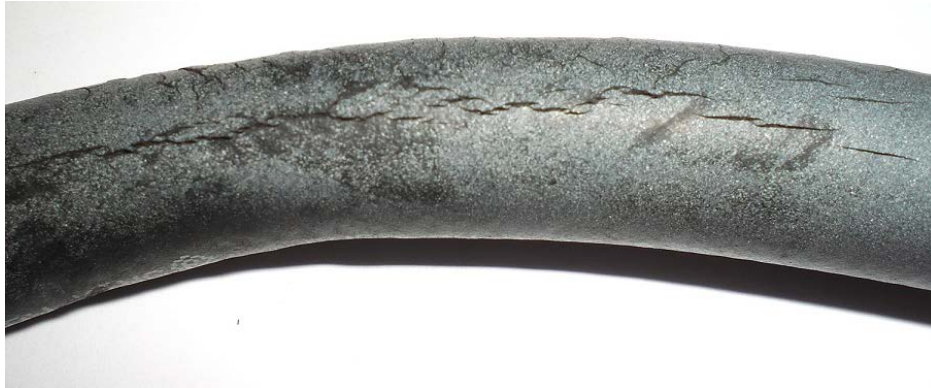
**(g) Contaminated / crazed / cracked**

Instances of airframe rubber push-on fuel hose hardening and crazing at significantly less than half the aircraft manufacturer's calendar life of 10 years have been reported. The hose (above) was hard and cracked only on the side which had been exposed to paint overspray during aircraft manufacture, some 4 years previously. The hose wall was still soft and pliable on the unexposed side in the same section.

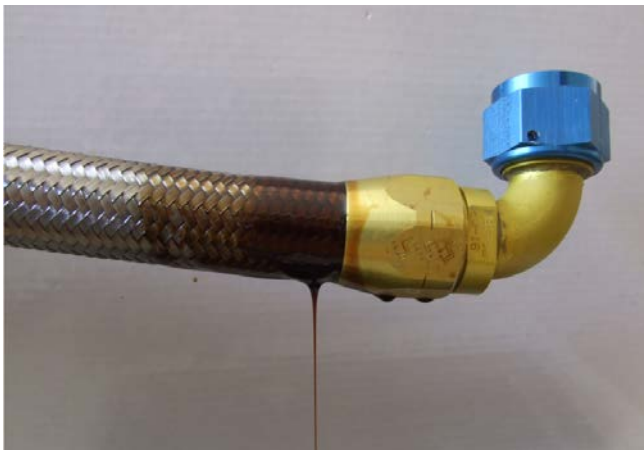
**(h) Leaking**

Any weeping/leakage from the end fittings that retain the flexible hose element or any leakage/seepage from any section of the hose is reason for immediate replacement.

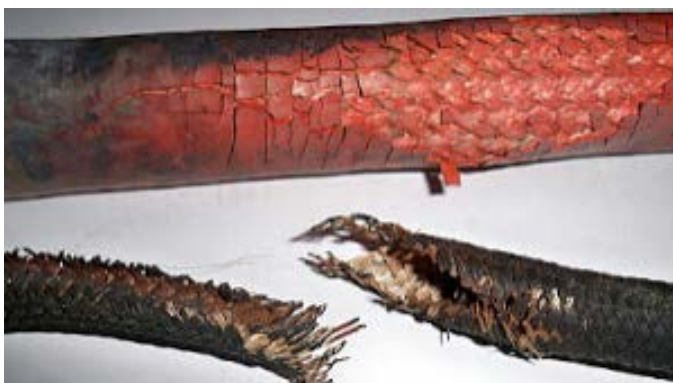
**(i) Damaged fire sleeve**

Be suspicious of any indication of damage to the fire sleeving. Particularly if the sleeve (and hose) have been exposed to fire/flame or exhaust gasses. Damage limits for fire sleeving may be provided by the aircraft or sleeve manufacturer. In the hose pictured, the fire sleeve was heat damaged, but the fuel hose inside was burnt through.

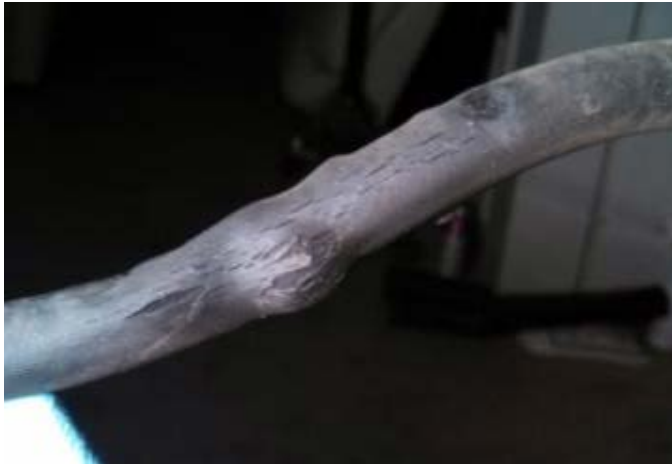
## (j) Blistered / bulged

Blistered hoses may be the result of age, fluid incompatibility or internal layer separation. Check for any evidence of swelling or 'ballooning' along any length of the hose during testing or operation. Swelling indicates catastrophic structural failure of the hose braid and the hose should be rejected immediately.
