# AIRWORTHINESS DIRECTIVE

## THE GLIDING FEDERATION OF AUSTRALIA

### GFA AD 678 Issue 1

| <b>Subject</b> | Increased risk of flutter of the tailplane and degraded security of tailplane attachment caused by loose bolts in the tailplane attachment bracket assembly and the tailplane control horn. |

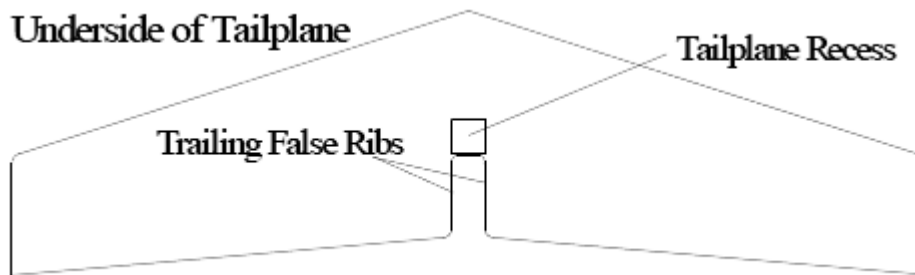
Figure 1. Plan view, Schempp-Hirth "all Flying Tailplane"

There are two configuration "Styles" for connecting the tailplane attachment bracket to the fin for Schempp-Hirth sailplanes with "All Flying Tails".

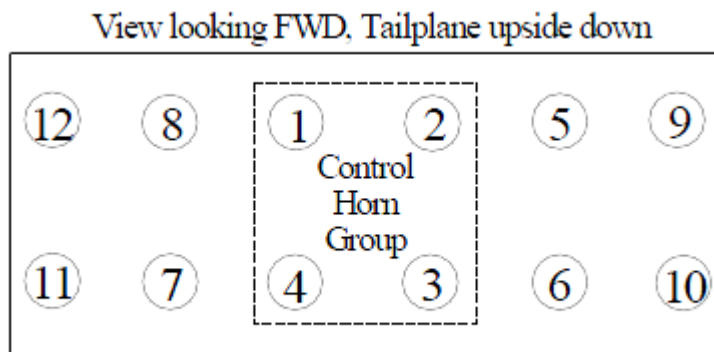
#### **Structure Drawings and Cut-out positions**

When testing for looseness of the 8 bolts, only a minimum torque is to be applied in a clockwise direction to determine looseness. **DO NOT** apply excessive torque to the bolt

heads during the testing process. Loose bolts previously found have turned easily. Applying excessive torque may damage the spar by compressing the wood fibres.

**For the “Style A” with 8-Bolt Installation Drawing No. 1 and,  
For the “Style” with 12-Bolt Installation Drawing No.2.**
