The Gliding Federation of Australia Inc

Occurrence Summaries

01/01/2016 to 31/12/2016

The Gliding Federation of Australia Inc
SOAR Accident and Incident Occurrences

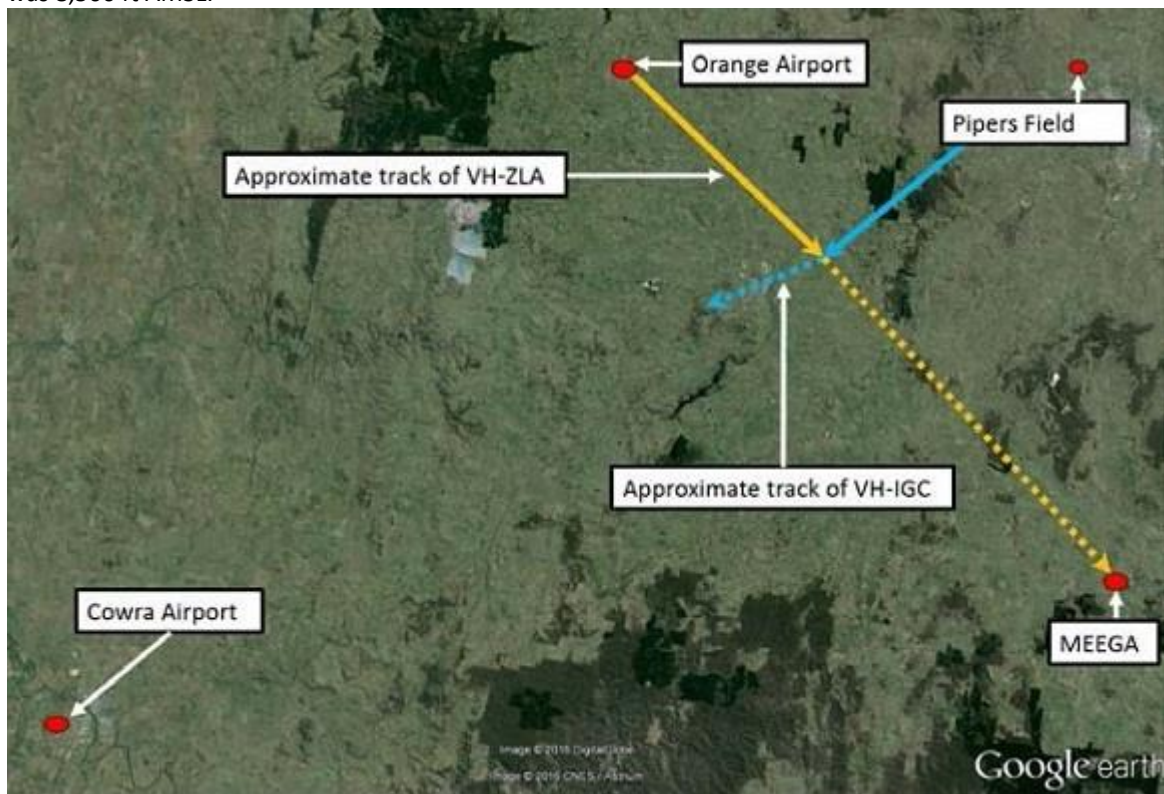
Figure 1: Approximate aircraft tracks and relevant locations

ATSB Investigation. On 21 February 2016, the pilot of a Glaser-Dirks DG-800B glider, registered VH-IGC (IGC), was participating in a coaching flight with a second glider and pilot from Pipers Field aerodrome, New South Wales (NSW) (Figure 1). The glider pilots planned to track towards Cowra, and to remain outside a 10 NM radius of Orange Airport, both also in NSW. The gliders climbed to about 8,000 ft above mean sea level (AMSL) as they departed Pipers Field, descended to about 7,100 ft at 9 NM south-west of Pipers Field, climbed to 9,100 ft and then descended again. Not long after they departed Pipers Field, the glider pilots both selected their radio (each glider was fitted with one VHF radio) to a discrete glider frequency 122.9. The pilot of the following glider reported being at the same level and about 1,000 m behind IGC. At about 1420 Eastern Daylight-saving Time (EDT), a Regional Express SAAB 340B aircraft, registered VH-ZLA (ZLA), taxied at Orange Airport, for a scheduled passenger service to Sydney, NSW. The flight crew consisted of a first officer, who was the pilot flying for the sector, and a captain, who was the pilot monitoring.[1] The flight crew broadcast on the Orange common traffic advisory frequency (CTAF) when taxiing and again when rolling on runway 11. As the aircraft climbed through 2,000 ft above ground level, the first officer initiated a slight right turn onto the departure track of 123° to track towards the waypoint 'MEEGA'. The captain broadcast a departure call on the CTAF and then contacted air traffic control (ATC) on Melbourne Centre frequency, and in response received a clearance to enter controlled airspace. The lower limit of Class E airspace in this area was 8,500 ft AMSL.

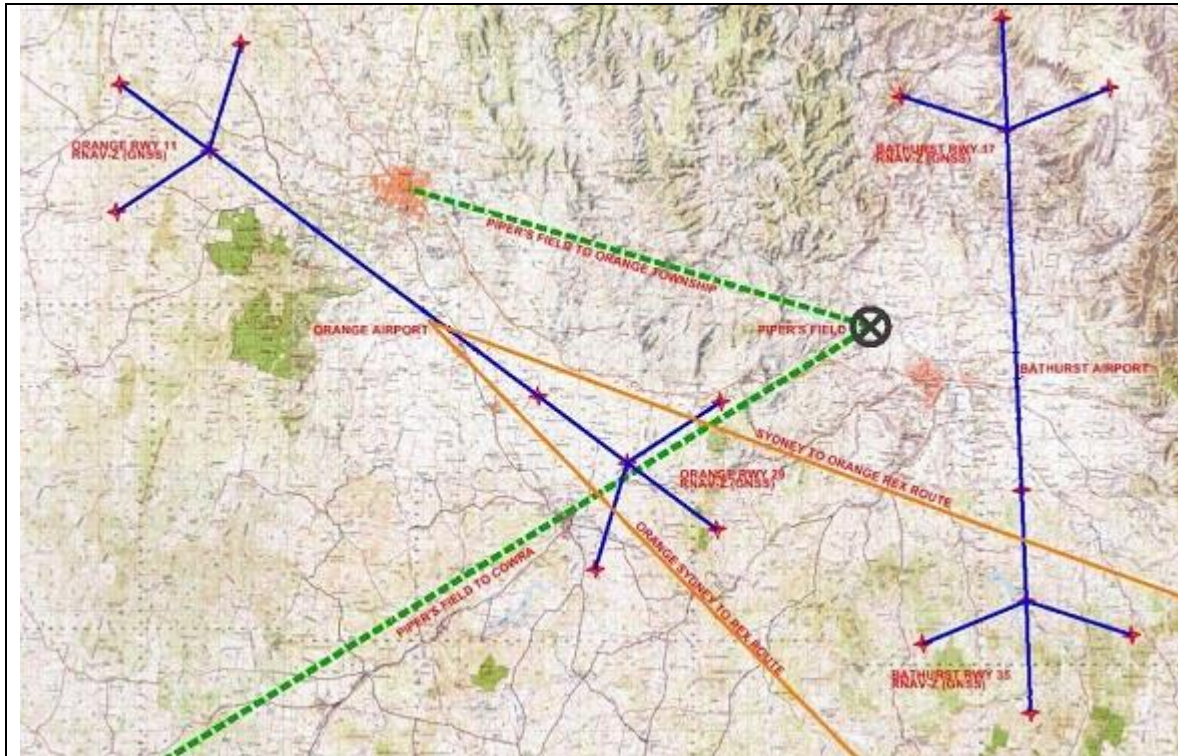
Figure 2: Regional Express Orange and Bathurst tracks relative to Pipers Field

Regional Express produced a number of charts showing approach and departure routes from Bathurst and Orange, including Figure 2, and made the following comments to the Bathurst Soaring Club:

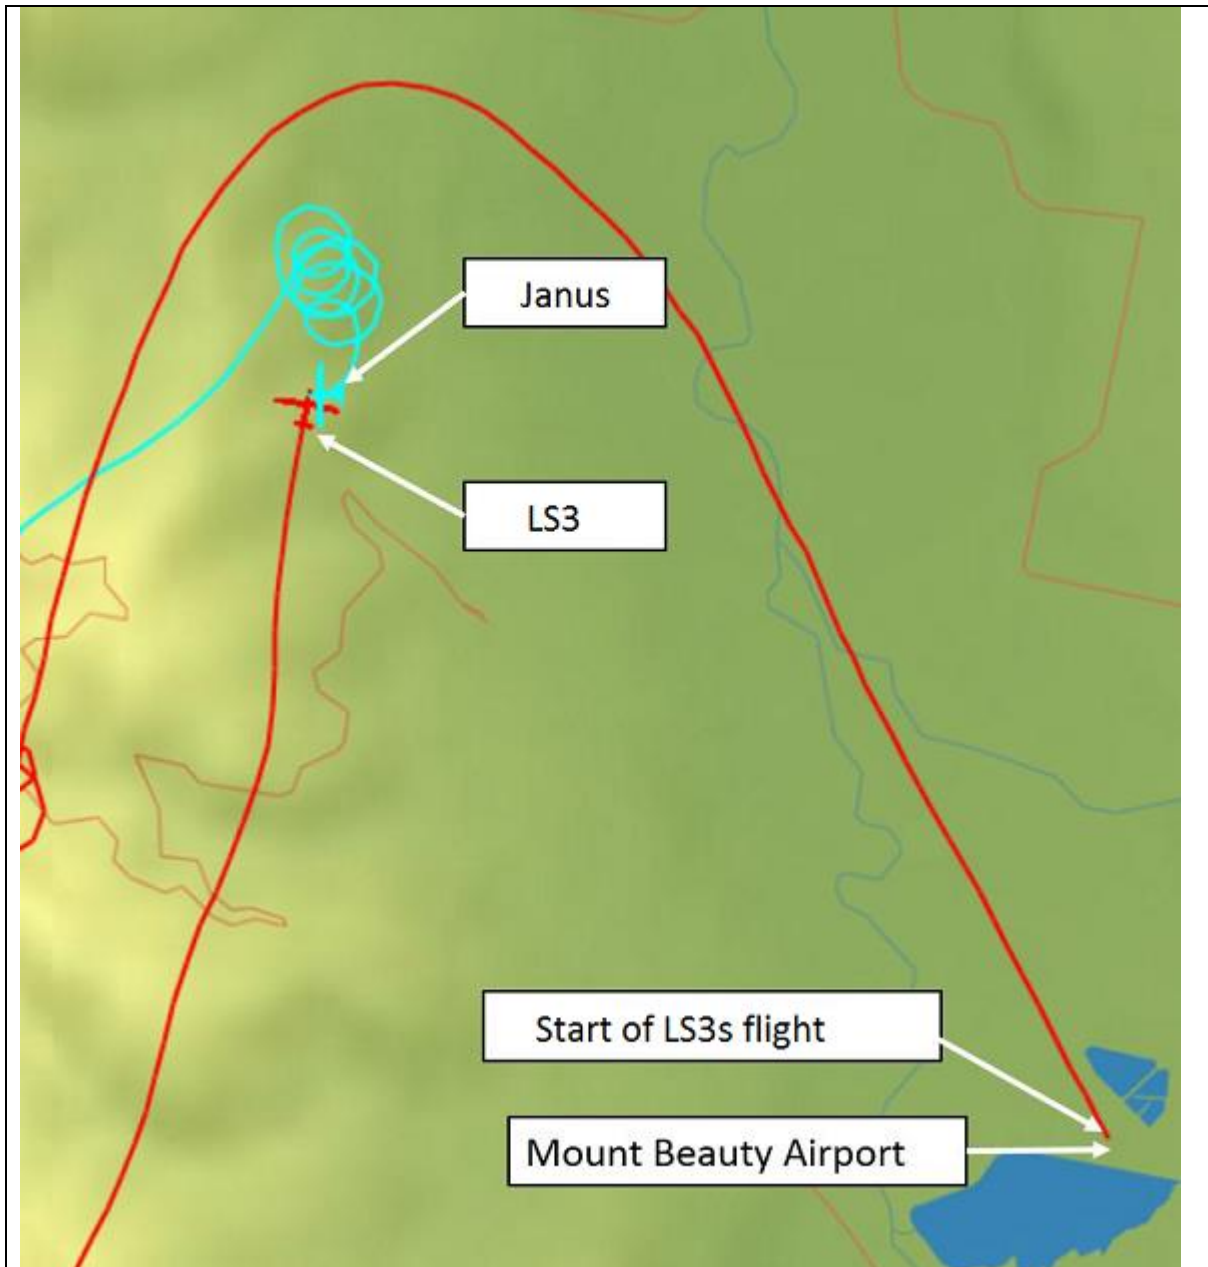
Figure 1: Relative tracks of the gliders and positions at 1355:02

Date	28-Mar-2016	Region	VSA	SOAR Report Nbr	S-0713		
Level 1	Airspace	Level 2	Aircraft Separation	Level 3	Near collision		
A/C Model 1	LS 3-a		A/C Model 2	Janus			
Injury	Nil	Damage	Nil	Phase	In-Flight	PIC Age	72
<p>ATSB Investigation. On 28 March 2016, at about 1306 Eastern Daylight-saving Time (EDT), a Schemp-Hirth Janus glider launched from Porepunkah Airfield, Victoria, for a pleasure flight. On board were two pilots, the pilot seated in the rear seat was the pilot in command for the flight. The glider tracked over Simmons Gap, to a ridge about 3 km north-west of Mount Beauty Airport (Figure 1). The pilots could hear and see other gliders being towed onto the ridge. They joined a thermal¹ and climbed in tight orbits ('thermalling') in a clockwise direction.</p>

At about 1335, the pilot of a Rolladen-Schneider LS3-A glider, launched from Mount Beauty Airport, Victoria, for a pleasure flight. At about 1355, the glider was 3 to 4 km north-west of the airfield and descending through about 4,000 ft, when the pilot heard an alarm sounding, but did not identify it as issuing from the FLARM collision avoidance system (see FLARM below) fitted to the glider. The glider was tracking to the north, and the pilot reported that they had been keeping a lookout for other gliders but were not aware of any in the vicinity at the time. The pilot tried to identify the source of the alarm inside the cockpit, which diverted their attention from looking outside. As the pilot became stressed by the noise, particularly as it became 'quite shrill', the cockpit fogged up, further reducing the pilot's ability to see outside. At that time, the Janus was thermalling and in a right bank at about 40–45°, and had completed four orbits. The front seat pilot sighted a glider approaching from the opposite direction at about the same altitude. They assumed that

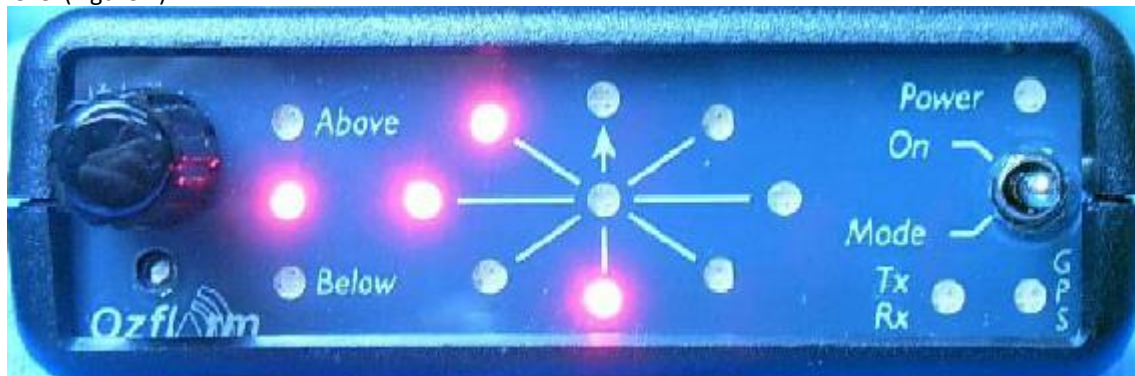
Figure 2: OZflarm display

FLARM is a collision avoidance system that shows other similarly equipped aircraft in the vicinity. The display shows the approximate direction of detected traffic and whether it is above, below or at about the same level (Figure 2).

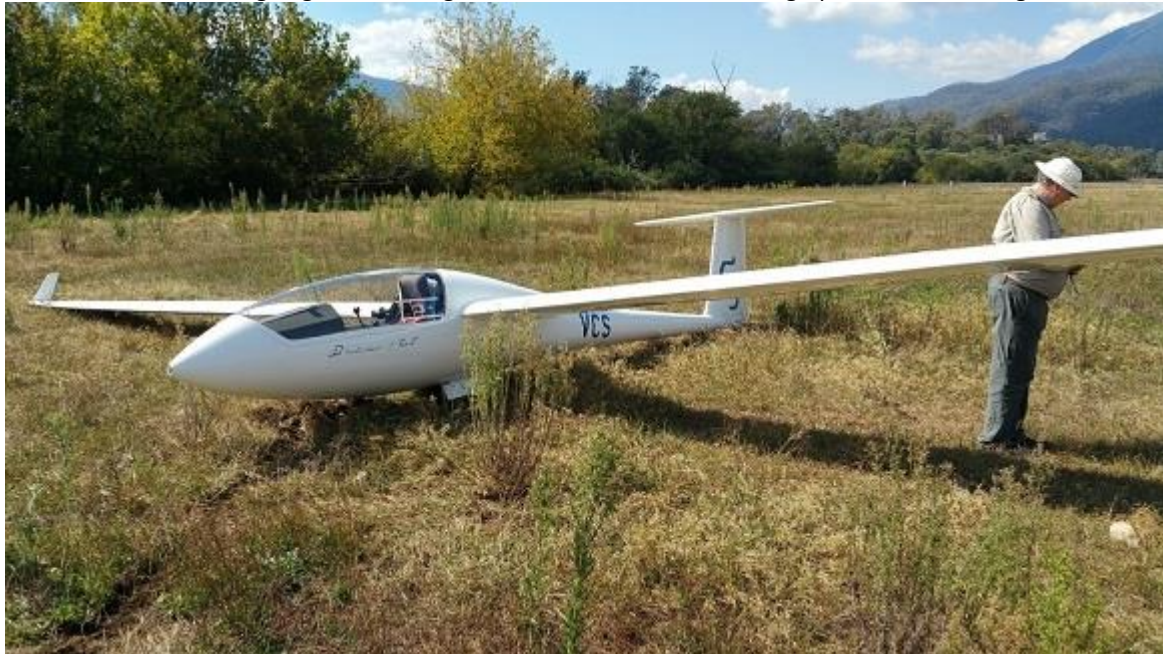
On 31 March 2016, at 1331 Eastern Standard Time, a Discus CS glider collided with a winch wire being wound in following the successful launch of an ASK-21 glider at Mt Beauty Airfield, Vic. The left wing of the Discus impacted the cable at an altitude of approximately 280 feet AGL. The impact caused the Discus to rotate about 90 degrees to the left and pitch to about a 45 degrees nose down attitude. The cable tore a small hole in the leading edge of the wing and then slid over the left wing tip and clear of the glider.

About 3 seconds after the cable strike and at a height of about 130 ft AGL the pilot recovered to a normal flying attitude. Several seconds later the pilot successfully landed in a paddock to the east of the airfield. The glider ground looped at the end of the landing roll, possibly after the wingtip contacted some of the high thistles in the paddock. The pilot was not injured and damage to the glider was minimal. The Australian Transport Safety Bureau was notified shortly after, but declined to investigate.

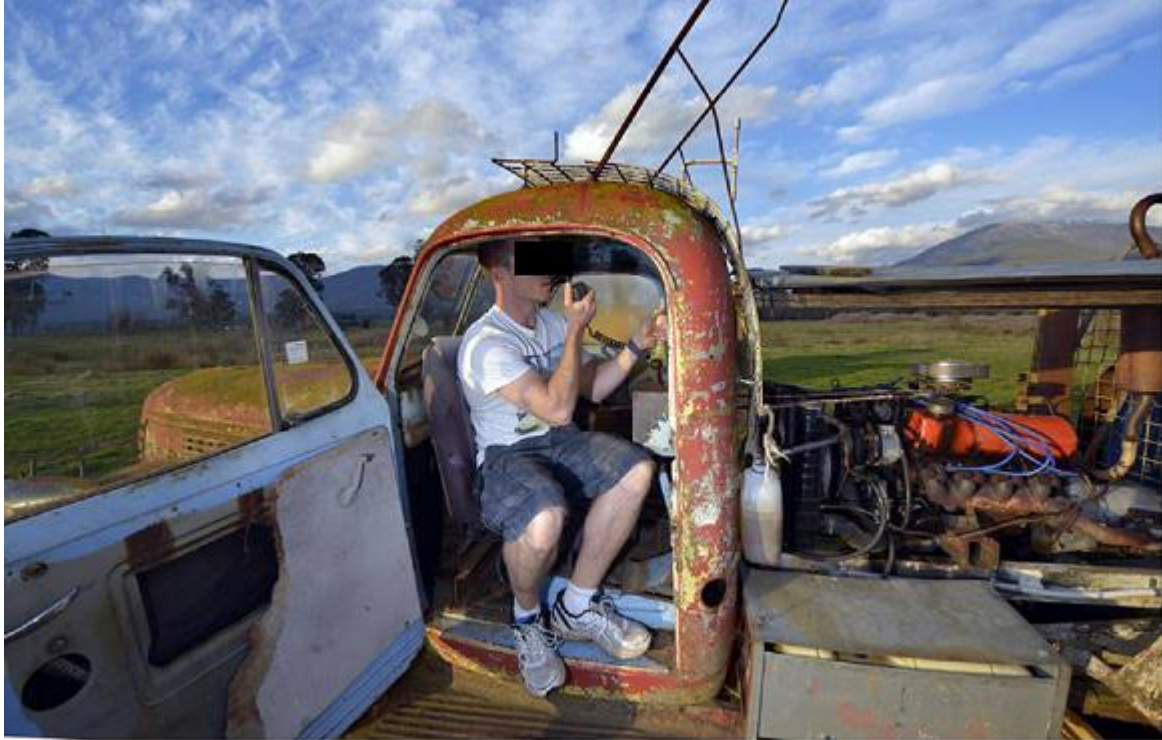
approximately 600 metres beyond the runway. This allows the club to lay out 1500 metres of cable. The winch is in poor condition externally and the rotating beacon used to signify the winch is operating is not readily visible from the air or ground.

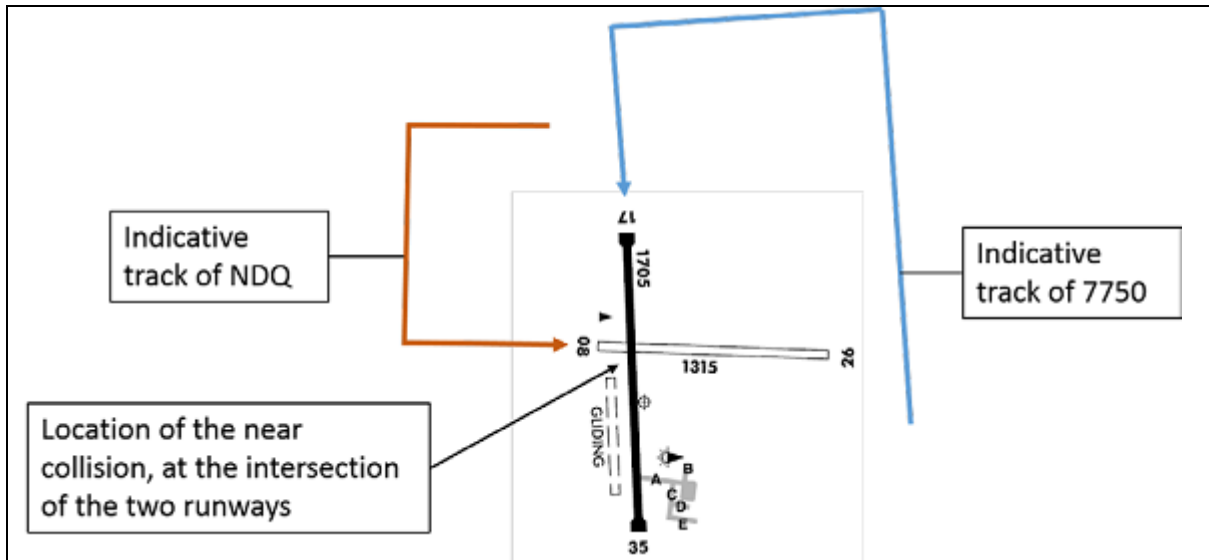
Figure 3: Layout of Bathurst aerodrome showing indicative tracks of 7750 and NDQ
Source: Airservices Australia – annotated by ATSB

Date	13-Apr-2016	Region	NSWGA	SOAR Report Nbr	S-0730		
Level 1	Airspace	Level 2	Aircraft Separation	Level 3	Near collision		
A/C Model 1	DG-1000S		A/C Model 2	N/A			
Injury	Nil	Damage	Nil	Phase	Landing	PIC Age	16
<p>ATSB Investigation. On 13 April 2016, an instructor and student of a Jabiru J170-D aeroplane, registered 24-7750 (7750), conducted a local training flight from Bathurst Airport, New South Wales. At about 1442 Eastern Standard Time (EST), as they were returning to Bathurst, the instructor broadcast on the Bathurst common traffic advisory frequency (CTAF) that they were inbound from the south-west, and added that they were estimating arrival in the circuit at 1446. As they subsequently arrived in the circuit, the instructor broadcast that they were joining the circuit on an early downwind for runway 17, for a full-stop landing. The wind was from the east-south-east. Powered aircraft were operating on runway 17 and gliders (and towing aircraft) were operating on runway 08. Bathurst aerodrome elevation is 2,435 ft above mean sea level (AMSL) (Figure 1). About a minute after broadcasting their arrival in the circuit, the pilot of 7750 asked Glider Ground[1] how many gliders were in the air. Glider Ground advised that there were 'two gliders, NGH and NDQ, just thermalling,[2] at 4,000 ft off the threshold of runway 26.' The pilot of 7750 confirmed sighting two gliders. Meanwhile, a student pilot of a Glaser-Dirks DG-1000S glider, registered VH-NDQ (NDQ) was conducting a solo flight at Bathurst. The student had been briefed prior to the flight to make a downwind call, stay close to the runway in use by the gliders, and to keep a good lookout. At about 1449, about 90 seconds after the pilot of 7750 had communicated with Glider Ground regarding glider traffic in the air, the pilot of NDQ broadcast on the Bathurst CTAF that they were on left downwind for runway 08. Immediately following the downwind call by the pilot of NDQ, the pilot of 7750 broadcast that they were on left base for runway 17, and soon after, broadcast that they were on final approach to runway 17 for a full stop landing. The pilot of NDQ reported hearing both those broadcasts, but did not make any broadcasts or directed radio calls in response. After 7750 touched down on runway 17, about 100 m before the intersection with runway 08, the pilot sighted a glider (NDQ) on short final for runway 08, at an estimated 100 ft above ground level. The pilot assessed that they did not have sufficient time to stop before the intersection of runway 08, so applied full power to cross runway 08 as quickly as possible. When at about 500 ft above ground level and on final approach to runway 08, the pilot of NDQ sighted 7750 their 10 o'clock[3] position at about the same altitude. As 7750 landed, the pilot of NDQ assessed that there was the potential for a collision, closed the glider's airbrakes[4] and initiated a climb to pass over 7750. As the glider passed over 7750 near the intersection of the two runways, the pilot of NDQ heard the aircraft's engine increase power. The glider then landed ahead on runway 08 (Figure 1). The instructor in 7750 lost sight of NDQ as it passed overhead. As 7750 accelerated with a high power setting, the instructor elected to continue the take-off. The pilot of 7750 then conducted a circuit before landing safely.</p>

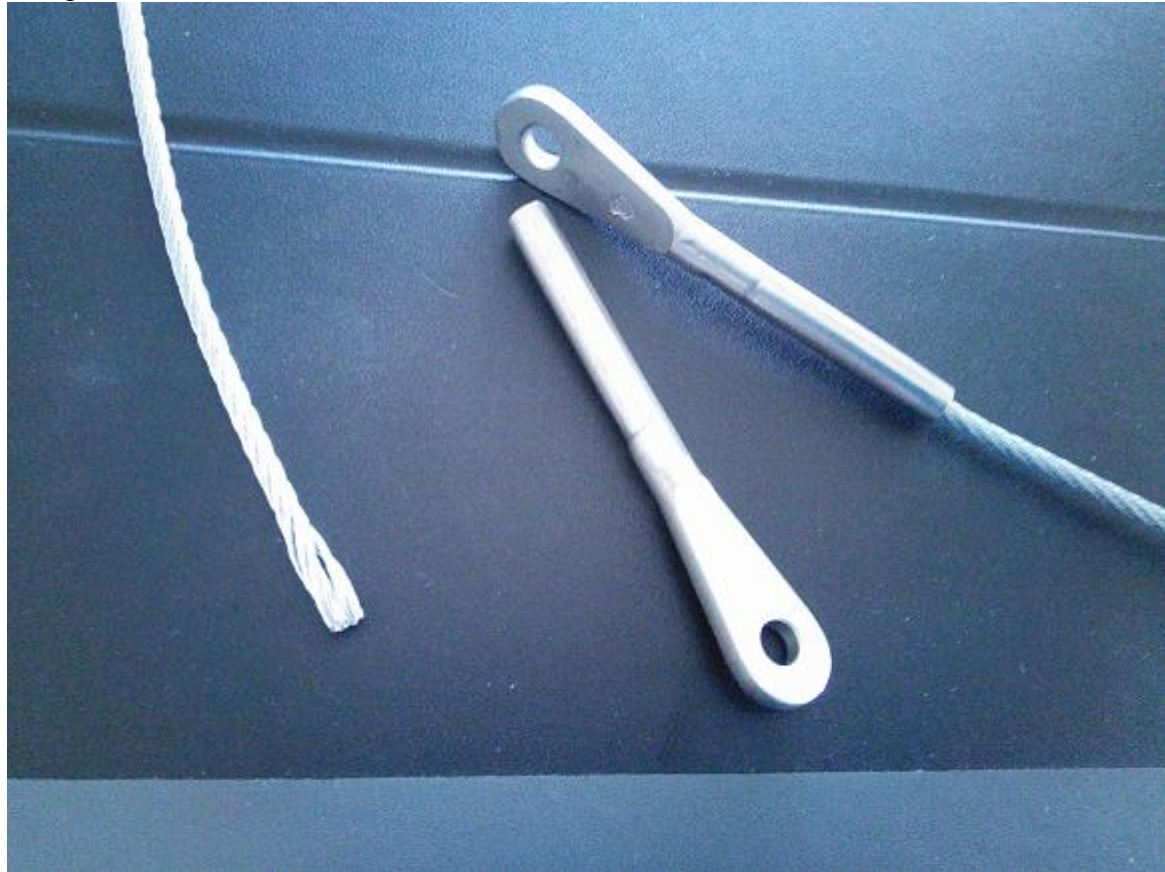
Date	12-Aug-2016	Region	NSWGA	SOAR Report Nbr	S-0759		
Level 1	Technical	Level 2	Systems	Level 3	Flight controls		
A/C Model 1	Xenos		A/C Model 2	N/A			
Injury	Nil	Damage	Nil	Phase	Landing	PIC Age	64

The spoiler actuating cable pulled through the crimped fitting when the pilot operated the spoiler lever on base leg. The pilot made an uneventful landing without spoilers. Investigation revealed faulty crimping during manufacture of the cables.

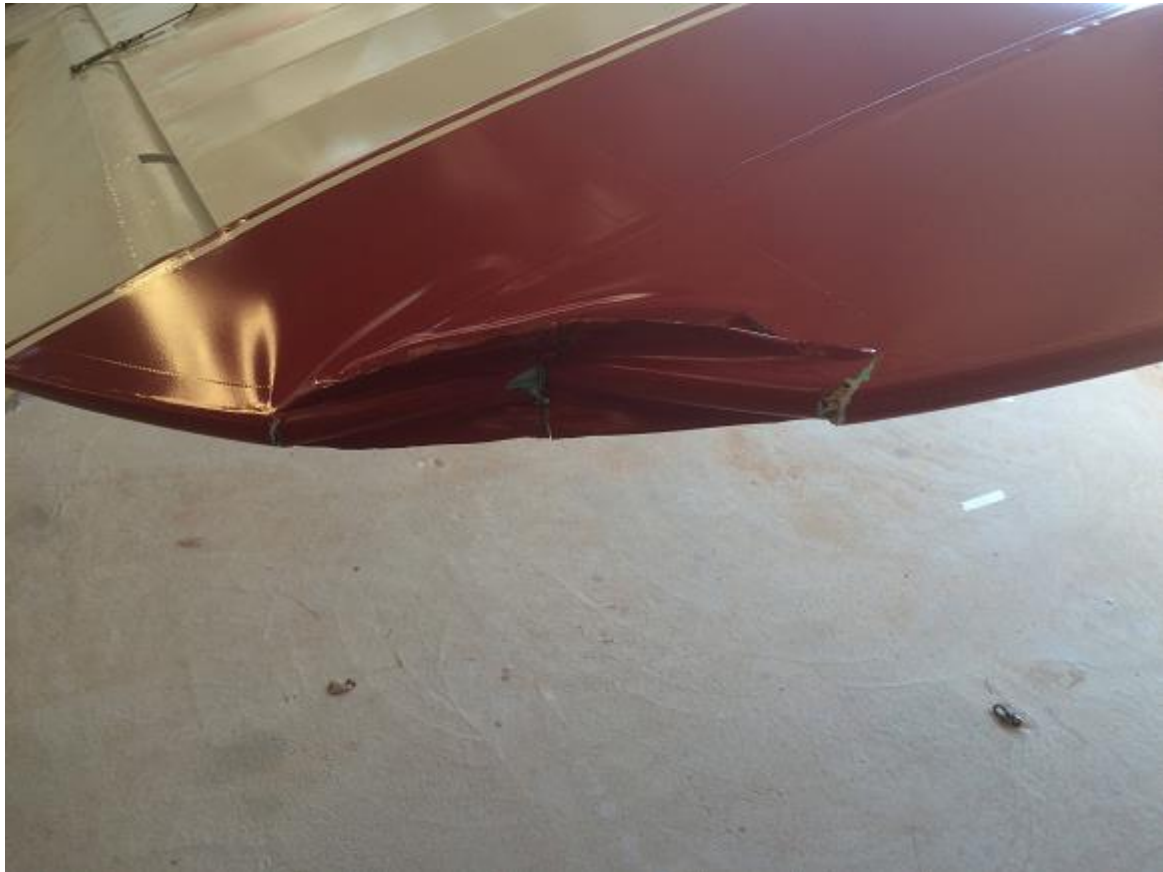
Date	13-Aug-2016	Region	NSWGA	SOAR Report Nbr	S-0762		
Level 1	Operational	Level 2	Ground Operations	Level 3	Ground handling		
A/C Model 1	Piper PA-25 235		A/C Model 2	N/A			
Injury	Nil	Damage	Minor	Phase	Ground Ops	PIC Age	70

While the tow plane was being pushed backwards into the hangar at the end of the day's flying, the right wing tip struck a steel column supporting the hangar door, breaking the wing tip bow in three places. To assist crew align the aircraft, there are two yellow lines painted on the floor marking where the mainwheels should be, and a red line between the two yellow lines to guide the tailwheel. The accident occurred when

the crew repositioned the tail wheel of the aircraft on the yellow line markings instead of the red line. All persons involved in pushing the aircraft into the hangar were experienced glider and or towplane pilots. Factors contributing to the accident include:

- failure to align the aircraft on the hangar centreline before commencing to push the aircraft into the hangar (primary cause);
- attempting to correct original misalignment as the aircraft was being pushed into the hangar;
- aligning the tailwheel to follow the yellow line instead of the red line into the hangar;
- failure to ensure the wing tips were clear of the hangar door columns on both sides before pushing the aircraft onto the hangar;
- the red line does not extend outside the hangar onto the concrete apron, as the yellow lines do (see accompanying photos) making it difficult to see in low light;
- the red line was obscured by the tailplane and fin of the aircraft;
- the light was poor making it hard to see the red line; and
- fatigue was probably a factor in the accident.

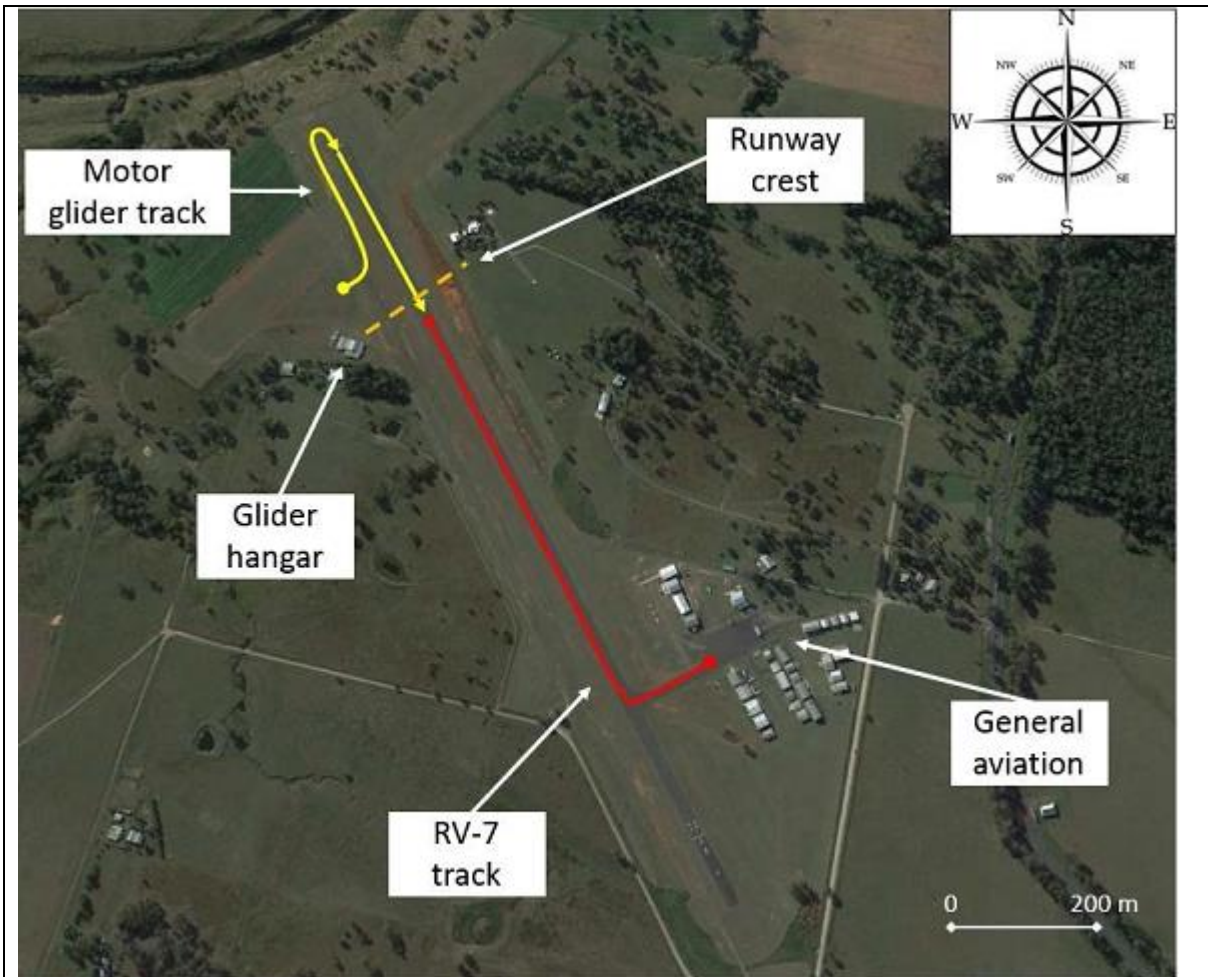
Figure 1: Gympie ALA and ground tracks of the aircraft

On the morning of 27 August 2016, a Van's RV-7 aircraft, registered VH-VTZ, and a Glaser-Dirks DG-400 motor-glider, registered VH-XJZ, were both prepared for flight from Gympie aircraft landing area (ALA), Queensland. The pilot taxied the motor-glider from the Gympie ALA glider hangars and back-tracked on the grass alongside runway 14 (Figure 1). Before entering the runway strip, the pilot made a radio broadcast on the common traffic advisory frequency (CTAF) 126.7, that they were entering and back-tracking runway 14. On arrival at the runway threshold, the pilot made another broadcast that they were lining-up on runway 14. The pilot taxied the motor-glider onto the threshold of runway 14 and conducted their engine run-up checks. After about 10–15 seconds, they made a broadcast that they were rolling on runway 14 and released the brakes for take-off. At about the same time as the motor-glider was backtracking runway 14, the pilot of the RV-7 made a broadcast on the CTAF that they were taxiing from the general aviation hangars. At the runway holding-point, the pilot then made a broadcast that they were entering and back-tracking runway 14 (Figure 1). Neither pilot heard the broadcasts from the other pilot. The motor-glider started the take-off roll from the threshold of runway 14 and as it approached take-off speed, the pilot noticed the top of another aircraft (RV-7) appear on the horizon. Both pilots applied their aircraft brakes and veered to their right. The aircraft came to a stop next to each other on the runway abeam the glider hangars at about 1110 Eastern Standard Time (EST). The pilots performed a radio check and verified they could hear each other and both were broadcasting on the CTAF 126.7. They then proceeded on their planned flights without further incident.

Gympie runway slope. From the runway 14 threshold, runway 14 slopes upward to a crest, which is in line with the glider hangars (Figure 1). Runway 14 then slopes downhill to the threshold of runway 32. The motor-glider pilot commented that in an aircraft low to the ground, such as a glider, stationed at the threshold of runway 14, the pilot would not be able to see an aircraft such as the RV-7, back-tracking runway 14, until the other aircraft was abeam the glider hangars (Figure 1). The RV-7 pilot commented that when back-tracking runway 14 in their aircraft they cannot see another low profile aircraft, such as a glider, until they are about 300 m from the threshold of runway 14.

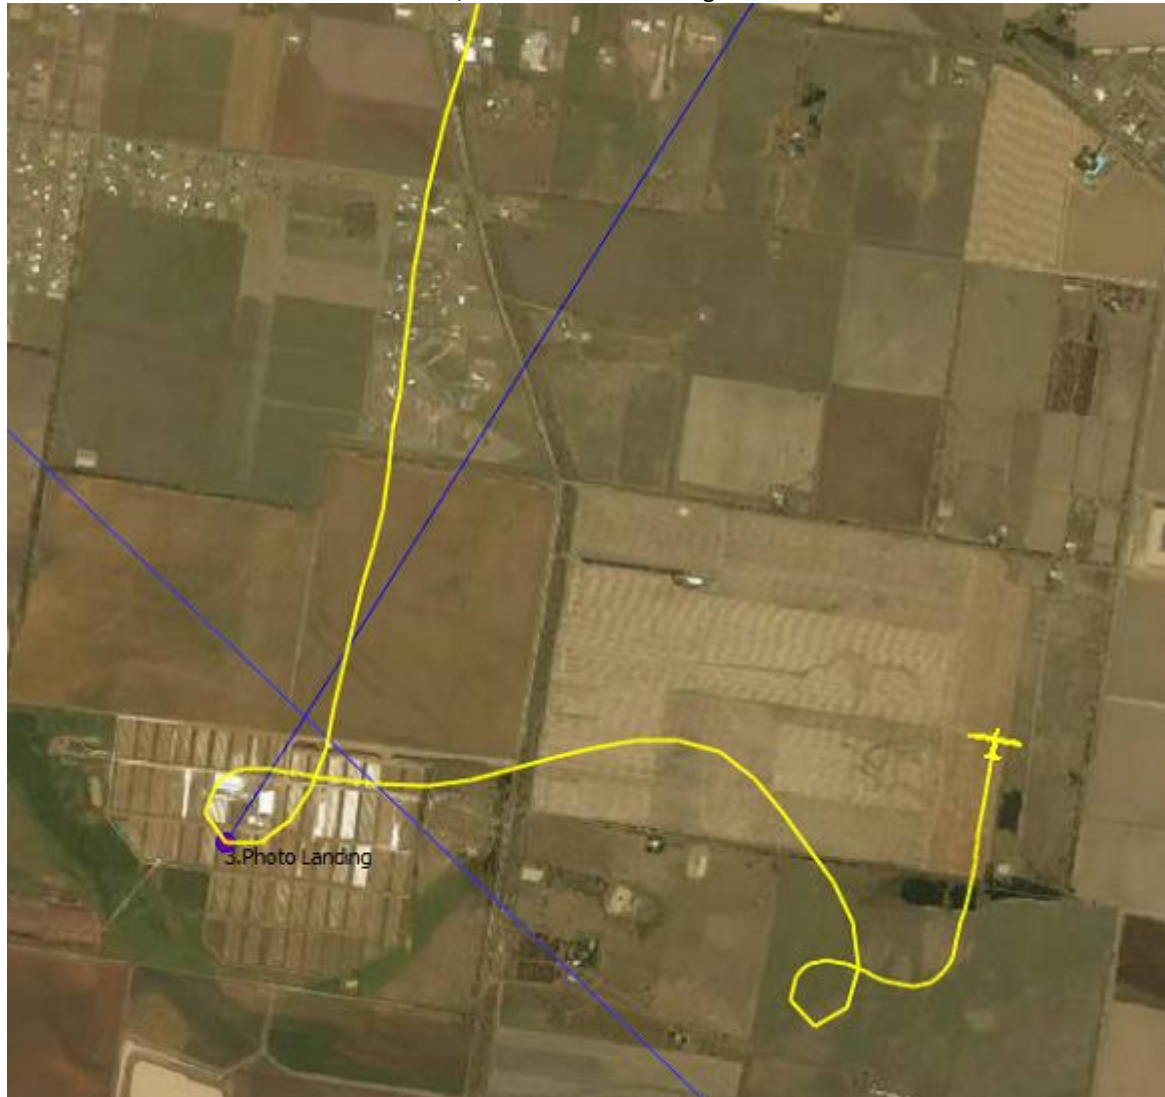
Level 1	Operational	Level 2	Aircraft Control	Level 3	Wheels up landing		
A/C Model 1		ASW 28		A/C Model 2			
Injury	Nil	Damage	Minor	Phase	Outlanding	PIC Age	63

The experienced pilot was competing in the Queensland State Championships. During the course of the cross-country flight an outlanding became inevitable after an unsuccessful search for lift and the pilot turned back towards a suitable paddock in order to land into wind. The pilot had not configured the aircraft for landing and did not complete the pre-landing check list. The aircraft landed with the undercarriage retracted and suffered minor damage. The flight logger trace revealed the pilot left the decision to break off the flight and commit to a landing late and at low level (600ft AGL). Landing mishaps commonly occur to pilots who become overloaded when close to the ground. Workload management can be eased by proper flight management which includes attending to pre-landing tasks (like lowering the undercarriage) early rather than later in the circuit. Refer also OSB 01/14 'Circuit and Landing Advice'.

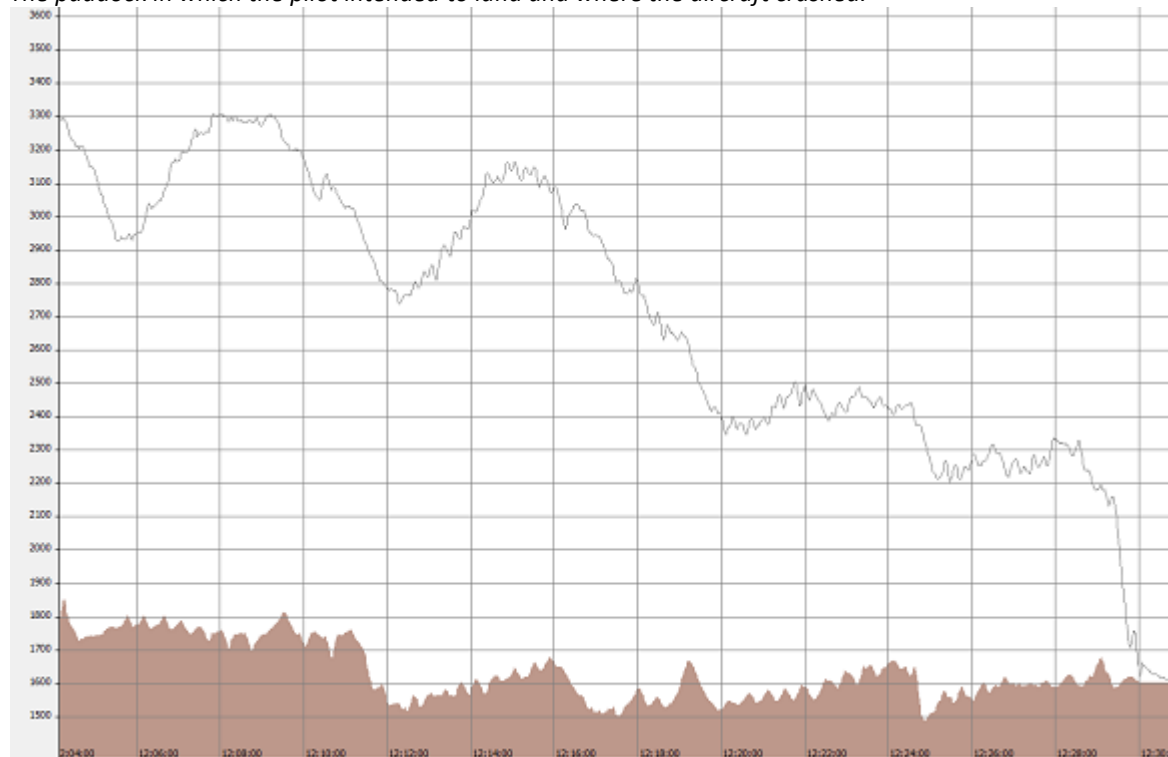
Barograph trace of the last 30 minutes of flight.

The flight trace, footage from the video camera and recorded audio revealed the pilot established the glider onto a north-easterly heading to land in a recently cropped paddock. The undercarriage was lowered and

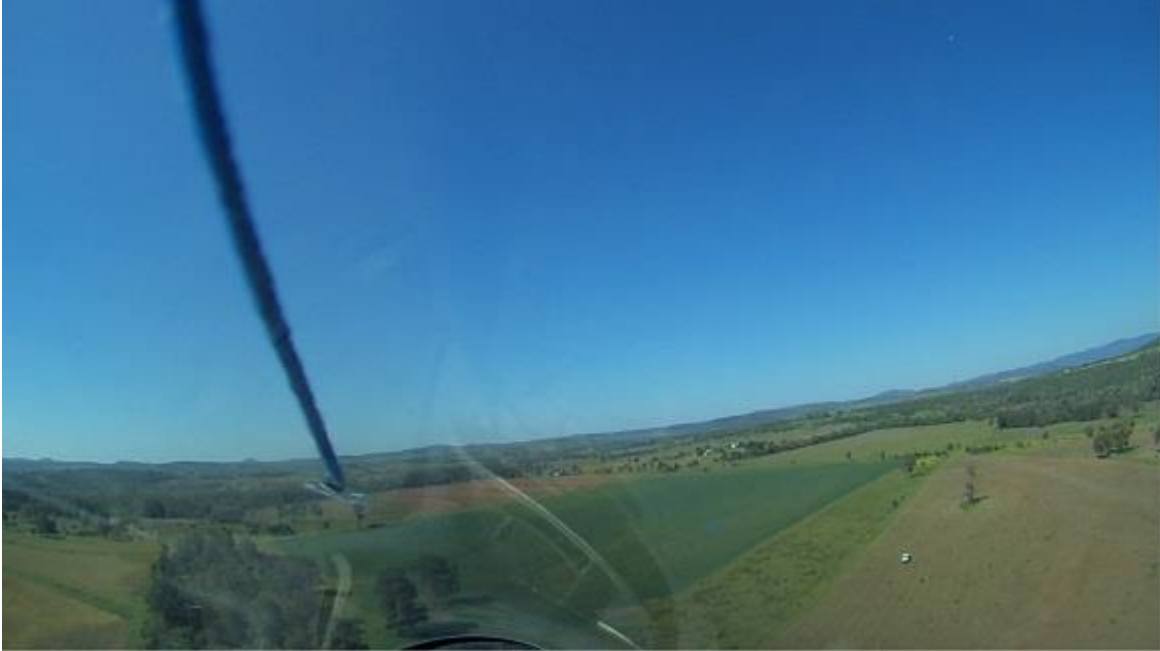
then airbrakes set to manage the glide path. At a height of approximately 200ft AGL the glider pitched-up momentarily and commenced a 30 to 40-degree bank to starboard and continued until the glider struck the upper branches of a tree. There was no attempt by the pilot to roll the wings level or avoid a collision.

Video footage from the cockpit showing the final approach to the selected outlanding paddock (foreground).

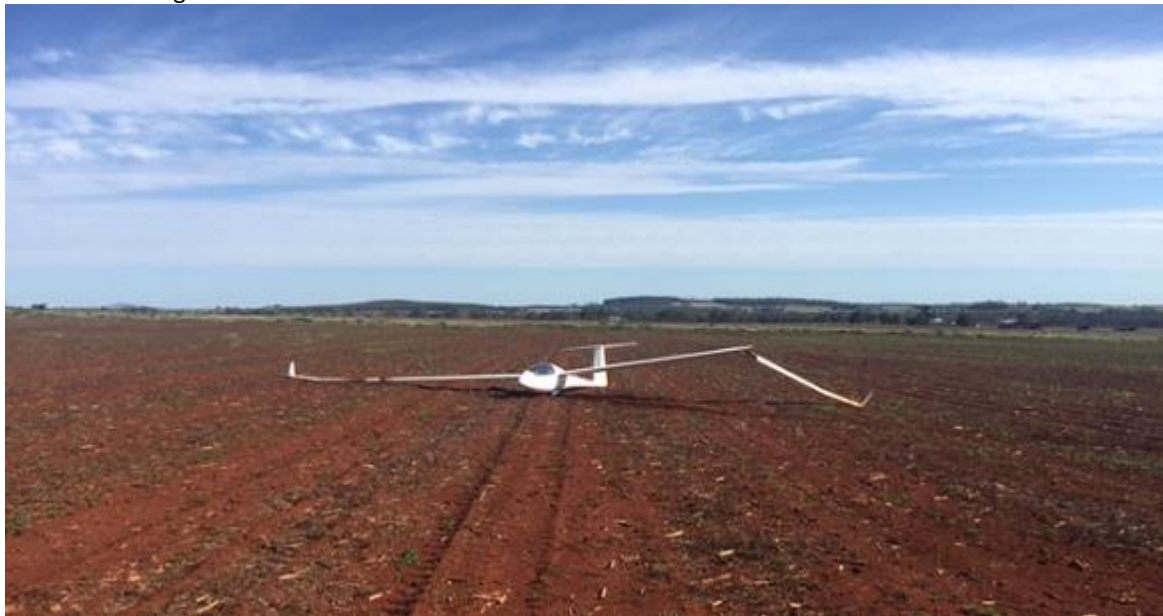
later disclosed that water ballast had not been dumped. While some gliders are designed to withstand a landing back at the airfield with water ballast on board it is always wise to land with empty water ballast tanks, especially when outlanding where surface conditions are unknown. Lateral control suffers when the wings are full of water and usually results in loss of aileron control on the ground run at a higher speed than would normally be the case. Landing with water ballast also places greater stress on the glider, and if the landing area is rough serious damage can be done as evidenced here. When a pilot is getting low and there is a prospect of having to land, then it is wise to dump the water ballast to avoid the higher rate of descent that comes with the glider being heavy. This will give the pilot the extra time needed to find a thermal and avoid the potential for damage during an outlanding. Causal factors include:

- Holding onto the water ballast for too long;
- Late decision to break-off the flight;
- Not configuring the aircraft for landing by dumping water ballast ([OSB 01/14 'Circuit and Landing Advice'](#) refers);
- Flying a modified circuit that prevented a more thorough inspection of the paddock;
- Strong crosswind component (~12 knots at 40 degrees);
- Soft surface of the paddock; and
- Landing with water ballast.

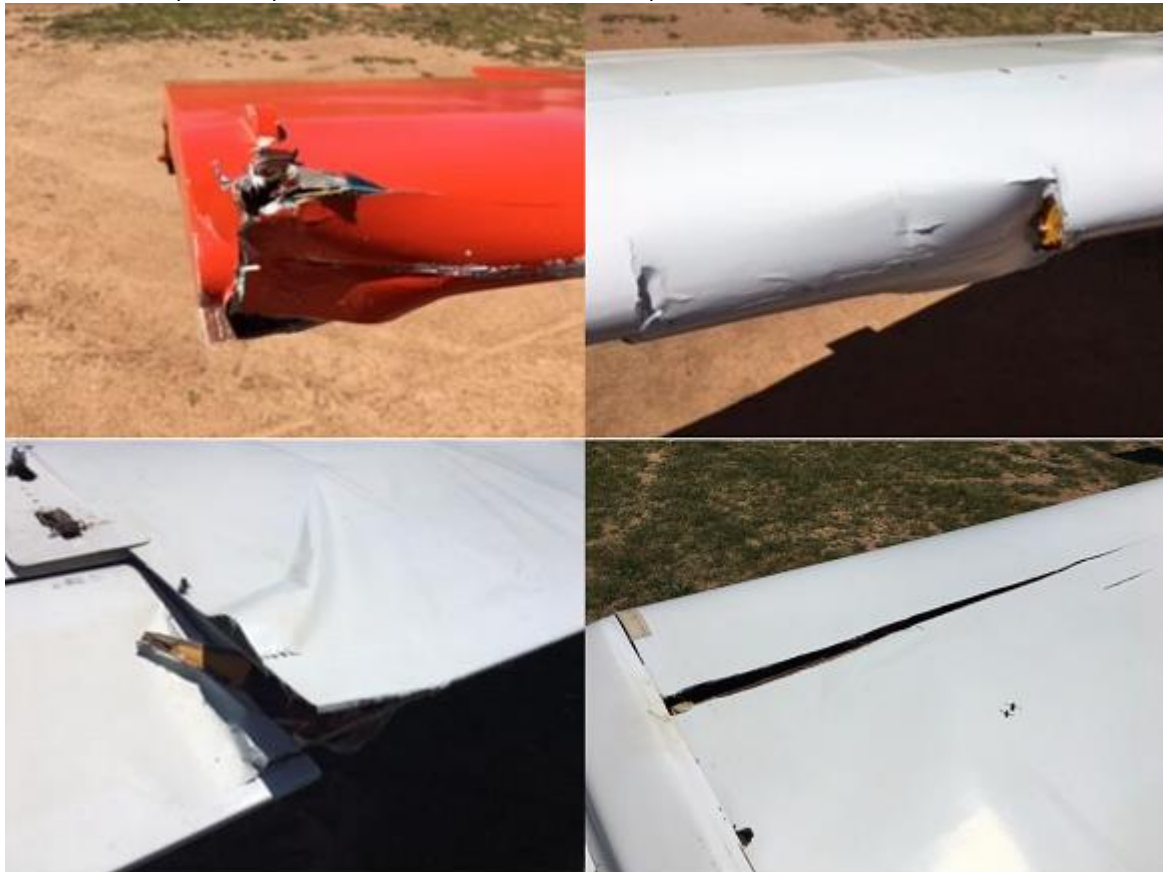
The owner towed the aircraft from its hangar to the tug hangar in order to clean oil residue from the bottom surfaces. The tow was paused when progress to desired point was blocked, and the owner got out of the vehicle to interact with other members. Sometime later after completing another task the owner got back into the car and drove off with the aircraft still attached. The aircraft wings collided with hangar door and suffered substantial damage. The pilot noted that the interruption and re-tasking led to a change in priorities, and upon completion of the secondary task the owner had forgotten that the aircraft was still attached to the car and that the primary task had not been completed. Interruptions and distractions are a significant threat facing pilots, and the omission of an action or an inappropriate action is the most frequent causal factor in incidents and accidents. Interruptions and distractions occur frequently, and while some cannot be avoided, most can be minimised or eliminated (through training, adoption of effective procedures, discipline and the use of good judgment). The following aspects should be considered to assess personal exposure, and to develop prevention strategies and lines-of-defence to lessen the effects of interruptions and distractions in all aspects of flying:

- Recognise the potential sources of interruptions and distractions;
- Understand their effect on the flow of duties;
- Reduce interruptions and distractions;
- Develop prevention strategies and lines-of-defence to minimise the exposure to interruptions and distractions; and
- Develop techniques to lessen the effects of interruptions and distractions.

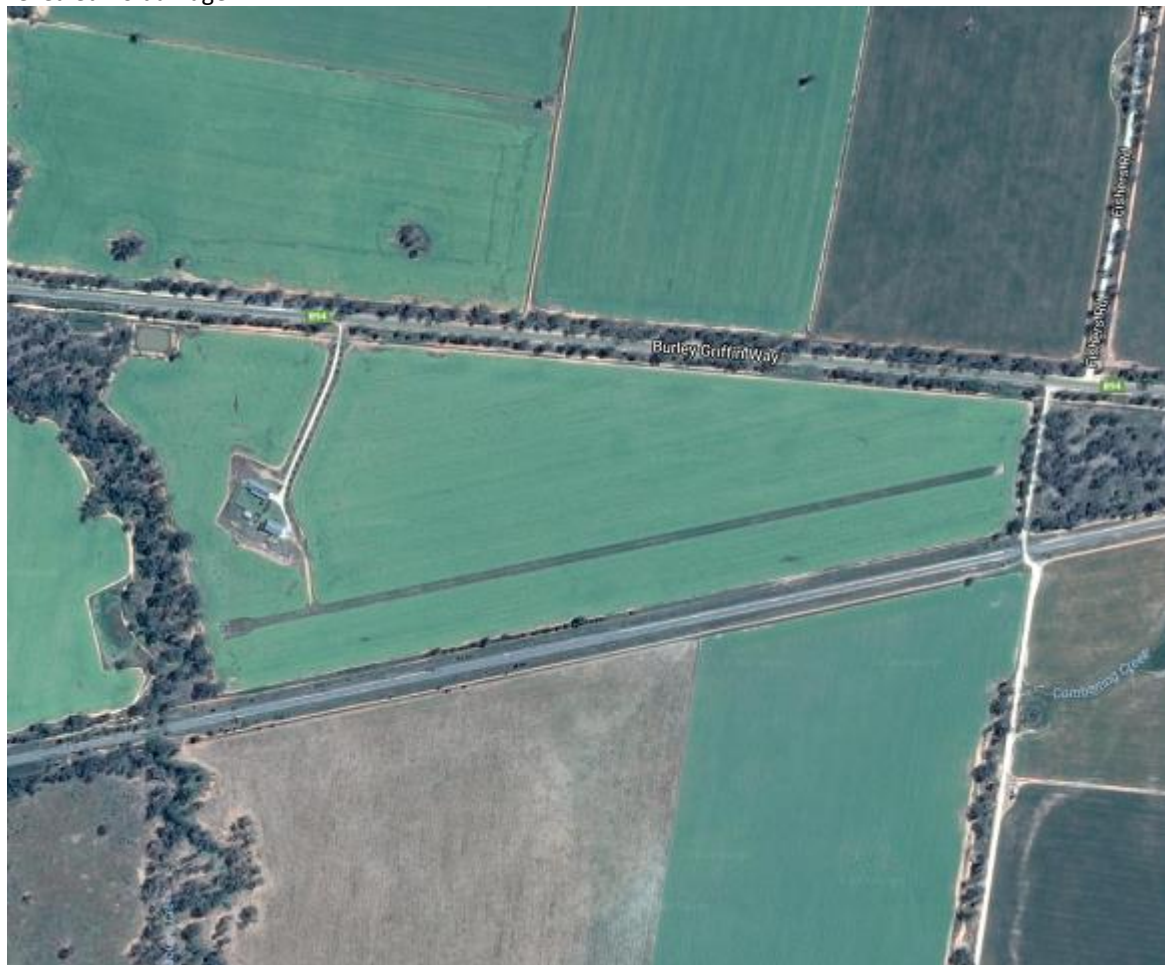
A/C Model 1		Janus B			A/C Model 2			
Injury	Nil	Damage	Nil	Phase	Outlanding	PIC Age	28

The pilot was returning to the home airfield after a cross-country flight from the South-South-East into a 10 knot headwind. The aircraft was below final glide but the pilot had maintained glide to a private airstrip approximately 10km east of the home airfield. No lift was found and the pilot subsequently joined circuit and landed on the private airstrip. The private airstrip was about 14 metres wide and was bounded by tall wheat crop grown to the very edge of the runway. As the glider's wingspan was 18.2 metres, the starboard wing caught a higher section of the crop towards the end of the landing roll resulting in a slow ground loop through 180 degrees. While the wings stayed level, the tail struck the ground before the end of rotation and the tailskid disbonded from the fuselage (as it is designed to do). A subsequent inspection of the airframe revealed no damage.
