The Gliding Federation of Australia Inc

Occurrence Summaries

01/01/2016 to 31/12/2016

The Gliding Federation of Australia Inc
SOAR Accident and Incident Occurrences

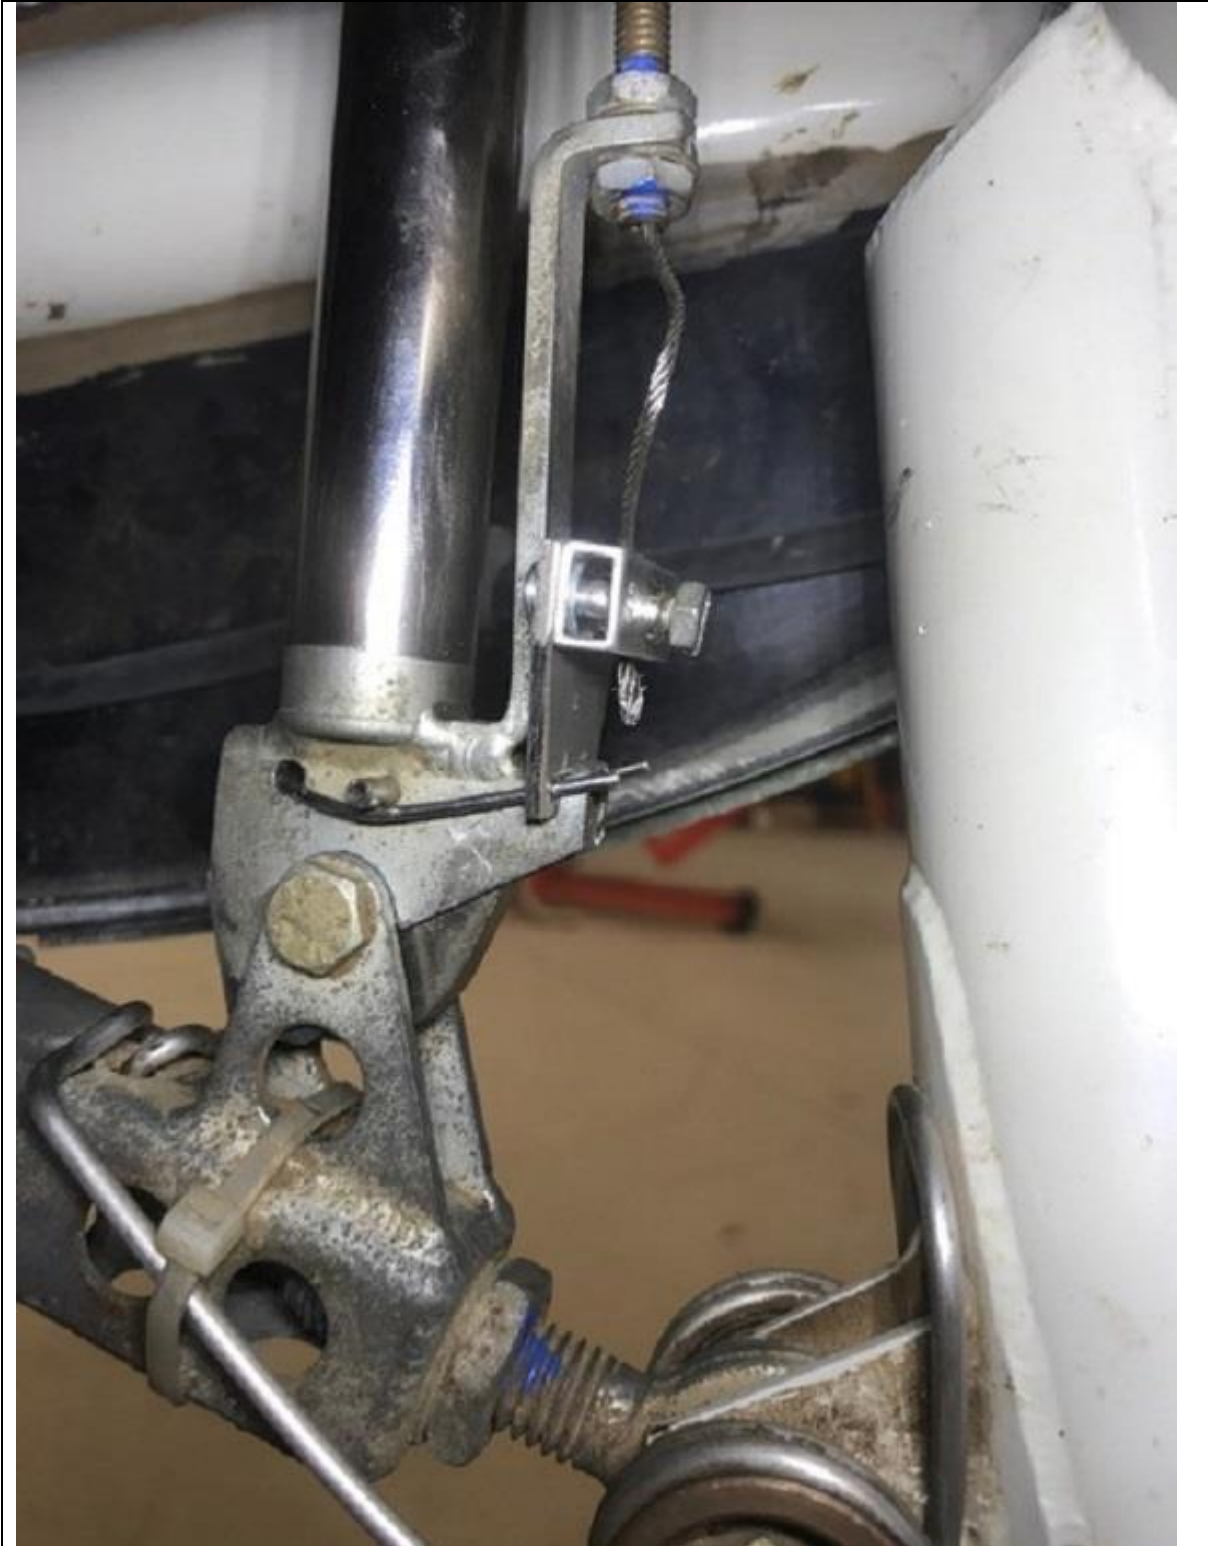
Date	11-Nov-2016	Region	SAGA		SOAR Report Nbr	S-0836	
Level 1	Technical		Level 2	Systems		Level 3	Other Systems Issues
A/C Model 1	Stemme S10-VT			A/C Model 2			
Injury	Nil	Damage	Nil	Phase	In-Flight	PIC Age	50
<p>The pilot was undertaking a positioning flight from Waikerie to Parafield in a powered sailplane. During the climb the pilot selected the undercarriage up. The undercarriage position indicator lights flashed red for a longer than normal period and the climb rate did not improve as expected. Shortly after the circuit breaker popped. The pilot climbed to 1500ft AGL, reset the circuit breaker and then lowered and raised the undercarriage but the circuit breaker again triggered. The circuit breaker was reset and this time the pilot received two green lights indicating the undercarriage was down and locked. Another glider in circuit confirmed the undercarriage was down, as did members on the ground when the sailplane passed over the gliding control van. The pilot elected to continue the flight to Parafield with the undercarriage down. Upon arrival at Parafield the command pilot informed the control tower that the sailplane may have an unsafe undercarriage condition, and a local helicopter with a high definition camera flew alongside and also confirmed the gear was down. As the command pilot was concerned the undercarriage was not overcentre, the emergency undercarriage deployment handles (which disconnect spindle drives) were pulled to allow full weight of undercarriage to assist the over centre, and the engine was shut down. An uneventful landing ensued and the undercarriage remained down and locked. The Tower controller offered the command pilot the opportunity to inspect the overcentre mechanism while on the runway. After a satisfactory inspection, the command pilot restarted the engine and taxied back to the hangar. The Tower sent a ground vehicle to meet with the command pilot to obtain a statement for a report. Investigation revealed a retaining spring had weakened over time and was not pushing down on the plate hard enough to reliably lock the latch hook at the bottom of the spindle drive. New Parts were fitted and the aircraft was returned to service.</p>

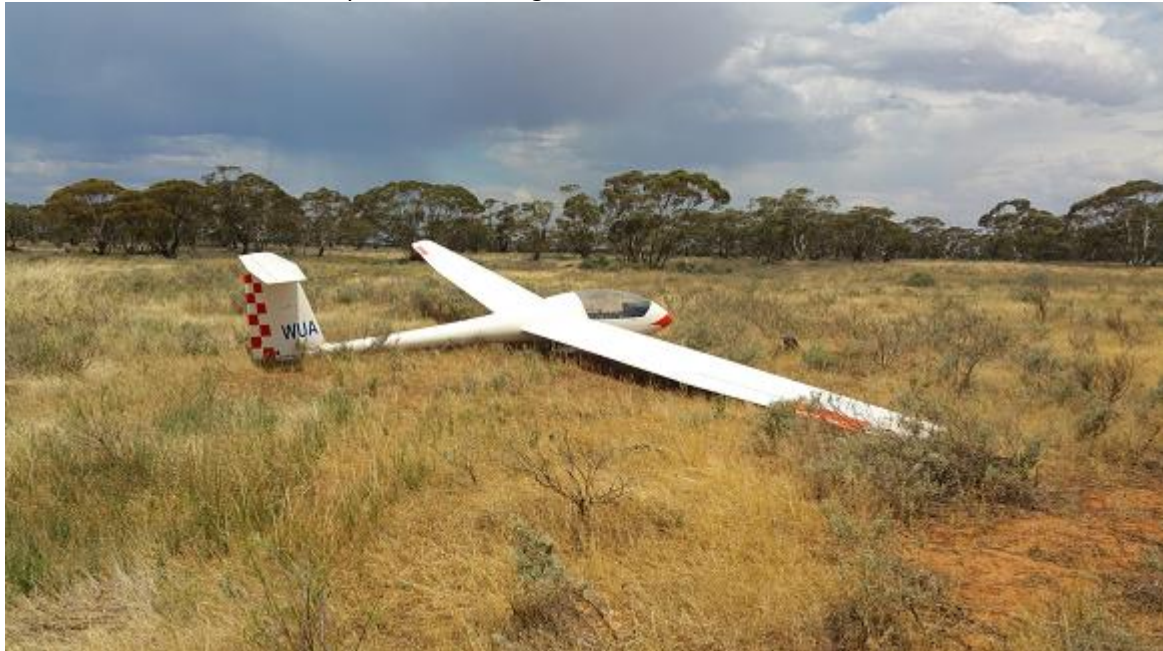
4. The pilot commenced his final approach from too far behind the runway perimeter for the prevailing conditions and performance of the glider being flown.

5. The glider was unable to penetrate the wind in order to complete a landing on the aerodrome; and
6. The pilot's options of a suitable landing place were limited by the unsuitability of terrain within gliding distance. Pilots should be aware that virga can significantly influence weather conditions. As rain changes from liquid to vapour form, it removes heat from the air due to the high heat of vaporisation of water. Precipitation falling into these cooling down drafts may eventually reach the ground. In some instances, these pockets of colder air can descend rapidly, creating a microburst which can be extremely hazardous to flight.

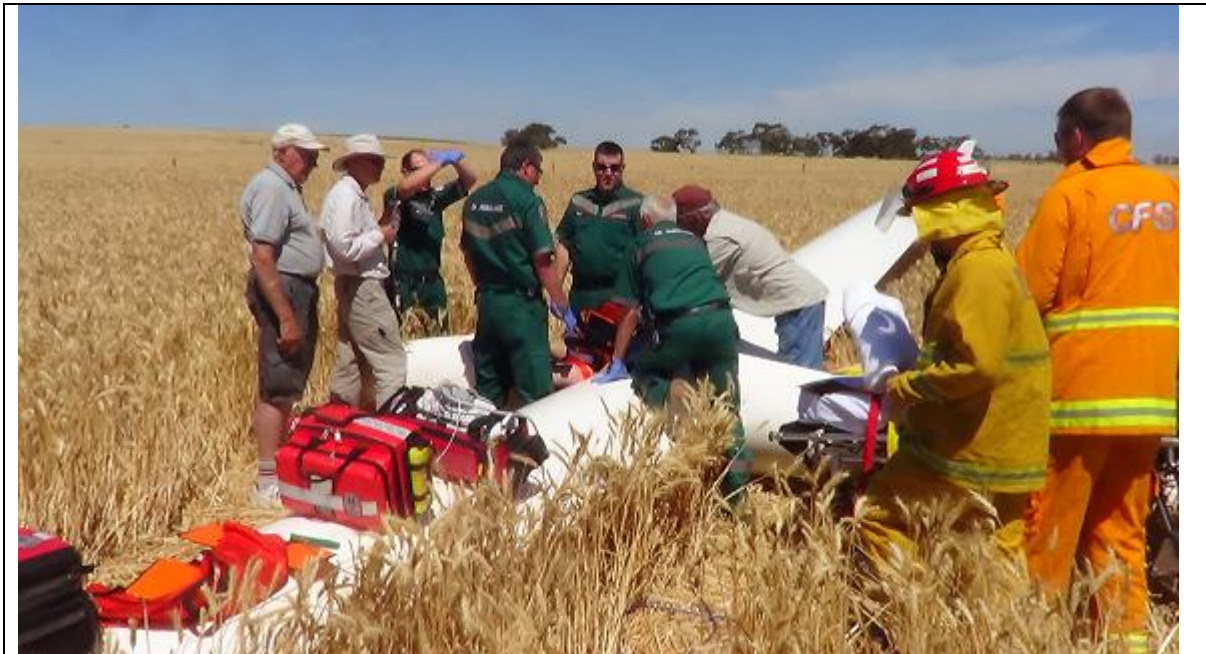
Date	26-Nov-2016	Region	SAGA		SOAR Report Nbr	S-0851	
Level 1	Operational		Level 2	Aircraft Control		Level 3	Hard landing
A/C Model 1	Standard Libelle 201 B			A/C Model 2			
Injury	Minor	Damage	Substantial	Phase	Launch	PIC Age	58
<p>Just as a winch launch was commenced a club member noticed the trace had been overrun and had wrapped around the main wheel of the glider. A stop signal was given but the glider was about 30 to 40 feet in the air by the time the winch driver cut power. The glider then descended and landed heavily in a wheat crop approximately 5 meters from the runway edge. The pilot suffered back pain and was conveyed to hospital for observations. Investigation revealed that the aircraft over ran the rope as the slack was being taken up, and the rings back-released and flicked up into the main wheel becoming trapped in the under carriage. This was not noticed by the launch crew who then gave the "All Out" signal. Another member close by observed the cable being overrun and called for the launch to be stopped. The glider was launched from the main wheel, resulting in the glider rotating early into the climb, and it had reached a height of between 40ft and 100ft AGL before the winch driver cut the power. The pilot managed to get the glider into a nose-down position but opened the airbrakes before safe speed had been attained, and the glider 'pancaked' heavily into a crop alongside the runway some 200 metres from the launch point. Although the pilot had recently come back to gliding after a 40-year break he was in current practice. The launch failure caught the pilot by surprise, and while the nose of the glider was correctly lowered, the pilot inexplicably opened the airbrakes prior to allowing the speed to build up. This accident could also have had much more serious consequences had one member not noticed the problem and stopped the launch early. Being launched from the mainwheel allowed the glider to pitch up due to a low and aft CG position. In such cases it is possible for the elevator to be ineffective, thereby causing the glider to pitch up uncontrollably. Had this been allowed to develop a stall/spin event was likely.</p>

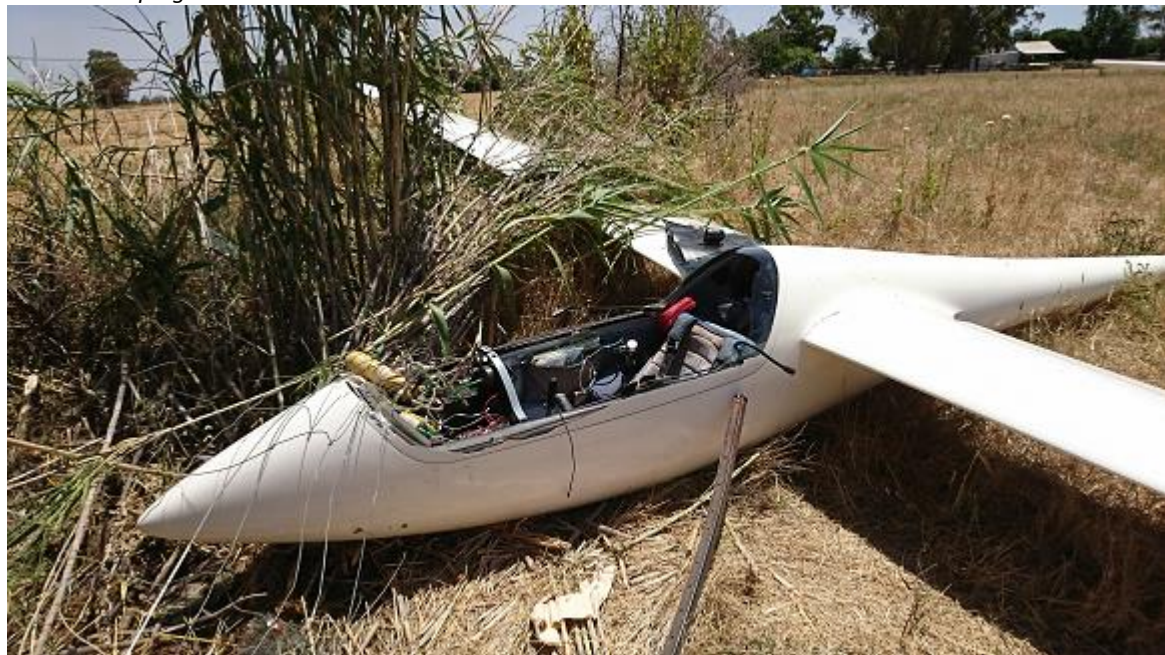
Date	29-Nov-2016	Region	NSWGA	SOAR Report Nbr	S-0864		
Level 1	Operational		Level 2	Terrain Collisions	Level 3	Wirestrike	
A/C Model 1	ASW 20B			A/C Model 2			
Injury	Minor	Damage	Substantial	Phase	Outlanding	PIC Age	73
<p>The pilot experienced strong sink after releasing from aerotow for a competition flight and turned towards another aircraft circling in lift nearby. The high sink rate persisted so the pilot increased speed to pass through it quickly. With no improvement in the rate of descent, the pilot elected to head for a paddock but soon realized the glider would not reach it. The pilot headed for an alternative paddock with another suitable paddock to the left. The pilot noted: <i>"I was falling short. The glider was heavy and sinking rapidly and I realised I could not complete a turn to the left. I decided to go straight ahead and hope to clear the fence"</i>. While attempting to land in the paddock the glider struck a power line above the fence line, and the aircraft fell to the ground and was substantially damaged. The pilot suffered minor injuries and spent a short time in hospital for observation. Inspection of the glider at the accident site revealed the undercarriage was retracted, the airbrakes were unlocked, the flaps were in negative and the aircraft was still carrying full water ballast. The high rate of descent from tow coupled with the aircraft configuration at the crash site</p>

suggests that the pilot omitted to lock the airbrakes prior to launch. The pilot may also have been using negative flap for aileron control during the ground roll and forgot to put them into neutral once control had been established. When then pilot released from tow and experienced a heavy rate of descent, this was initially attributed to strong sink and the pilot did not think to check the aircraft configuration. When the sink rate persisted, the pilot became overloaded to the point where the ability to troubleshoot potential problems had diminished (cognitive tunnelling). The pilot reported: *"I was current in out-landings, having made an outlanding two days earlier and another two weeks before that. In those outlandings I had time to choose a suitable paddock, go through my checks and complete a circuit. In retrospect, as soon as I realised the sink rate was not reducing I should have reduced my speed, checked the airbrake and flap settings and started dumping water."*

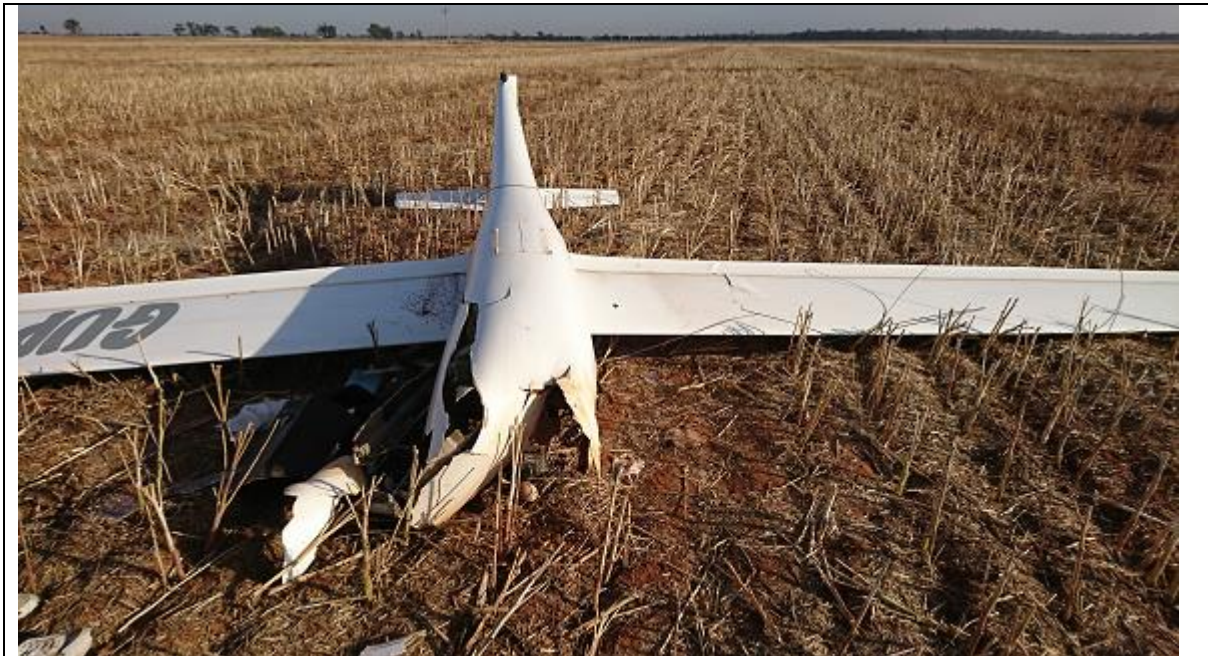
Date	29-Nov-2016	Region	NSWGA	SOAR Report Nbr	S-0865		
Level 1	Operational	Level 2	Terrain Collisions	Level 3	Wirestrike		
A/C Model 1	Ventus c		A/C Model 2				
Injury	Serious	Damage	Substantial	Phase	Outlanding	PIC Age	62

The pilot was competing in the NSW State Gliding Championships. It was Day 3 and the glider was on the final leg of a 510km flight. The pilot had been airborne for nearly four hours, and had spent most of the flight on oxygen while operating between 6,000ft and 12,000ft when the last turnpoint was rounded. With just over 160kms to run conditions began to soften, with high Cirrus casting a shadow across the ground. Upon rounding the turnpoint the pilot noticed that the aircraft's navigational GPS had not automatically changed to the next point. The pilot manually adjusted the navigational computer but mistakenly set its heading to the airfield and not to the assigned control point just to the North of the airfield. About halfway home and on final glide, the pilot realised the navigational error and reset the navigation computer to head for the control point. It was then the pilot realised the glider was under the glideslope. The pilot noted *"I think this rattled me as I had wasted height thinking I was home"*. The pilot took a climb over a sunny spot on the ground as the cirrus shadow moved in. However, the climb was weak so the pilot pushed on towards some other sunny areas in the hope of a better climb rate. About 20kms from the control point the ground was in shadow, and the pilot realised there was little prospect of getting a climb. The pilot noted: *"I was indecisive; go to control point and outland? Back track to farmer harvesting? Turn toward (the airfield)?"* The pilot decided to back track but did not find lift so headed towards the airfield. The pilot made reasonable progress

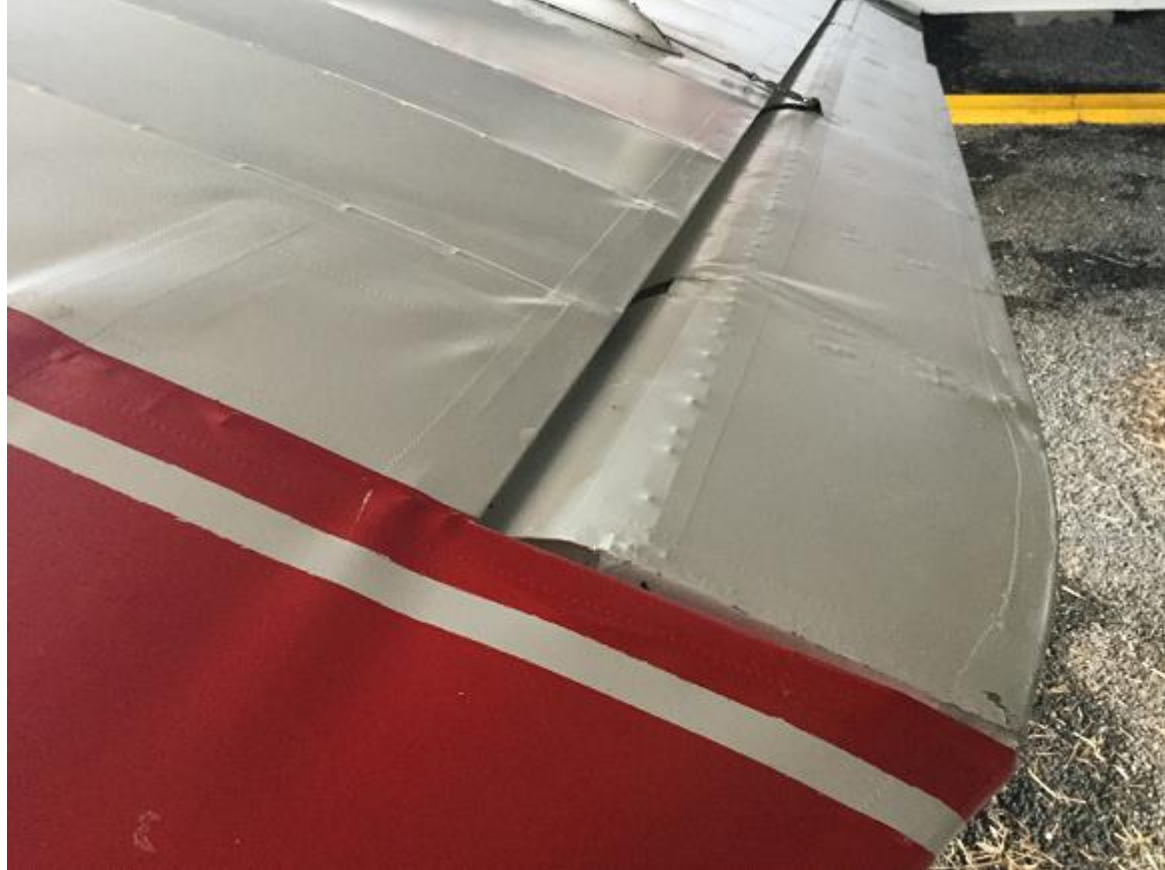
Date	5-Dec-2016	Region	NSWGA	SOAR Report Nbr	S-0866		
Level 1	Environment	Level 2	Weather	Level 3	Other Weather Events		
A/C Model 1	Piper PA25-235/A1		A/C Model 2				
Injury	Nil	Damage	Minor	Phase	Ground Ops	PIC Age	70
<p>While taxiing from the fuel bowser to the glider hangar the tow plane was struck by a squall causing it to roll onto its left wing tip and come to rest sideways across the edge of the taxiway. The gliding operation had ceased due to an approaching squall and the gliders had been returned to the hangar. The tow pilot, in the belief that the storm front was still some distance away, elected to refuel the tug. However, the storm developed much more rapidly than anticipated and, as the tow pilot was taxiing back from the refuelling point to the hangar the tow plane was suddenly engulfed by torrential rain and, more significantly, a 50 knot gust of wind which tipped the tug onto its left wing causing moderate damage to several ribs and the left aileron. A gust of this magnitude is outside the limits of controllability of any aircraft. The CFI noted the primary cause of this accident was an incorrect assessment of the rate of development of the storm and its subsequent severity. This was coupled with the well intentioned decision to refuel the tug before putting it</p>

away which, with the benefit of hindsight, was not appropriate. This accident highlights that storm cells can be totally unpredictable and that getting everything safely away sooner rather than later is always the wisest course of action.

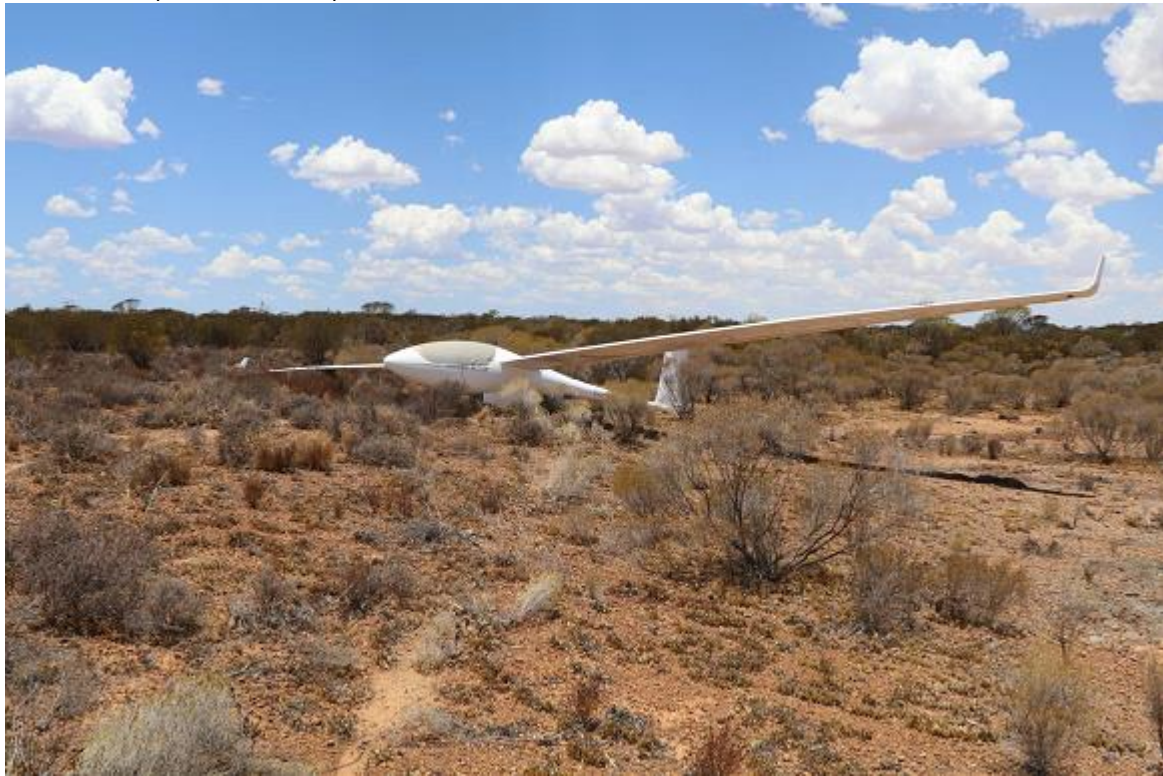
Date	9-Dec-2016	Region	WAGA	SOAR Report Nbr	S-0871		
Level 1	Operational	Level 2	Terrain Collisions	Level 3	Collision with terrain		
A/C Model 1	ASH 26 E		A/C Model 2				
Injury	Nil	Damage	Substantial	Phase	Outlanding	PIC Age	62

The pilot was attempting a 750km FAI triangle during a club camp at a remote site. After completing about 450km of the task and during the final leg of the task the pilot took a climb to 6,500 feet and headed off across some scrub land; a distance of about 30 kms from high point to the nearest landable paddock. While crossing the scrub the glider flew through consistent heavy sink and the pilot decided to deploy the sustainer motor. However, when the motor was raised it did not lock as the glider was flying too fast. Running out of height and options, the pilot stowed the motor, picked the most suitable spot in the scrub to land, completed the pre-landing checks and landed in in scrub where the glider ground looped and came to a stop. The pilot activated the SPOT for a trailer retrieve but after about an hour the pilot realised the glider was in the middle of very rough terrain with no possible vehicle access. As it was approaching sunset, the pilot activated the 911 alarm on the SPOT. Whilst waiting for the Rescue Helicopter to arrive the pilot was in contact with a commercial flight, which was later replaced by a dedicated high orbiting King Air. When the Rescue Helicopter arrived the pilot was air-lifted out.

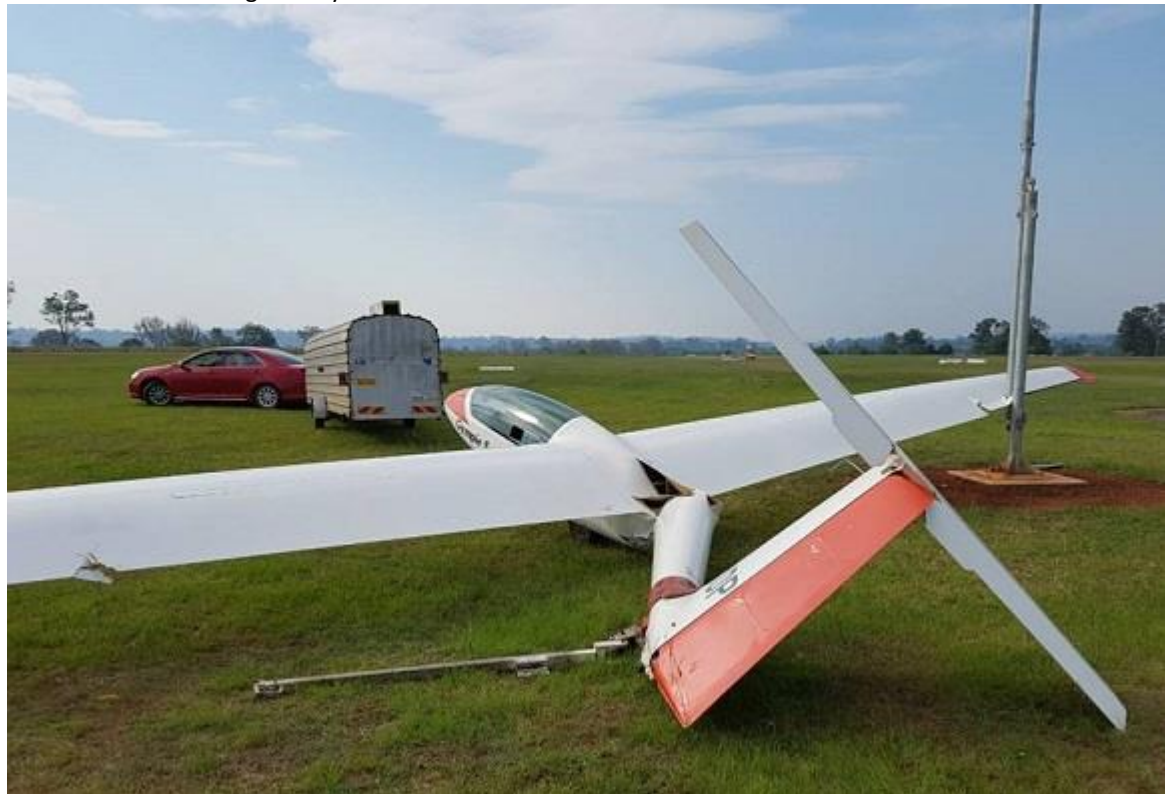
Date	17-Dec-2016	Region	GQ	SOAR Report Nbr	S-0877		
Level 1	Operational	Level 2	Ground Operations	Level 3	Taxiing collision/near collision		
A/C Model 1	SZD-51-1 Junior		A/C Model 2	N/A			
Injury	Nil	Damage	Substantial	Phase	Ground Ops	PIC Age	56

The glider was being towed back to the hangar at the end of the day. An inexperienced member was driving the retrieve vehicle with an experienced club member in the passenger seat when it struck the windsock post. Contributing factors included inattention/distraction of both the vehicle driver and the supervising member. When taxiing gliders, drivers need to pay particular attention to obstacle clearance. Keep a good look out and take things slowly.

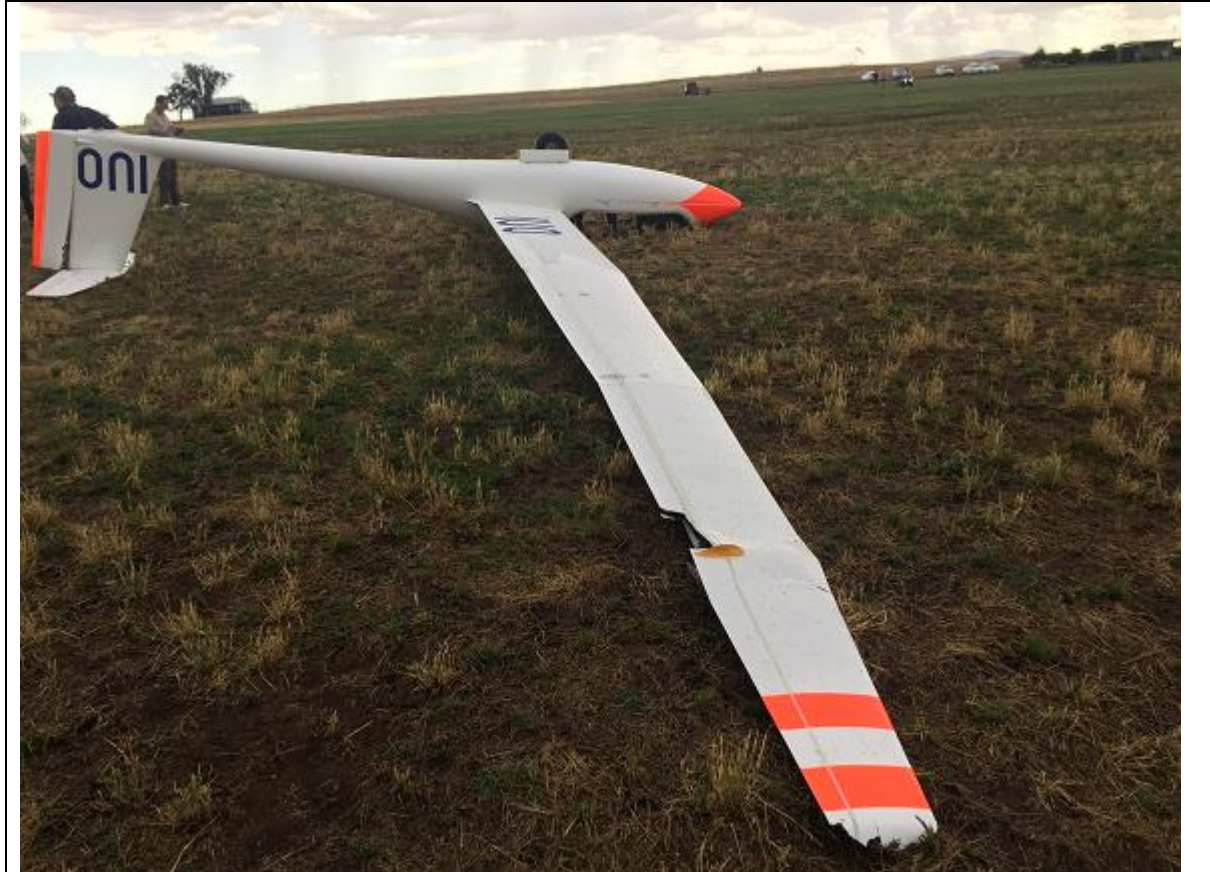
Date	21-Dec-2016	Region	NSWGA		SOAR Report Nbr	S-0933	
Level 1	Environment		Level 2	Weather		Level 3	Turbulence/Windshear /Microburst
A/C Model 1	PW-5 "Smyk"			A/C Model 2	IMC A-9A Callair		
Injury	Nil	Damage	Write-off	Phase	Ground Ops	PIC Age	63
<p>The weather was thermic and there were storms visible on the high ground to the east. Clouds close to the club were cumulus with a fair amount of vertical development. A street to the south-west began to emit showers, with one shower close to the launch point. The shower crossed the end of the airfield and the wind increased from around 5-10kts to 76kts (measured on the weather station) within a few seconds. The unoccupied tow plane was blown backwards into a PW5 glider. The tow plane sustained minor damage to the elevator and rudder and the glider sustained damage to fuselage and wing. Once the wind abated all aircraft were removed to hangars/trailer to prevent further damage.</p>
