Occurrence Summaries 01/01/2017 to 31/12/2017 Region(s): All Club:

Christopher Thorpe Executive Manager, Operations The Gliding Federation of Australia Inc.

The Gliding SOAR Accident	The Gliding Federation of Australia Inc SOAR Accident and Incident Occurrences								
General Statistics									
Date From:	Date From: 01/01/2017								
Date to:	31/12/2017

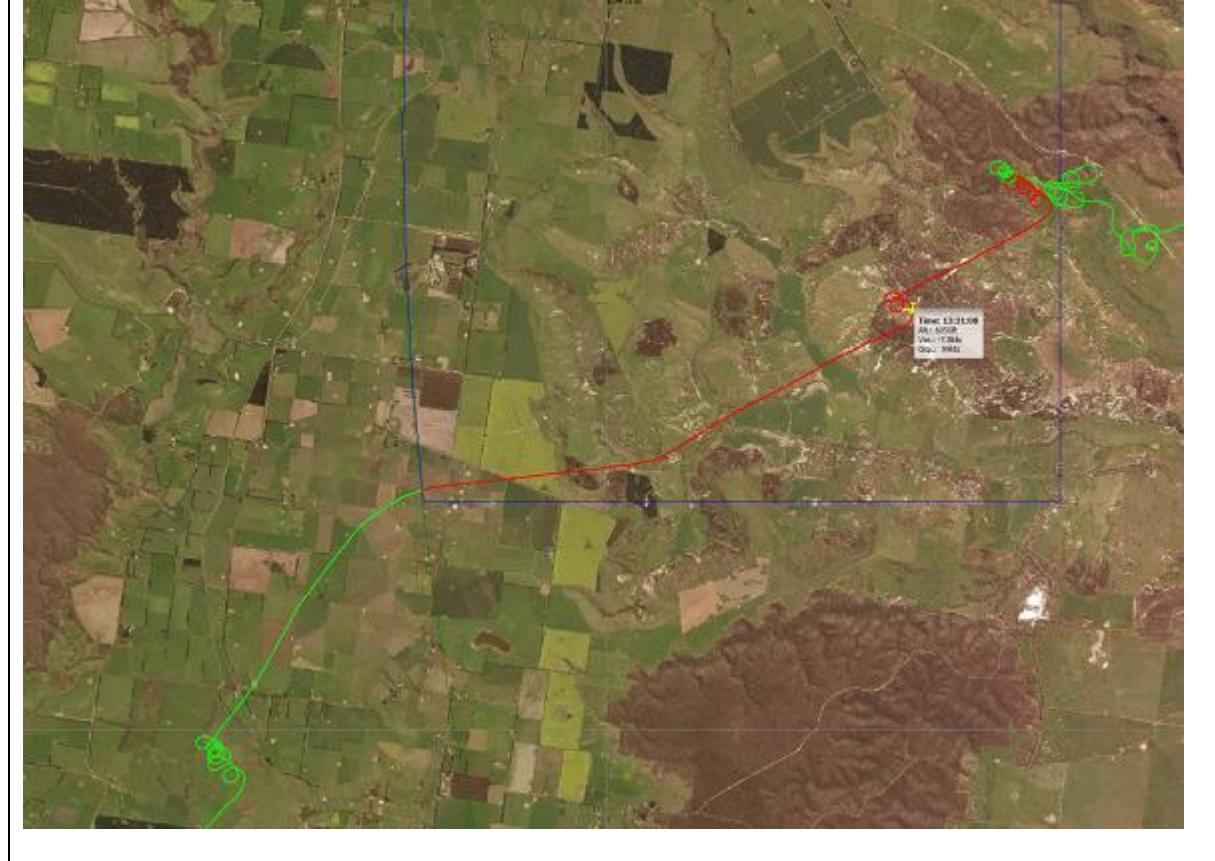
During a cross-country flight the experienced pilot flew into controlled airspace without a clearance. The infringement was identified by the pilot's CFI following a review of the pilot's OLC trace. The infringement occurred despite the pilot carrying appropriate maps and GPS navigation device and may have been caused by inattention. The pilot was counselled.

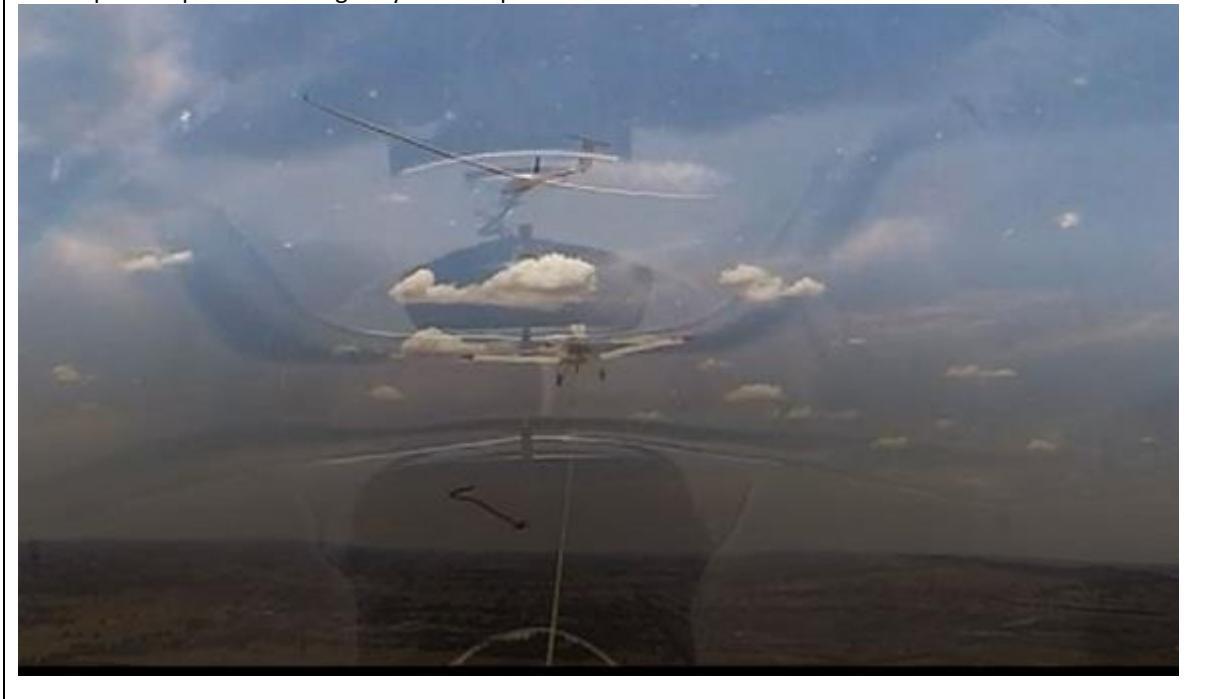
Date	4-Jan-2017	Regior	Region VSA SOAR Report Nb			ort Nbr		S-(0891			
Level 1	Airspace		Level	2	Aircra	ft Sep	arati	on	Level	З	Near collis	ion
A/C Mod	el 1	Pi	per PA-	-25	-235/A1		A/C	Model	2	Binc	ler EB29 DR	
Injury	Nil	Dama	age		Nil	Pha	ise	In-Flig	ght		PIC Age	70
On day 1	of the 2017 Wor	ld Glidin	g Cham	pic	onships a t	owing	com	binatio	n appr	oache	ed, from belo	ow and
behind, a	motor glider on	the right	climbi	ng	under pov	ver. Tł	ne to	w pilot	turned	sligh	tly left to pr	ovide
clearance	e but the motor g	lider cor	tinued	to	drift towa	rd the	tow	ing con	nbinatio	on's fl	ight path. Tl	he pilot of
the towe	d glider attempt	ed to ale	t the to	ow	pilot to th	e pote	ential	l conflic	t but t	his tra	ansmission v	vas given at
a late sta	ge and the tow p	oilot did r	ot read	ct. S	Seconds la	ter th	e mo	tor glid	er pass	ed fro	om right to l	eft over and
between	the tow plane an	nd glider	under t	tow	v with sepa	aratio	n esti	mated	at less	than	100ft. The t	ow plane is a

two-seat, side by side Pawnee with the pilot sitting in the in the left seat. It is possible the tow pilot's vision was impeded up and to the right by the cockpit roof.

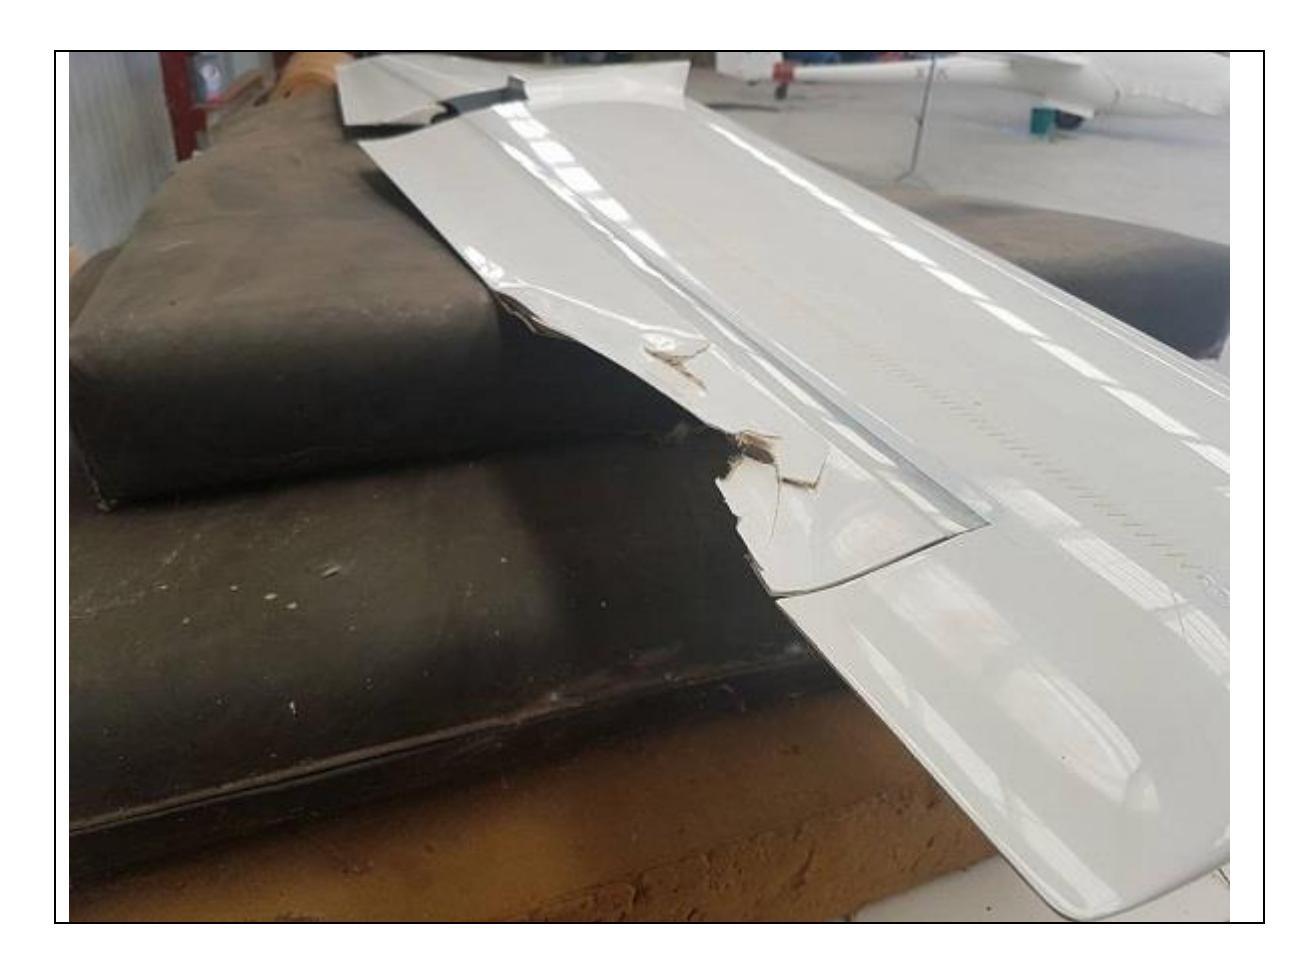
Date	7-Jan-2017	Region		VSA		SOA	AR Repo	ort Nbr		S-	0892
Level 1	Operational		Level	2 Terra	in Co	llisior	าร	Level	3	Collision w	ith terrain
A/C Mod	el 1		AS	G29		A/C	Model	2			
Injury	Nil	Dama	age	Substantial	Pha	se	Grour	nd Ops		PIC Age	39
Whilst to was caug	wing the glider a ht against the ve	round th hicle. Th	e aproi e eleva	n area the tov tor was subst	w vehi antia	icle tı lly da	urned s maged	harply	and t	he elevator	of the glider

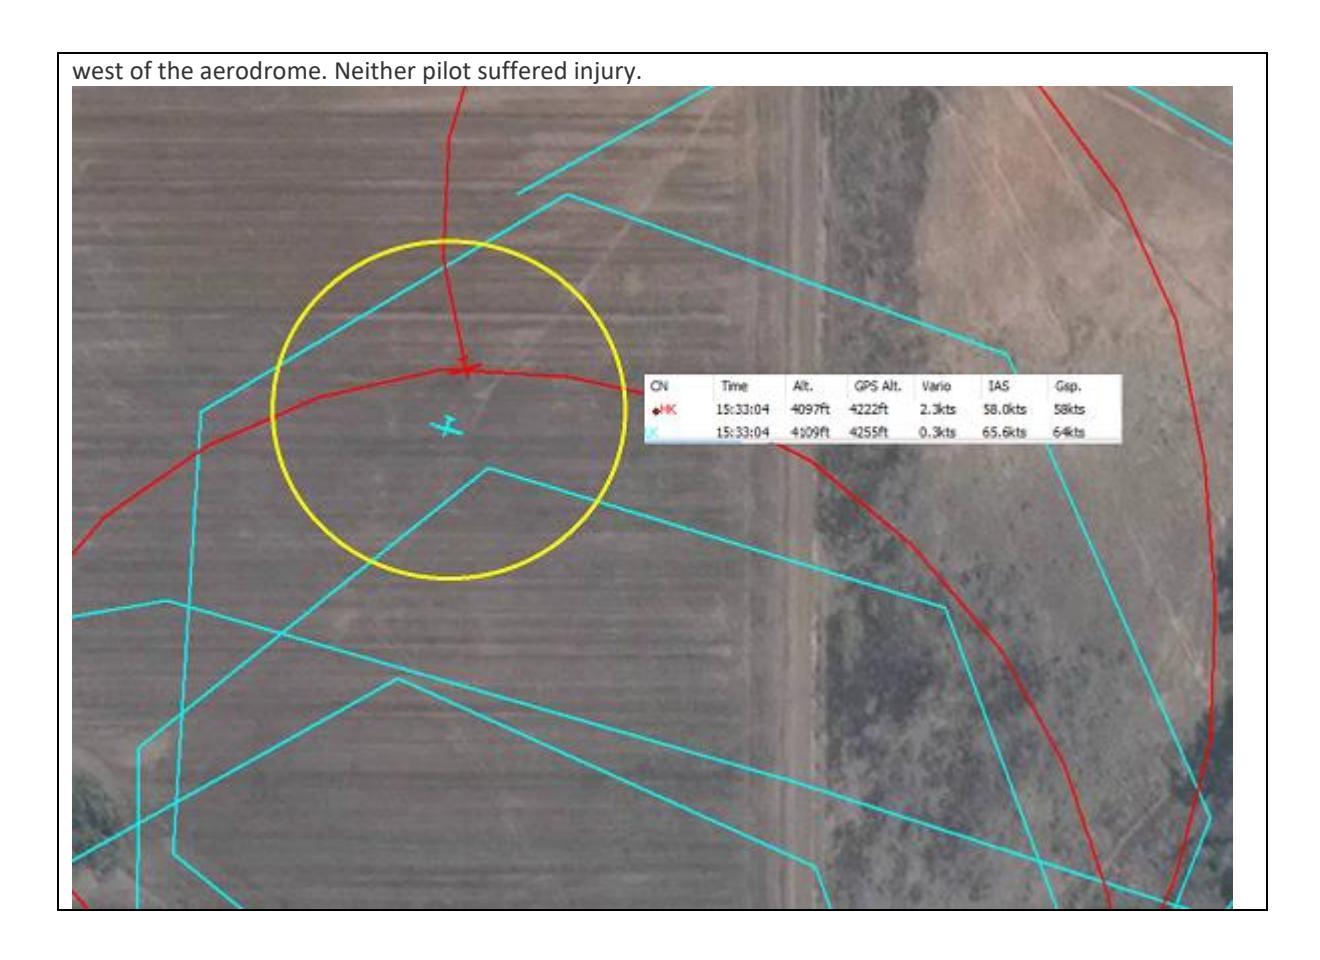
now only	several metres	behind and	d higher.	At the mo	ment	of co	llision,	the rela	ative	positions of	the two
gliders su	iggests a double-	blind scen	nario whe	ere neithei	r pilot	had s	sight of	the oth	ner gl	ider. The sta	arboard wing
top surfa	ce and leading e	dge of the	lead glic	ler struck 1	the lef	ft win	gtip of	the oth	ier, ai	nd both pilo	ts felt the
impact. B	Both gliders were	only supe	erficially	damaged a	and re	main	ed cont	rollable	e. On	e pilot flew	back to
Benalla a	erodrome and tl	ne other co	onducted	l a precaut	tionar	y out	landing	onap	rivate	e airstrip abo	out 19 kms

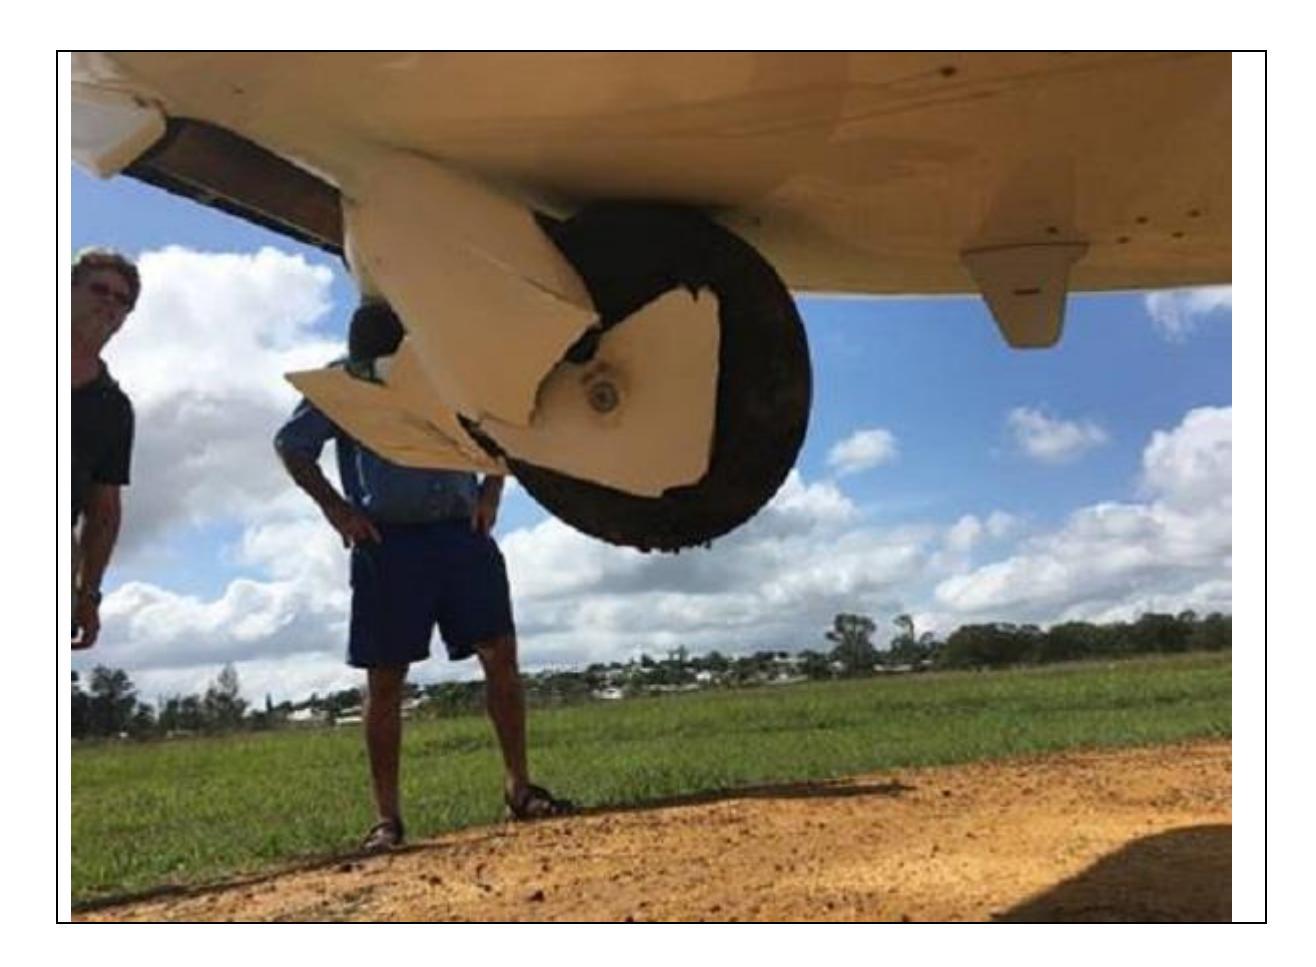
Date	13-Jan-2017	Regior	۱		GQ		SOA	R Repo	ort Nbr		S-I	0901		
Level 1	Operational		Leve	el 2	Airc	raft Co	ontro	_	Level	3	Hard landi	ng		
A/C Mod	el 1	S	unda	ncer	D13/15		A/C	Model	2					
Injury	Nil	Dama	age	Su	bstantial	Pha	ise	Landi	ng		PIC Age 67			
The pilot had recently taken delivery of a new touring motor glider and, after a few assessment flights with										flights with a				
check pilo	ot, flew back to t	he home	airfie	eld. C	On landing	the pi	ilot m	nisjudge	ed the f	lare r	esulting in t	he aircraft		
touching	down heavily an	d rebour	nding	into	the air. Th	e pilo	t misl	handled	d the re	cove	ry from the	bounce and		
the aircra	ift impacted on t	he nose	whee	l, wh	ich collaps	ed ca	using	the ro	tating p	prope	ller to strike	the ground.		
Contribut	ing factors inclue	de limite	d exp	erier	nce on typ	e and	low c	urrenc	у.

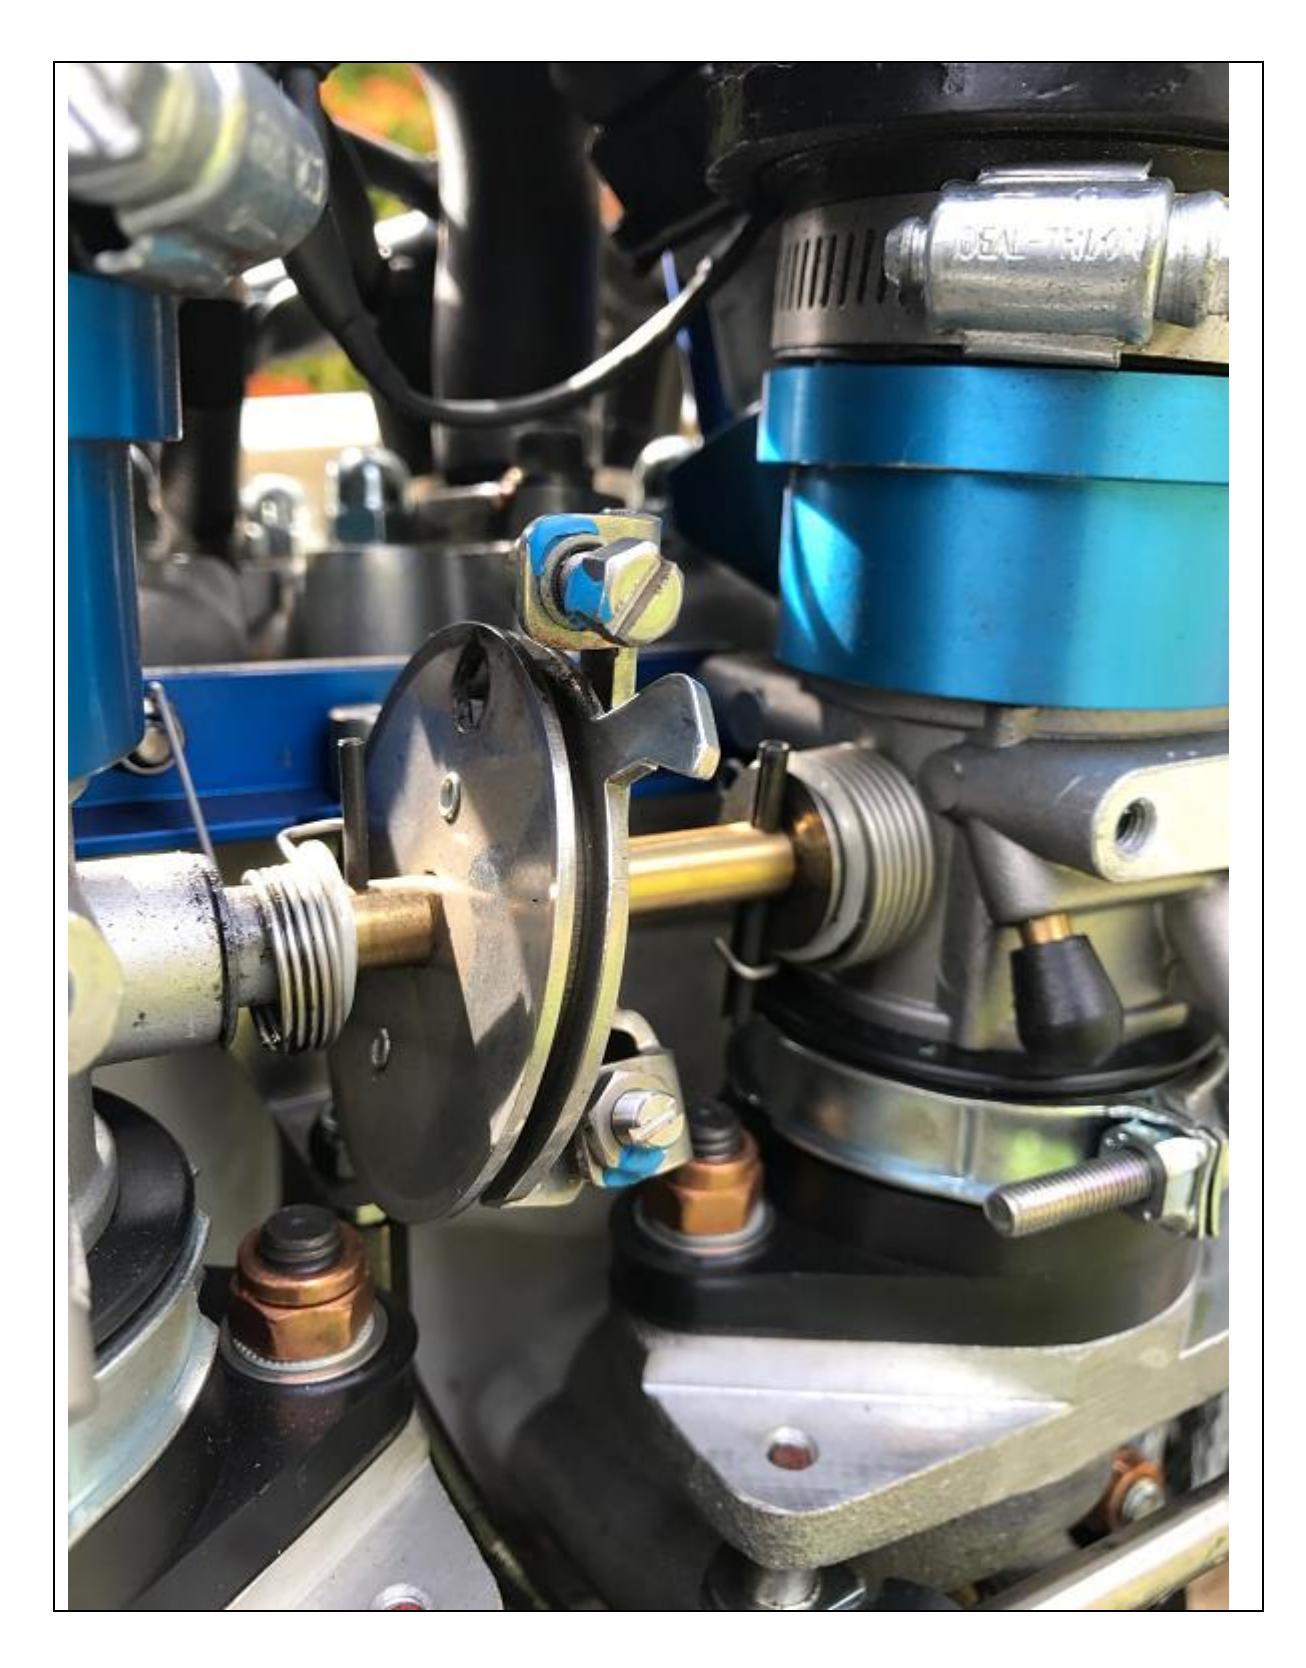
Date	14-Jan-2017	Regior	1	NSWGA		SOA	AR Repo	ort Nbr		S-I	0894	
Level 1	Technical		Level	2 Powerplant/Propulsion Level 3 Engine fail				ure or				
				malfunction					n			
A/C Mod	el 1		DG-	1000M		A/C	Model	2				
Injury	Nil	Dama	age	Nil	Pha	ise	Launc	h		PIC Age 52		
After self	-launching to a s	afe heigh	it the c	command pilo	t atte	mpte	d to sh	ut dow	n the	engine but	could only	
reduce th	rottle to 5,000 R	PM. The	comm	and pilot turi	ned of	f witł	n ignitic	on and	subse	quently retr	acted the	
engine no	ormally. Inspection	on reveal	ed the	throttle cabl	e whe	el ha	d becor	ne par	tly de	tached from	the throttle	
body spir	ndle. The engine	had only	run fo	or 11 hrs since	e repla	ceme	ent.

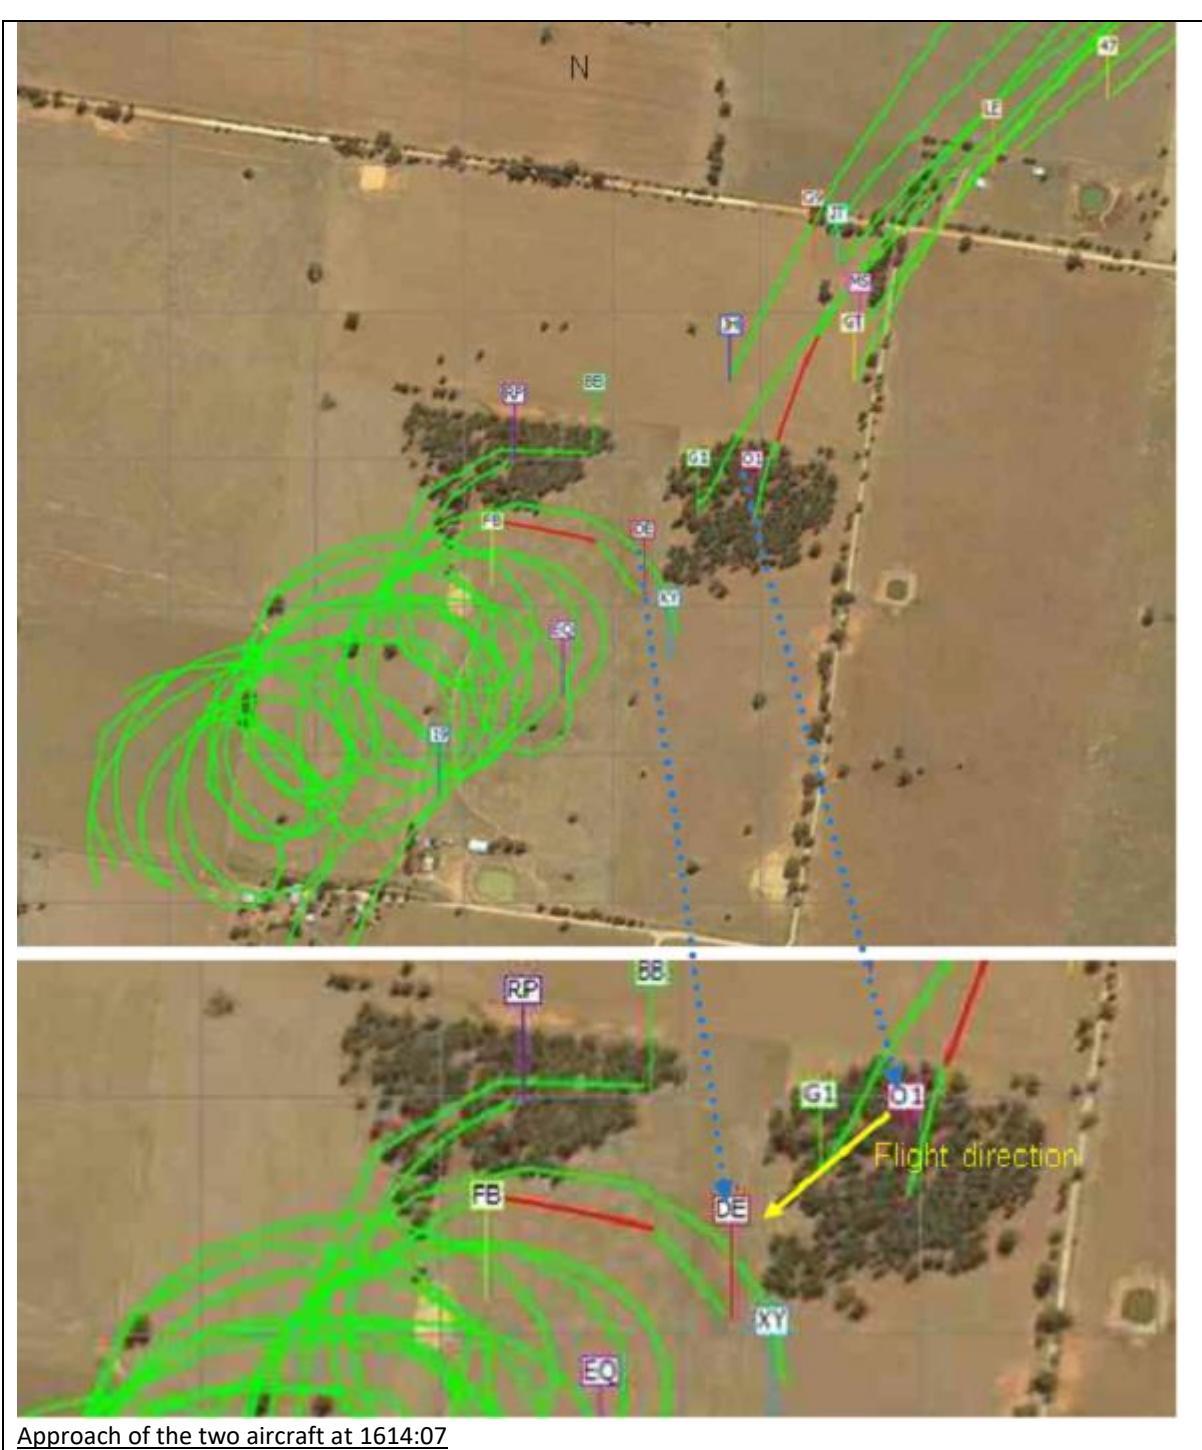
Glider DE was at an altitude of 5,030 ft and glider O1 was at an altitude of 4,860 ft. Gliders DE and XY were directly in front of glider O1, glider G1 was in front of but displaced slightly to the right of glider O1, and another three gliders (FB, BB and JH) were behind glider O1 on the right. At this stage glider DE has rolled out of the turn and is heading off on track. The red line shows a collision alert of the Flarm of glider DE.

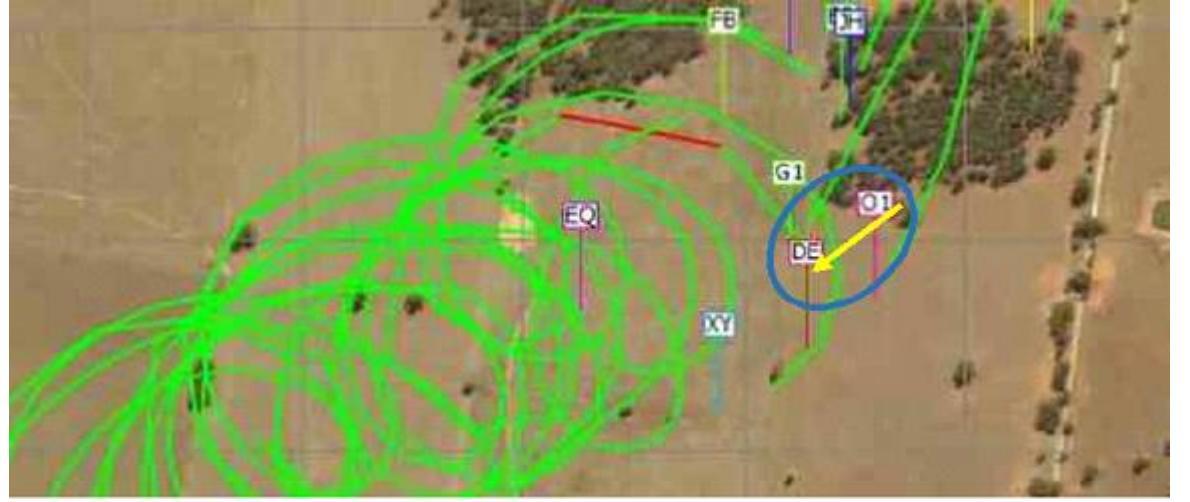
Approach of the two aircraft at 1614:14

Glider DE is at an altitude of 5,0230 ft and glider O1 is at an altitude of 4,940FT. Gliders DE and XY are now directly in front of glider O1, with glider G1 closer and to the right of glider O1. Glider G1 has pulled into the thermal to the right and glider JH is continuing through the thermal. The red line shows a collision alert of the Flarm of glider O1.

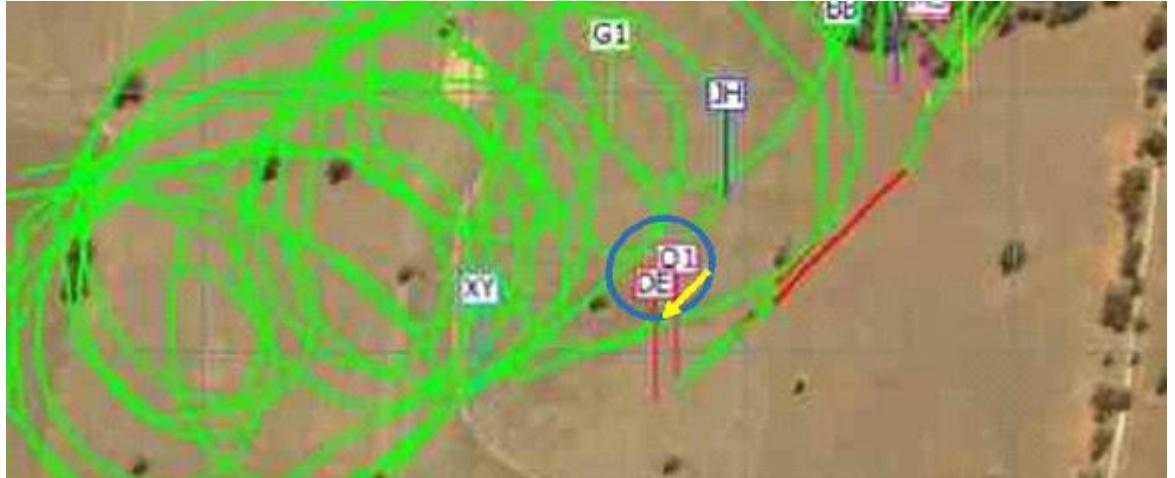
<u>Approach of the two aircraft at 1614:18</u> Glider DE at an altitude of 5,042 ft and glider O1 is at an altitude of 4,970 ft.

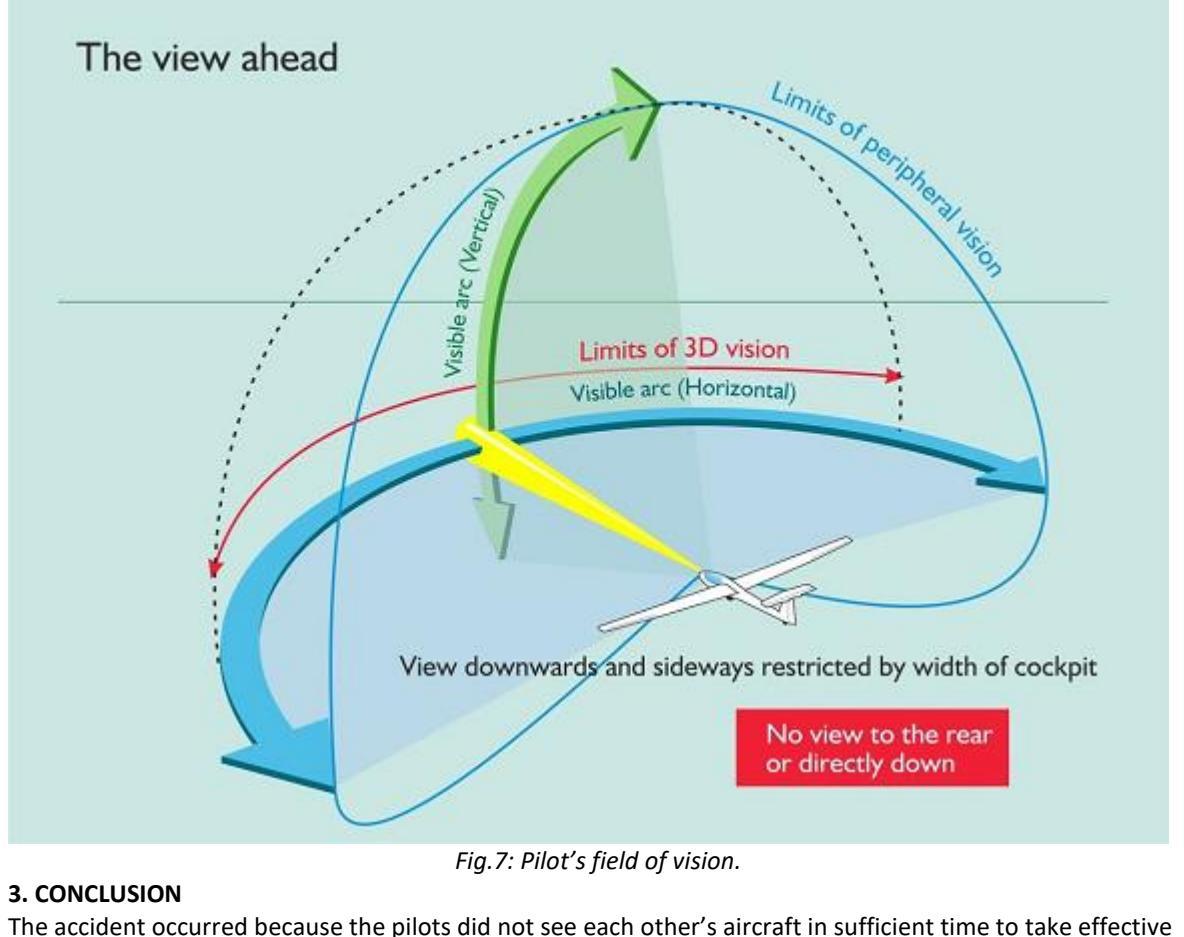
consequently vision, is vulnerable to many things including, but not limited to, dust, fatigue, emotion, age, and optical illusions. In flight, vision is influenced by atmospheric conditions, glare, lighting, canopy deterioration and distortion, aircraft design, acceleration forces and so forth. Most importantly, the eye is vulnerable to the vagaries of the mind. We can 'see' and identify only what the mind permits us to see. Another inherent eye problem is the narrow field of vision. Although our eyes accept light rays from an arc of nearly 200°, they are limited to a relatively narrow area (approximately $10 - 15^{\circ}$) in which they can actually focus on and classify an object. Anything perceived on the periphery must be brought into that narrow field to be identified. Motion or contrast is needed to attract the eyes' attention, and the field of vision limitation can be compounded by the fact that at a distance an aircraft on a steady Collision Course will appear to be motionless. The aircraft will remain in a seemingly stationary position, without appearing to move or to grow in size, for a relatively long time, and then suddenly bloom into a huge mass, almost filling the canopy. A large smear or dirty spot on the canopy can hide a converging aircraft until it is too close to be avoided. Light also affects our visual efficiency. Glare during flight directly into the sun makes objects hard to see and scanning uncomfortable. An aircraft that has a high degree of contrast against the background will be easy to spot, while one with low contrast at the same distance may be impossible to see (especially against a cluttered background). A dirty, scratched, opaque or distorted canopy will make matters worse. While gliders have large canopies and theoretically offer an excellent field of view to the pilot, there are still blind arcs. The following diagram illustrates the field of view from a glider; the yellow cone is the narrow area in which we focus.

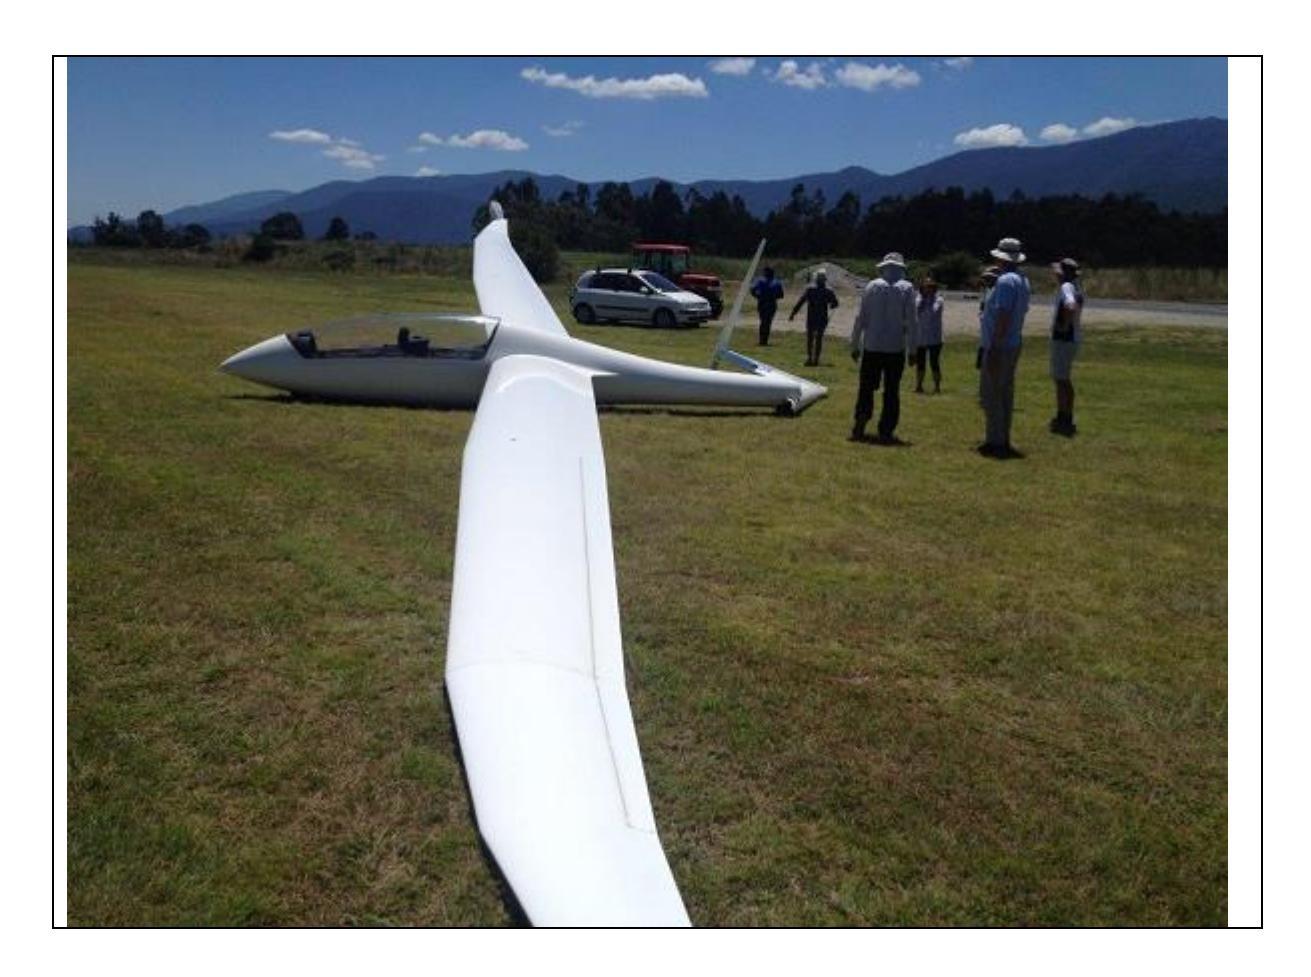
Date	28-Jan-2017	Region	I	WAGA		SOAR Report Nbr				S-0915	
Level 1	Consequential E	vents Level 2 Low Circuit Level 3					3	Low Circuit			
A/C Mod	Model 1 Hornet A/C Model 2							2			
Injury	ury Nil Damage Nil Phase Landing									PIC Age	68
The pilot	made a late decis	sion to b	reak off	the flight ar	nd the	n pro	ceedeo	d to fly a	a low	and modifie	ed circuit.
During ev	very flight pilots n	eed to c	onsider	when to sta	rt hea	ding	for the	circuit	joinir	ng area. The	decision will
be influe	nced by wind stre	ength and	d directi	on, and the	locati	on fo	r the ci	rcuit joi	ining	area. Pilots	must make a
positive decision to join the circuit to land, and plan to arrive at the circuit joining area between 800 ft –									800 ft –		
1,000 ft AGL, depending on glider performance.

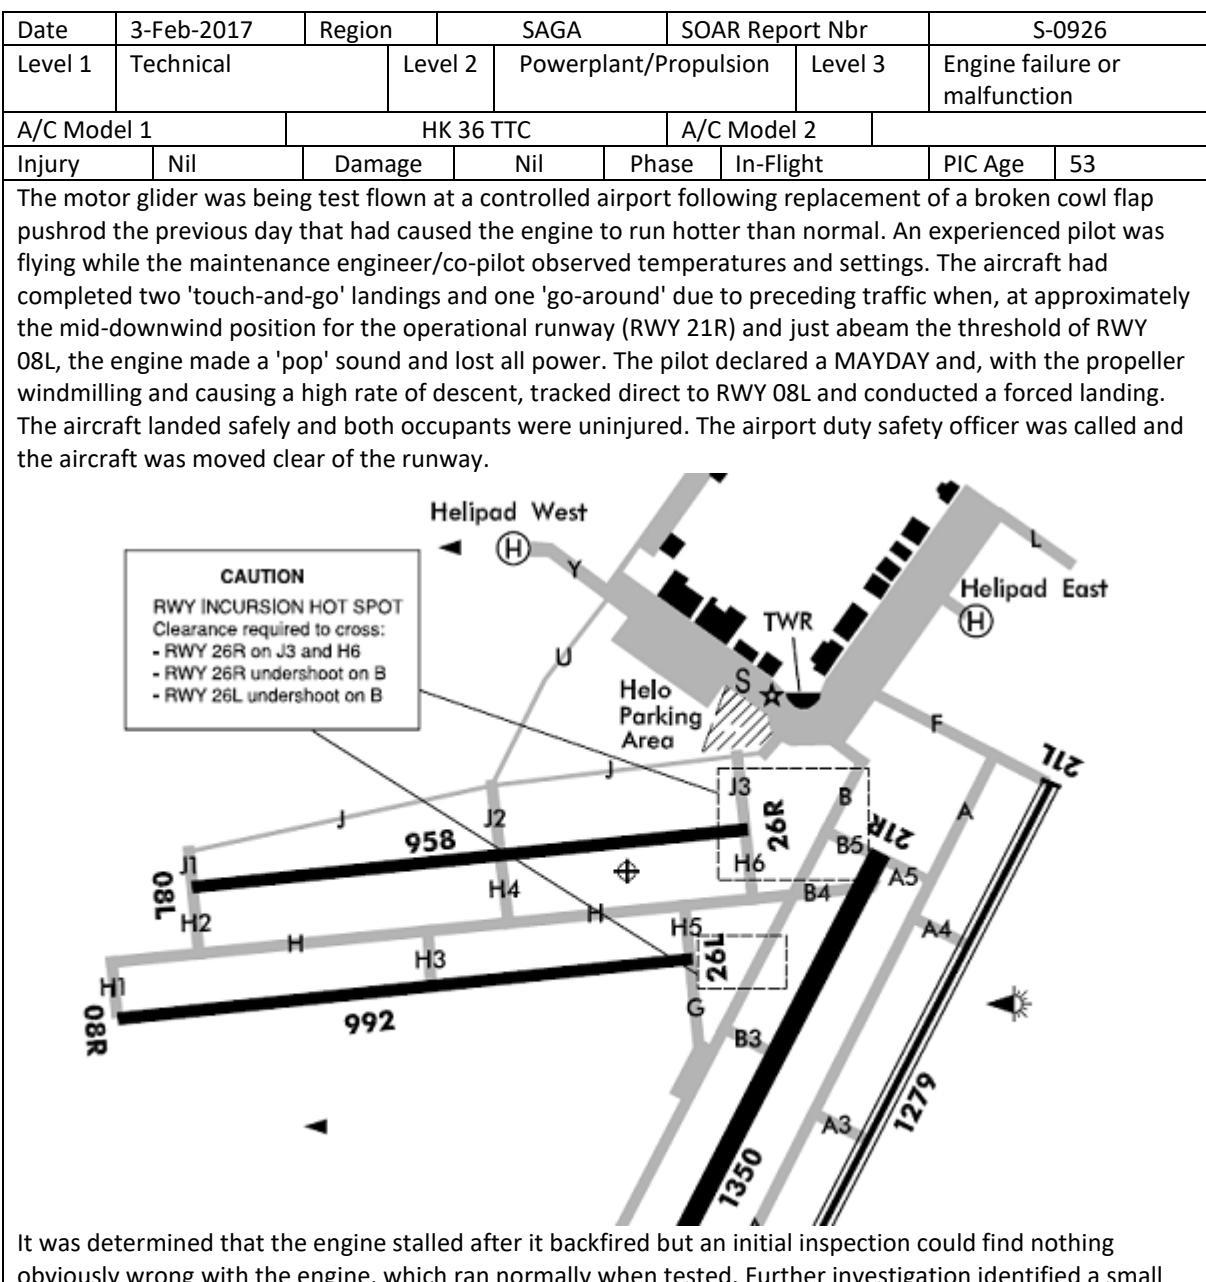
It was determined that the engine stalled after it backfired but an initial inspection could find nothing obviously wrong with the engine, which ran normally when tested. Further investigation identified a small split in the underside of a vacuum hose between a solenoid and the left carburetor. When power was applied and the pressure increased in this hose, the split would open leading to unbalanced carburettors. The damaged hose was replaced and the engine is operating normally.

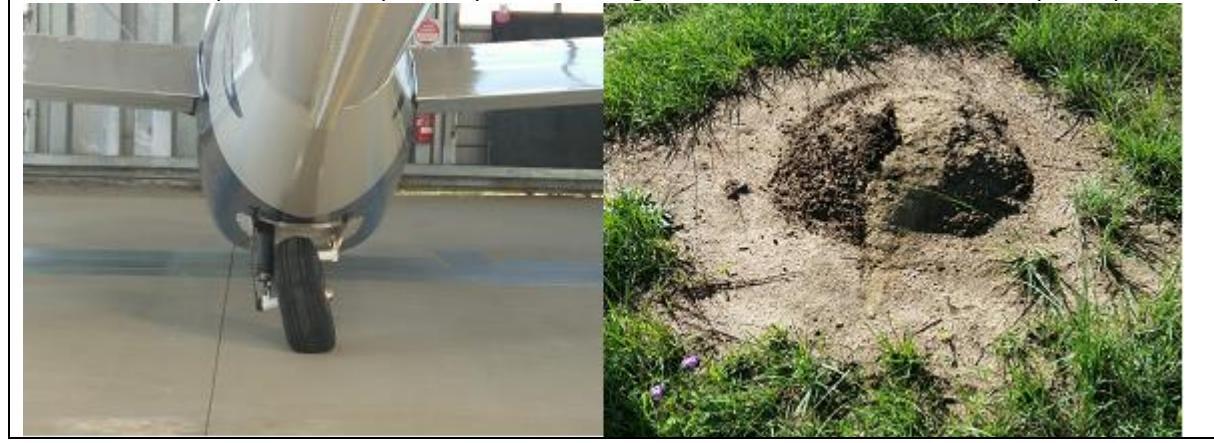
The sortie was a currency check being conducted by an Instructor. The pilot under check had completed a normal landing when, just after touchdown and while the aircraft had a lot of momentum, the crew heard a loud bang from the main undercarriage and a felt a shock indicating the glider had hit something on the ground. Subsequent investigation of the runway revealed the glider's main wheel had impacted an ant mound. Several other ant mounds, consequent of recent rains, were found in the runway and all were levelled. Inspection of the main undercarriage revealed one leg to be twisted laterally about 10 degrees and the wheel was displaced vertically sideways about 10 degrees. The aircraft has been sent away for repair.

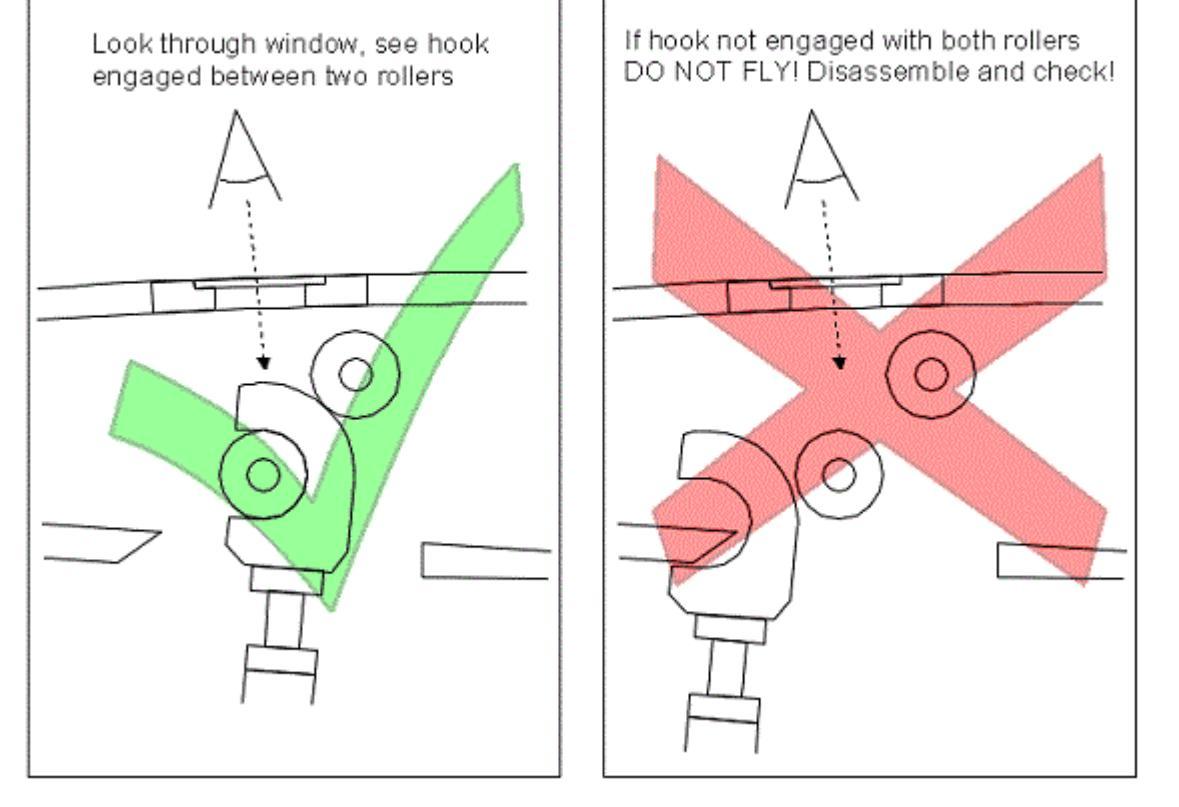
- Notice the angle of the Elevator with the control stick fully aft. The fairing should be fully concealed within the vertical fin. If the hook is not properly mated with the ball bearings the leading edge of the Elevator will not dip far enough.

- Perform a positive control check! This will confirm that the hook is both pushing and pulling the nose of the Elevator.

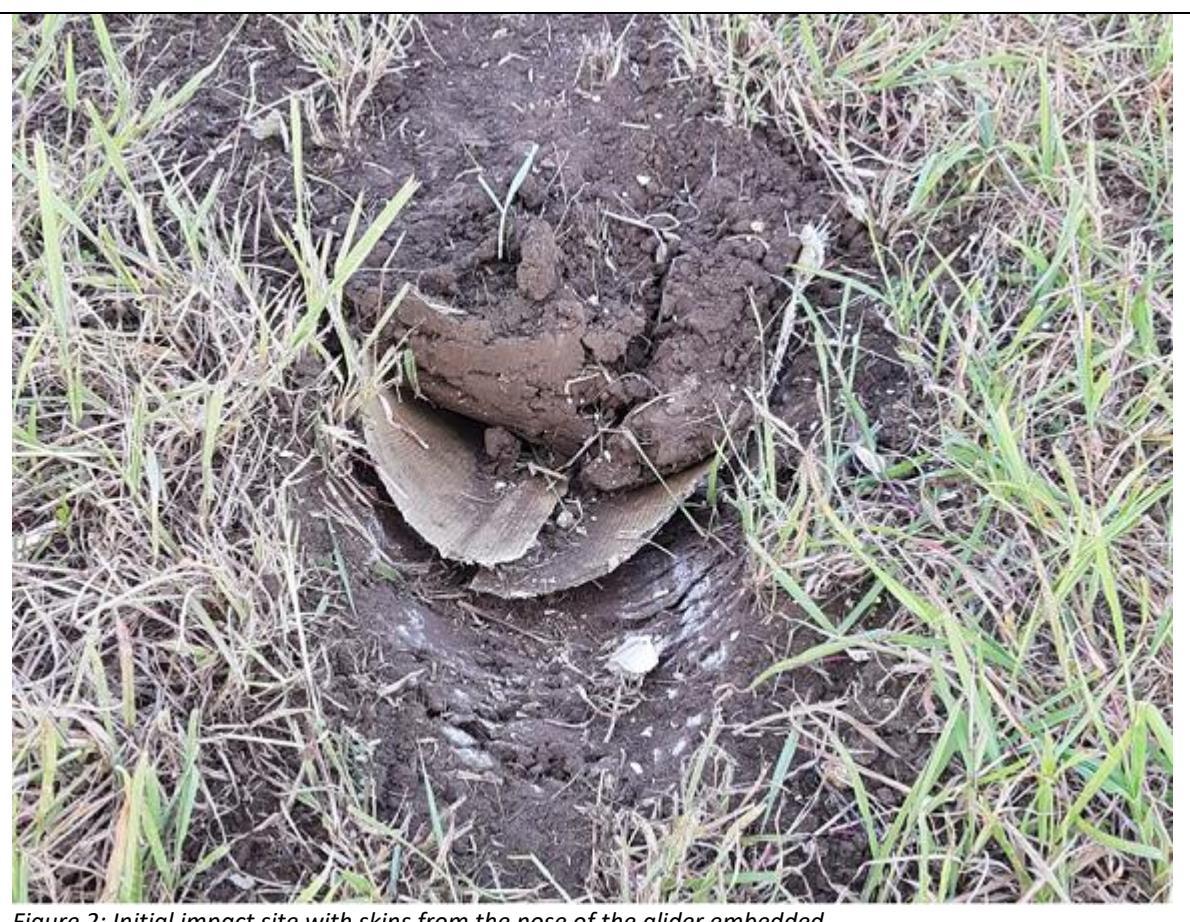
Figure 2: Initial impact site with skins from the nose of the glider embedded.

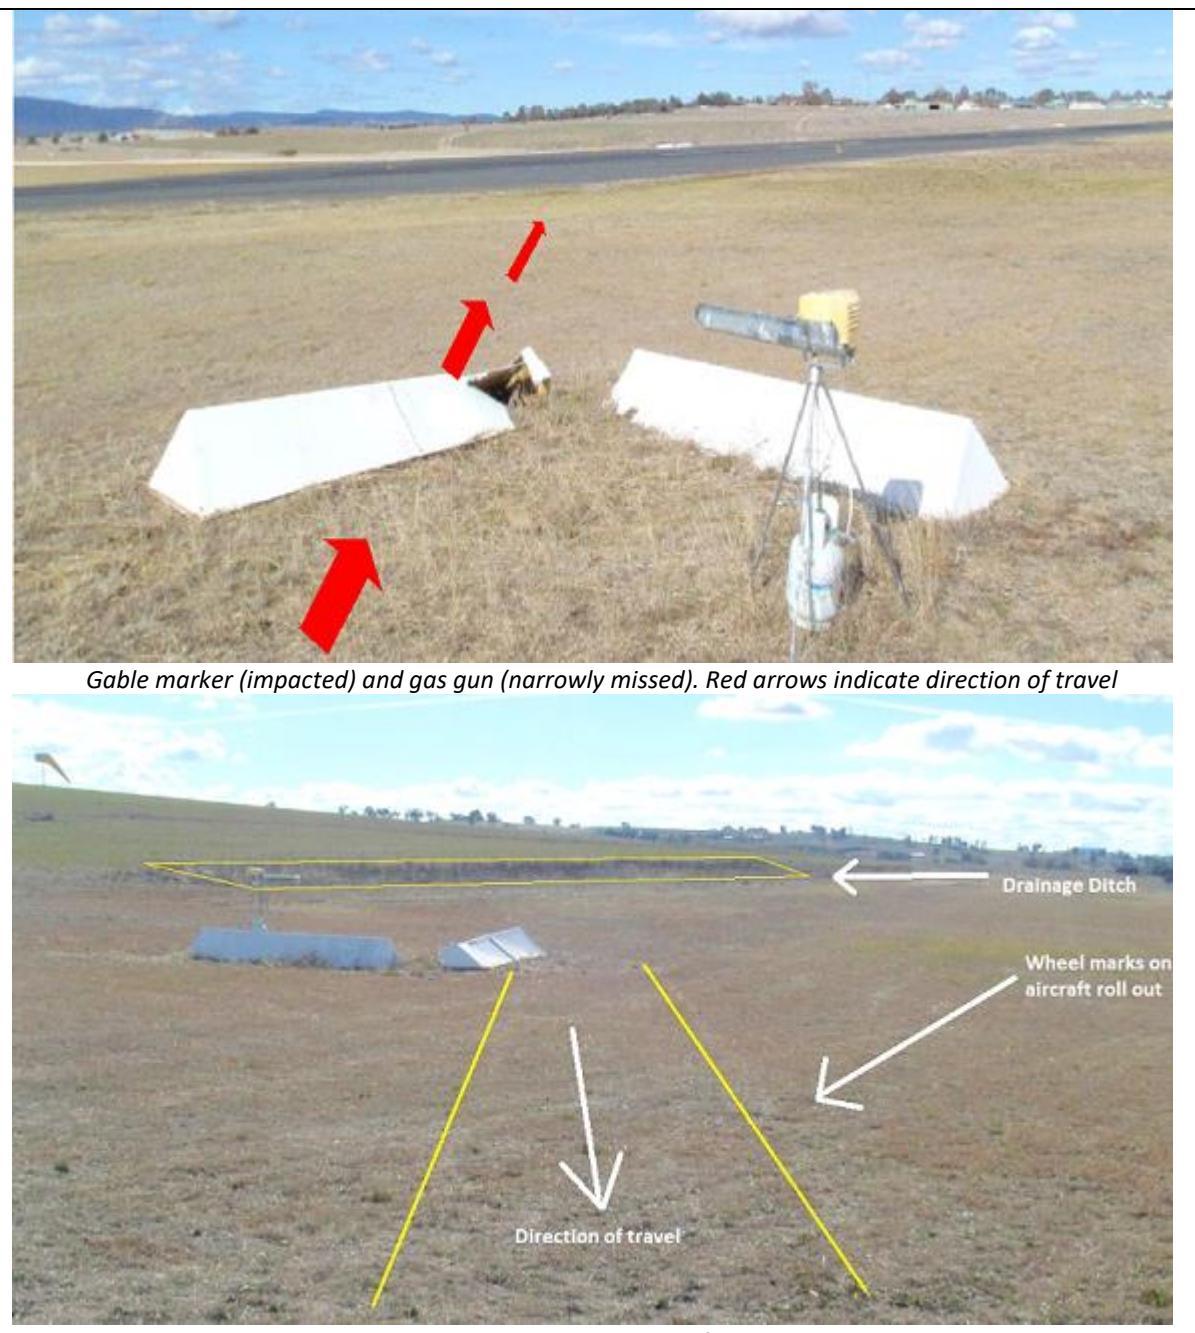
During the final stages of the approach, the tow pilot attempted to extend the glide by raising the aircraft's nose, to clear a drainage ditch running parallel with the main runway. The pilot successfully cleared the drainage ditch but airspeed had decayed, resulting in a hard landing and impact with a frangible runway gable marker. The gable marker was destroyed, and the aircraft's wing narrowly missed an airfield bird-scaring gas gun. It is likely that the aircraft missed the gas gun as a result of the aircraft bouncing due to the hard landing. The ground roll was short and the aircraft came to rest at the intersection of RWY 17/35 and RWY 08/26.

Missed drainage ditch and aircraft wheel marks

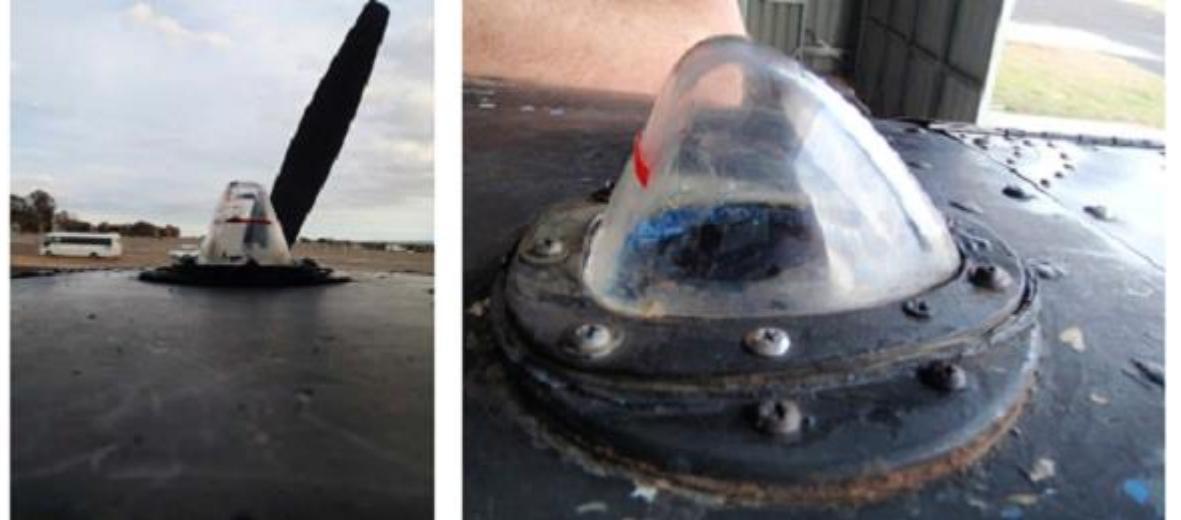
empties. The gauge's sight glass is located on top of the fuel tank, within the pilot's line of sight from the cockpit. The sight glass on the incident aircraft was marked with a red line.

Fuel tank quantity gauge, seen from (L) cockpit and (R) side
