Occurrence Summaries 01/01/2017 to 31/12/2017 Region(s): All Club:

Christopher Thorpe Executive Manager, Operations The Gliding Federation of Australia Inc.

The Gliding SOAR Accident	The Gliding Federation of Australia Inc SOAR Accident and Incident Occurrences								
General Statistics									
Date From:	Date From: 01/01/2017								
Date to:	31/12/2017

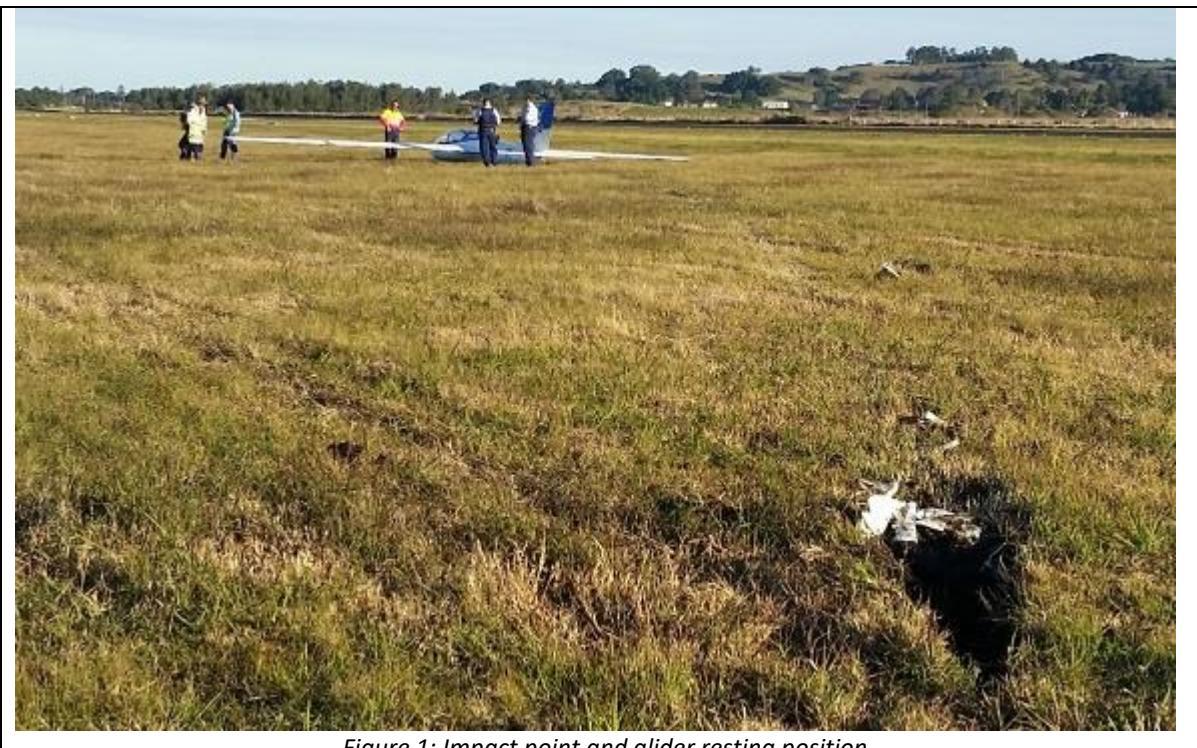
Figure 1: Impact point and glider resting position

According to witnesses, the wingtips both briefly contacted the ground on initial impact. The undercarriage separated from the glider, and the impact left an indentation of approximately 30-40cm in the soft grass. The glider slid to a stop and came to rest about 100m beyond the point of first ground contact. Given that it was outside the gable markers and not on the runway, the pilot remained in the aircraft until help arrived. No evacuation was needed. The pilot was assessed by local first responders, removed from the glider and taken to Lismore hospital, and later to the Gold Coast University hospital.

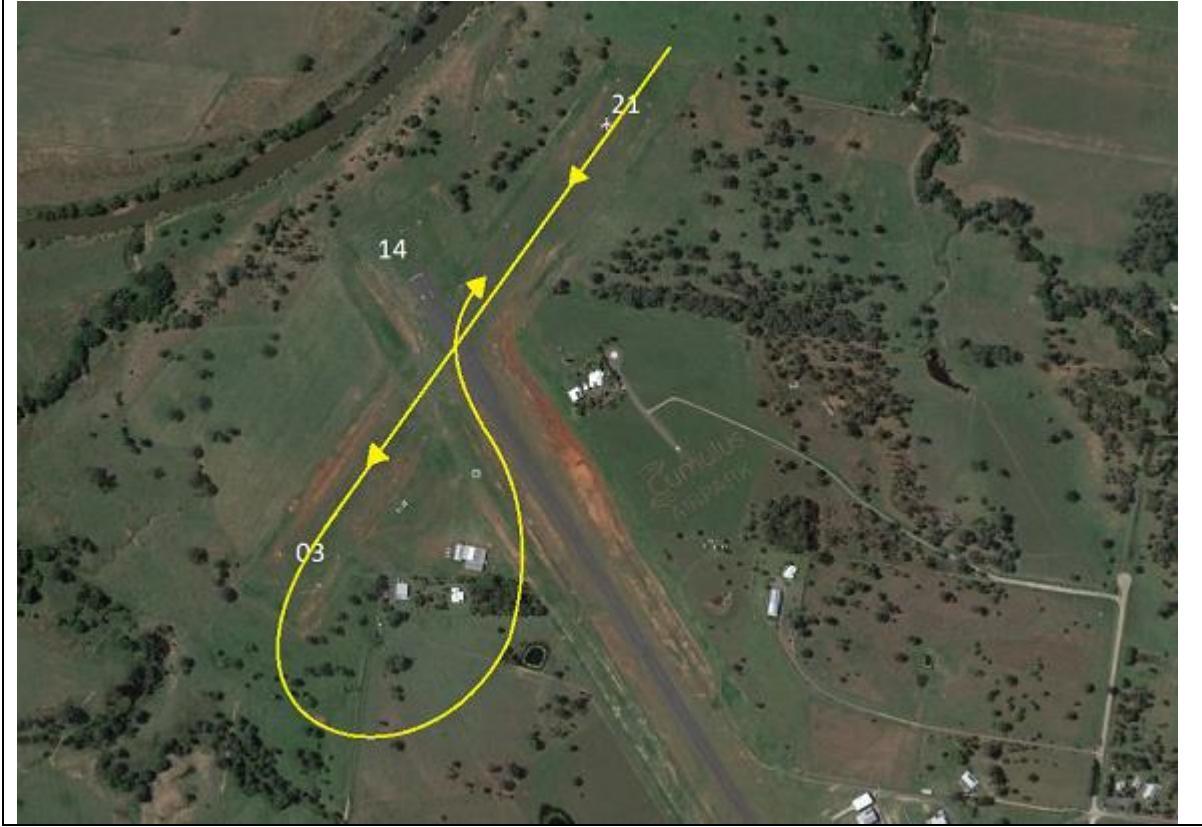
While demonstrating a simulated launch failure to the student, the instructor misjudged the round-out from a very steep approach and the aircraft landed heavily with some sideways drift. The tail boom broke off just behind the wings. The tow was taken to the usual 2000ft AGL on a day with little thermal activity. The decent was used for training sequences, such as control co-ordination, and a high approach was made to the operational runway (RWY 21) with the intention of demonstrating a simulated launch failure from about 500ft AGL at the far end of the runway. The instructor conducted a 270 degree turn to the right followed by a 90 degree turn to the left to align with runway 03. Unfortunately, the instructor had not identified that the wind speed had increased since launch and the glider drifted further downwind than anticipated during the turn. This placed the glider in a very steep approach to the remaining 350 metres of runway. The instructor used full airbrake and sideslip to increase the descent rate. Unfortunately, the instructor did not close the airbrakes in time to prevent the glider from landing heavily with some sideways drift. The instructor stated that prior to the flight they believed the wind was abating and was surprised to find the wind had increased.

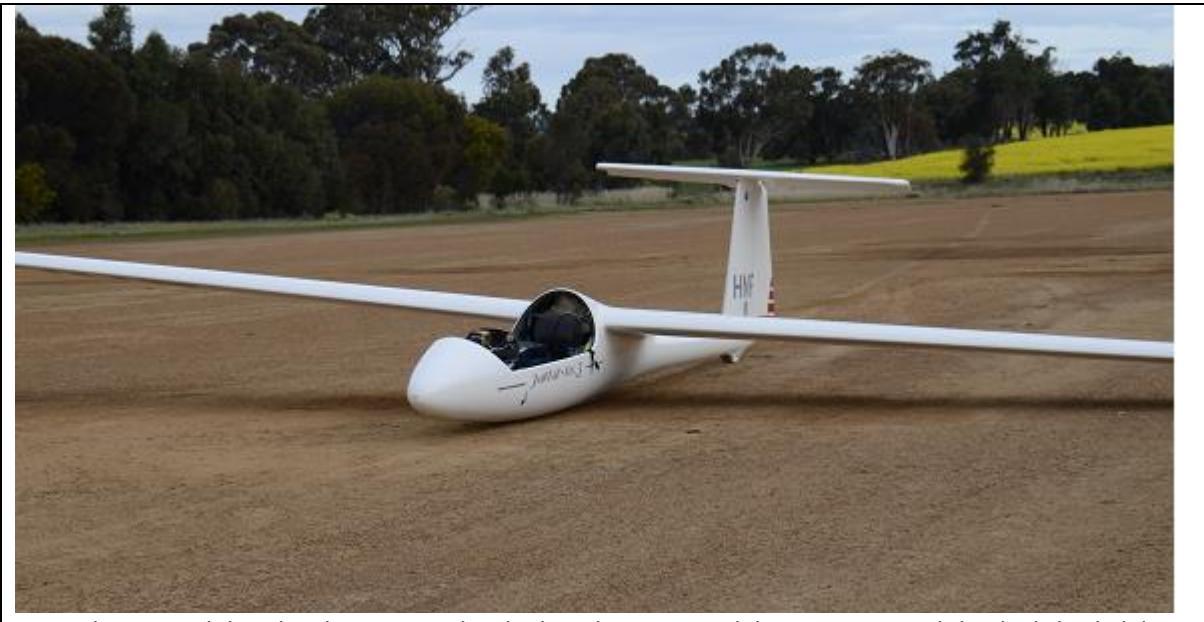
It was determined that the elevator coupling had not been secured during rigging and the dual check did not identify the problem. Inspectors must ensure the release button is securely locked during rigging, and should use a mirror and torch if necessary.

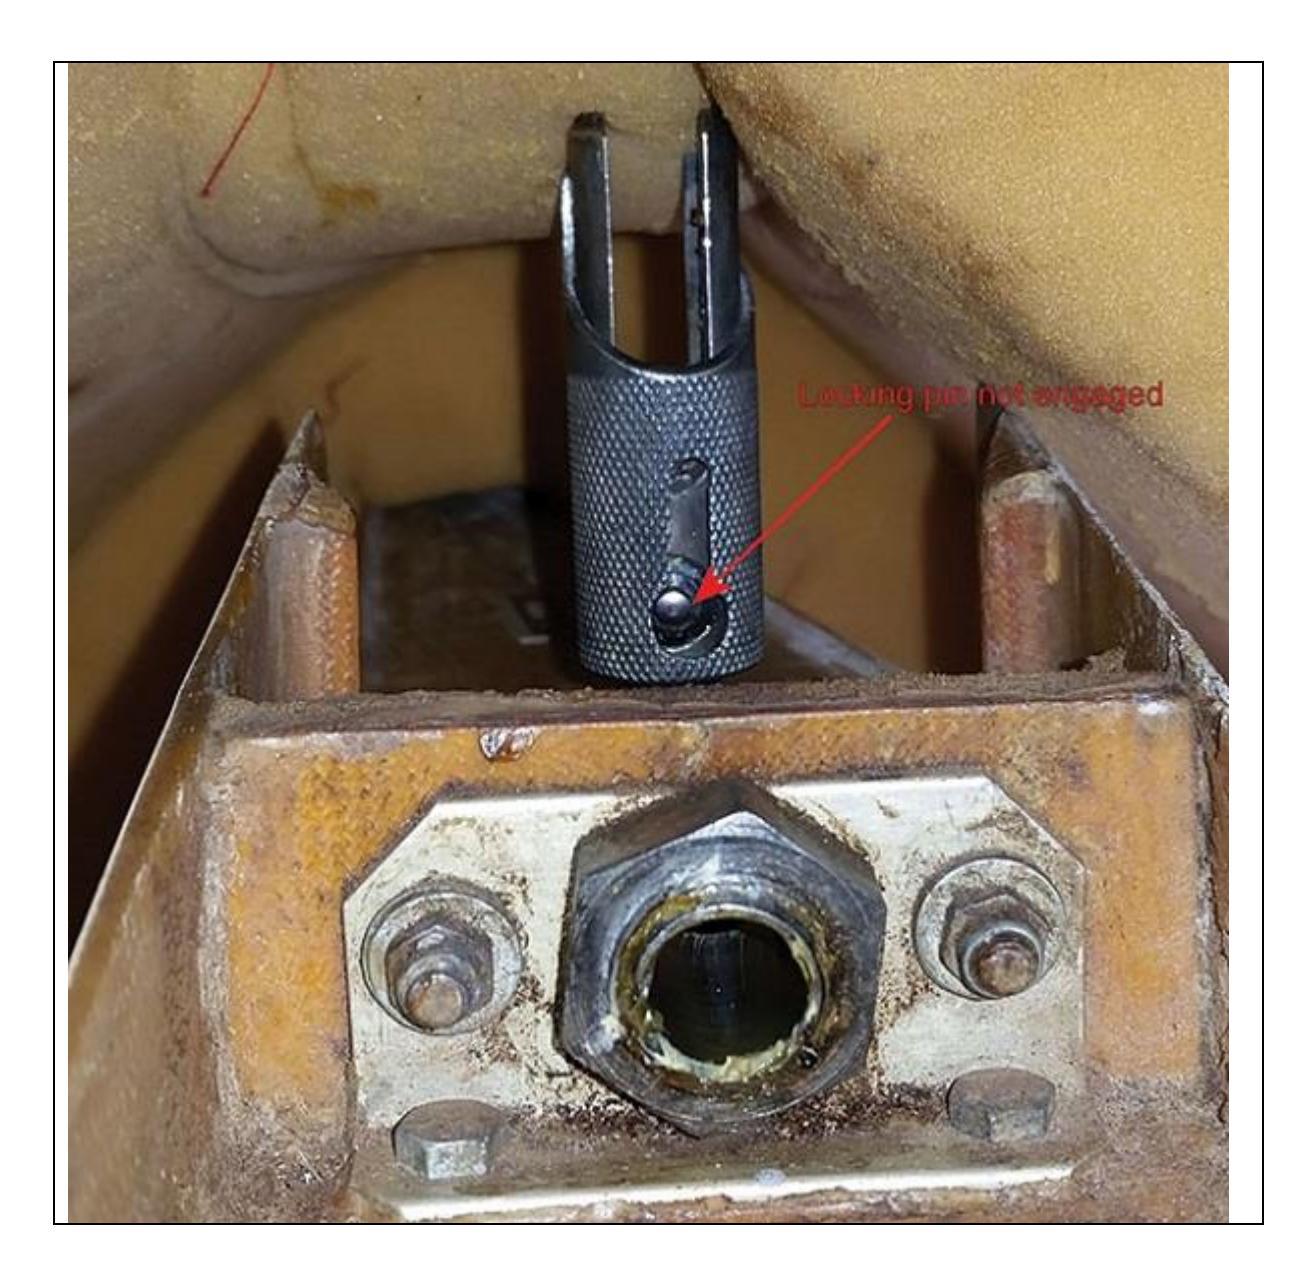
Date	9-Sep-2017	Regior	n	VSA			AR Repo	ort Nbr		S-1032		
Level 1	Technical		Level	2	Syster	ns		Level	3	Flight cont	rols	
A/C Mod	el 1		ASK	21Mi		A/C	Model	2				
Injury	Nil	Damage Nil		Pha	ase	Grour	nd Ops		PIC Age	68		
During the Daily Inspection the starboard wing airbrake pushrod was found disconnected from the l'Hotellier												
coupling	coupling in the fuselage. It is thought the diconnect occurred during landing on the prevous flight.											
Investiga	Investigation evealed the L'Hotellier was functioning correctly, leading to the conclusion that it was not											
properly	connected at tim	e of rigg	ing. Thi	s aircraft use	es sprii	ng-loa	aded W	edekin/	d safe	ety sleeves a	and the	
manufact	turer is unaware	of simila	r occuri	ences on th	is mod	lel. Tł	ney not	ed that	а сон	rectly fitted	d Wedekind	
sleeve wi	ll prevent an uni	ntention	al disco	nnection as	long a	s the	ball dia	meter	is wit	hin specifica	ation and the

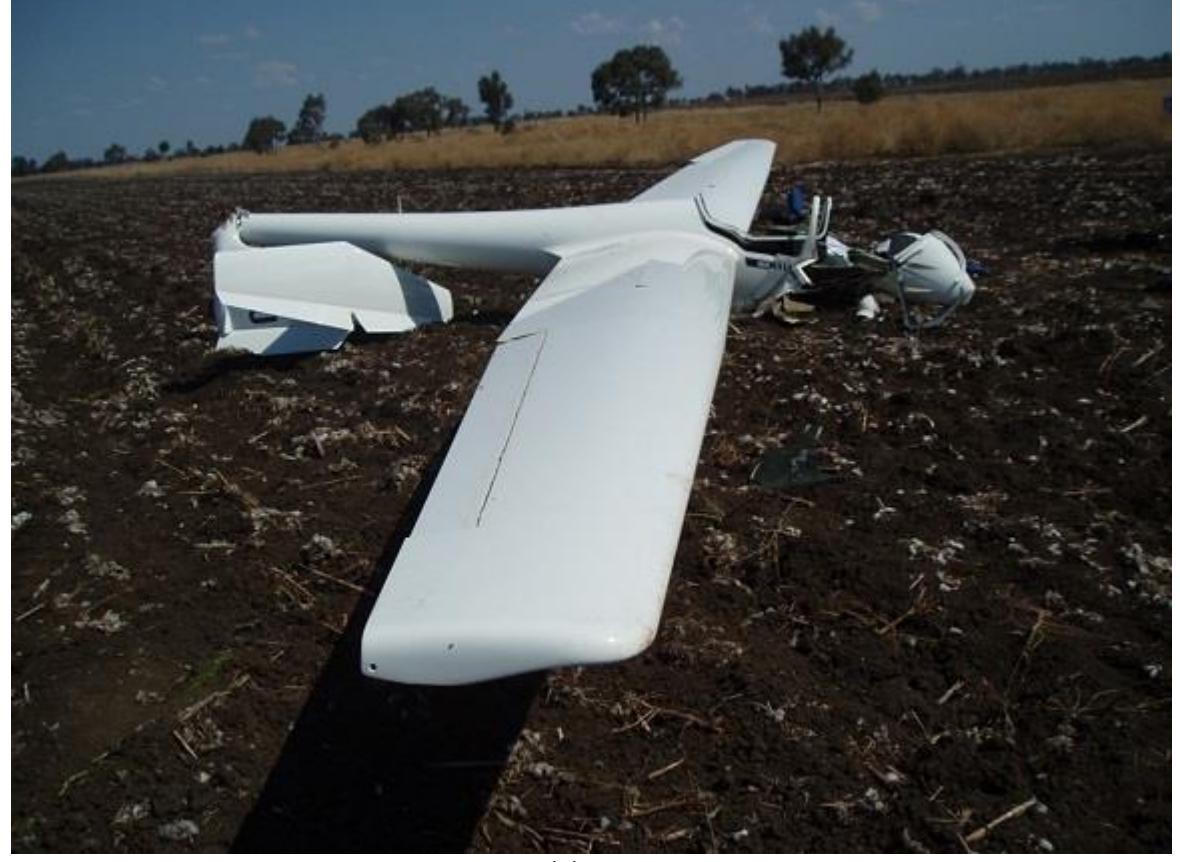
Figure 1: Glider resting position

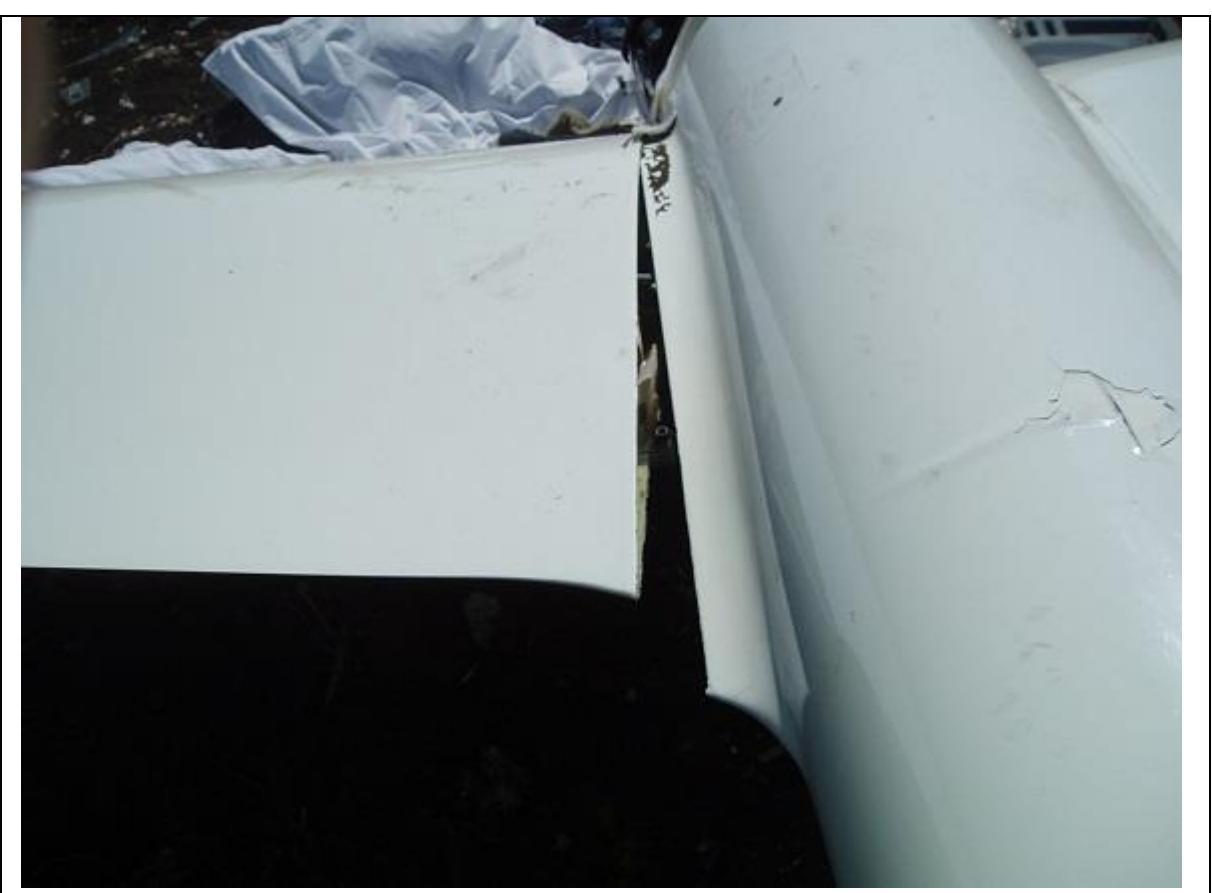
Figure 4: Left wing displacement

- Evidence of impact (as marked by dust/sand imprinted from the field into the airframe) was visible on both wings, up to half the length of each wing from the tips inward. The outboard halves of both wings thus hit the ground on impact, likely (almost) simultaneously.
- The right wing was still in place. The left wing was mostly in place but torqued slightly forward and upward (refer Figure 4).

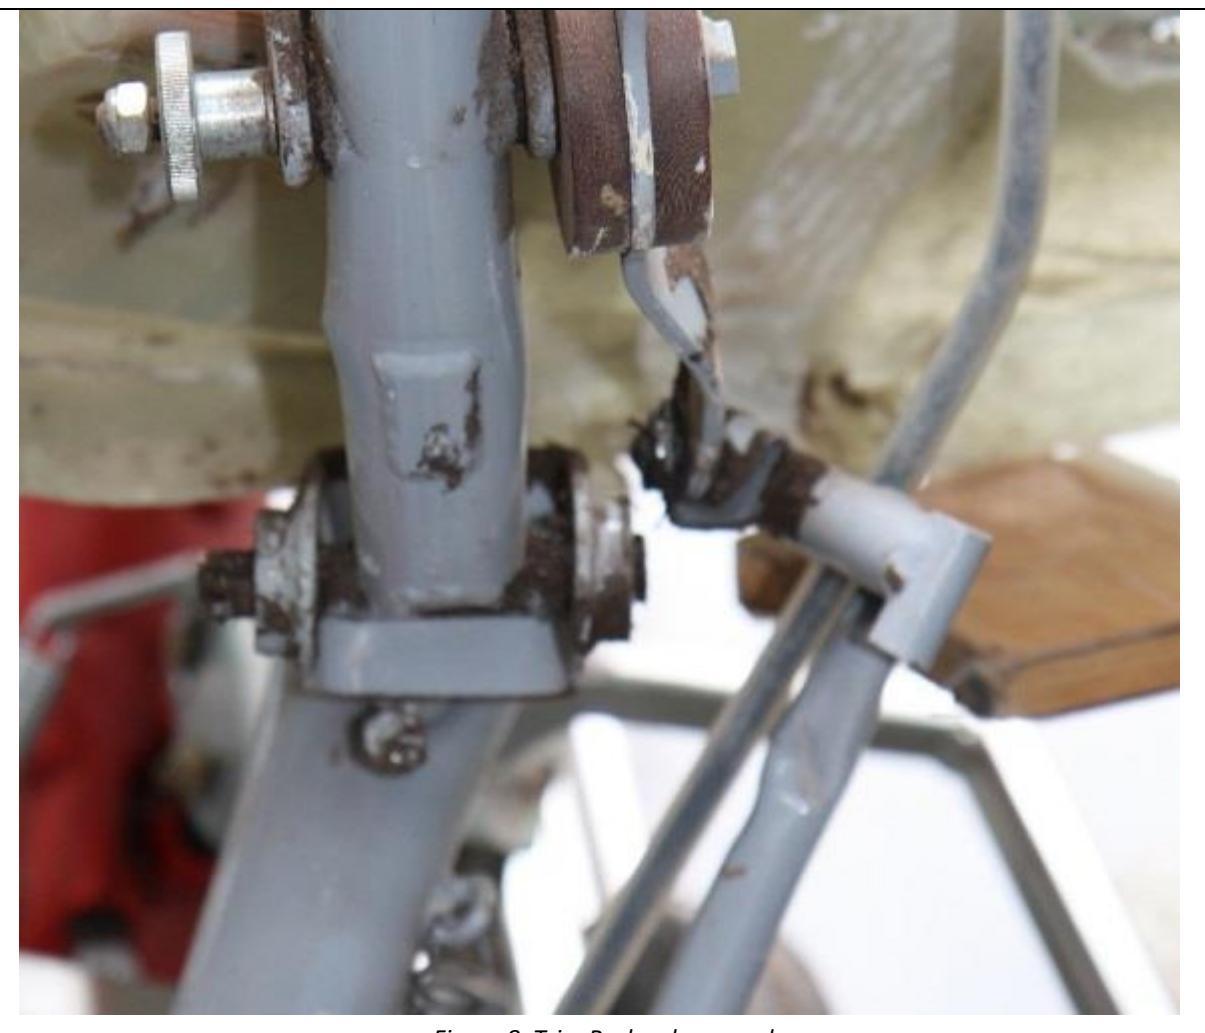
Figure 8: Trim Pushrod rear end

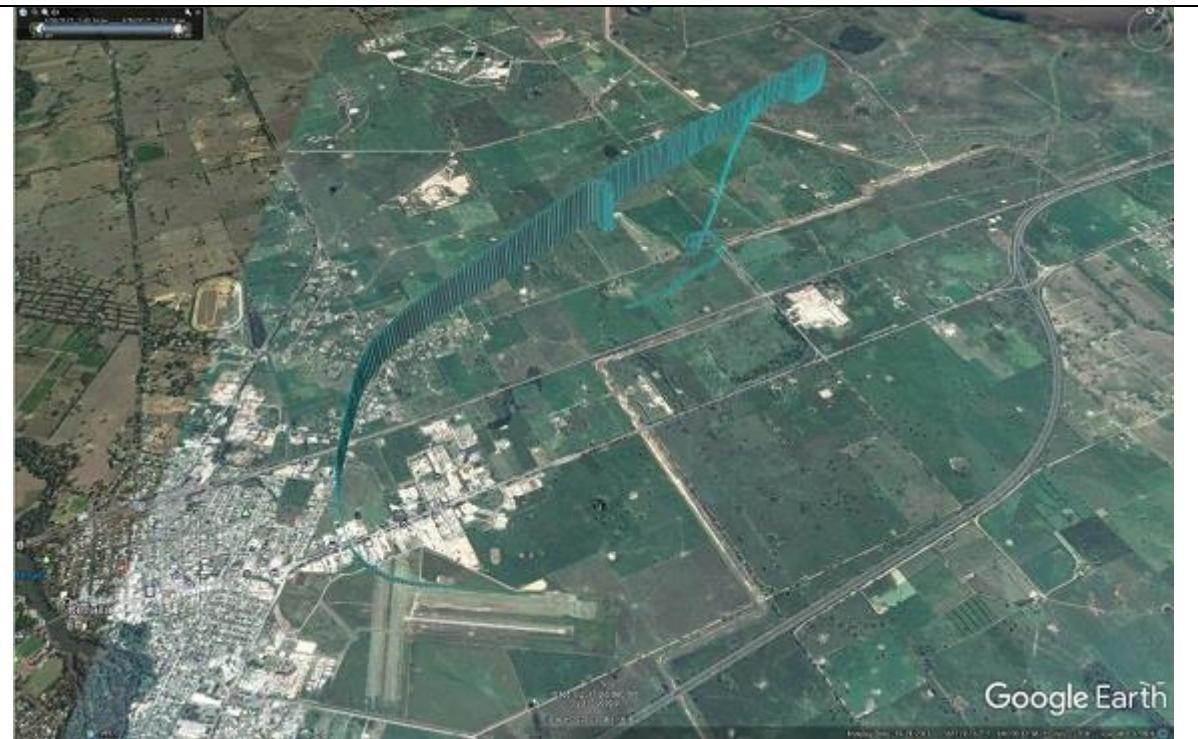
Figure 3: 3D representation of the flight track (Google Earth)

The aircraft was observed by a witness who was driving their car in a south-westerly direction along Murray Road. The witness: "...noticed a white glider flying very low to the ground. The glider was travelling towards me from the West. I looked at it and I thought it was going to land as it was that low. Suddenly it appeared that the wind flipped his right wing and then the glider went straight towards the ground. I believe the glider was about 20 metres off the ground when it flipped." In a subsequent telephone interview with the witness, the GFA's investigator was informed that the aircraft was flying towards the witness and parallel to the road. The witness saw the aircraft's "right wing go up and the left wing go down". The witness stated the aircraft "spiralled to the left into the ground". The aircraft impacted the ground about 150 metres and 90 degrees to the right of the last recorded data point.

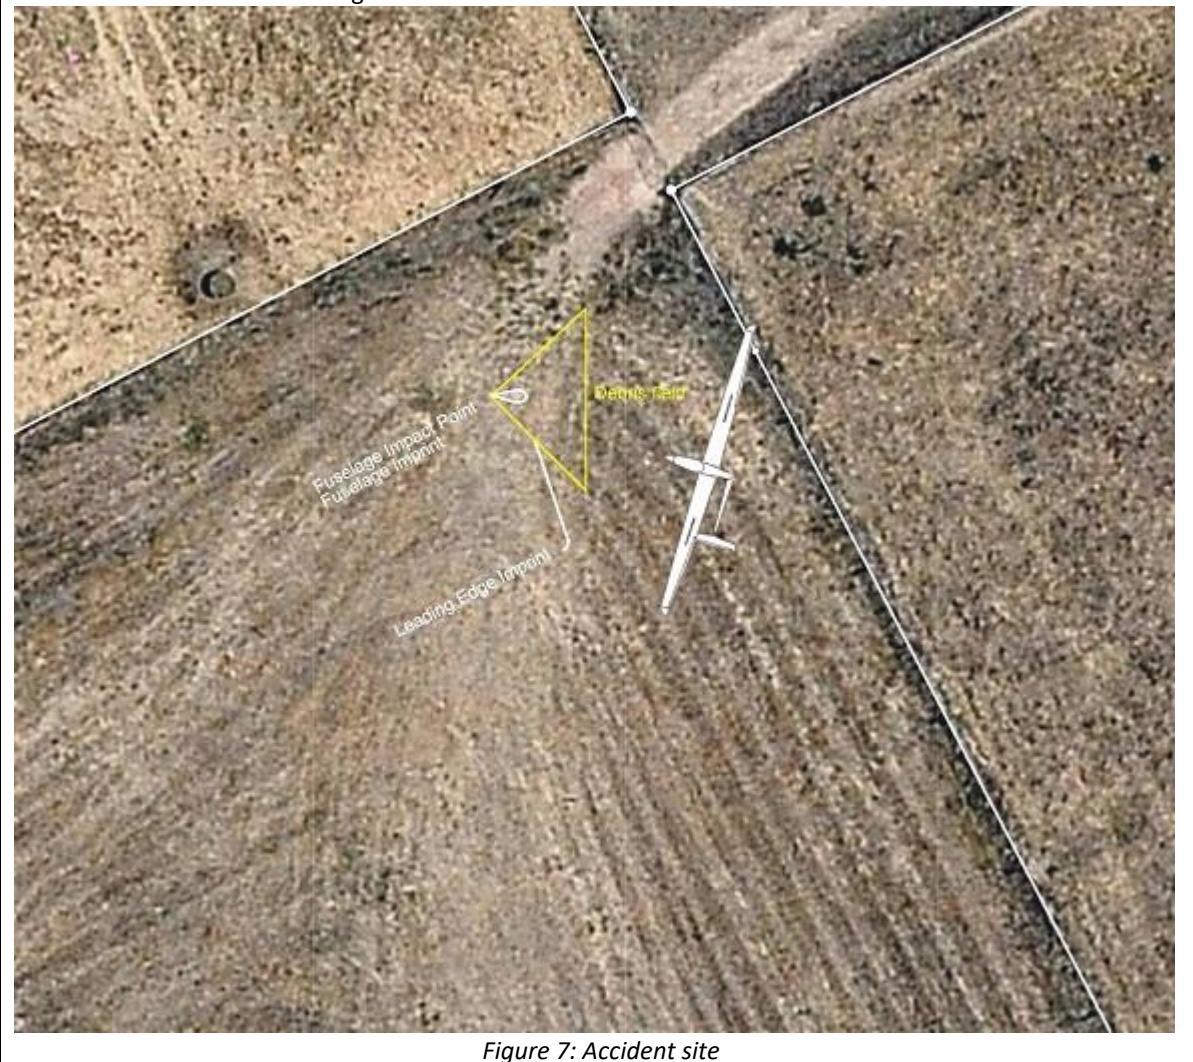
Examination of the occurrence site and wreckage indicated that the aircraft was in a left-hand spiral when it struck the ground in a left-wing-low, very steep nose-down attitude. After the initial impact the aircraft rebounded rearwards approximately eight metres. The aircraft came to rest right side up on a Westerly heading, with the right-hand wingtip passing through a post and wire fence. The nose of the aircraft left a single conical impact point some 75mm deep and 100mm in diameter. The impact point was about 8.1 metres from the final resting place of the fuselage. The tail boom broke behind the wings, with the tailplane tucked under the left-hand wing.

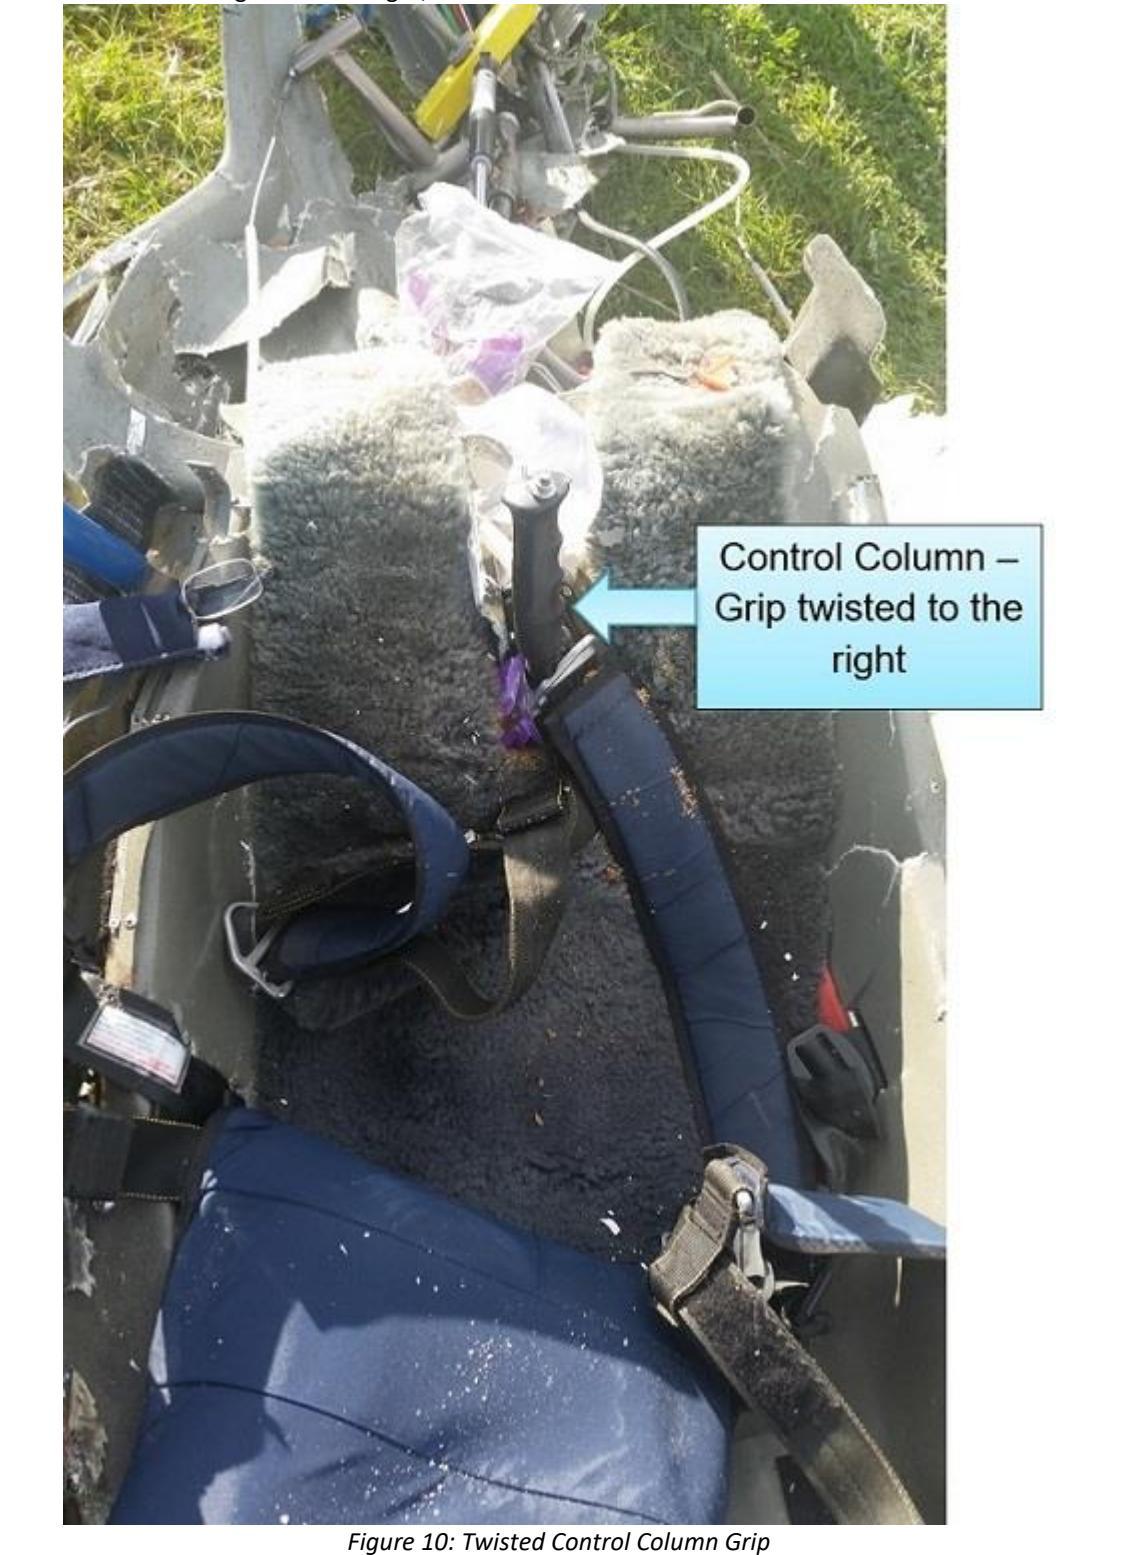
the fuselage and cockpit areas, control continuity was established. The hand grip from the control column was rotated about 45 degrees to the right, i.e. clockwise.

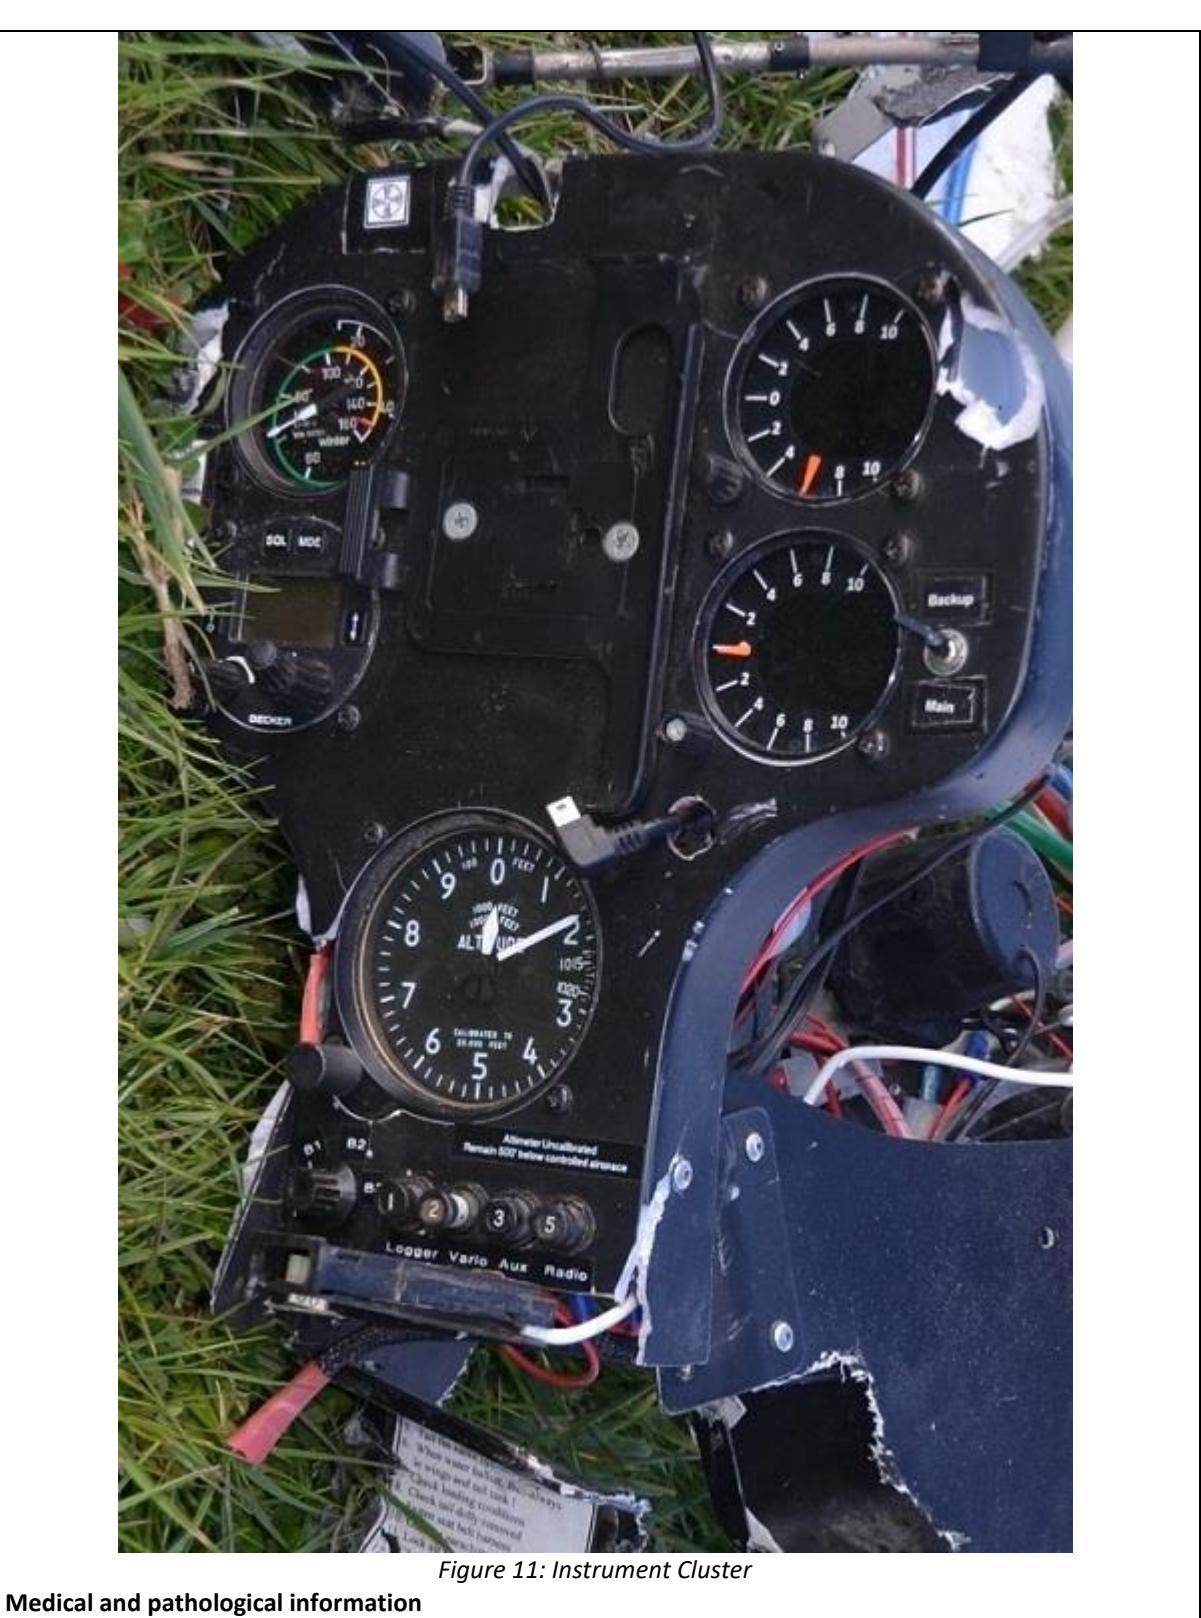
The undercarriage was found to be collapsed and the tyre deflated. The undercarriage lever was noted in the 'down and locked' position, and the guide rod immediately forward of the handle was bent upwards by impact forces. Dirt and debris accumulated between the tire and wheel confirmed the undercarriage was down and locked at the moment of impact. It was also noted that the left and right airbrakes were unlocked but a lack of damage to the airbrake mechanism in the wings is indicative of them being in the closed position prior to impact. The airbrake lever was in the locked position in the cockpit. The airbrakes most likely become unlocked when control circuit integrity was lost. The instrument cluster suffered substantial damage. The electrical system master switch toggle was broken and the number 2 circuit breaker to the electric Variometer had popped. The needle electric Variometer (top right in the instrument cluster) was indicating a rate of descent of 600ft per minute. The needle on the Air Speed Indicator (top left in the instrument cluster) was stuck on 70 knots, and the needle on the altimeter (bottom left in the instrument cluster) was indicating 160 feet.

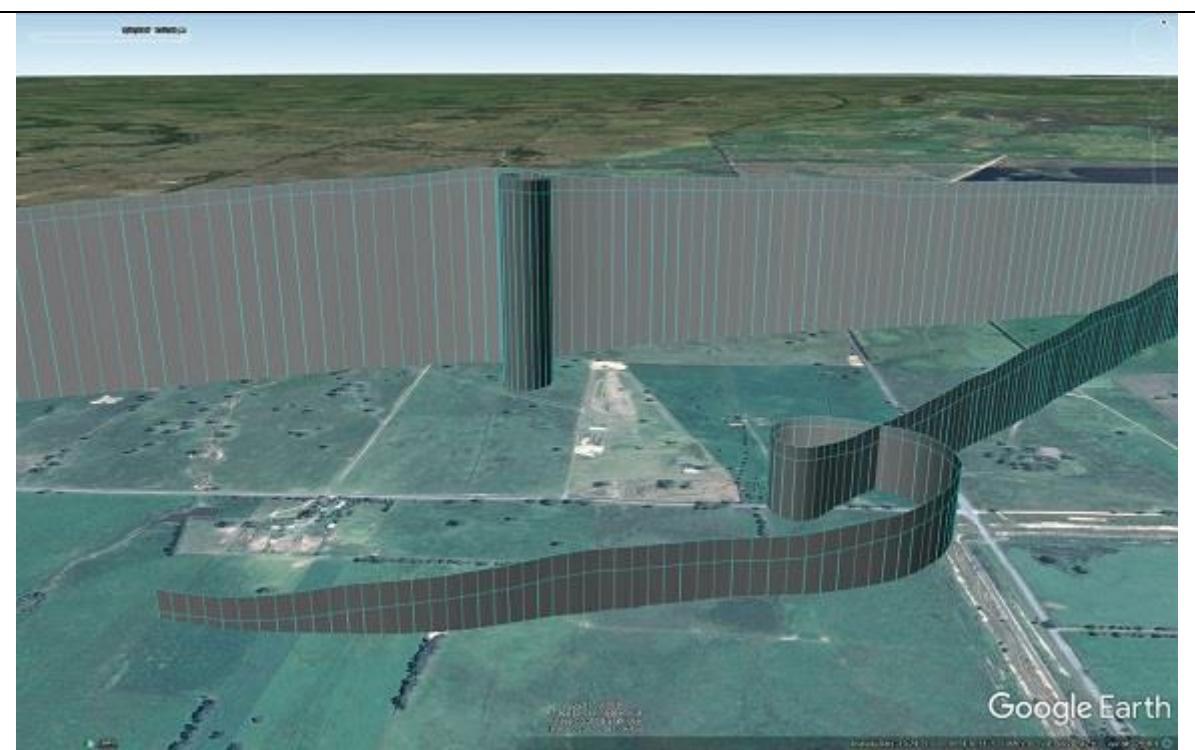
Figure 12: Flight Track

While GPS and pressure altitude and GPS track data cannot be relied upon with absolute accuracy due to horizontal and vertical resolution errors, and the two-second sampling rate, in this case the heights and track data recorded are consistent with the statements of the tow pilot and the sole witness to the accident. Using the last recorded data point and the position of the aircraft wreckage, it was possible to extrapolate the flight path and identify the probable landing point.

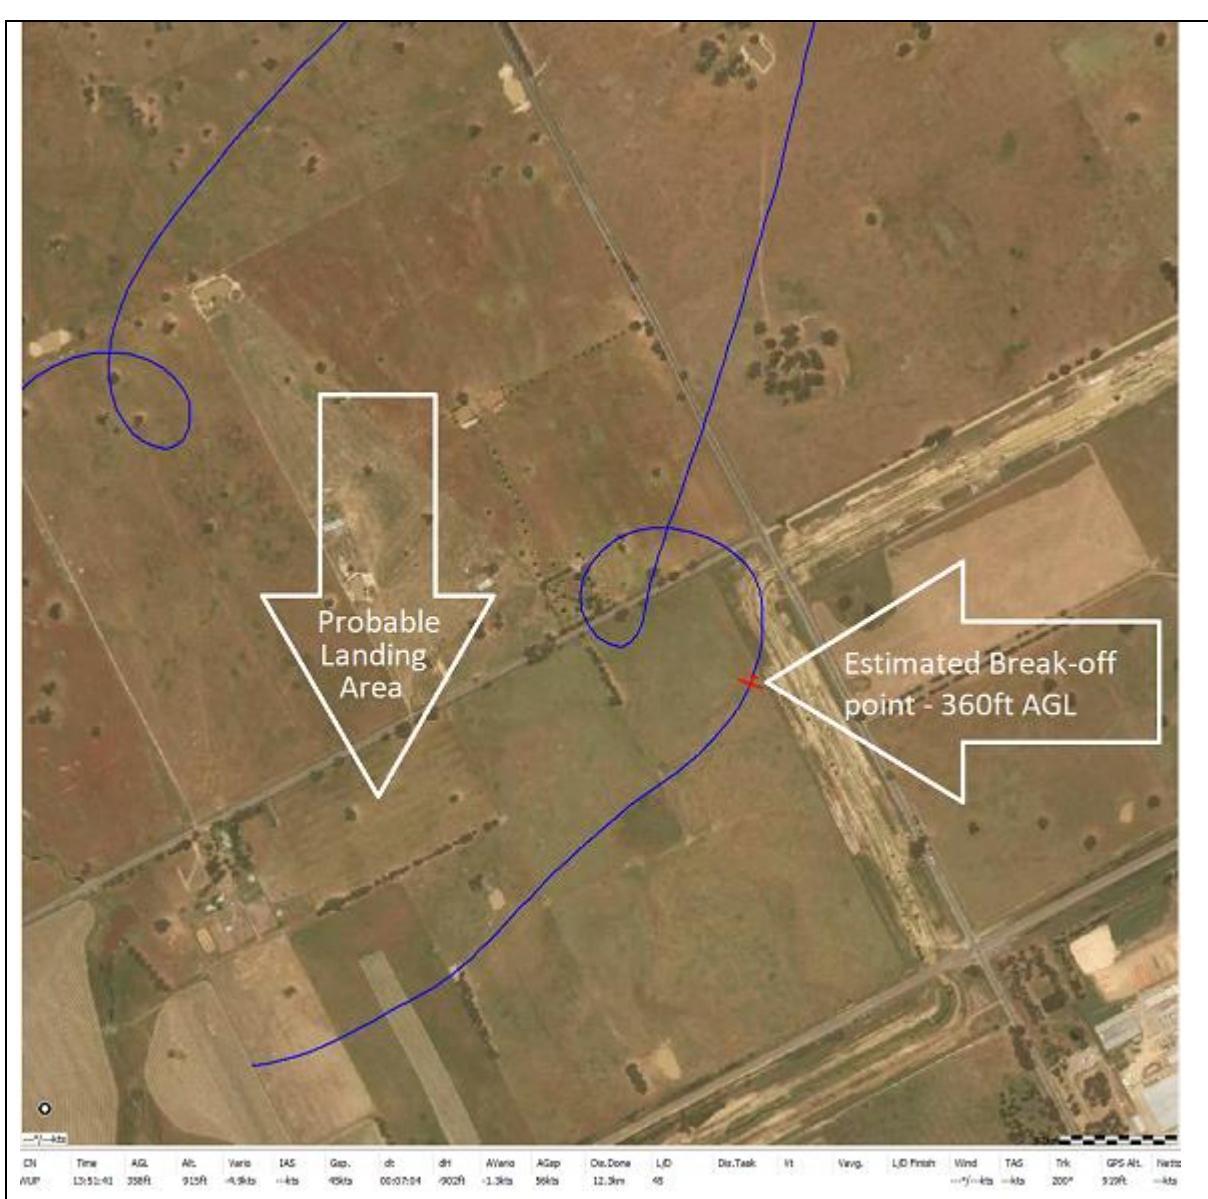
Figure 15: Estimated Break-off Point

- 3. The pilot made a very late decision to break-off the flight and conduct a landing. The flight trace suggests the pilot made the decision to break-off the flight immediately following the last attempt at contacting a thermal and at a height below 500ft AGL (refer Figure 15: Estimated Break-off Point). Breaking off the flight at this height is contrary to GFA training and safe practice. Glider Pilots are trained that when below 2,000 ft AGL, searching for lift and other upper air activities should normally be conducted upwind of the intended circuit joining area, and that the glider should be flown so as to ensure it can always join circuit at a safe height and commence a normal downwind leg. The normal height for joining circuit in a high-performance glider like the LS8 would be around 800ft AGL or higher. Sufficient height is especially important when landing in a paddock of which the pilot has no knowledge, as it enables the pilot to properly check for any hazards and allow for safe flight to an alternative landing area should the first option prove unsuitable.

Reconstruction of the flight trace, which did not record the last seconds before impact, and review of the statement of a witness suggests the pilot was attempting to conduct a downwind landing in a paddock parallel to Murray Road. The aircraft appears to have departed controlled flight after rolling out of the right-hand turn to wings level while on final approach to the paddock. As previously mentioned, the nature of injuries to the pilot's left hand and left forearm, plus the orientation of the control column grip, suggest he was holding the control column with his left hand at the time of impact with terrain. It is unusual for a pilot, at such a late stage of the circuit and final approach, to be flying left-handed. This is because the airbrake controls used to manage the final approach are manipulated by the pilot's left hand and are usually held for the duration of the approach and landing. It is therefore probable the pilot was flying left-handed because he changed hands to lower the undercarriage, the lever for which is on the right-hand side of the cockpit. If this was the case, then the pilot had not configured the aircraft for landing prior to turning onto final approach, which is indicative of workload management being affected by increased stress. The ergonomics of this control activation sequence are relevant to possible contribution to low level loss of control leading to

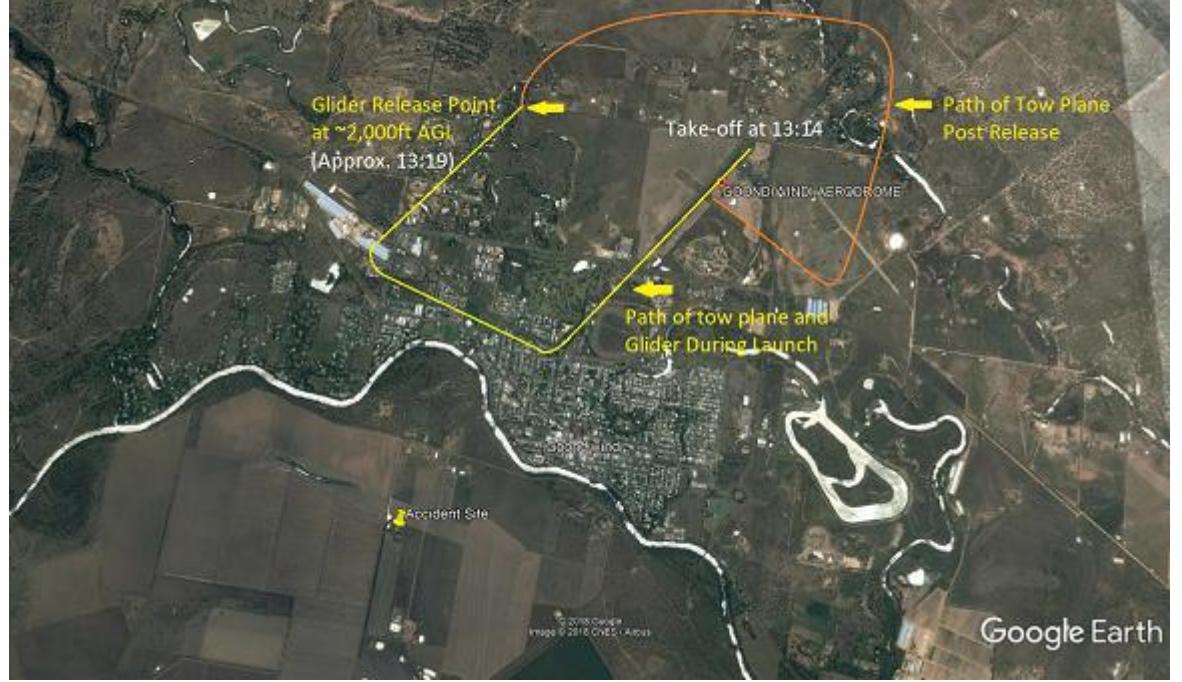
Figure 1: Aerodrome environs showing take-off path of the towing combination (yellow) and the path of the tow plane after the glider pilot released from tow (orange).

A few minutes after release, the glider was observed by a number of other pilots in a steep nose-down attitude spiralling towards the ground approximately 4 kms south-west of the airfield along the extended centreline of Runway 22.

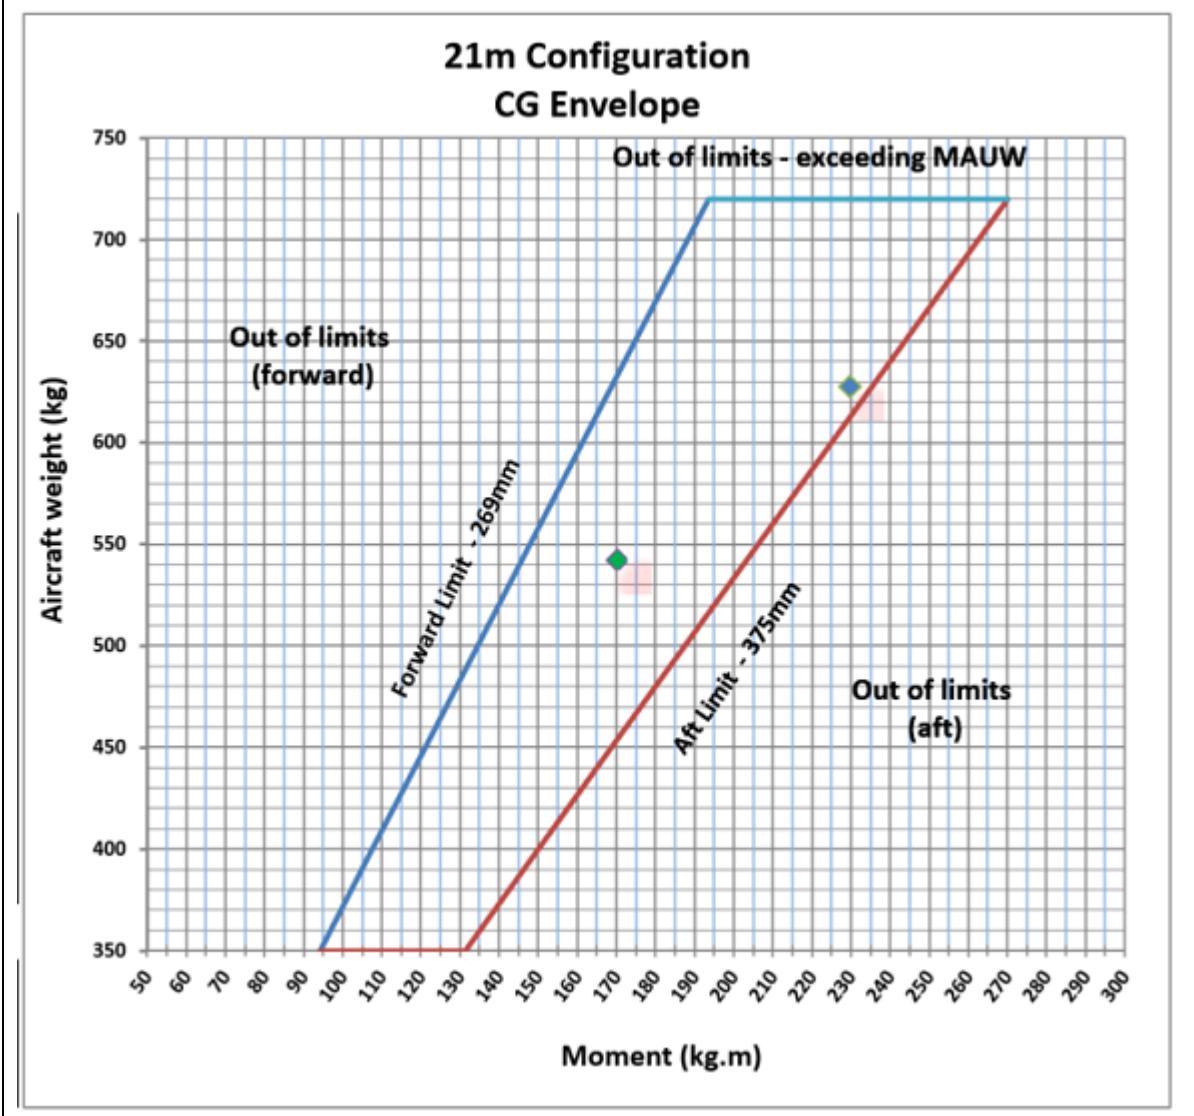
Figure 16: VH-IBS Calculated CG envelope.

According to the manufacturer's calculations and scenario interpretations it is highly unlikely that the aircraft was flown outside its CG range (refer Figure 16).

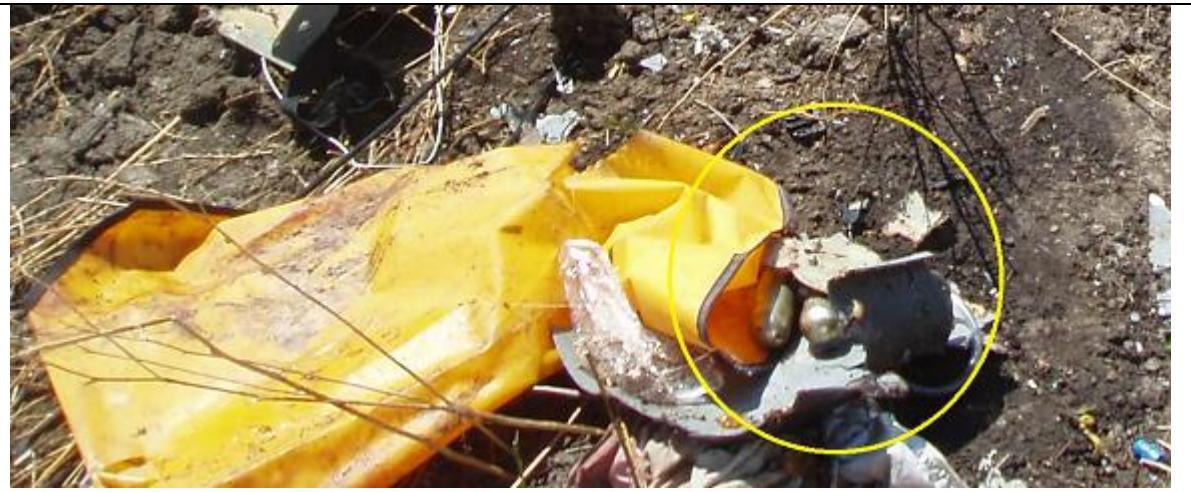
Figure 20: Cushion and gas cylinders at the accident site.

The manufacturer's review of the cushion in the wreckage (refer Figure 20) revealed that the gas cylinders had been affixed to the cockpit structure, possibly at the base of the instrument panel. It appears the cylinders were not contained in the pouch, so it is possible the actuating lanyard was within the pilot's reach. If so, the safeguards against inadvertent activation would not have been present. The manufacturer was provided with copies of photographs taken of the cushion at the accident site. According to him the cushion did not display the tell-tale signs of activation (split seams and deformation). The designer and manufacturer concluded they were "...of the opinion that the cushion has not inflated. I can see two tears in the cushion, but they are not ruptures due to pressure because my experiments during development showed that the weak points were the seams of the cushion."2.3. Human Factors
