Occurrence Summaries 01/01/2017 to 31/12/2017 Region(s): All Club:

Christopher Thorpe Executive Manager, Operations The Gliding Federation of Australia Inc.

The Gliding SOAR Accident	The Gliding Federation of Australia Inc SOAR Accident and Incident Occurrences								
General Statistics									
Date From:	Date From: 01/01/2017								
Date to:	31/12/2017

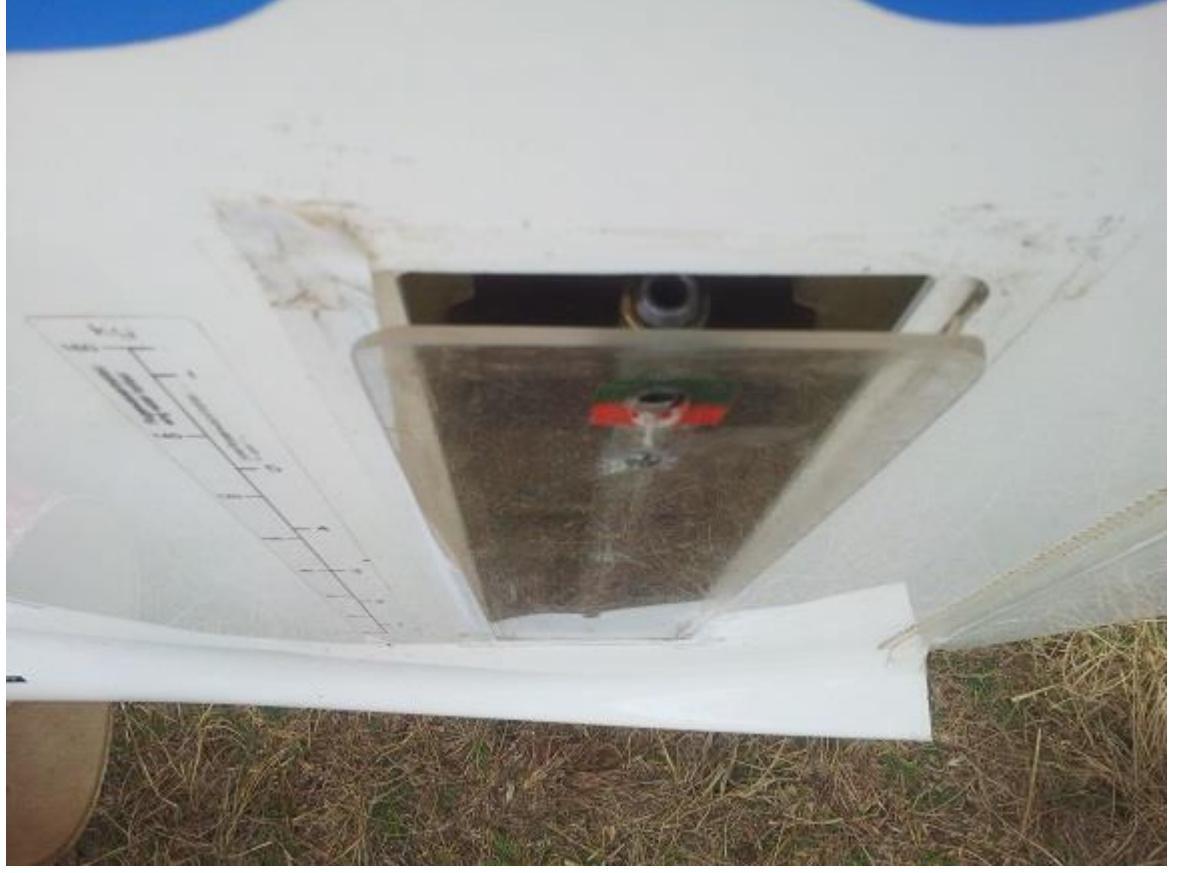
- the top plunger had not been pushed up into its locating hole, and was barely resting with a light spring pressure against the top of the ballast box,
- the top of the cover had moved outwards about 5 mm from the surface of the fin, and
- there was only one piece of tape present, that being on the vertical front edge of the cover, but it
 had been progressively peeling off from the top so that less than the bottom 15cm was still
 attached.Had the flight continued much longer, it is likely that the perspex cover would have
 completely detached from the ballast box, potentially allowing the weights to depart from the
 glider. The serious ramification of the five brass weights falling onto persons or property on the
 ground needs no further explanation.

Care must always be taken in properly securing any type of ballast, as failure to do so can lead to serious or fatal consequences.

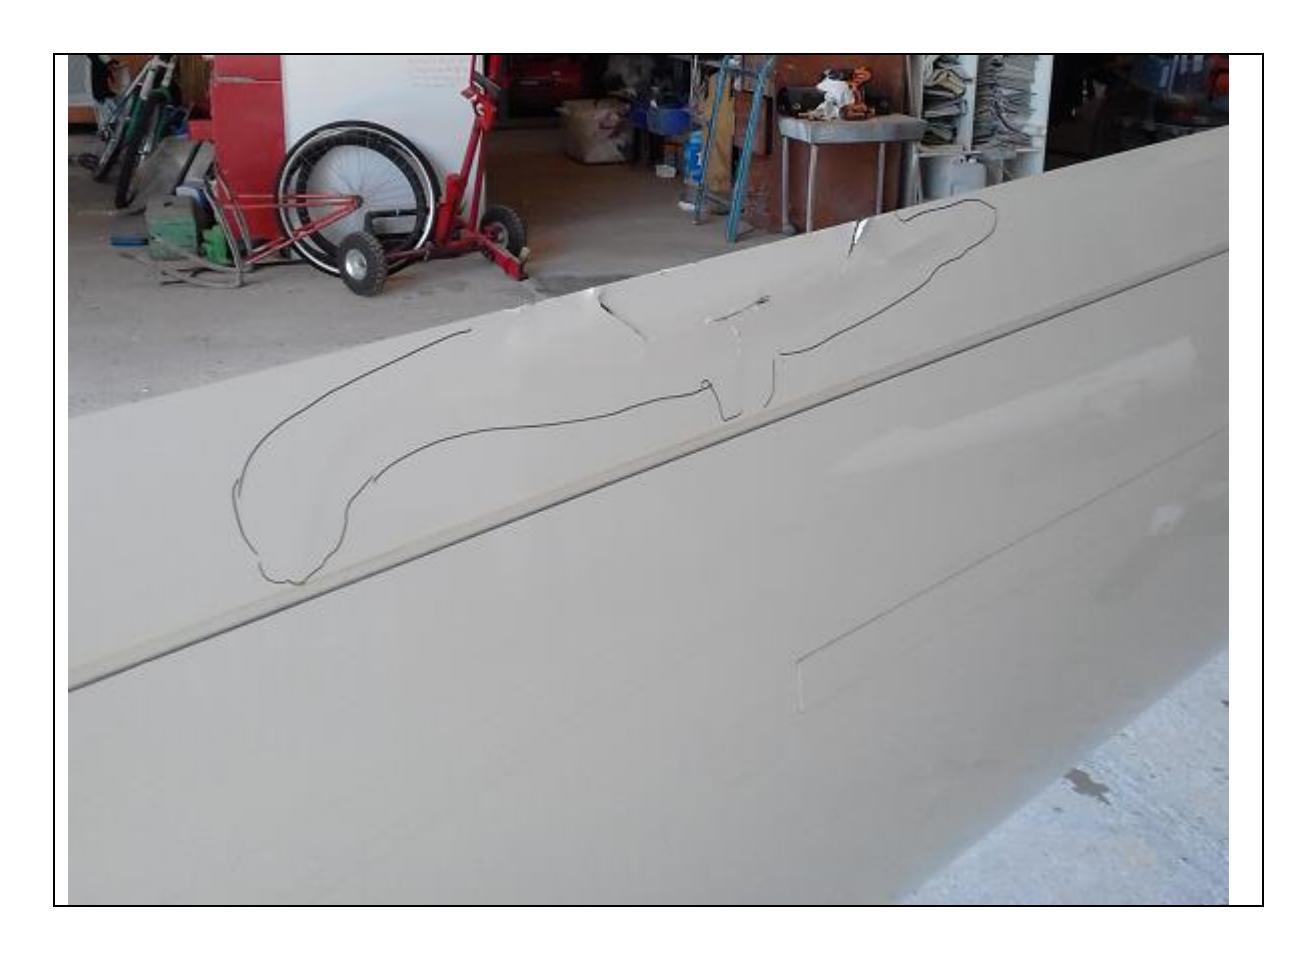
Date	13-Nov-2017	Regior	n	NSWGA			SOAR Report Nbr			S-1081		
Level 1	Operational		Leve	2	Groun	id Ope	eratio	ons	Level 3		Taxiing collision/near	
											collision	
A/C Mod	el 1		LS	S10-	st		A/C	Model	2			
Injury	Nil	Dama	age	Su	bstantial	Pha	ise	Grour	nd Ops		PIC Age	
While to	ving the glider to	the fligh	nt line,	, a n	ortherly w	ind gu	ıst lif	ted the	port w	ing a	nd wing-wal	ker off the
ground re	esulting in the sta	arboard v	wingtip	р со	ntacting th	ne gro	und.	As the	pilot sl	owed	to a stop th	e towing-bar
disconne	cted from the tai	l dolly. T	he glid	der c	continued	towar	ds th	e car ai	nd the	trailin	g edge of th	e port-wing
aileron co	ollided with the v	ehicle. T	he aile	eron	was dama	aged c	over a	total l	ength o	of 600	mm and ful	l chord
width in p	olaces.

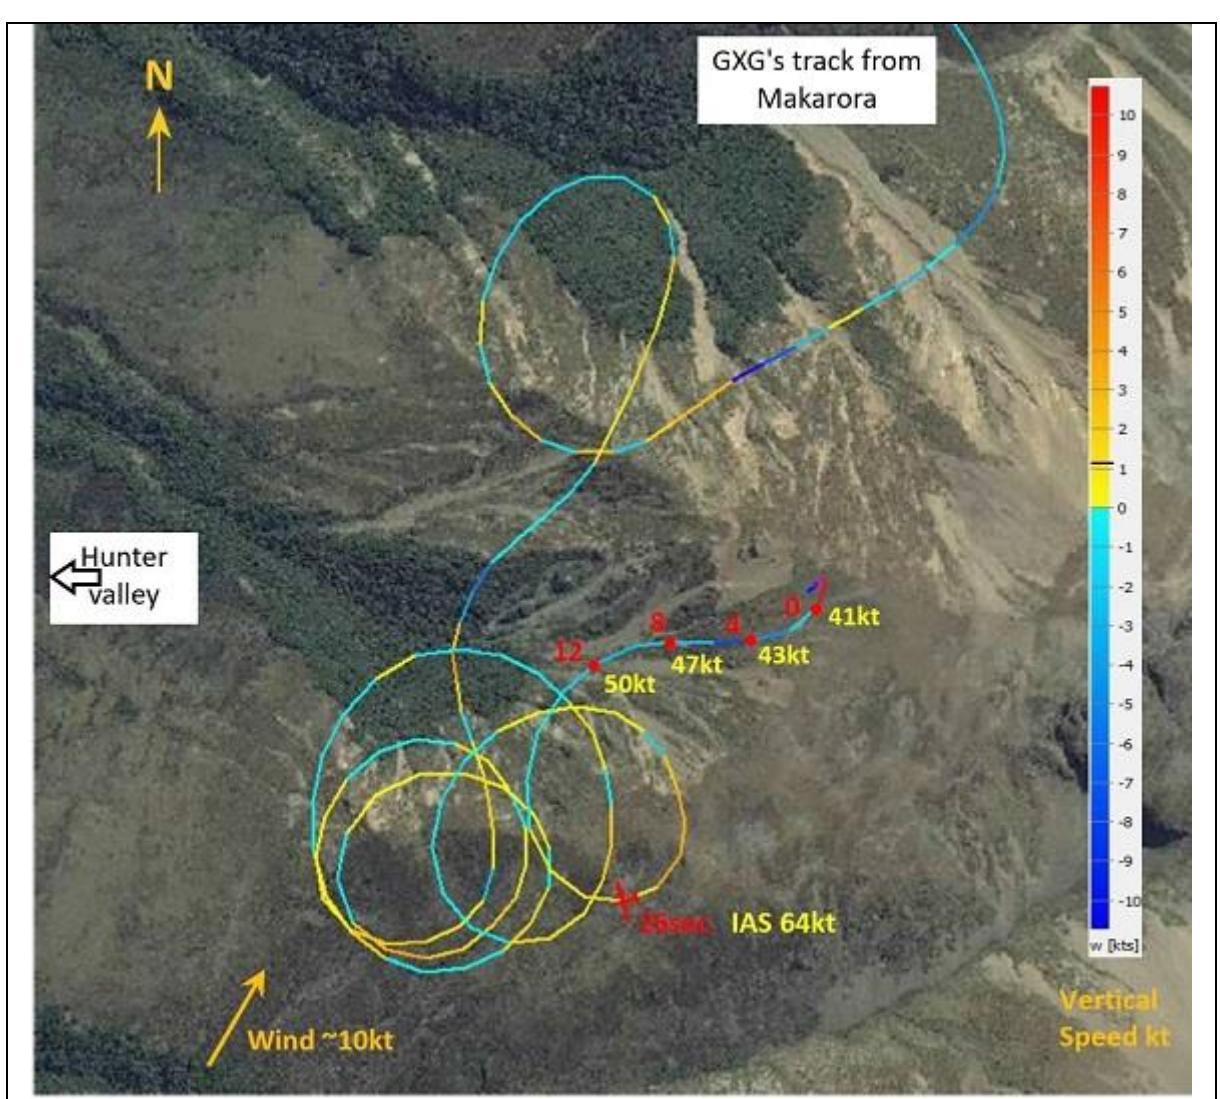
- 1625 ZK-GXG arrives on the western side of the Hunter Ridge at 4500 ft and completes six right turns attempting to gain altitude from thermal uplift (refer to Figure 3). The wind averages 182°Magnetic and 8-10 knots (kt) and the glider's indicated airspeed (IAS)10 ranges between 49 and 68 kt in the turns.

- 1629:11 No lift is gained and ZK-GXG stops circling and tracks close to rising terrain on a northeasterly heading (refer to Figures 3 and 4)
- Next 6 seconds ZK-GXG's IAS progressively reduces (refer to Figure 3 and 4)

Figure 3: ZK-GXG's track below the Hunter Ridge showing spot speeds up to 26 seconds before the stall. Refer also to Figure 4. (Source: ZK-GXG LX9000)

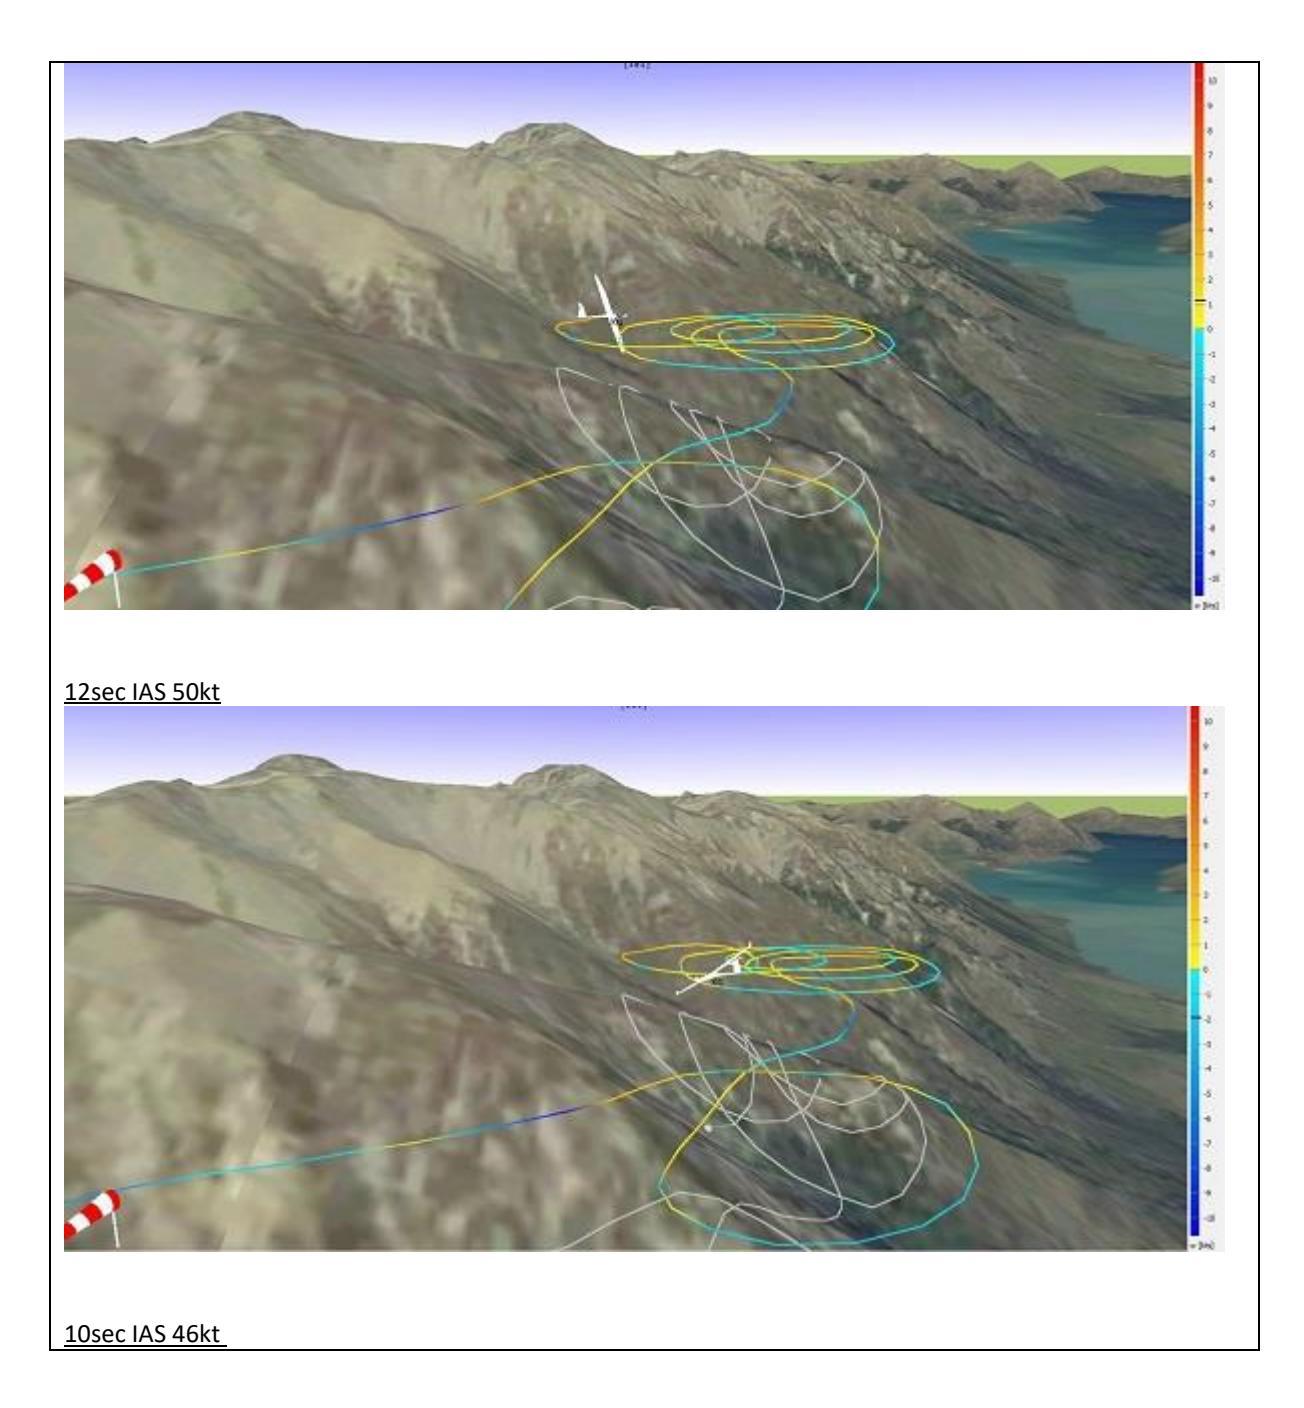
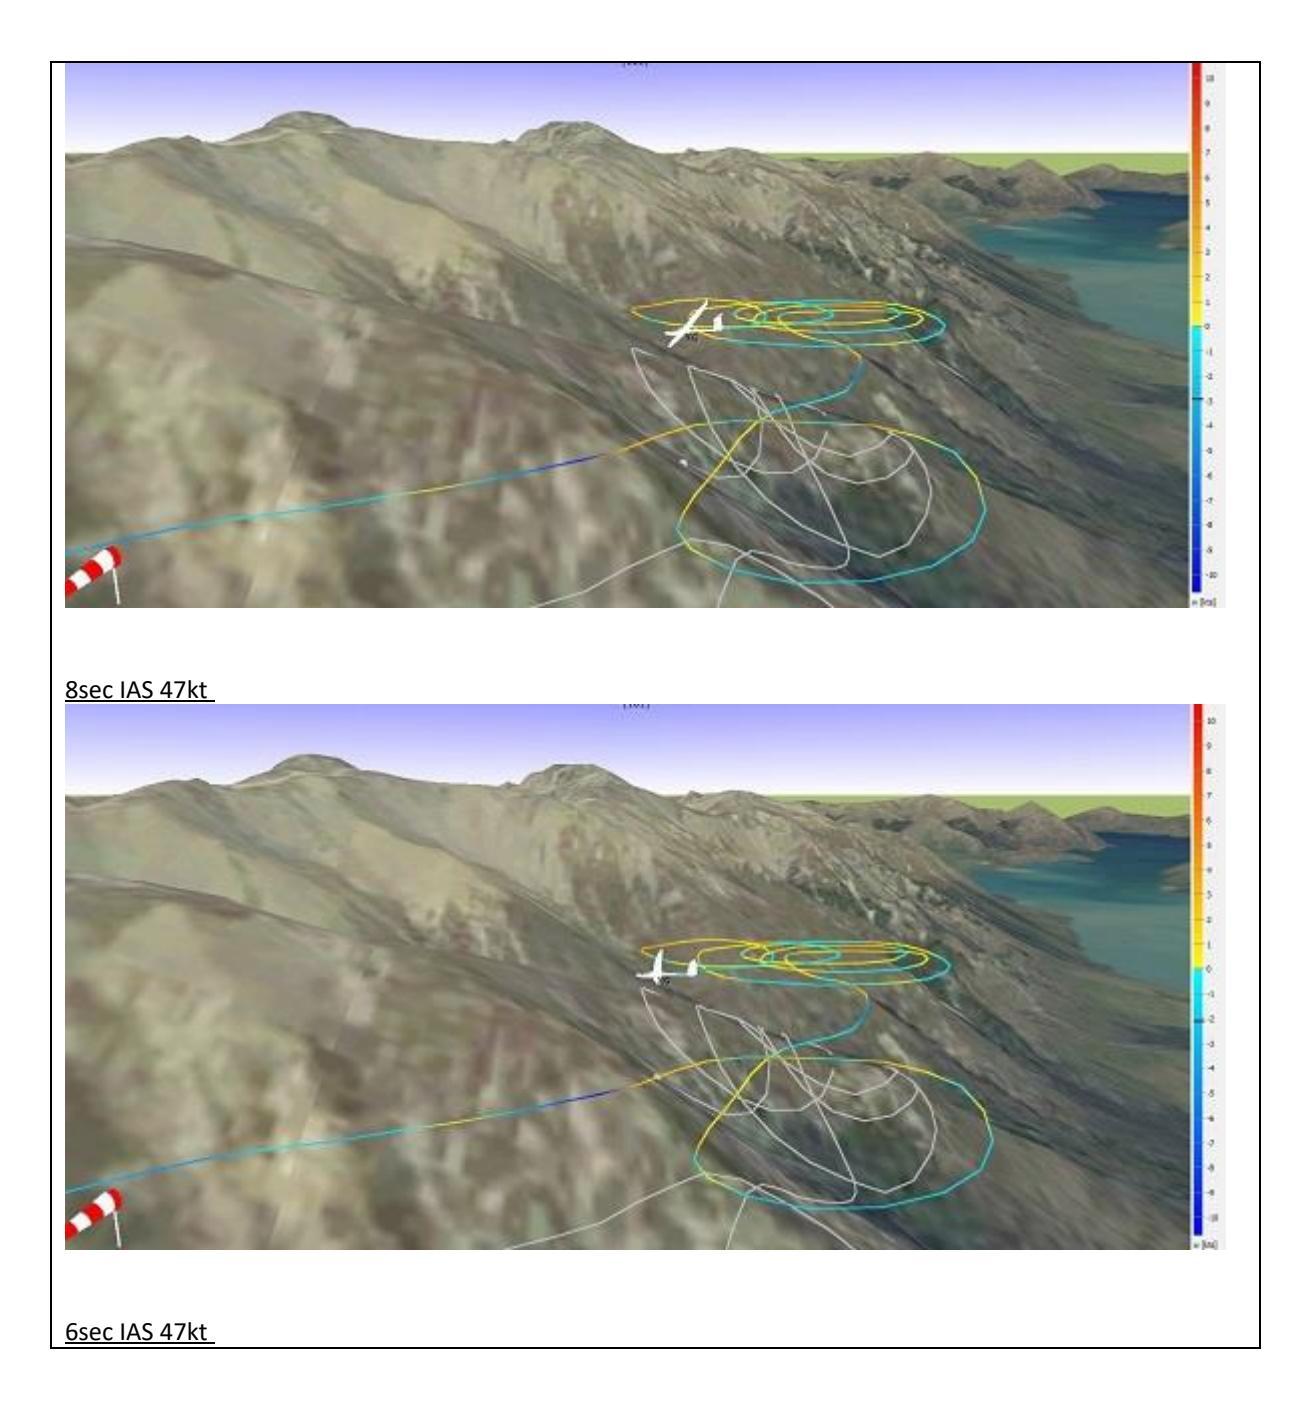
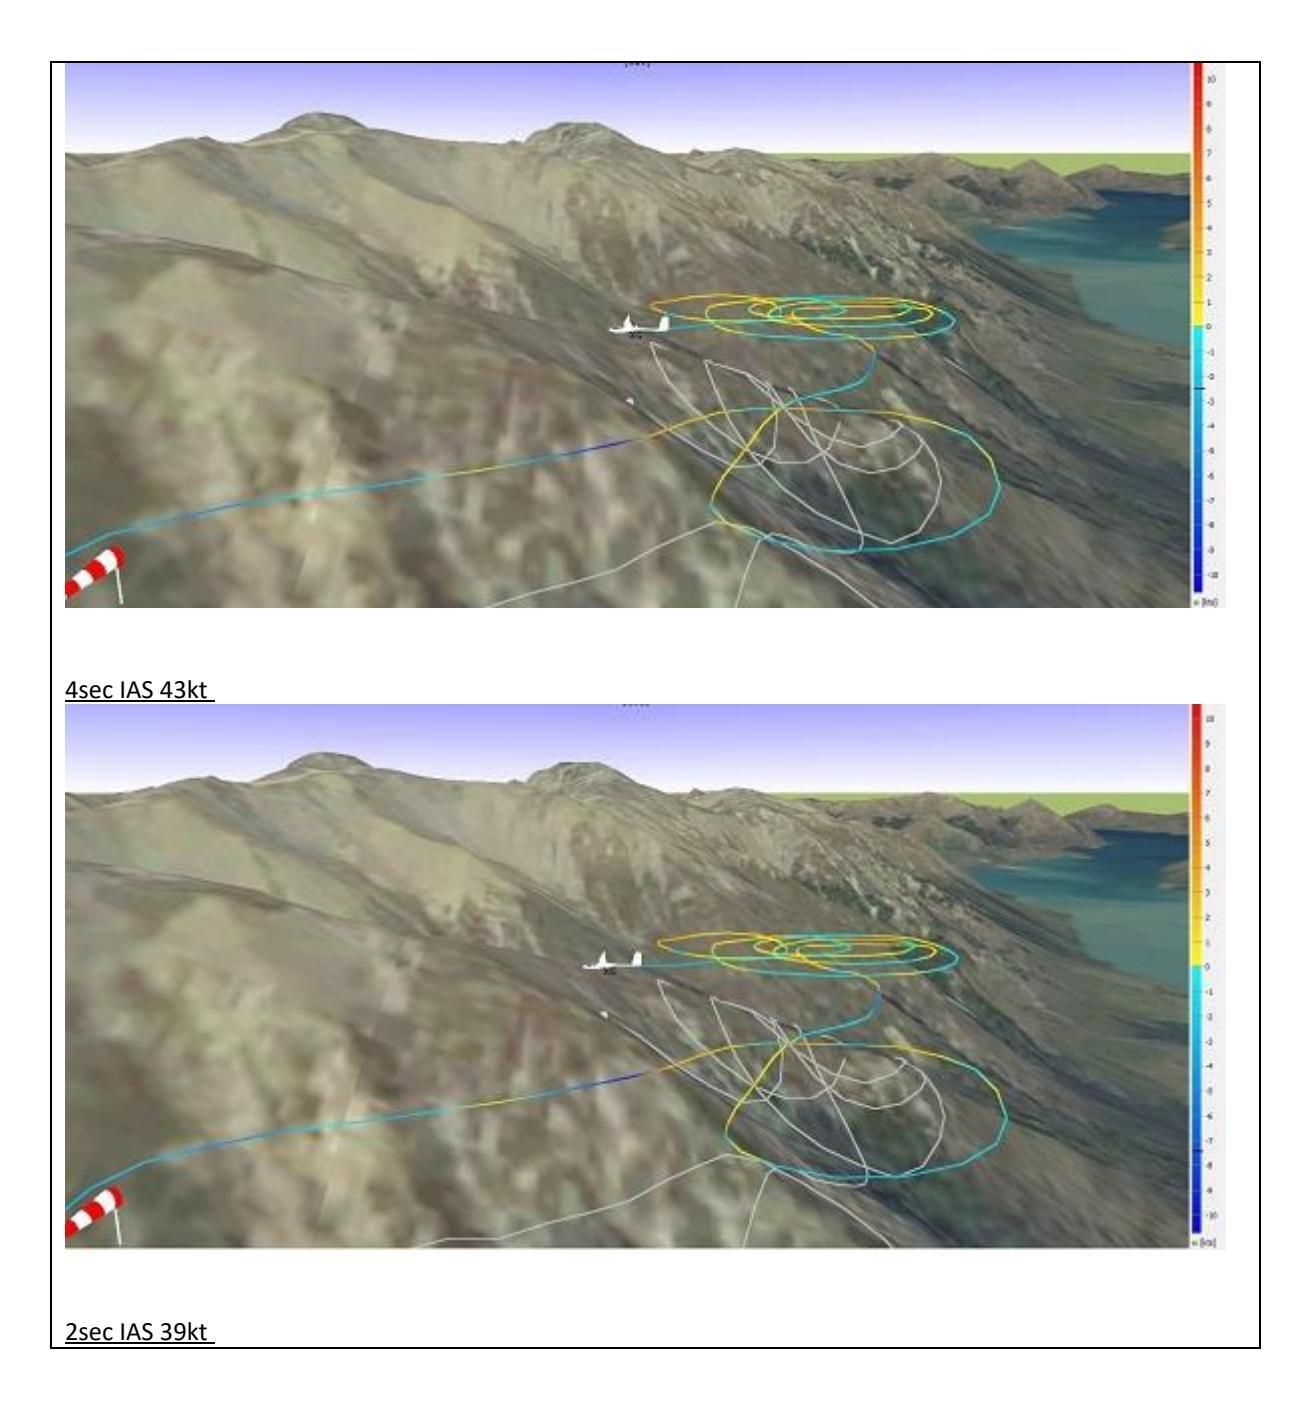
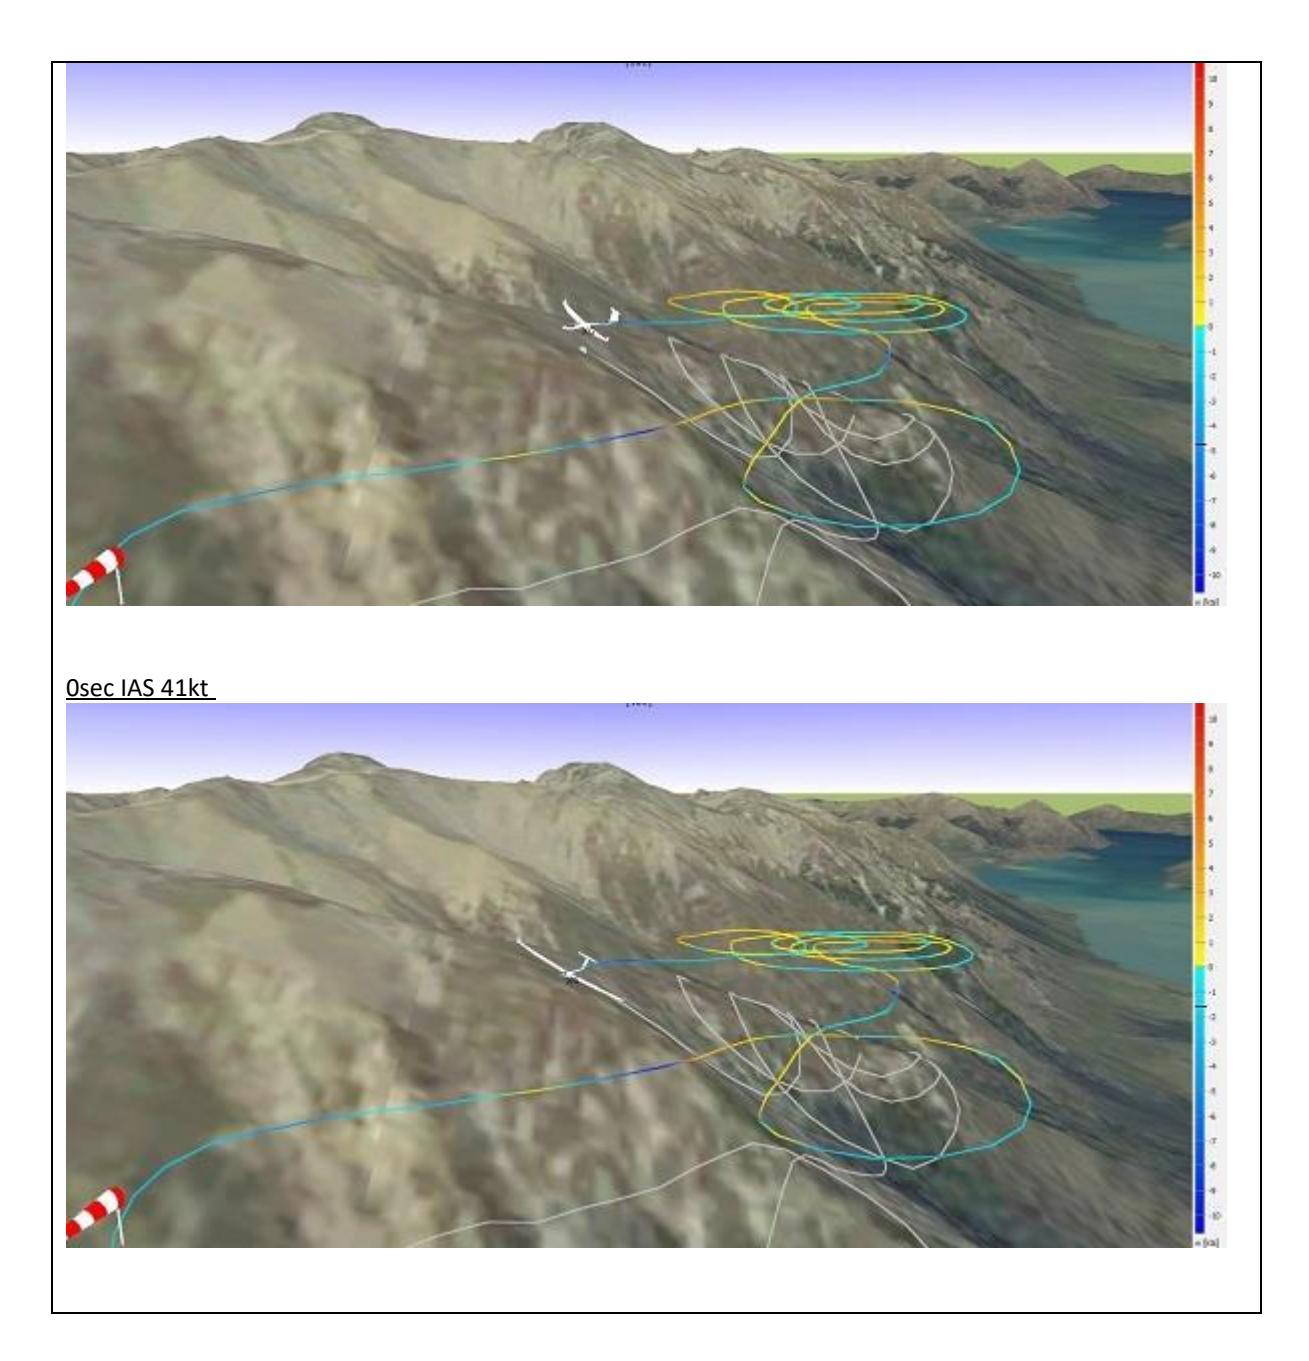
- 1629:17 The IAS reduces to 41kt, ZK-GXG enters a left turn, rapidly loses height and strikes terrain two seconds later (refer to Figures 4 and 5)
- 1658 Passing Championship pilots observe the damaged glider below the ridge and see no sign of movement. They make a MAYDAY call "glider down on the Hunter Ridge" to the Championship operations base. Championship emergency response procedures commence

On the following page(s), Figure 4 shows a series of See You[™] screenshots of the last 26 seconds of ZK-GXG's flight before the aerodynamic stall. These screenshots were created by GNZ using data from the LX9000 installed on ZK-GXG. Use the mouse scroll wheel, or arrow keys, to animate these eight images. Note: The white dot at the end of the ground trace in each screenshot indicates the ground clearance directly below the glider.

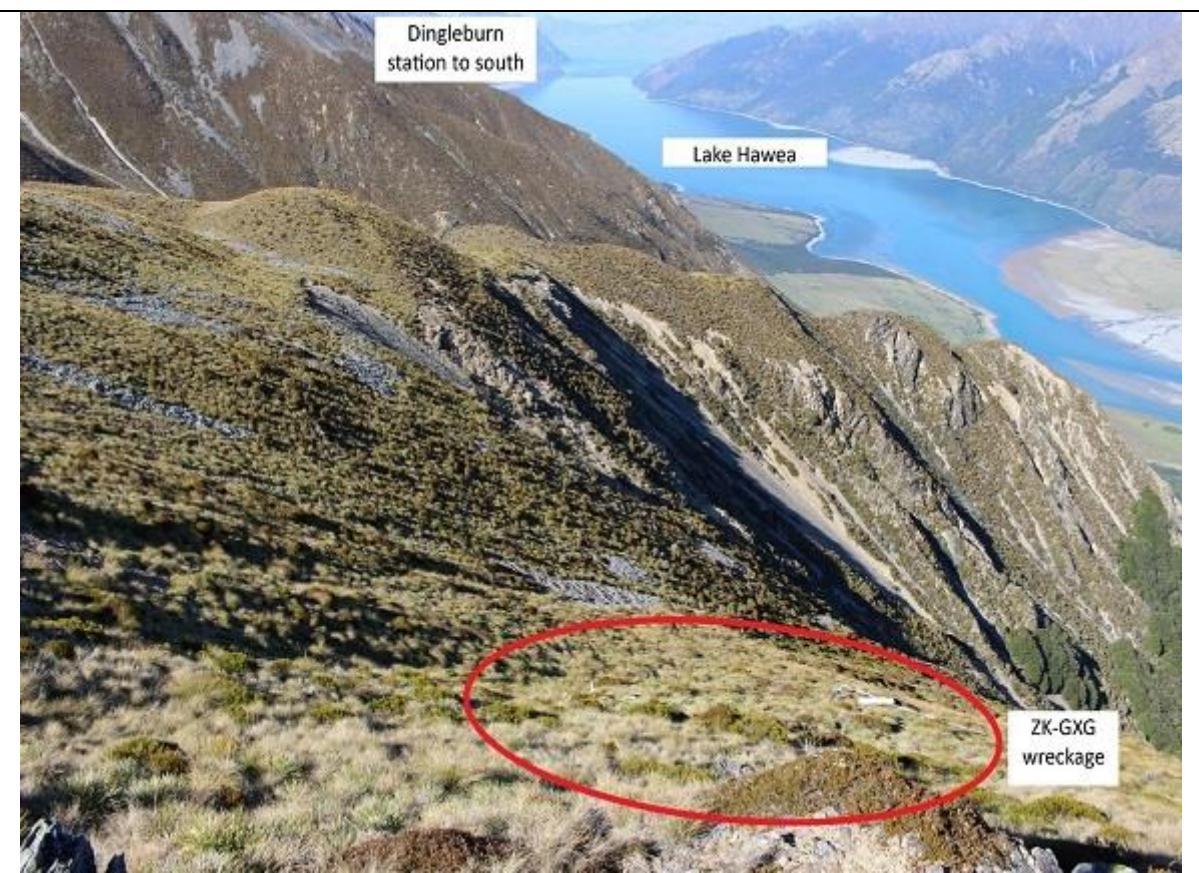
Figure 6: ZK-GXG on a 30° slope facing south. The Hunter River valley is to the right and Dingleburn Station airstrip is further south. (Source: CAA field investigation 0839 23/11/17 NZDT)

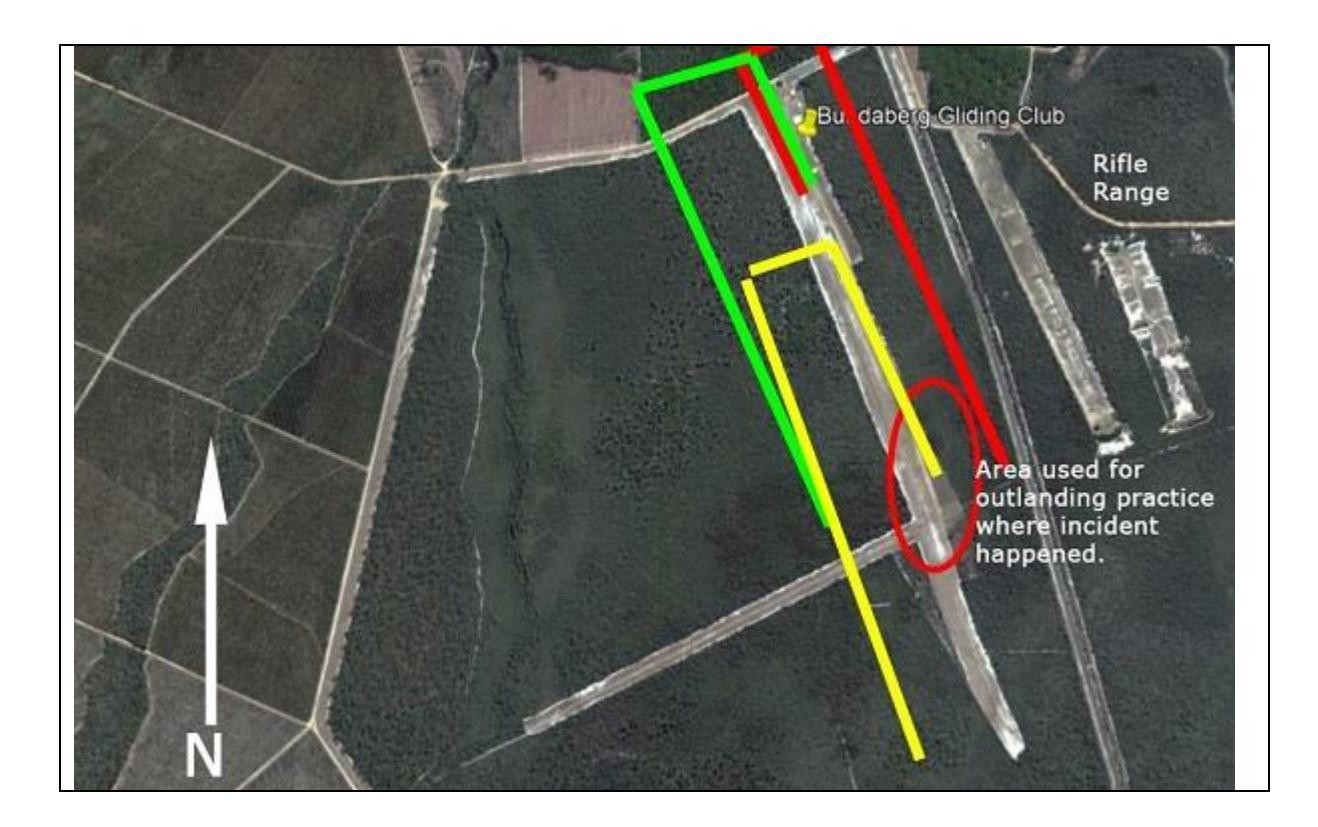
The sortie was a training flight involving a simulated outlanding on a section of the home airfield. The 'runway' was road between high grass that forms part of the perimeter track. During the ground roll, the main wheel caught in a rut and the glider ran off the starboard side of the 'runway'. The starboard wing caught in long grass, and the glider was turned through 90 degrees to the right. During the excursion the glider slid sideways for a period resulting in debris lodging between the tyre and hub of both the main and tail wheels. The main wheel inner tube was punctured, and the tyre later went flat. At this airfield the winds are predominantly from the east, so the club generally flies right-hand circuits. One of the Club's instructors likes to use a section at the far end of the runway for outlanding practice as it is not too familiar to the student. Upon review of this incident, the Club's Training Panel have decided not to conduct outlanding practice in this area in future but will use the cross strip, which is not often used.
