The Gliding Federation of Australia Inc

Occurrence Summaries

01/01/2019 to 31/12/2019

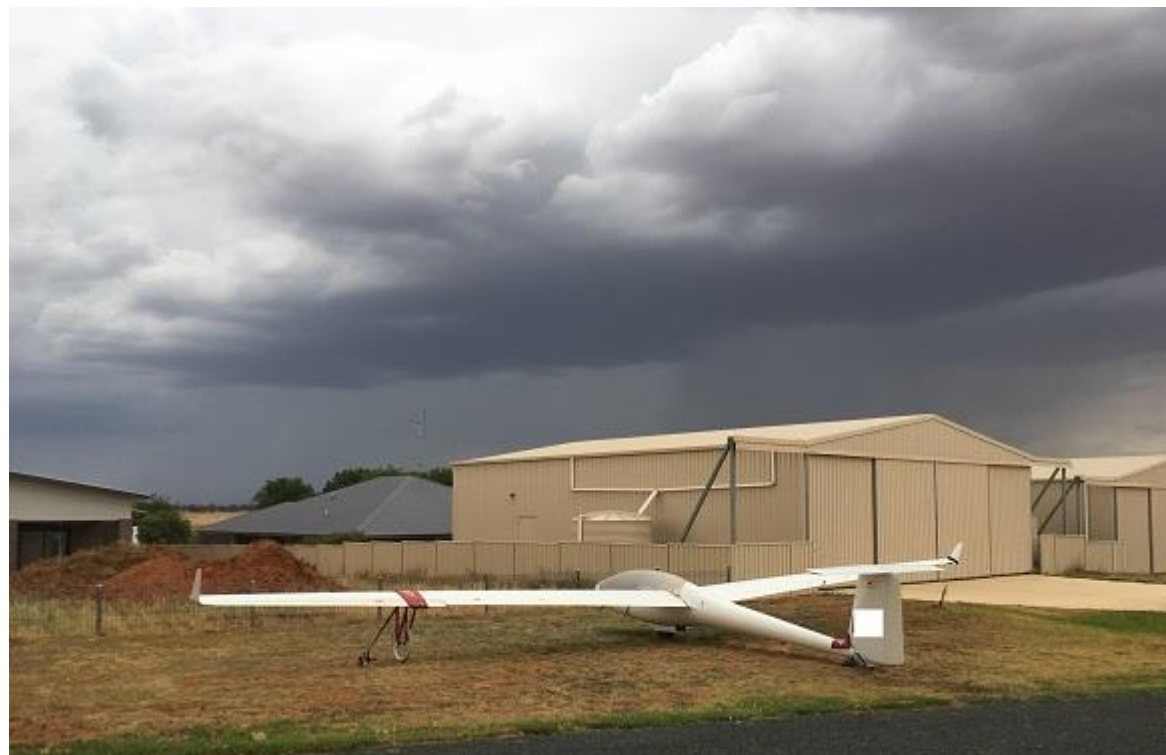
After completing a cross-country flight, the pilot landed back at the home airfield just as a storm hit. A wind of 58 kts was blowing as the pilot climbed out of the cockpit and heavy rain began falling. With the wind blowing over the tail of the glider, the pilot held the port wingtip to steady the glider for 10 minutes until the storm passed. The pilot stated: *"I was not injured and there was no damage to the glider, which is fortunate. Lesson learnt here is to outland earlier and tie down the glider before a storm arrives, so as to prevent potential personal injury and damage to the glider."* Weather does not stay constant and may not behave in a manner consistent with the forecast conditions. It can deteriorate rapidly. When the actual conditions differ from that forecast, pilots need to consider the impact this may have on the planned flight. They need to continually assess the weather enroute and lookout for deteriorating conditions behind, around, and ahead. Make decisions early and when in doubt, look for alternative landing areas. For further information, see:

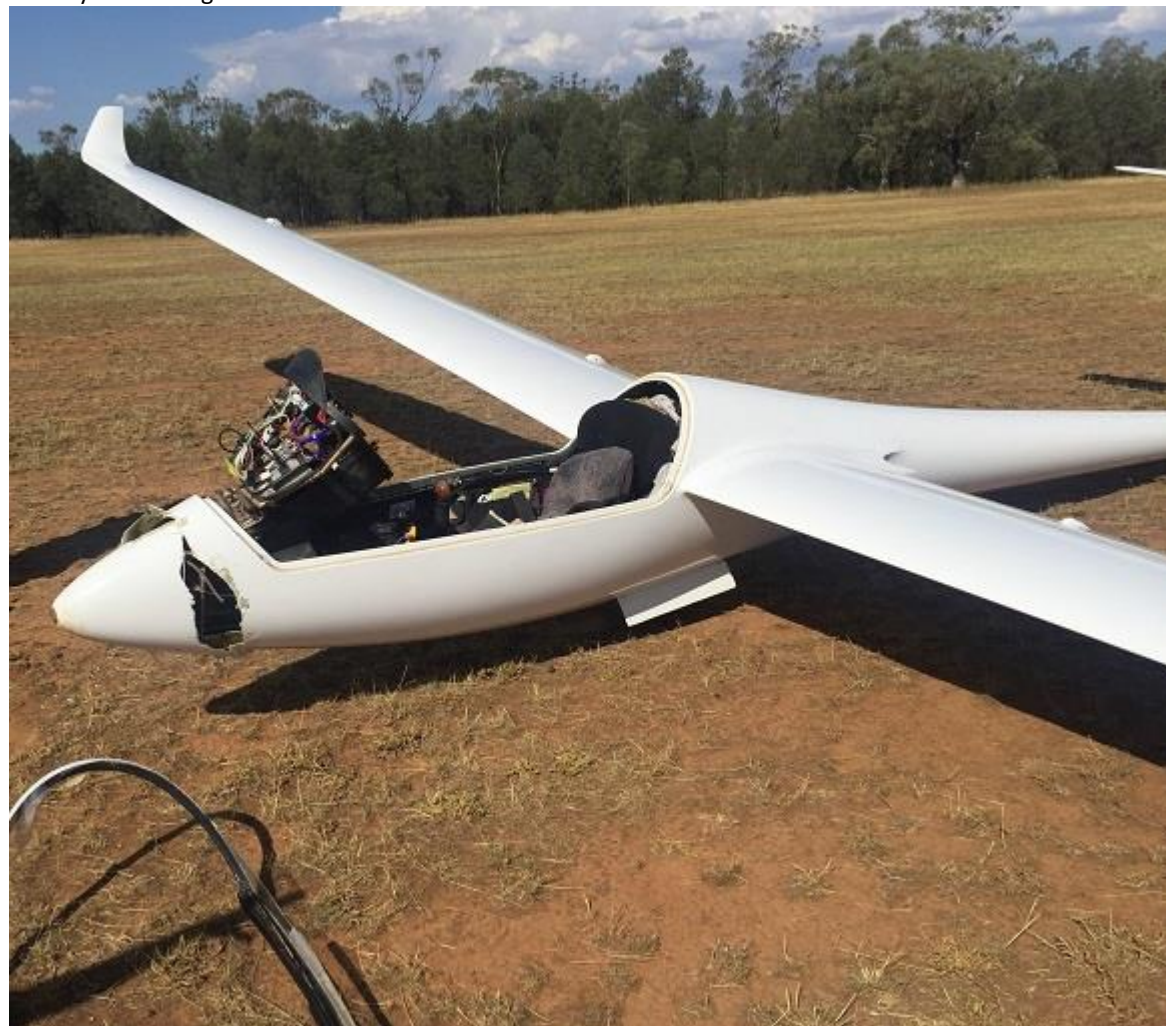
the pilot that the wind was calm and the preferred runway was 14. At 16:33 and at a height of about 1,000ft AGL, the pilot turned onto final approach to RWY 14. During the final approach the pilot received a warning over the radio of a dust devil on the eastern side of the runway. The pilot stated: *"I was already aligned on the west side and decided to shorten my landing (we usually land long in competitions) to minimise the chances of contacting the dust devil. The glider did not have any water left, the approach was done at the usual airspeed of 62-65kts. Just before touchdown I noticed significant turbulence and higher than usual ground speed. While rolling on the ground the deceleration on the slightly uphill strip was slower than usual and I quickly lost aileron authority. Indicating a strong tail wind. I glanced at the ASI and the needle was barely bouncing over 20 knots but the ground speed was still quite high, the left wing dropped and I realised that a ground loop was inevitable. As the glider started to turn left, I pushed the stick forward and after about 90-degree turn, the glider violently became airborne to about 1.5-2m high. The glider then nose-dived and contacted the ground shattering the nose cone, canopy and tailplane. I was unhurt and walked out."* Witnesses reported the thermal crossed the runway as the glider touched down and lifted it about 3 metres into the air while rotating it 270 degrees. Although the pilot was unhurt, the aircraft was substantially damaged. The Competition Safety Officer advised that a number of Dust Devils passed across the airfield during the period of the competition, which were mostly avoided by ceasing launching or using a different runway for landing.

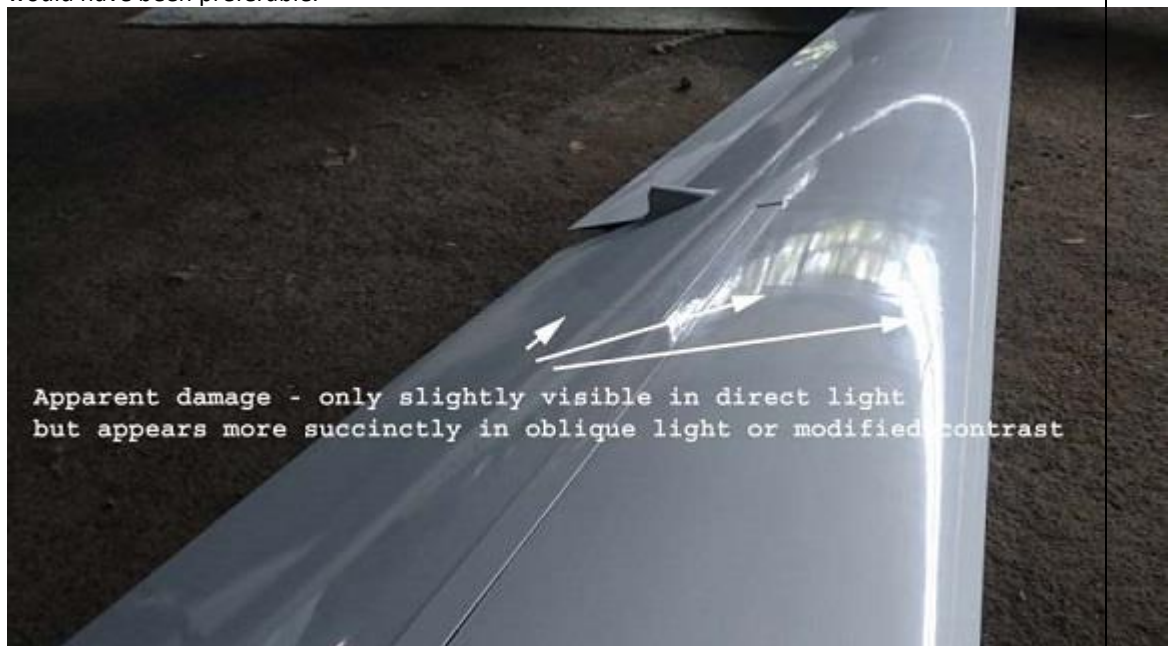
- The launch appears to have been too fast at all stages, and the damage sustained suggests the speed exceeded the glider's maximum manoeuvring speed during the pilot induced oscillations. The excessive speed may have been the result of the wind speed increasing with height.

- It is not easy to give too fast signals in a light glider such as the PW5 when approaching maximum speed on the launch, and even experienced pilots can have difficulty. In this case, an earlier release would have been preferable.

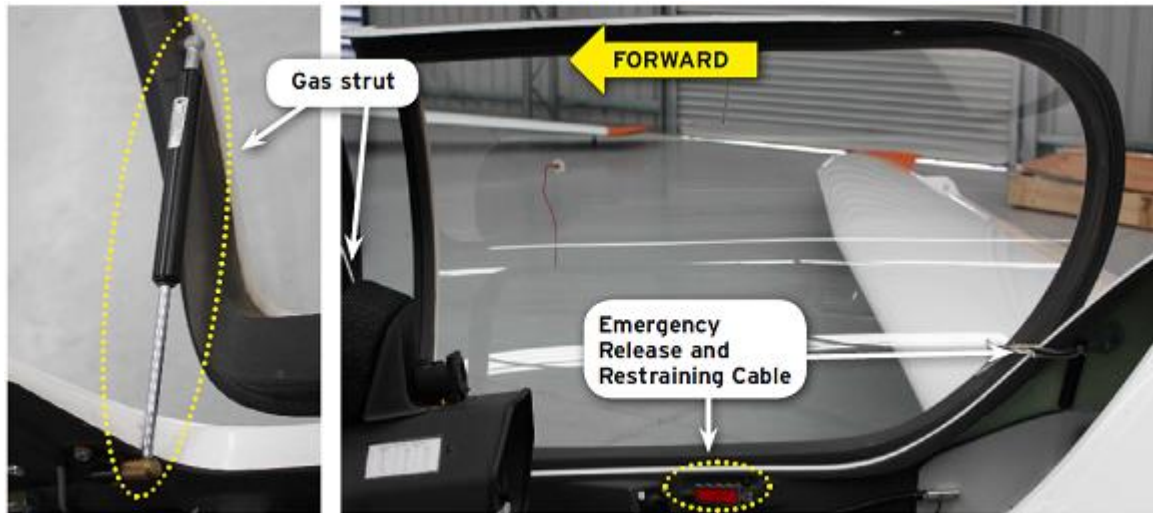
Figure 6. Gas Strut and retaining cable

The canopy hinges are attached to the fuselage mounts by a control rod connected to the emergency release handle lever (red square within the small yellow ellipse in Figure 6). It also has a gas strut attached at the front of the canopy and a restraining cable at the rear to prevent the canopy from over-extending (highlighted by the large yellow ellipse in Figure 6) when opened.

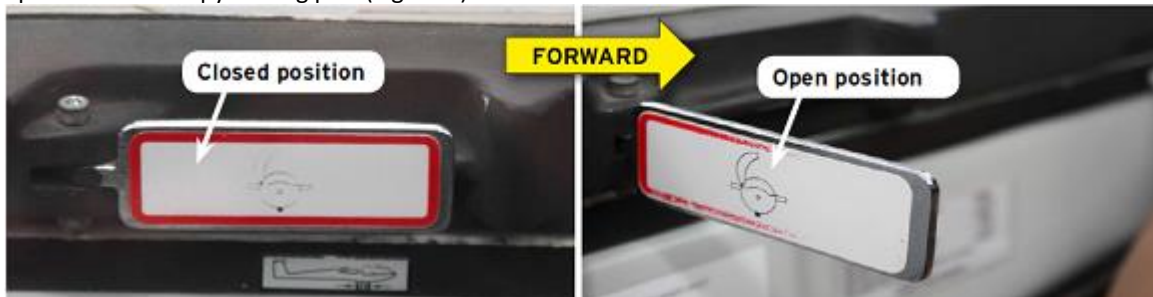
Figure 7. Closed and open positions of canopy locking handle

When the canopy is closed, it is locked into position by the canopy white-red locking handle lever which operates the canopy locking pins (Figure 7).

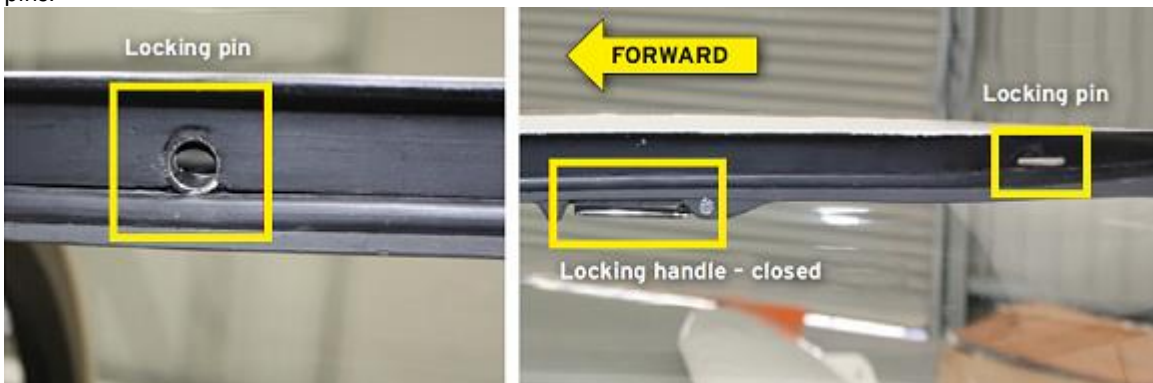
Figure 8. Rear canopy locking pin(s)

The closed handle, depicted in Figure 7, is further amplified by the underside view of the port side of the canopy in Figure 8, which demonstrates the relationship between the locking handle and the canopy locking pins.

Should the rear canopy be inadvertently locked prior to closing, the canopy will sit upon the pinning mechanism (see Figures 8 and 9) and can, at first glance, appear to be locked for flight. Closer inspection should reveal that the canopy sits slightly proud of the frame but if the inspection is cursory, it is feasible that the canopy could be incorrectly assessed. The Aviation Safety Investigation Team recommends that the leading edge of the rear canopy be fitted with a high visibility surface, which becomes visible (to external parties) should the rear canopy be incorrectly seated; as demonstrated in Figure 16.

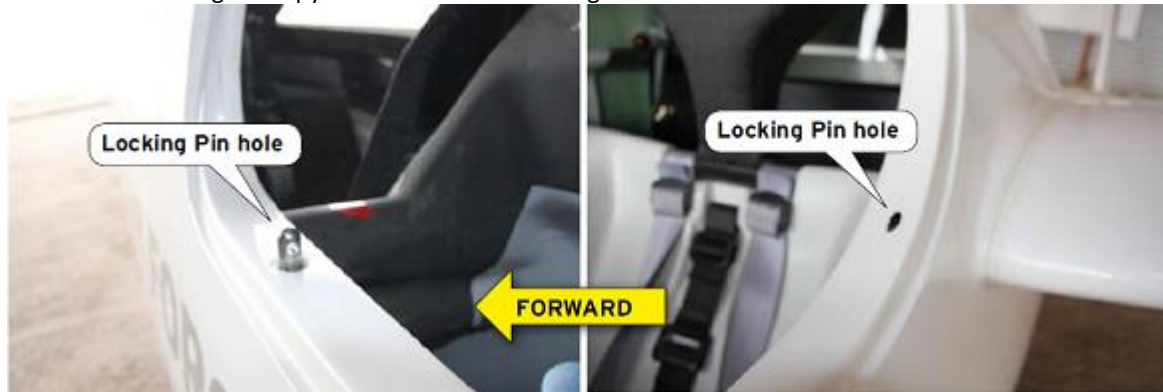
Figure 9. Mating location of the locking pins on the fuselage

The canopy locking handle (from Figure 7) moves the locking pins to mate with the front and rear locking pin holes on the fuselage canopy structure identified in Figure 9.

Cycling the canopy locking handle from the open to the closed positions moves the handle lock and pinning mechanism freely through the matching locations on the fuselage (as seen in Figure 8 and 9). When the locking handle is in the closed position the locking pins extend into/through the matching locations on the fuselage ensuring positive engagement of the locking pins to the fuselage. Thereafter, the canopy is fully closed and locked flush with the fuselage (Figure 10), with the handle flat against the inside of the canopy (as seen in Figures 7 & 8).

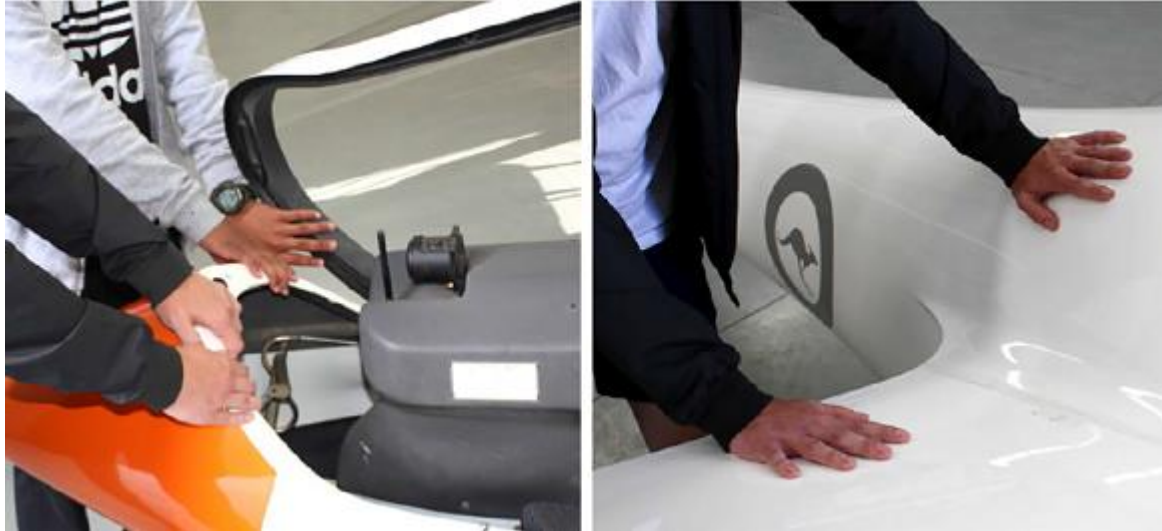
Figure 11. Pulling from nose and pushing via the wing root

Prior to the event flight, the glider was situated third-in-line awaiting aerotow launch and accordingly, the command pilot completed the pre-boarding and pre-take-off checks (ABCD and CHAOTIC). For solo operations, it is normal that the rear canopy is not opened so as to maintain a sterile rear cockpit. Conversely, it is usual to have the front canopy open, as it is firstly, easier to communicate between the pilot and attending ground crew; and secondly, it facilitates ground movement, the methods for which are

demonstrated in Figure 11.

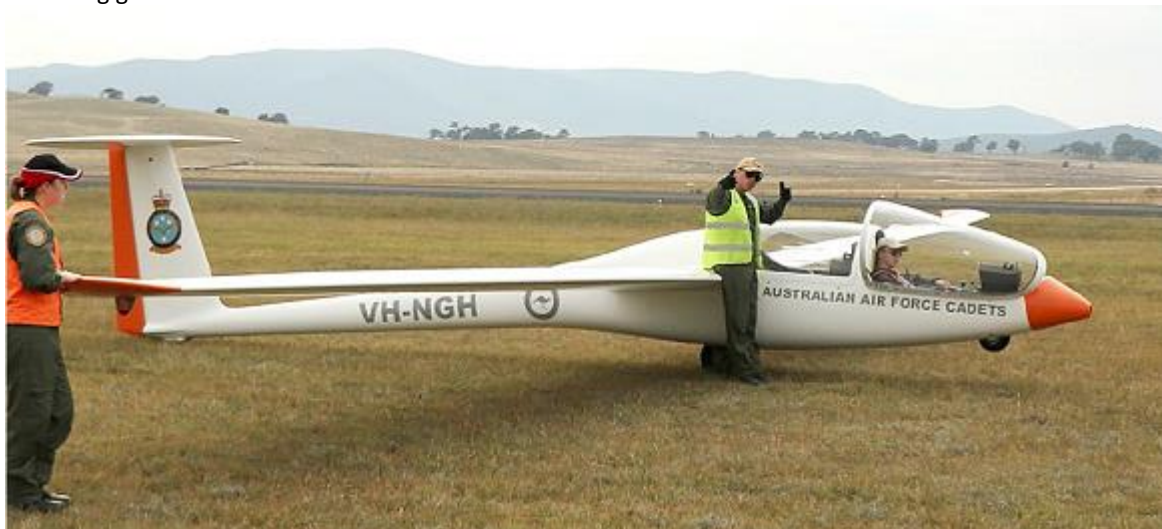
Figure 12. Event glider in third position on the launch line

During the ground handling evolutions for the event glider, the pilot sought assurance from the ground crew/canopy holders that the rear cockpit remained secure after each move forward. The canopy holders who attended the glider revealed that, during the ground moves, they “*didn’t pay any attention to the canopy handles, sliding vent or notice the rear canopy not being flush with fuselage.*” They also recounted that the rear canopy was never opened as the glider progressed down the launch line, adding that they were unsure of the position of the canopy handle throughout the process. Figure 12 shows the glider third in position on the launch line with the canopy closed. Both the pilot and supervising instructor stated they had locked the rear canopy and closed its sliding vent. The security of the rear canopy was also confirmed by the attending ground crew.

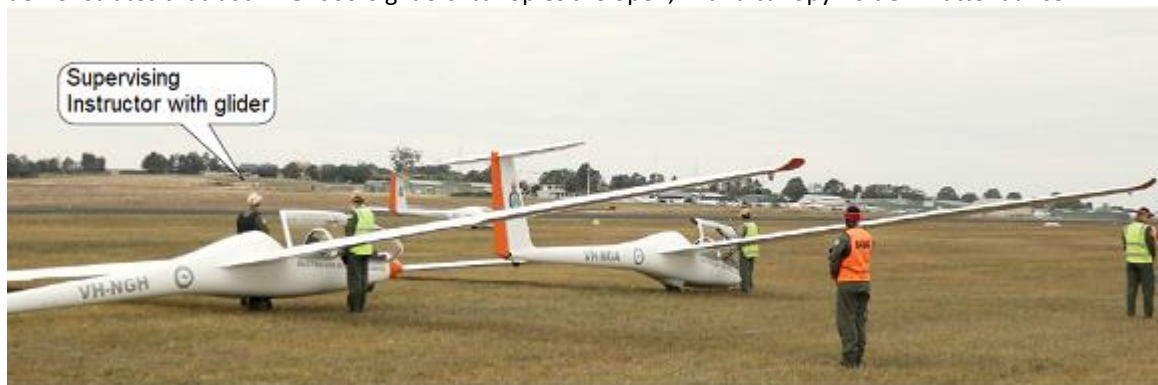
Figure 14. The event glider in second position with the rear canopy opened

The pilot and supervising instructor both attested that the rear canopy had been locked, and the sliding vent closed, prior to the PIC boarding the aircraft. Figure 13 demonstrates that the canopy locking mechanism was ajar and the canopy sliding vent was open soon after the pilot was secure in the aircraft. Figure 14, taken about 10 minutes later than the Figure 13, shows the event glider, now second in line for an aerotow launch, with the rear canopy opened. This is despite the interviewed ground crew stating that 'the rear canopy (of the event glider) was never opened during the move down the launch line'. Figure 14 also demonstrates that both DG1000-S gliders' canopies are open, with a canopy holder in attendance.

Additionally, Figure 14 demonstrates that the supervising instructor was in attendance during the glider's line-up sequence (seen on the left-hand side of glider; from where the canopy locking handle would be accessed via the sliding vent). This is also contrary to the information furnished by the supervising instructor. The aforementioned comments, and figures 13 and 14, demonstrate that there are numerous discrepancies within the information gathered by the Aviation Safety Investigation Team (from written statements/interviews) and permanent/physical evidence (photographic/ aircraft)). As such, the Aviation Safety Investigation Team is unable to establish an accurate history of the event glider's ground movements

To ensure that launch sequencing is better managed, the Aviation Safety Investigation Team recommends that a dedicated, and suitably qualified, 'lead ground-handler' is assigned to all solo piloted airframes during the launch sequence. The 'lead ground-handler' is to provide a continuity of service to the pilot and ultimately, assurance that the glider is, in all respects, ready to launch. The 'lead ground-handler' qualification (and the duties thereof) should be clearly articulated within AAFC Orders, Instructions and Publications. The Aviation Safety Investigation Team acknowledges that both non-physical and perishable evidence (witness recollection) can be unreliable (corrupted over time/memory conformity/quality/reliability). The Aviation Safety Investigation Team were unable to definitively establish the position of the locking mechanism handle when the glider came to rest.

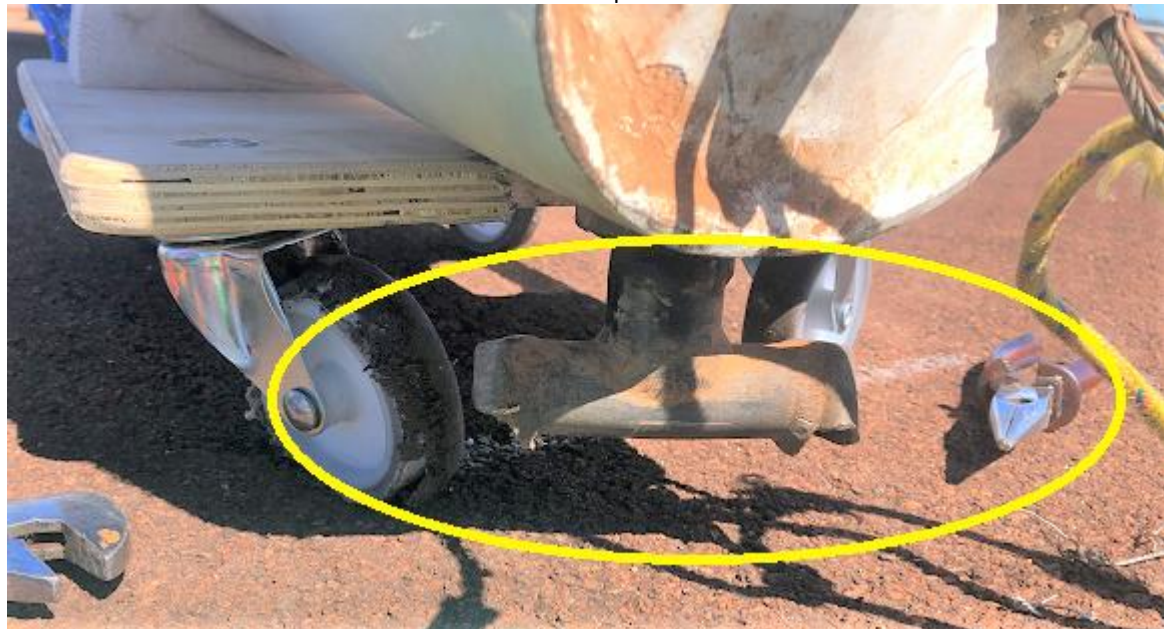
Just after landing engine-off at a Regional Airport, the motor glider veered sharply to starboard with the wings level and the pilot was unable to regain directional control with the rudder. As the glider rolled off the bitumen surface onto the grass verge, the pilot heard a loud noise and the aircraft came to a sudden stop. Subsequent inspection of the fixed tailwheel mechanism revealed that the left fork broke just after touchdown, causing the tail wheel to tilt to one side and turn the glider to the right. The right-hand tailwheel fork strut subsequently sheared off when the tailwheel dropped off the bitumen, which was about 50mm higher than the grass verge. In addition to the broken tailwheel, the bottom off the rudder suffered some abrasion. The pilot reported that the aircraft had suffered a heavy landing three weeks earlier and, although an examination at that time not identify any damage, it is believed the tailwheel forks may have been weakened (fatigued). The pilot noted that the glider is an early model with a fixed tailwheel and, unlike later models, it doesn't have any shock absorbing mechanism. The tailwheel was professionally repaired and the aircraft returned to service. The owner intends to replace the tailwheel with the later model.

Metal fatigue refers to a weakened condition induced in metal parts by repeated stresses or loadings, ultimately resulting in fracture under a stress much weaker than that necessary to cause fracture in a single application. To the naked eye, there is no way to detect metal fatigue until it starts being too late: you can only see cracks that are already forming and/or propagating. Also, you cannot minimise fatigue, as once it starts setting in it is an irreversible process. Non-destructive testing techniques such as radiography (basically X-raying), Ultrasonic testing can be used to detect microfractures before they reach the problem stage. A common and cheaper technique is the use of a Dye Penetrant, where a dye in a carrier fluid is painted into the surface and then wiped off. The fluid is light enough to penetrate and 'wick' into any fine cracks and will highlight cracks that are invisible to the eye (the dye is often fluorescent). If a crack is detected, what can be done is very much subject to the extent and location of the cracking. Extensive damage and/or damage to a critical area will require repairing by replacement, whereas minor damage may be capable of being dressed out.

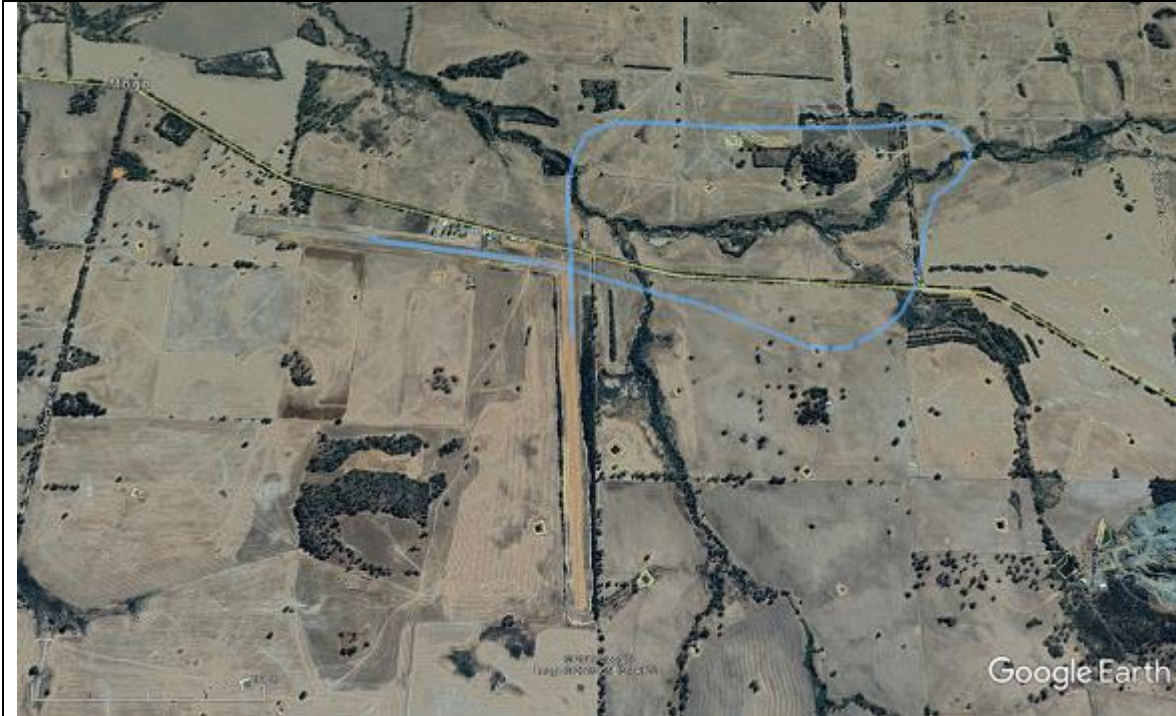
With the rope laying across the port airbrake, the pilot under check cracked the airbrakes and determined handling was unaffected by the rope. The pilot approached RWY 18 higher than normal and on the upwind side to minimise the chance of snagging the trailing rope. The landing proceeded normally and without further incident. After exiting the glider, the crew noticed that the rope was not only draped around the wing at the airbrake area, but that it was also draped over the leading edge of the port wing at the fuselage and trailed back over the top of the port tailplane and elevator (see photo below).

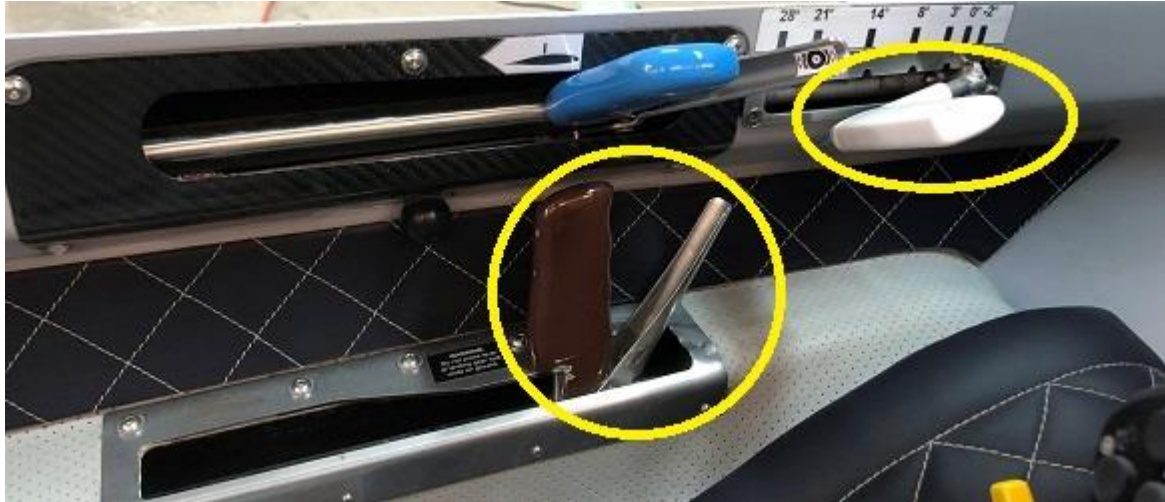
Level 1	Operational	Level 2	Aircraft Control	Level 3	Hard landing
A/C Model 1	SZD-56-2 Diana 2			A/C Model 2	
Injury	Nil	Damage	Minor	Phase	Landing
After entering the circuit, the pilot configured the aircraft for landing by lowering the undercarriage. A stabilised approach was flown and as the aircraft touched down the undercarriage collapsed. Investigation revealed that the undercarriage locking mechanism had not fully engaged. The undercarriage handle includes a lever that operates the locking mechanism. To engage or disengage the lock, the lever is squeezed against the handle. The pilot suspect that the undercarriage lock may have been inadvertently disengaged when the flaps were deployed, as both levers are in close proximity (see photograph).					PIC Age 70

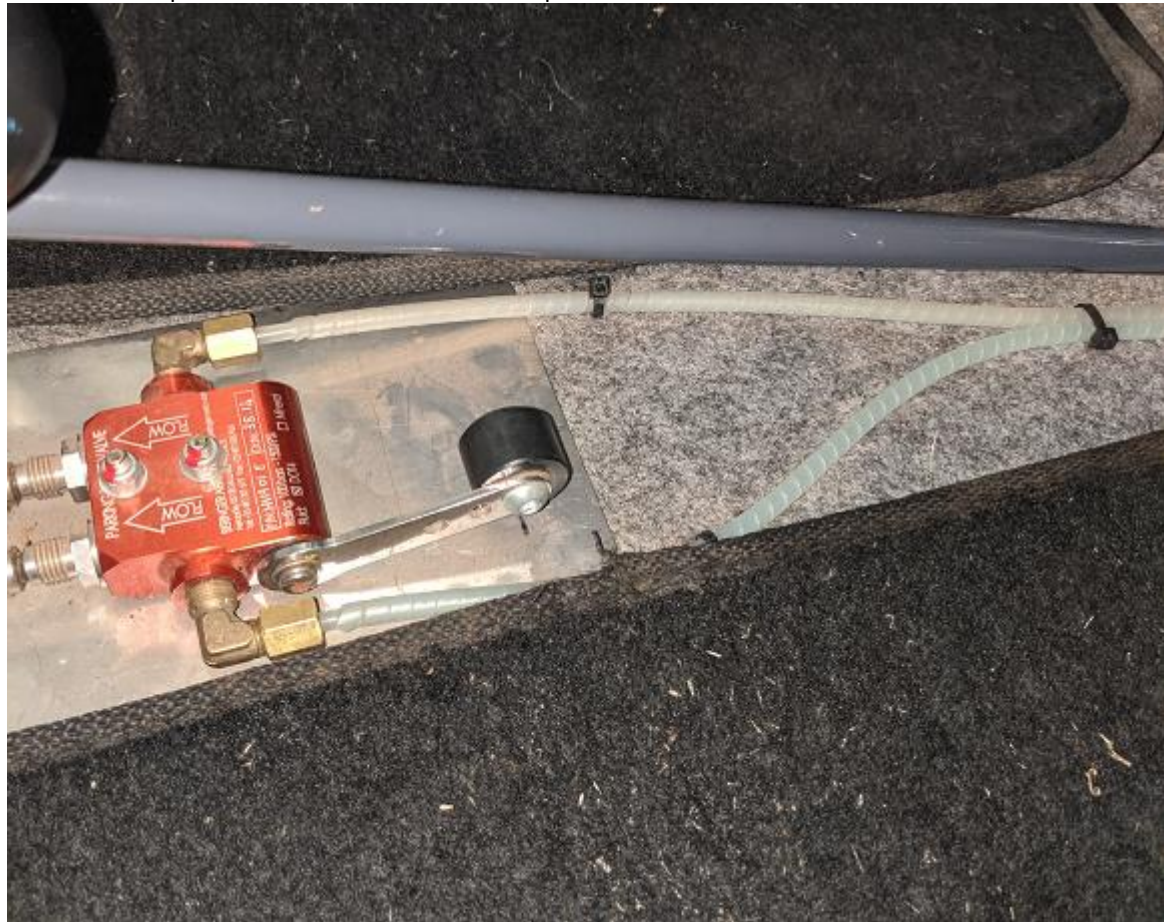
After further investigation, the tow pilot identified that the floor mat on the starboard side most likely had moved and lifted the floor-mounted park brake handle sufficiently to cause the brakes to engage (refer photograph). The tow pilot surmised that even the small application of brake caused sufficient drag to heat the brake fluid and vaporise moisture in the system, which then progressively pressured the pistons to the point of locking-up the brakes. The mat was removed from the starboard side to prevent this occurring again. The mat on the port side is considered sufficiently clear as to not pose a problem. The Tugmaster briefed all tow pilots on the characteristics of the park brake.

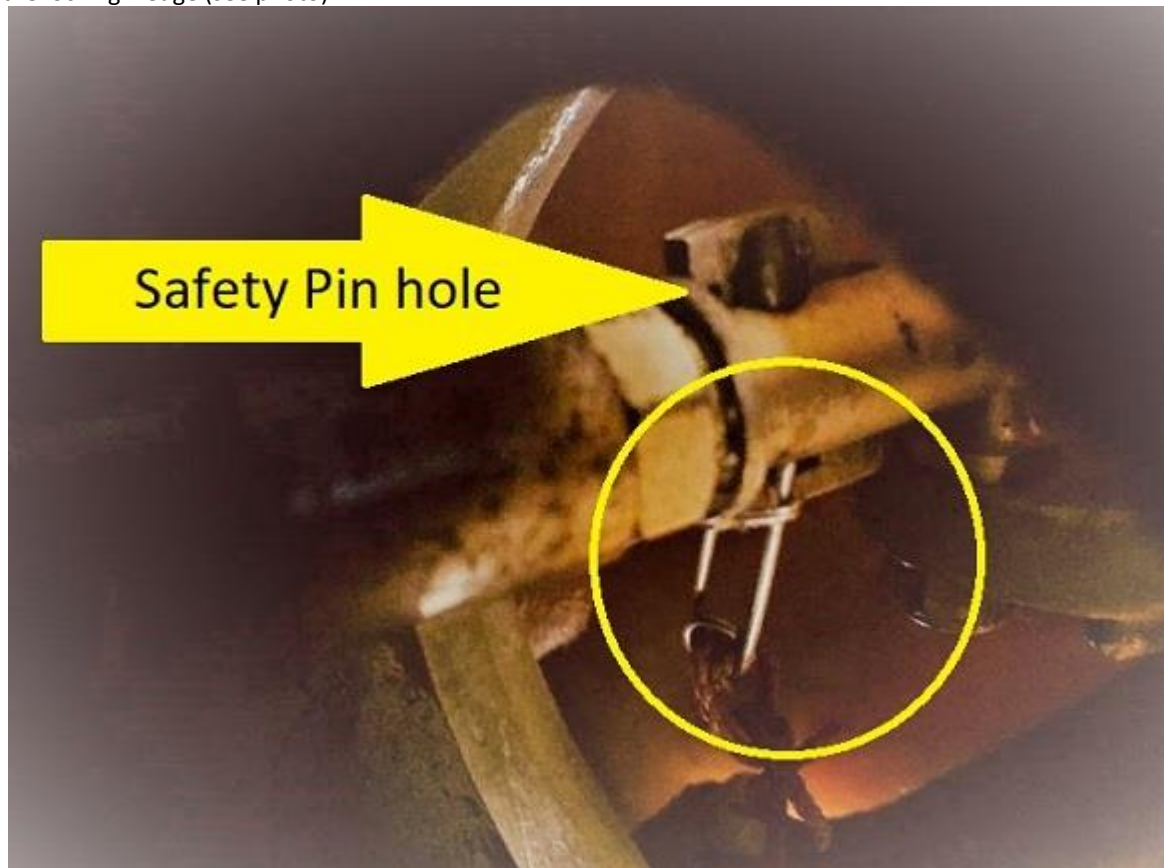
During the daily inspection on the 16 Oct 2019 of VH-UIY, the left and right L'Hotelier safety pins were found to be incorrectly fitted following the post form 2 inspections. The pins were fitted on the incorrect side of the locking wedge (see photo).

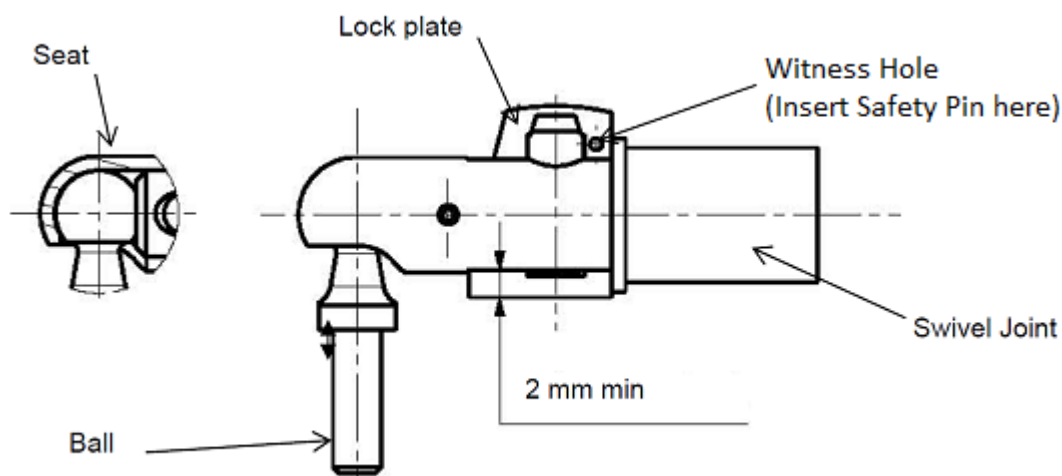
L'Hotelier connections rely upon proper engagement of a ball and socket, which are secured by a spring-loaded tab that must be pressed out of the way to make the connection. With the tab in position, a witness hole is exposed, allowing a locking pin/clip to be fitted to secure the connection (see diagram). The controls can become disconnected in flight if the pin is not fitted. It is therefore crucial to check that the ball and socket are correctly engaged by pulling on the connection. This can be difficult if access is tight or illumination poor: a torch and mirror, or even an endoscope or phone camera, can help. A "positive check" of the control connections can also be conducted after assembly of the sailplane. This should involve at least two individuals; one to hold the control surface stationary while the other individual attempts to move the flight controls in both directions.

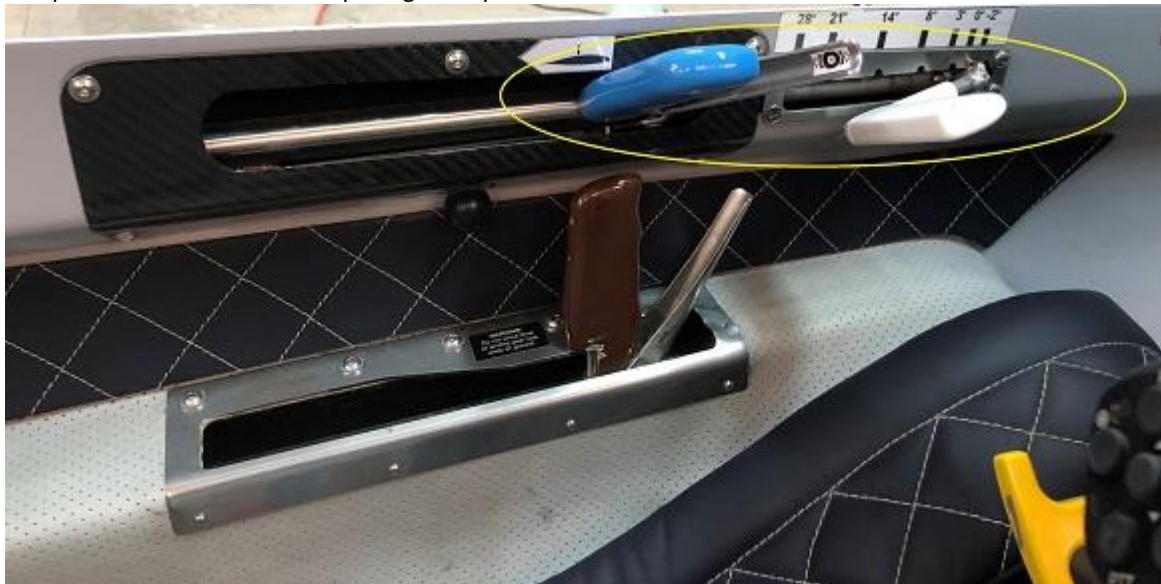
The pilot was conducting a local soaring flight and had made two climbs to over 7,000ft AGL. After about 40 minutes of soaring the glider had descended to around 2,000ft AGL where the pilot found conditions to be gusty and weak (the tow pilot reported that the thermals were very rough and gusty, even close to the ground, with strong lift and sink). A few attempts to work the weak thermals were made but the glider continued to descend. At about 1500ft AGL and 5kms from the aerodrome, the pilot decided to break off the flight and headed back to the circuit. The pilot configured the aircraft for landing by lowering the undercarriage, and then joined the base leg at about 350ft AGL. Upon turning final at a similar height, the pilot selected +28 degrees of flap. The pilot stated *"(I) then proceeded to activate the airbrake, and noticed the plane wasn't coming down and started to stress about the overshoot developing... so I slowed the glider and dawdled down to a hard landing."* A number of witnesses observed the aircraft on final approach and noted that the airbrakes were not deployed, and the glider was wallowing as if flying slowly. Then, when at a height of around 50ft AGL the glider was observed to stall and pitch down. The pilot recovered level flight just as the glider struck the ground. The undercarriage collapsed and the glider skidded to a halt. Upon investigation the pilot advised that he was having trouble losing altitude during the final approach and so decided to slow the aircraft down in order to prevent an overshoot. The pilot acknowledged the need to maintain safe speed near the ground but said that he panicked when the aircraft would not descend. While the pilot believed he was using the airbrakes for approach control, witness reports indicted otherwise. A review of the cockpit layout revealed the flap and airbrake levers are in close proximity (see photograph), and pilot believes he had been pulling on flap lever instead of the airbrake lever.

The pilot learned to fly late in his life and had been flying for just over two years. In that time, he had accumulated 285 hours over 152 flights, of which 35 hours and 18 flights were on type. The pilot underwent further remedial training with his instructors. Accidents involving inadvertent and/or incorrect control input at critical stages have been contributing factors in many gliding accidents. In many cases, this has been brought about by pilot unfamiliarity with aircraft type during high workload flight situations. Airbrake and flap levers are generally located on the left side cockpit wall. There have been many instances of pilots misidentifying these in high workload situations, such as when landing. The most common fault being that pilots think they are deploying airbrakes when in fact they are using the flap lever. Although not entirely a problem to familiarity with glider type, it can happen much more readily if the pilot is not familiar with the glider they are flying. Pilots should take time to familiarise themselves with their cockpit layout and get used

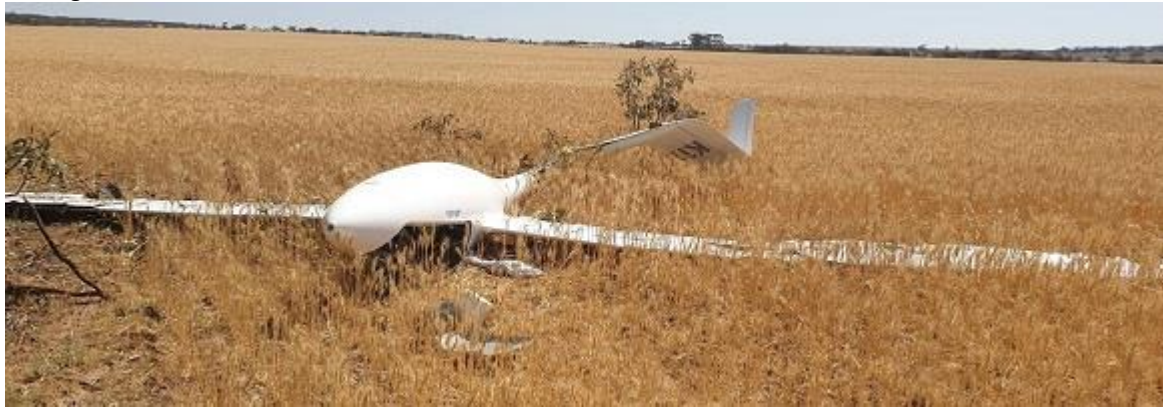
Figure 1: Glider's final Resting Position

At approximately 1350 hours on 15 November 2019 a LAK 17A single-place glider launched behind a Piper Pawnee tow plane from the Cunderdin airfield in Western Australia as part of a local gliding competition. Following release from the tug aircraft at 1960 ft AGL, the pilot experienced difficulty in controlling the aircraft. During the control difficulty, the pilot heard a “bang” and the aircraft rotated violently to the right. The pilot was unable to control the rotation of the aircraft and jettisoned the canopy at 1420 ft AGL and was thrown from the aircraft. The aircraft subsequently impacted the ground and was destroyed (See Figure 1). The pilot managed to open his parachute just prior to impacting the ground. The parachute was a Mars ATL 88190. It had been repacked on 5 December 2018 by a registered packer. It had a minimum deployment height of 100m or 328 feet. The Australian Transport Safety Bureau (ATSB) was notified of the accident but declined to investigate. The Gliding Federation of Australia (GFA) Regional Technical Officer, Deputy Chair Airworthiness Department and the Competition Safety Officer arranged the investigation and clean up. The West Australian police attended the scene during the pilot rescue but declined to take further part in the investigation.

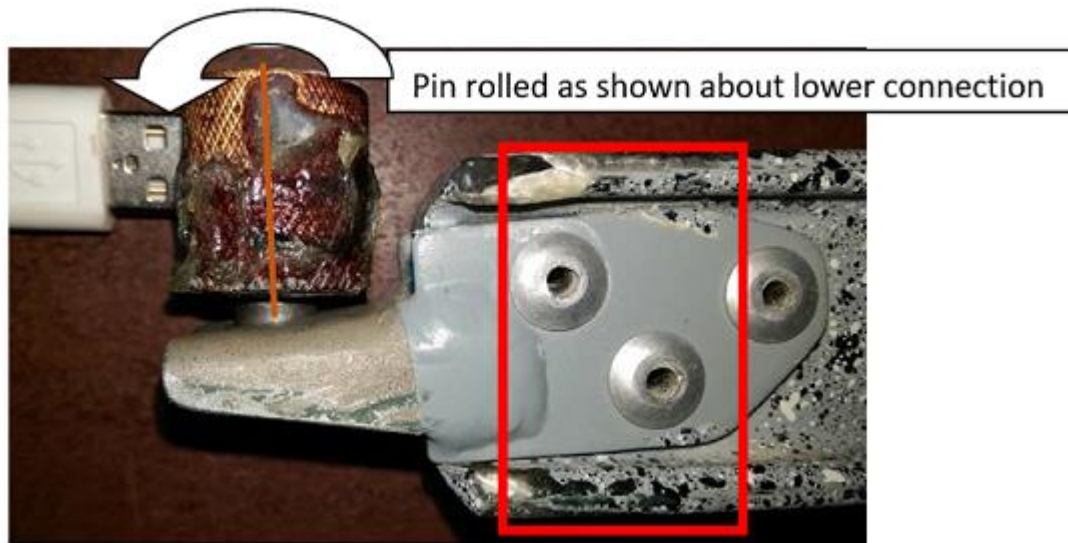
Figure 15: Retaining Pin and spar stub fitting.

The starboard wing extension retaining pin was examined and no similar areas of debond were found except for a small area of dark brown resin debonding from the brass. The above examination of the wing extension retaining pin suggests that the pin assembly had debonded prior to the accident flight and was not properly locking the wing extension in place at take-off. During normal assembly and disassembly, the wing extension slips in and out easily. To install the wing extensions, the retaining pin must be pulled up, the extension inserted into the main wing and then the pin locks flush with the wing. Electrical tape is used to cover the hole in the wing where the retaining pin is inserted. Inspection of the retaining pin hole in the wing upper surface post impact showed the electrical tape was in place. The gap between the main wing and wing extension is sealed using electrical tape. It is possible that the electrical tape kept the wing extension in place for several flights with the debonded retention pin. The retaining pin engages in a hole in a metal fitting riveted to the end of the wing extension spar stub. The metal fitting on the port wing extension spar stub had three points of damage see as shown in Figure 14. This damage is consistent with the retaining pin rotating as the spar stub moves outboard. The pin damaged the outboard edge of the hole and at the top edge of the fitting. The edge of the pin assembly also has marks on it where contact occurred showing the pin to be correctly orientated in reference to the spar stub.

The spar stub slides into the wing socket and is firmly engaged by the locking pin. Figure 15 shows the locking pin engaged with the spar stub fitting in the actual orientation. The retaining pin takes no load except to prevent the wing extension moving outwards. The spar stub fitting angles downwards and is firmly connected to the spar stub. The fitting has not moved since manufacture as evidenced by nil disturbance of the paint around the rivets. The downward angle of the fitting would prevent the pin from fully engaging in the hole, resulting in additional load being applied to the pin

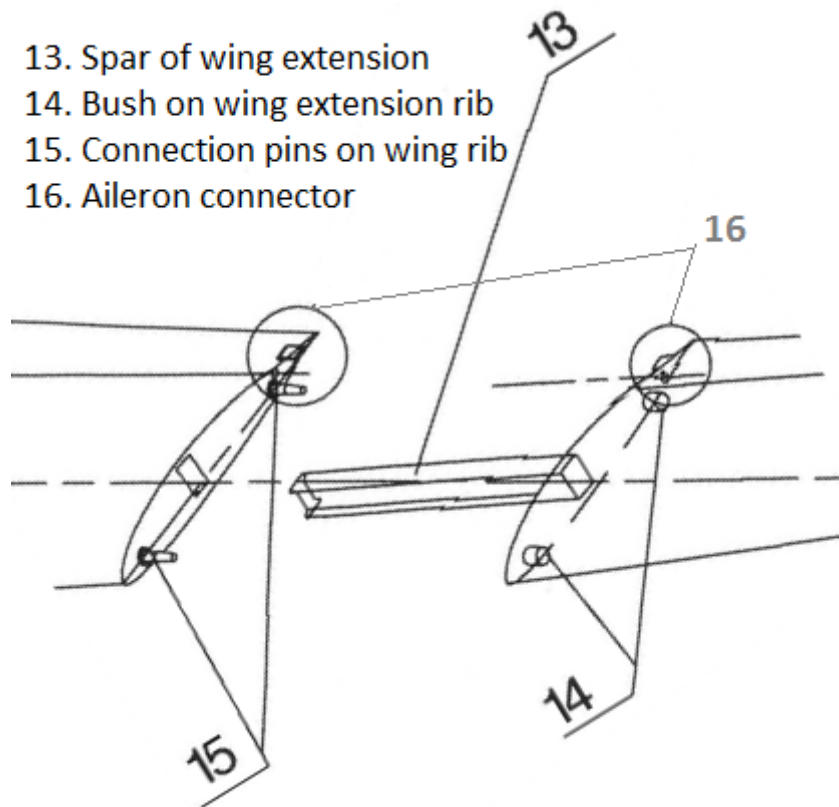
Figure 17 Diagram of Wing Extension Installation (LAK-17 maintenance manual).

It is most likely the failure of the retaining pin mechanism enabled the wing extension to move outwards by a few millimetres, thereby resulting in the wing extension only engaging the shear pins on the taper (Items 15 in Figure 17). The increased tolerance between the pin and fitting would allow the wing extension to rotate nose-up by approximately 1 degree.

It is suspected that the port wing extension oscillated and continued to work itself further outboard, finally disengaging from the rear shear pin. This allowed the wing extension to suddenly rotate up to 7 degrees nose-up in pitch (which could be the “bang” heard by the pilot). Notwithstanding, the wing extension stub spar would have kept the wing extension roughly aligned with the wing. A 7 degree rise in angle of attack at the tip would increase the lift and drag at the outboard extremity of the port wing, causing the aircraft to violently roll to the right and a yaw to the left. The pilot, who would have been looking straight ahead and unaware the wing tip extension was causing an asymmetric aerodynamic effect, interpreted the roll as a spin. Effectively the aircraft was in a strong roll with adverse side slip and uncontrollable. The metal tab on the port wing extension aileron (Item 16 of Figure 17) became disconnected from the main wing aileron as the port wing extension moved outwards. This allowed the port wing extension’s 1-metre span aileron to float in the airflow whilst the main wing aileron would move with control inputs. This resulted in damage to the main wing aileron, as evidenced by witness marks on the underside of the main aileron, caused by the impact of the wing extension aileron connecting tab as the wing extension swung fore and aft in flight. This damage was not noticed prior to the flight (the ground impact sequence could not result in this type of damage).
