The Gliding Federation of Australia Inc

Occurrence Summaries

01/01/2020 to 31/12/2020

The Gliding Federation of Australia Inc
SOAR Accident and Incident Occurrences

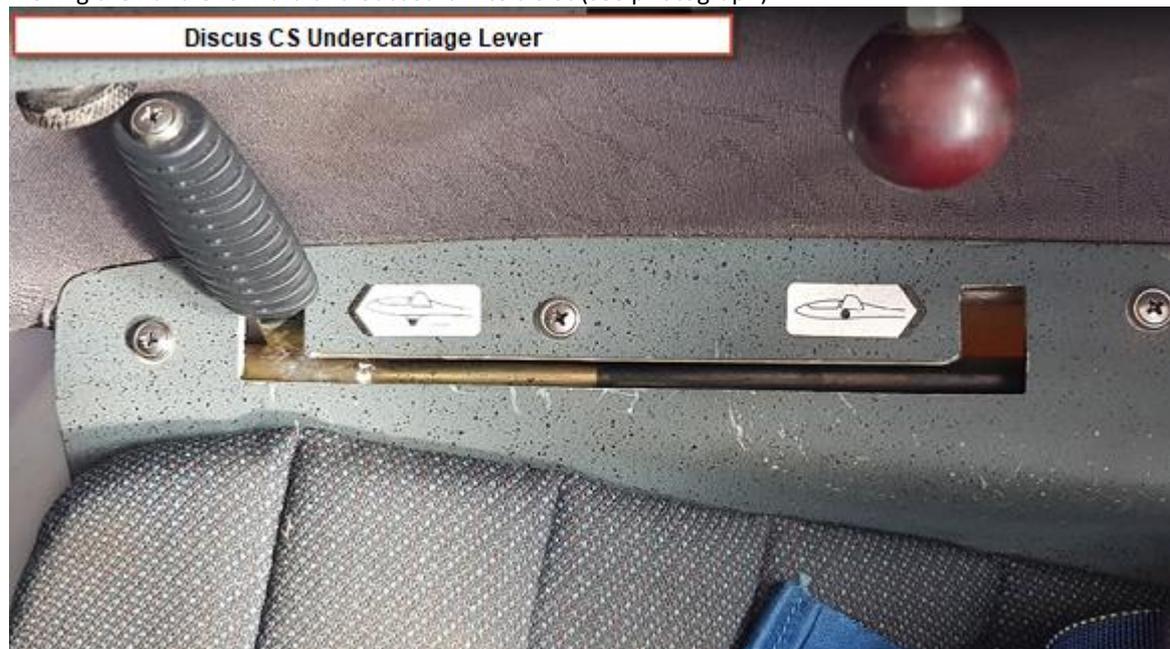
The pilot reported they completed the pre-landing check list and lowered the undercarriage. In so doing, the pilot failed to completely engage the locking mechanism. On touchdown after a short ground roll, the undercarriage collapsed tearing both the landing gear fairings from the aircraft.

The undercarriage retracted on landing most likely due to the undercarriage lever not being correctly positioned into the slot to lock the wheel in the down position. The undercarriage doors were torn off and an area on the underside of the glider forward of the main wheel suffered abrasions and loss of paint from sliding across the grass runway. The Discus CS undercarriage lever is normally held in the down position by moving the handle forward and outboard into a slot (see photograph).

There is no detent or locking device to stop the handle moving inboard but friction and directional forces would normally retain the handle in the locked position. If the handle is not fully pushed outboard, it is

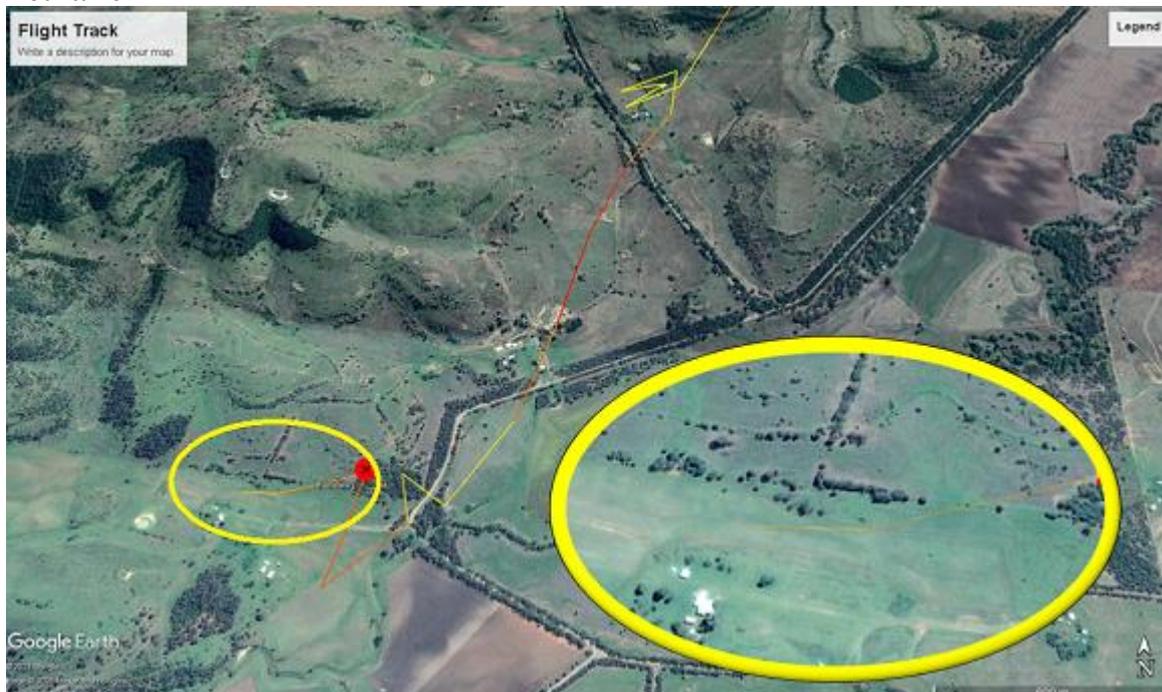
The pilot worked a weak thermal to no avail and turned back towards landable paddocks in the valley. For the next 10kms the pilot attempted to work a few thermals but was unsuccessful and kept pushing on. The decision to land was made at around 500ft AGL and the pilot made a straight-in approach to a ploughed paddock. The pilot reported that the starboard wingtip contacted the upwardly sloping ground during the flare and while the aircraft was still airborne. The pilot closed the airbrakes and applied opposite rudder and aileron inputs, but the glider yawed through 45 degrees to the right before touching down on the mainwheel and tailskid. The glider came to an abrupt stop in the soft soil. Upon exiting the cockpit, the pilot observed the tailskid had detached and there was a crack in the starboard wing/fuselage trailing edge fairing. The pilot's CFI noted the pilot made his decision to break off the flight too late and with only just enough height to land in a marginal paddock, despite flying over better paddocks earlier. The pilot was counselled on conducting safer outlandings and what to expect when flying in the leeward side of hills and mountains.

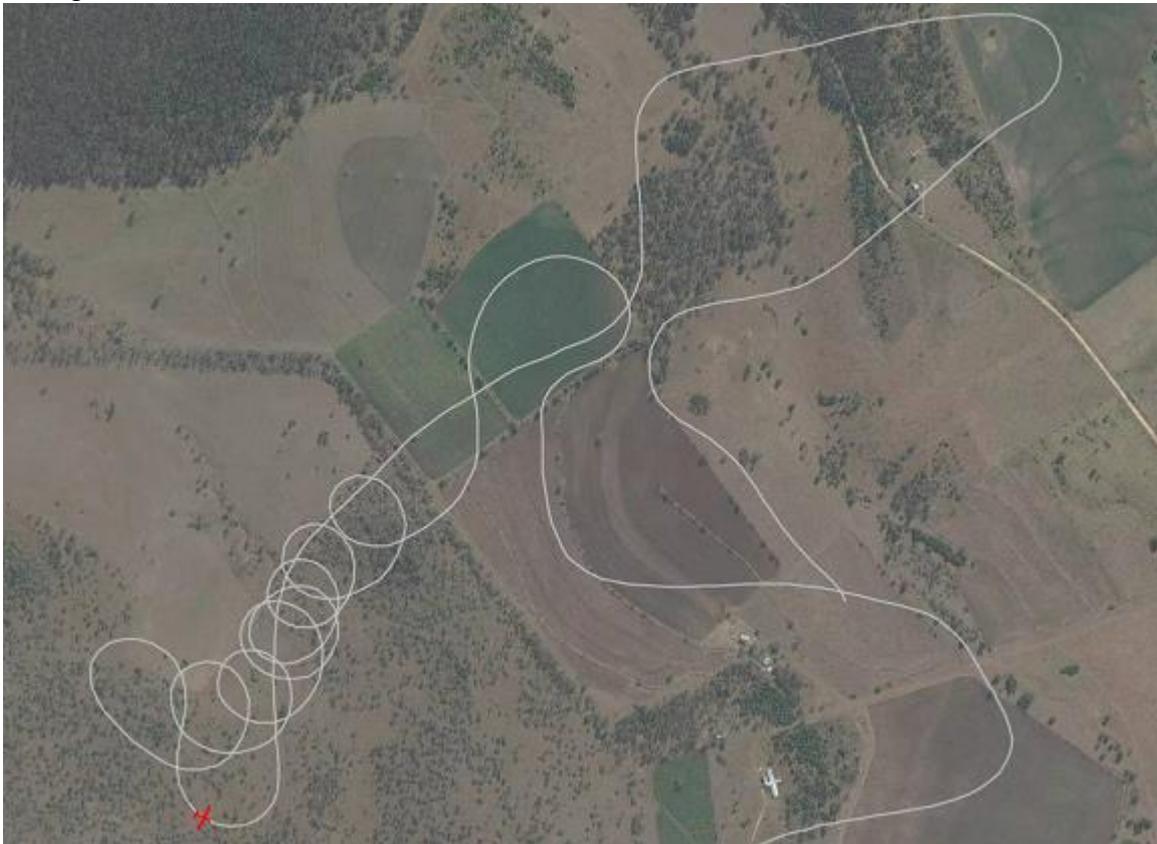
Graphic 1 – Flight Trace

The pilot was competing in a Grand Prix event organised by the local club. On the final leg of the task and about 45kms from home, the pilot found himself below final glide and struggling to find lift. The pilot flew into an area of landable terrain with which he was familiar and arrived at about 1300ft AGL. The pilot identified a suitable outlanding paddock running north-south next to a farmhouse, and then used the available height to search for lift while remaining within reach of the identified paddock. The pilot spent the next 5 minutes maintaining or slowly losing height in weak lift to the West (downwind) of the paddock before breaking-off the flight for landing. The pilot descended upwind of the paddock and joined circuit on a left-hand base leg at about 500ft AGL (refer graphic 1). The pilot joined final at about 400ft AGL and set an aiming point about one-third the way into the paddock, where the plough furrows were better aligned for landing.

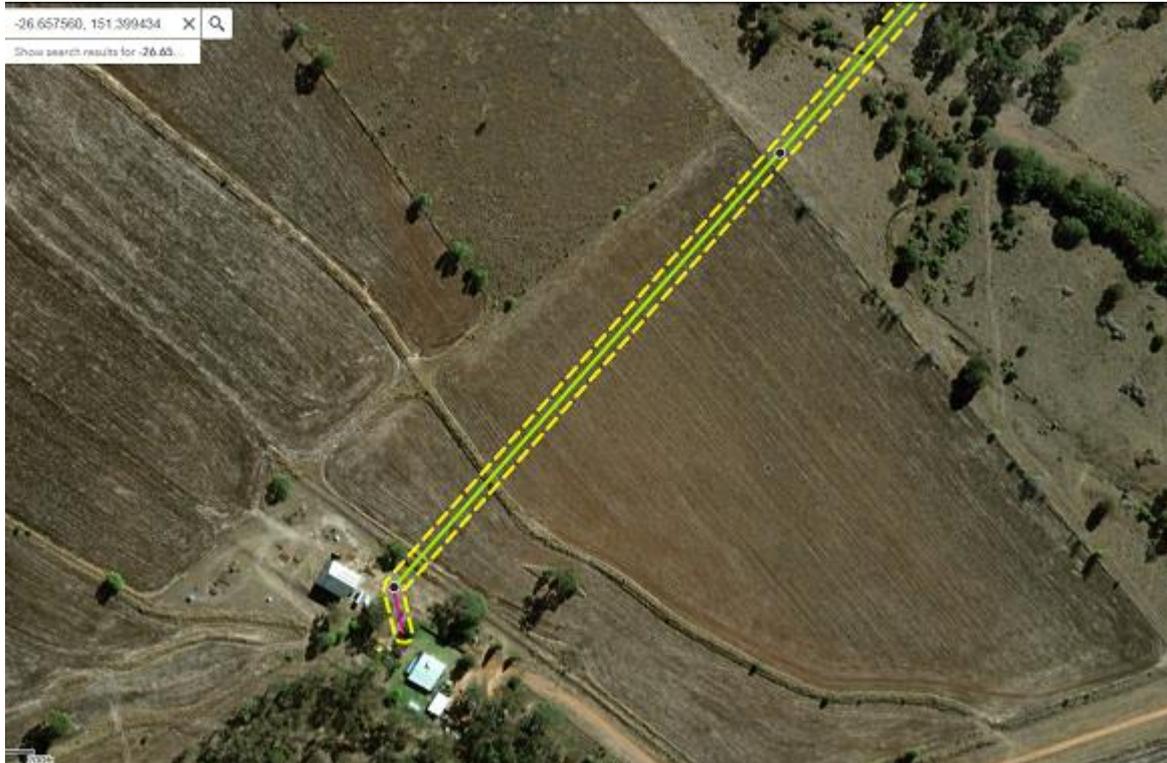
As the glider crossed the boundary fence, and at a height of about 30ft AGL, the pilot noticed a wire pass over the canopy. The starboard wing then struck the wire, identified as a 'Single Wire Earth Return' powerline, that was strung between two poles about 40 metres inside and parallel to the paddock fence line (refer graphic 2 and photograph 1). Witness marks identify the wire struck the starboard wing about mid-span and slid down the leading edge until it cleared the wingtip. The impact caused the glider to yaw severely to the right and skid partially sideways onto the ground. Upon touchdown, the aircraft skidded sideways in the paddock and came to rest approximately 70 degrees to the right of its flight path. The pilot reported: "As to why it (the powerline) caught one wing, I can't say with certainty. I was toward the left-hand side of the paddock, as I'd assessed that had a better landing surface; the paddock was ploughed in a race-track pattern and that side seemed to have smoother furrows in the correct direction, which would mean that the bow of the wire would be higher to my left and lower to my right. But I may have had some small angle of bank on making a last second correction." The glider was subsequently inspected for structural

damage at an Approved Maintenance Organization and found to have only minor abrasions to the starboard wing leading edge and a cracked winglet.

Graphic 2 – position of powerline (image from the lookupandlive.com.au website).

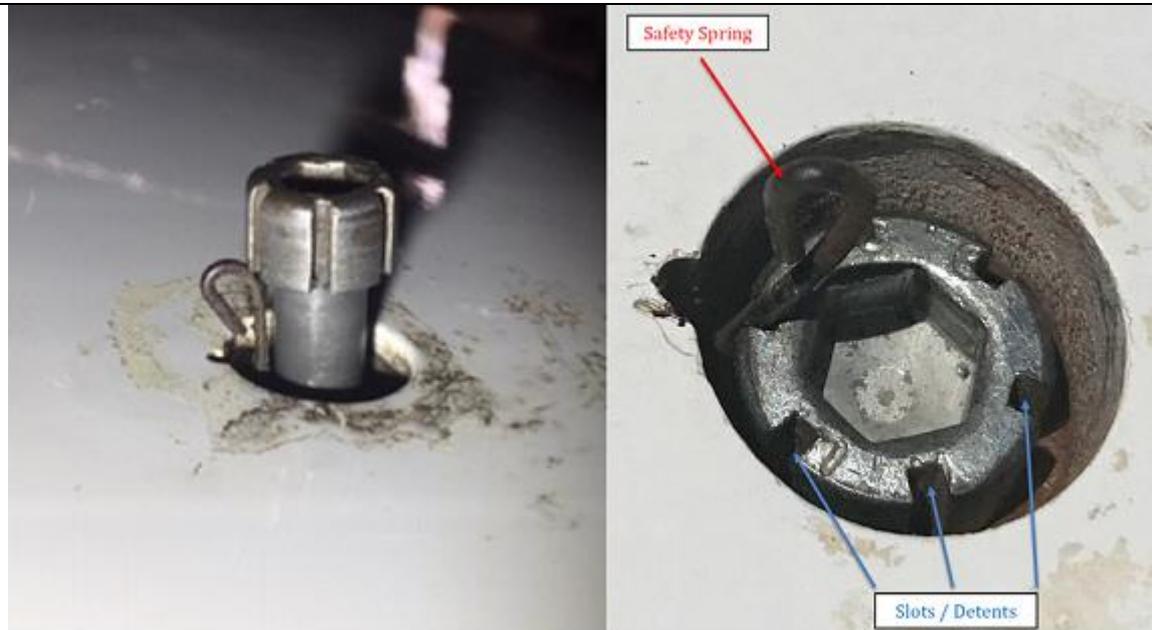
The aircraft was subsequently inspected by a GFA authorised inspector, who identified that the tailplane securing bolt had approximately 3 to 3 1/2 turns remaining to become fully secured. It is believed the tailplane was held in place by the gap sealing tape until the adhesive became soft and allowed the elevator to move in the airflow. Inspection of the threaded retaining plate epoxied into the top of the fin showed an accumulation of grit and perhaps some fine metal filings in the old grease. This contamination may have retarded proper tightening of the bolt when using the Allen key rigging tool that has only a short lever arm to stop overtightening. The bolt head was found to be worn around the slots where the retaining spring clip engages to stop it rotating but was otherwise in good condition (refer Pic 2).

2 – Securing bolt detail.

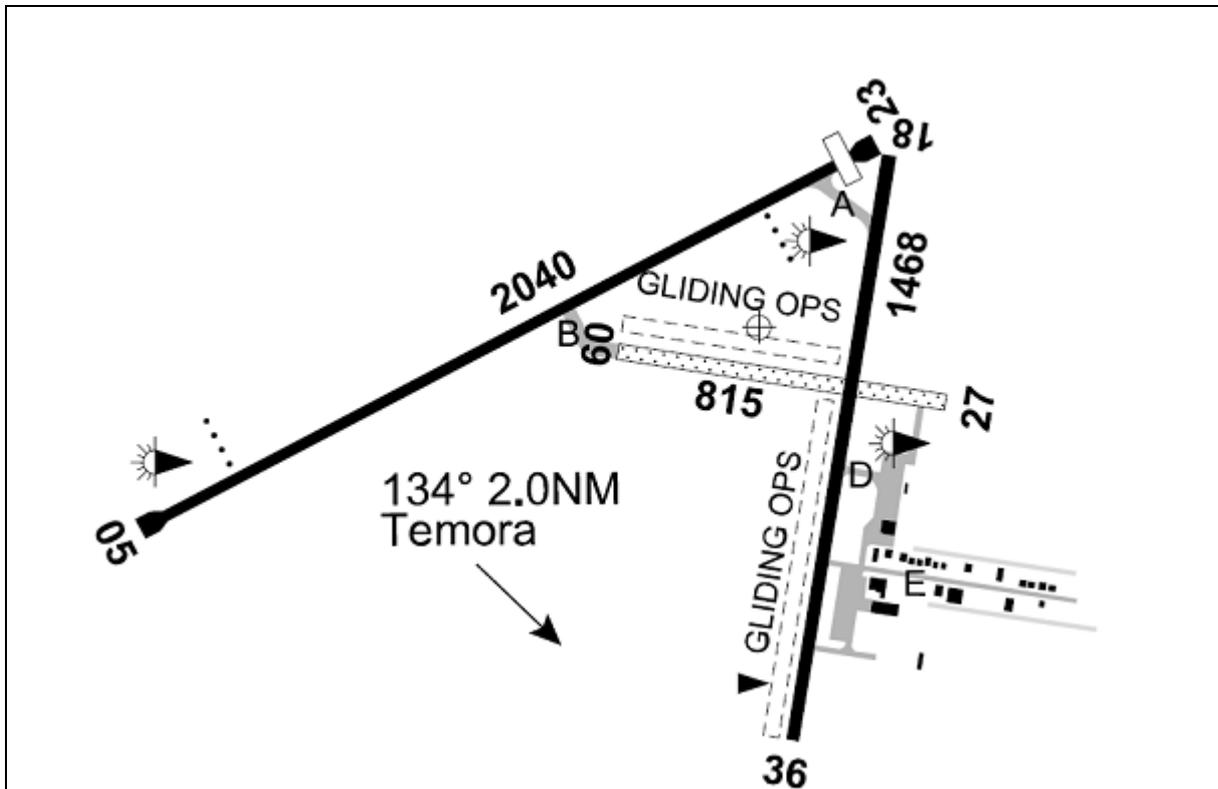
Recent wet Spring weather caused rapid growth of vegetation on the glider runway, which had only been mowed 2 weeks prior to this event. Then pilot reported experiencing lift during the downwind leg and that he turned onto final approach too high. The pilot deployed full (90 degrees) flaps during the approach but after rounding out he lost count of the flap wheel revolutions and rolled out with positive flap. As speed reduced, aileron authority was lost, and the left wing contacted tall weed that initiated a partial ground loop. The pilot commented he had been caught out approaching low from the north-north-west and hadn't considered other runway options because he didn't want to "upset the locals". His final use of the glider RWY 18 in preference to the main RWY 18 (sealed surface from which he departed) was made because he was too cramped in the circuit to line-up with the sealed surface. The pilot had not considered the length of the grass/weeds on the glider runway despite being involved in a runway change earlier in the day for this very reason. Other options were a right-hand turn from the inbound leg onto RWY 23, or a straight-in approach from right side of RWY 18. The CFI noted that the pilot has been disorientated previously with available runways and perceives an airfield etiquette focussed on gliders using only certain runways.

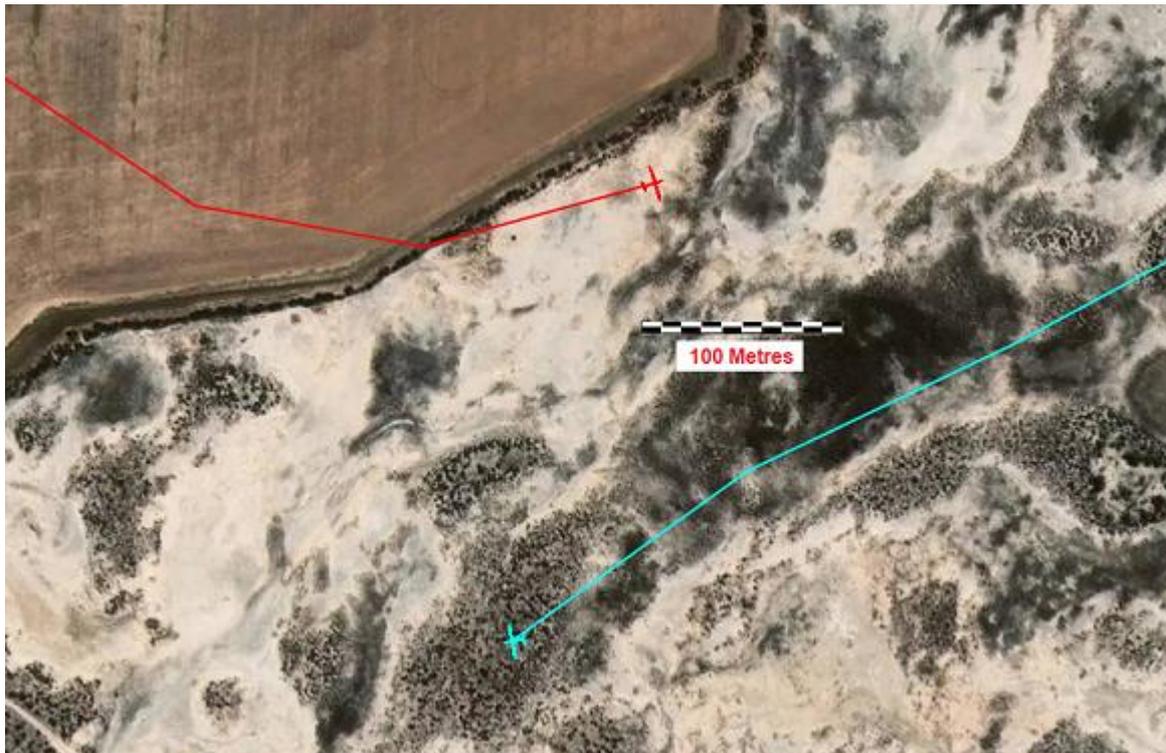
radio call to alert the pilots of the (two-seat glider), requesting them to confirm the tug had been sighted. I received no response to my call and the glider did not alter course.” The tow pilot turned away to the left by 60 degrees to provide clearance, at which point the pilot flying the two-seat glider made a 30-degree heading change, also to the left. It is estimated that the tow plane passed within 50 metres of the two-seat glider at the same height (Refer Fig. 1). The Crew of the two-seat glider later advised they had heard the radio call from the tow pilot but thought the message was from their tow pilot, whose tug they had released from some three minutes earlier. They stated that they did not sight the towing combination until the tug commenced its turn to the left.

Fig. 1. Flight paths of glider under tow (Red) and two-seat glider (Cyan). The tow plane is the length of the tow rope (55 metres) ahead of the glider under tow. The tug and two-seat glider were at the same height and came within 50 meters laterally of each other.

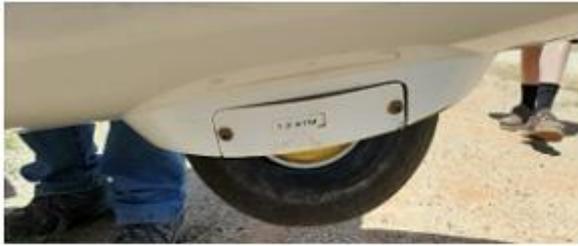
Photo 1 - Displacement of the removable tyre valve cover.

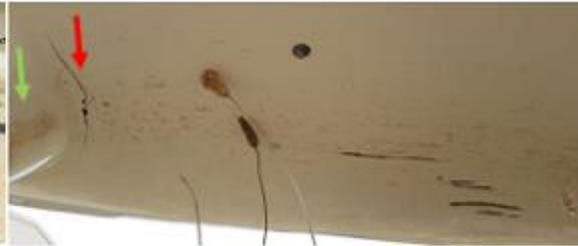
Photo 2 - Split behind the nosewheel fairing (red arrow) and scuff marks where the fairing hit the ground (green arrow).

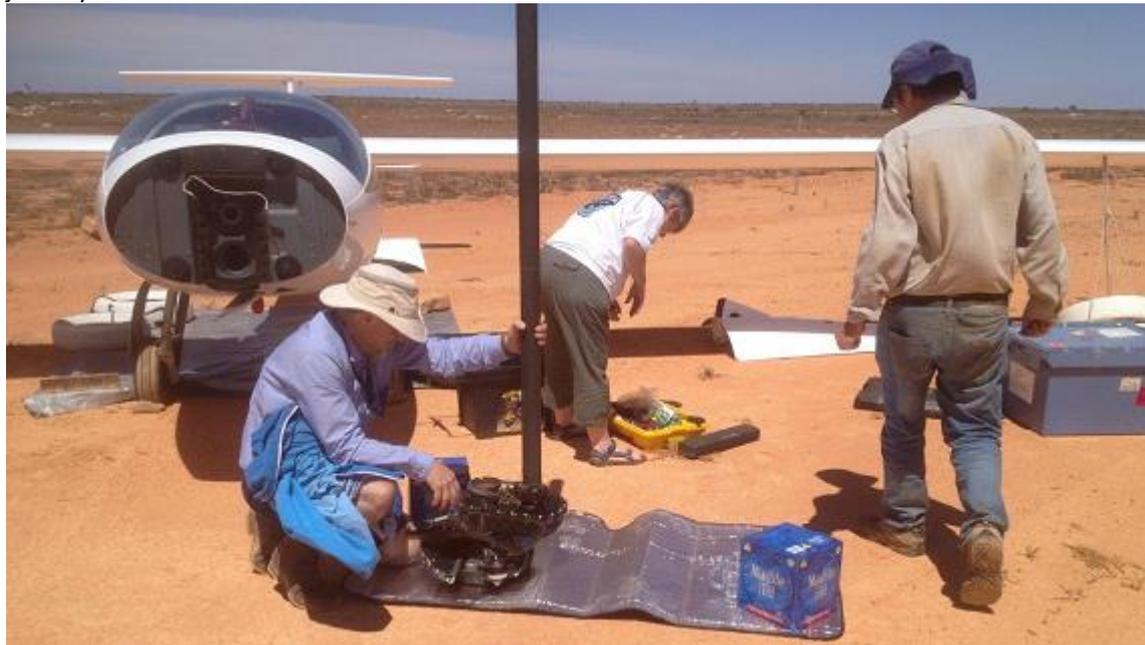
The glider was being ferried from South Australia to West Australia by its new owner and another pilot experienced on type. During the cruise the flight crew reported the engine was running slightly rough with some power loss, but that the vibration was more of an unusual feel. They attributed the rough-running to a fuel-related problem (running on AVGAS rather than MOGAS) and were not overly concerned. However, the vibration from the rough-running engine was sufficient to cause the pitot probe on the cowling forward of the propeller to dislodge and strike the propeller. The propeller suffered catastrophic failure, and the flight crew elected to land at a nearby aerodrome. As the command pilot stated: *“Extremely luckily, we were over Loongana as there are hundreds of kilometres of large rocks, and a safe outlanding would have been unlikely. Unfortunately, it was too early for thermals and there was a 30kn wind”*. Investigation identified that broken and kinked air pressure balance tubes on the Rotax 914 engine carburettors had led to the engine running rough – probably causing oscillations of the carburettor balance. The glider was repaired and continued its journey without further incident.

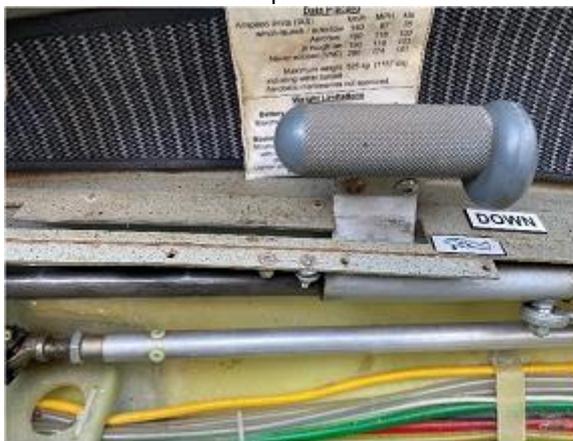
Before

Investigation revealed that this incident occurred despite the undercarriage overcentre mechanism being within specification, and the replacement 14 months earlier of the 3 Large rubber torsion elements and 2 fork rubber bearing blocks. Uncommanded retraction of LS type glider undercarriages is not uncommon and usually occur when the glider travels over rough ground or experiences a sudden jolt as in the case of this incident. It is likely the sudden jolt caused the mechanism to loosen and allow the undercarriage lever to dislodge. The aircraft owner fabricated a locking mechanism to prevent the undercarriage lever coming out of the detent and subsequent trials have shown it to be effective and safe (refer photos).

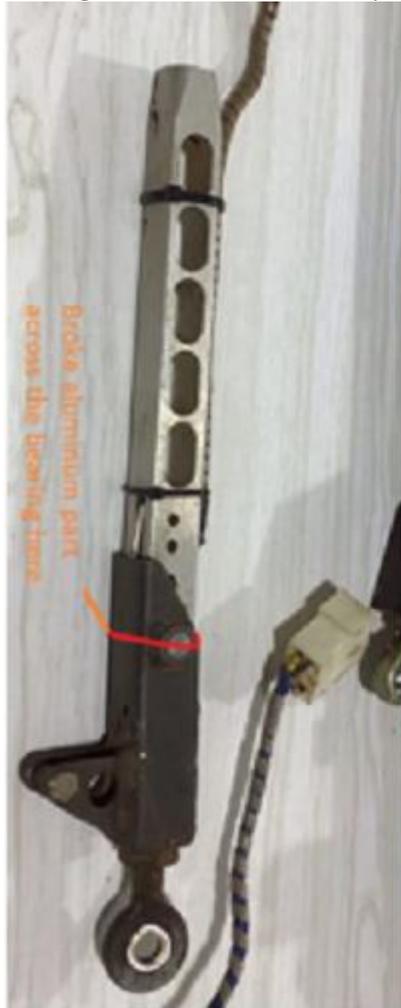
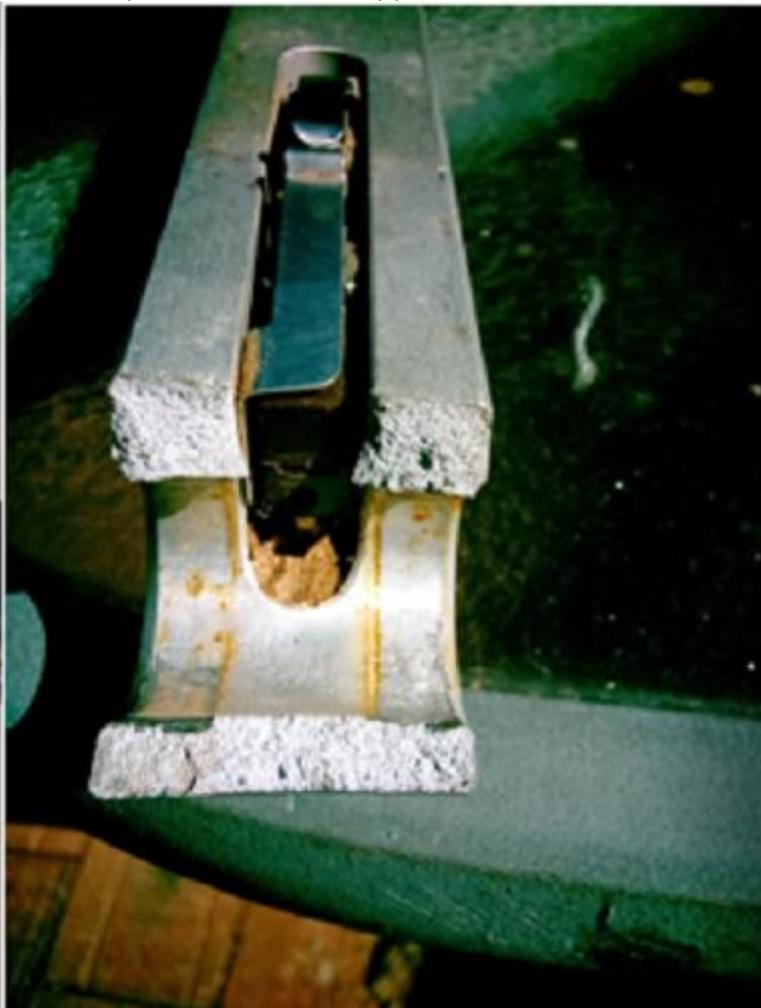
Upon exiting the aircraft, the pilot observed the right-hand undercarriage strut had snapped where it connects to the airframe, resulting in wheel collapsing and causing minor damage to the undercarriage extension mechanism. The wing was found to be undamaged. Investigation found the aluminium undercarriage overcentre linkage had fractured and the extension leg was bent. Examination of the linkage revealed stress corrosion cracking, i.e. the growth of crack formation in a corrosive environment that can lead to unexpected and sudden failure of normally ductile metal alloys subjected to a tensile stress. The damage was indicative of a hard crosswind landing some time previously. The damaged parts were replaced with borrowed parts and checked as operational. Later investigation of both trailing arms showed signs of bending and small cracks, and they were both replaced with new factory parts.

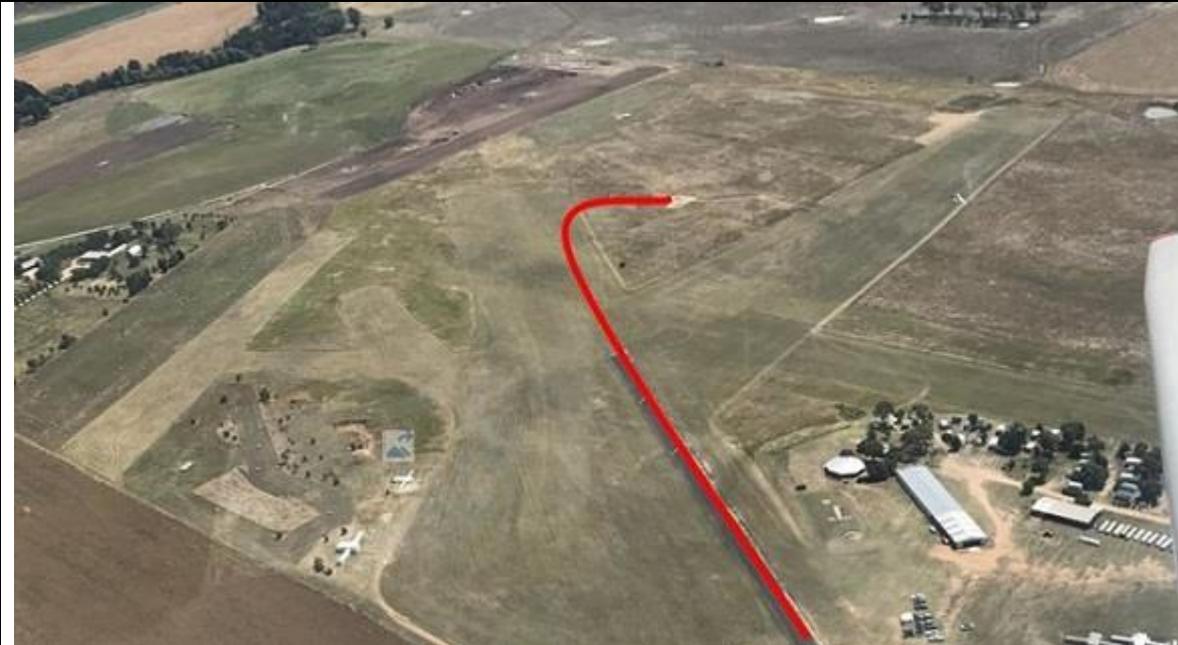
Several people witnessed the accident and reported the aircraft climbed slowly to a height of about 120ft and then stopped climbing. They observed the glider turning to the right with a steep angle of bank and saw the right wing of the glider hit the ground. The pilot advised that even though the engine was providing full power, the glider was not climbing so he elected to turn back to the airfield to land on RWY 08. Realising that the glider was sinking and would not reach the alternative runway, the pilot shut down the engine shortly before the right wing contacted the ground. Investigation identified that the glider most likely stalled during the turn around the into-turn wing due to low airspeed and the high angle of bank (stall speed increases with load factor, which in turn increases with bank angle). The right wing contacted the ground and pulled the fuselage into the ground nose first. The glider slid for about 3 meters before the tail struck the ground, resulting in the fuselage breaking behind the engine bay and the starboard tailplane being broken in half. The CFI concluded that the likely reason the glider stopped climbing was due to it flying into an area of heavy sink, more than the glider's usual 400ft/m climb rate. Although the airbrakes were found to be unlocked at the crash site, it is likely this occurred when the cockpit structure was compromised.

Fig. 2 – Flight Path
