# Collision with terrain involving experimental ASH-25E glider VH-GOA

13 km west-north-west of Bathurst Airport, New South Wales, on 21 January 2018

**ATSB Transport Safety Report**  
Aviation Occurrence Investigation  
AO-2018-009  
Final – 17 December 2019

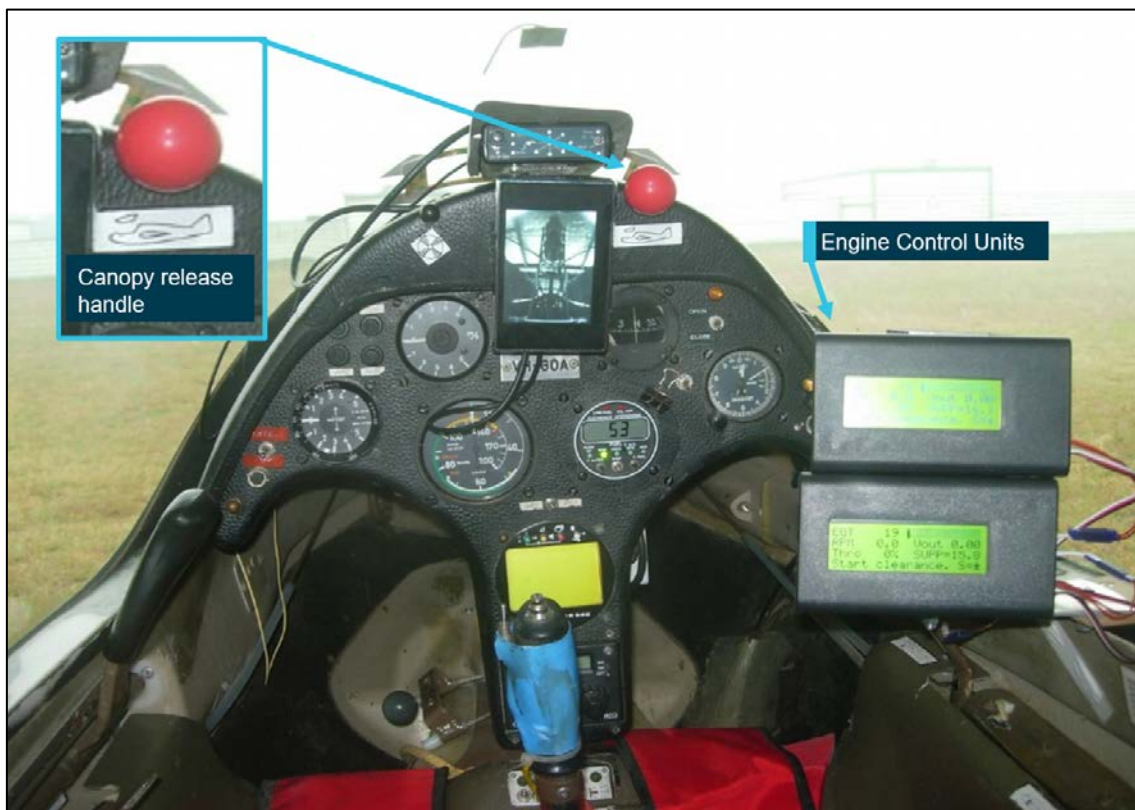
**Figure 5: View from front seat in GOA's cockpit**

A placarded canopy jettison release handle was positioned on the top right side of the instrument panel (Figure 5).

The Titan engines' fuelling and operating speed were controlled by the two electronic control units (ECUs), which also regulated performance, and were each powered by a lithium polymer battery. The ECU displays were fitted inside the cockpit (Figure 5). The engines' ignition system was designed in a manner to prevent start-up when the pylon was lowered. In the event of an emergency, the flight manual recommended lowering the pylon, which would cause the fuel flow to stop immediately.

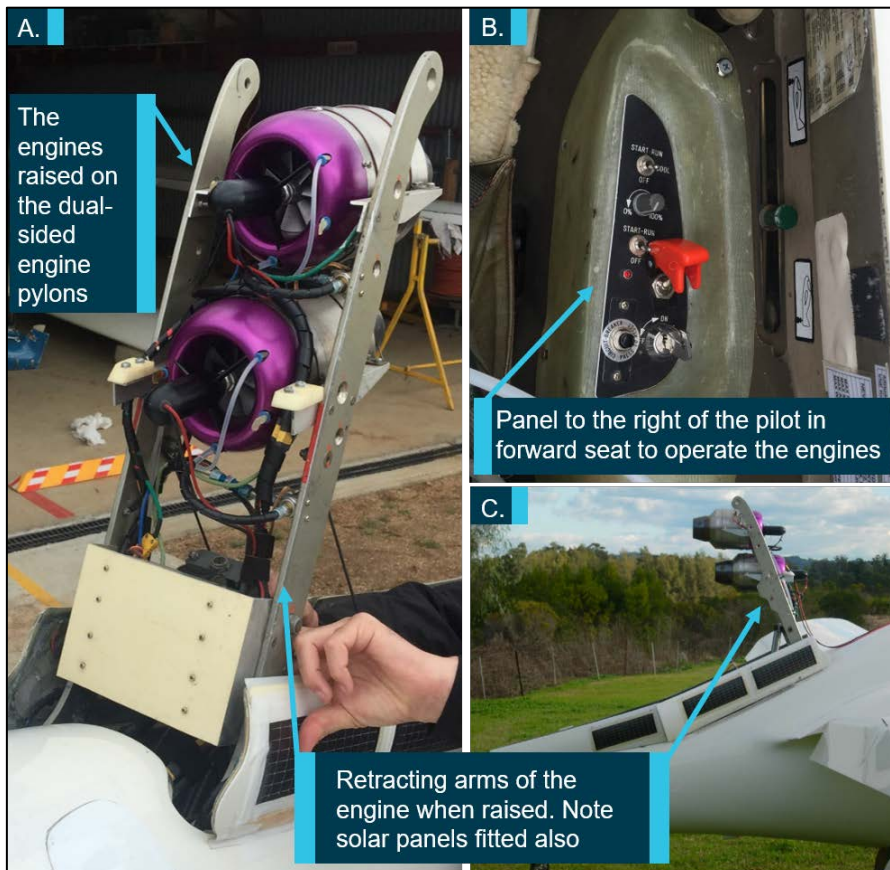
**Figure 6: Images of the engines fitted to GOA**

The two vertically-aligned Titan AMT Netherlands gas turbine engines were installed on the existing dual-sided pylon. The Titan was constructed from a single radial compressor and an axial flow turbine stage (Figure 6). Fuel attachments on the front cowl of the engine, with Teflon tubing and push-in Polytetrafluoroethylene (PFTE) fittings were used. The engines were housed in the engine bay when not in use, and were raised as part of the one-switch start sequence.

The ATSB considered how the recorded fuel leak from the lower engine may have occurred, and consulted with gliding experts and the manufacturer. They advised that there may have been a leak within the fuel lines, or at the connection point between the PFTE tubing and the engine cowling. It was the manufacturers' opinion that this can occur when the lines are roughly cut (for example using pliers).

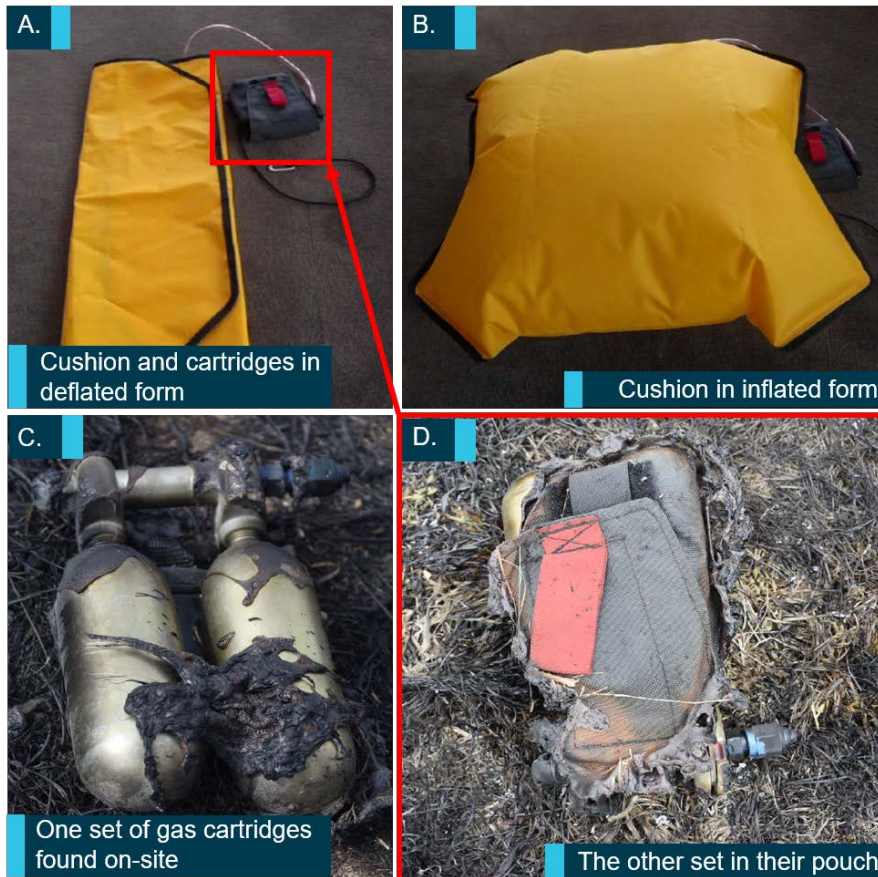
**Figure 9: The components of the egress assist cushion**

fed the gas through to an inflatable bag via a manifold and flexible hose (Figure 9). Using it required both hands – one to steady the pouch, and the other to manipulate a lanyard.

Due to the extent of fire damage, it could not be determined whether the pilot deployed the egress assistance cushion.

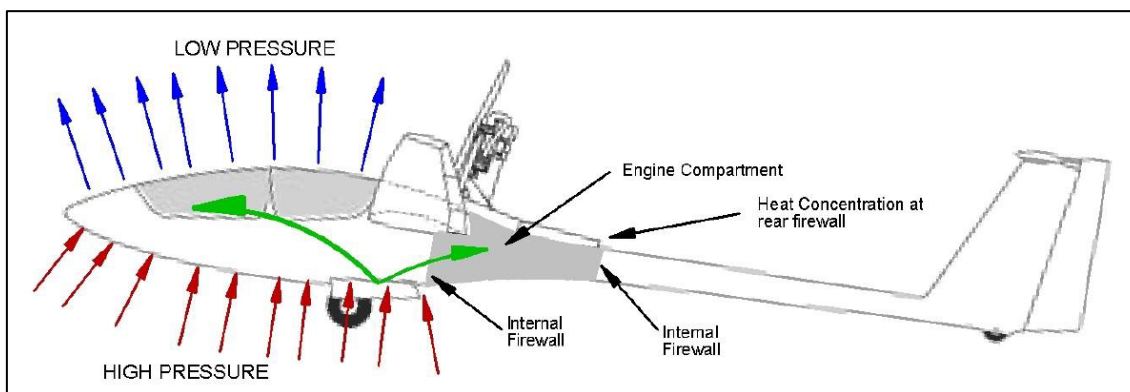
**Figure 13: ASH 25E diagram displaying pressure, airflow in and out of the airframe**

The AAN outlined the fire protection standards from EASA publication CS-22 (summarised in the *Context* section of this report), the engine installations of key concern (including the 'fully buried' engine such as GOAs), and the risks of defects in any fire retarding paint. Intumescent paint was suggested for use, which is 'a paint cover which, when heated, expands [to shelter] the material it is covering, from heat and combustion...' Glider pilots were also encouraged to consider the effects of airflow on fire propagation, and used a diagram of the ASH 25E (Figure 13). Lastly, the AAN covered pilot actions in the case of an engine fire, with the key advice being to shut off the fuel supply and contain the fire.

The AD provided pilots with inspection guidelines and procedures to meet a minimum standard for fire containment and retardant. Before 30 June 2019, all glider operators and inspectors needed to complete a Form 2 inspection, inspect the condition of fire retardant paint, determine the configuration of the firewall(s), and provide the Inspection Schedule to GFA. By 30 November 2019, all paint deficiencies were required to be rectified. All subsequent inspections then needed to include a paint inspection, and also an assurance that no flammable material is attached to the cockpit side of the firewall. If the glider cannot be fitted with a firewall, a 'strong case for non compliance' must be made to GFA.
