AIRWORTHINESS ADVICE NOTICE

TYPE AFFECTED: Jantar and Jantar Standard. All variants.

SUBJECT: Miscellaneous airworthiness information.

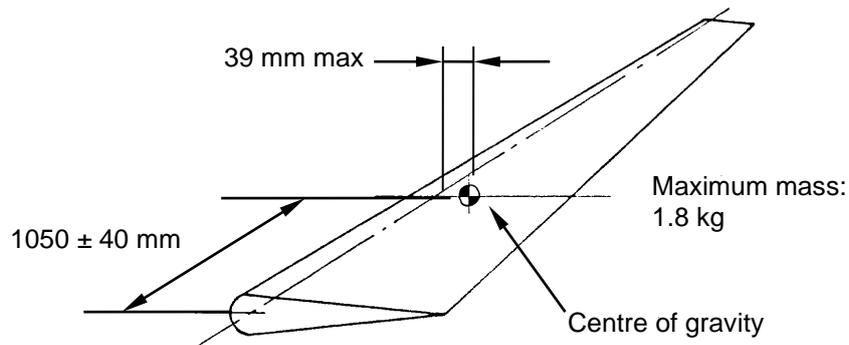
FIGURE 3. SZD-48-1 AILERON BALANCE

1. The allowable centre of gravity positions for the control surfaces of the SZD-42-2 Jantar 2B and the SZD-48-1 Jantar Standard 2 are not recorded in the Maintenance Manual. These figures were included in the Flutter Analysis report and are reproduced here to aid inspectors.
