AIRWORTHINESS DIRECTIVE GLIDERS

GFA AD/129 L.E.T. KUNOVICE 16

L-13 Blanik all serial numbers (Mandatory Bulletin No. L13/052 refers)

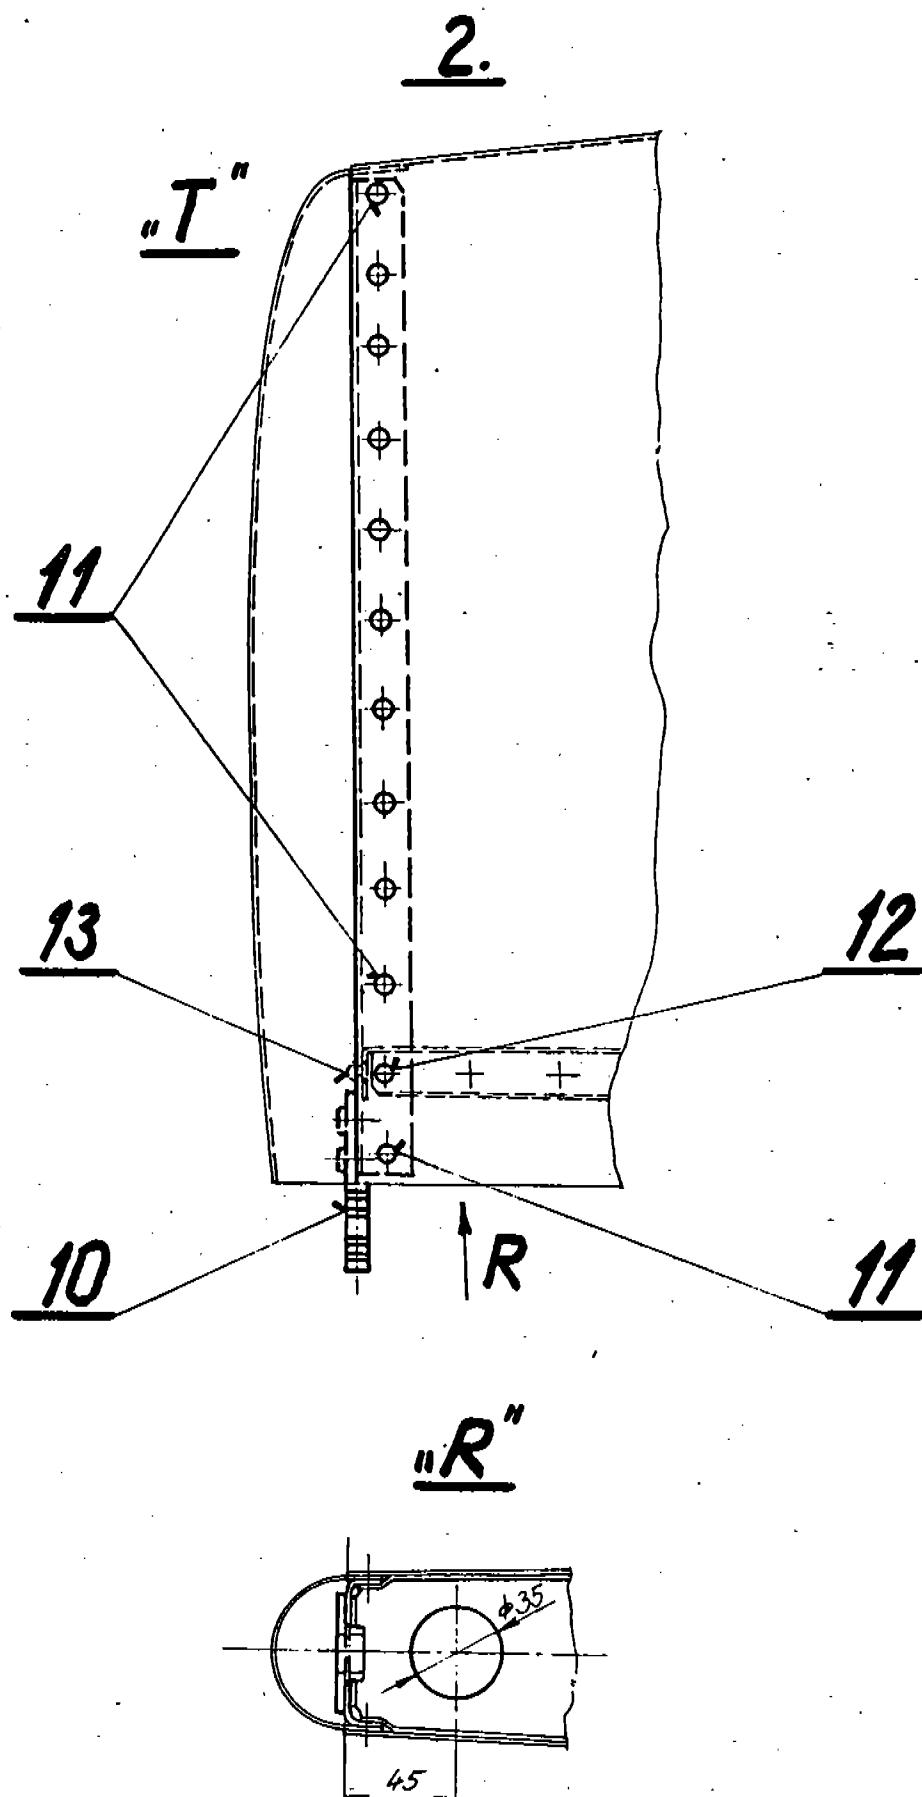
A number of L-13 Blaniks operated in U.S.A. have been reported to have developed cracks in the bend radii of tailplane end ribs at outer elevator hinge attachments. It is likely that this defect would occur in gliders subject to frequent trailering.

Caution: Should the cracks be longer than 10 mm a warning must be given in the maintenance release and aircraft logbook to replace the tailplane end rib during next overhaul or within 50 hours in service whichever comes first according to para. C of this Bulletin.

- 2) Carefully drill off original rivets pos. 3 and 5 using a 2.6 mm dia. drill and rivets pos. 4 and 6 using a 3 mm dia. drill. See Fig 1, view "P".
- 3) Drill holes at the ends of cracks using a 2 mm dia. drill and de-burr the holes carefully.
