CANCELLED
AIRWORTHINESS DIRECTIVE GLIDERS

REF. NO. GFA/AD/178 GENERAL 4.

GLIDER TYPES AFFECTED.

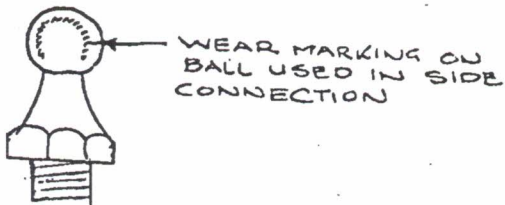
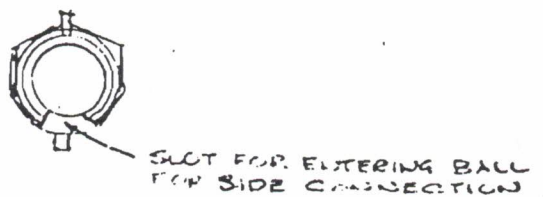
SKETCH 2.

The female part of the coupling of the second mentioned type has an open end and it is possible to use this type of coupling as an in line or as a side connection type, however when used as a side connection coupling the ball part of the coupling is subjected to more rapid wear due to the reduced bearing surface at the open end of the female part of the coupling. The resulting wear pattern can lead to the female part of the coupling obtaining a clamping grip on the ball part of the coupling and any rotary movement can lead to failure of the ball shank.

Tests have shown that approximately two degrees of twist between the ball and its shank can cause failure.

All gliders fitted with ball joint couplings with side connections are to be inspected before further flight, to ensure the correct type of female connection is fitted. If an open ended type female coupling is fitted it is to be replaced with a closed end type. If any discernable wear marking is evident on the mating ball component, the ball and female part of the coupling are both to be replaced before further flight.
