## AIRWORTHINESS DIRECTIVE

Mini-Nimbus B  
Mini-Nimbus C (up to Serial No. 110)  
Nimbus 2B  
Janus B

Elevator drive bracket - earlier type (Sketch 1 or 3)  
Later type (Sketch 2) is not affected.

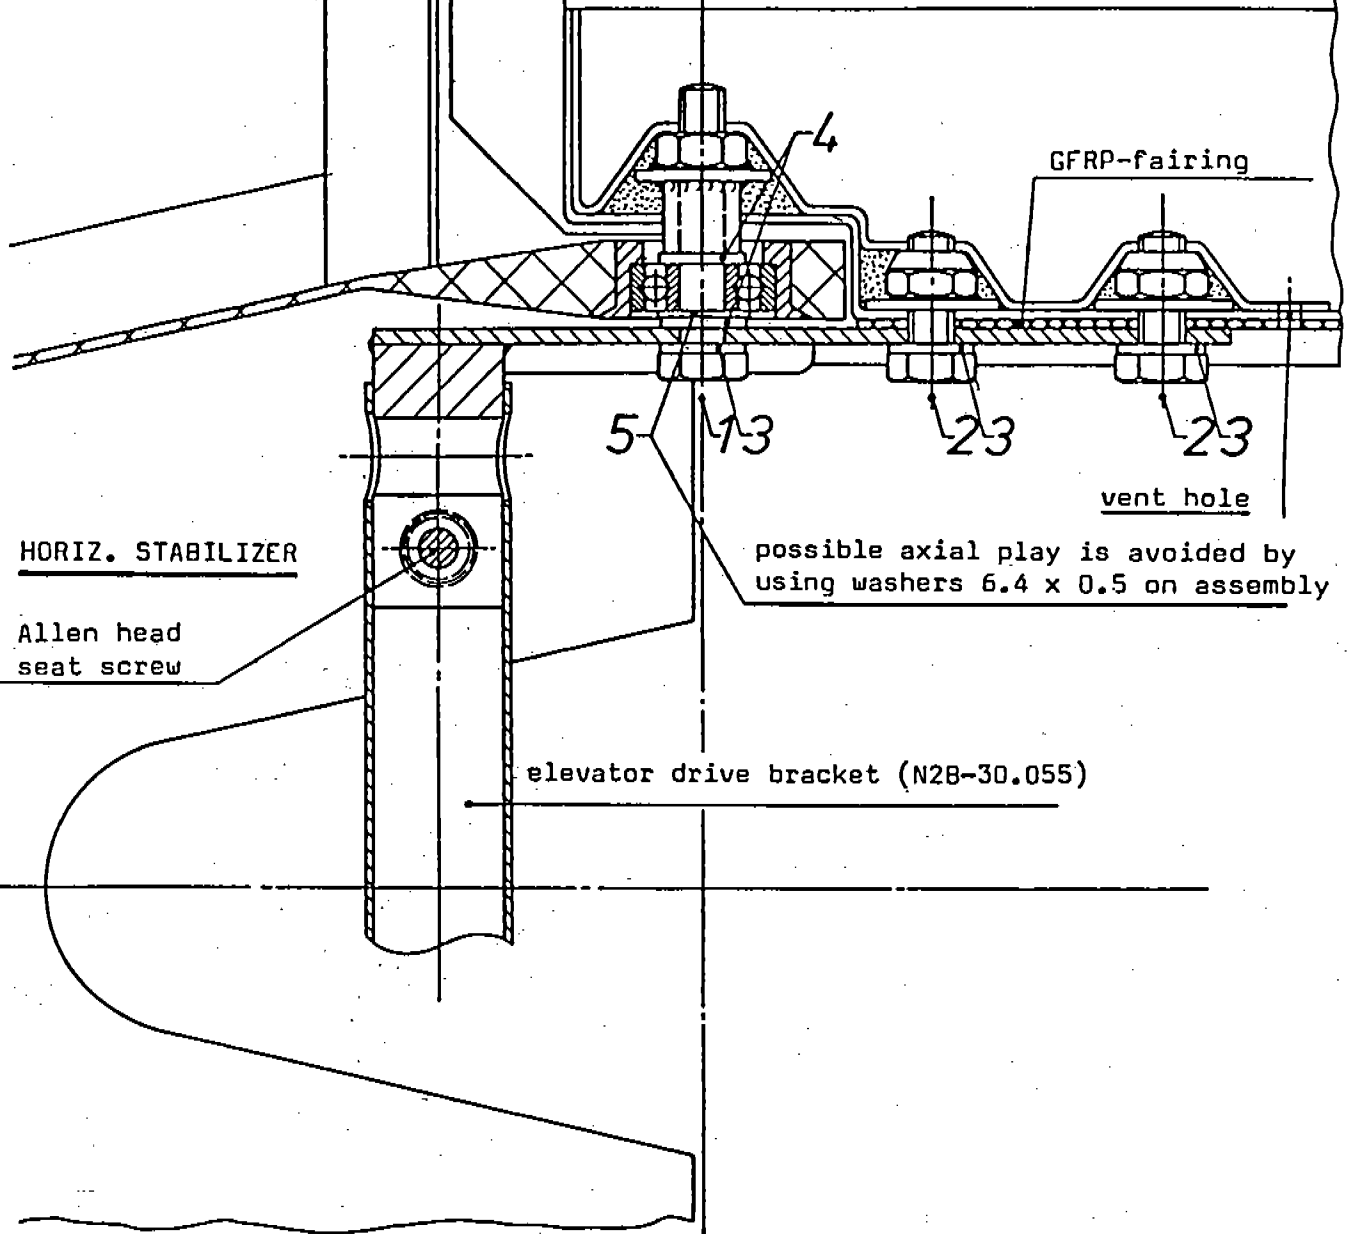
ELEVATOR

Difficulties in the control of the sailplane were encountered when an earlier type elevator drive bracket broke on one side in flight. The schempp-Hirth factory have issued Technical Notes TN 386-24, TN 295-19 and TN 328-8.

The earlier type elevator drive bracket according to sketch 1 must either be replaced by a reinforced bracket (as shown in sketch 2) or be reinforced by means of welding metal strips according to sketch 4.

On sailplanes having an earlier type elevator drive bracket according to sketch 3 (bracket with bushings), a reinforcement by means of welding on metal strips according to sketch 4 is required.

Material: 4130 steel  
Weld with gas or T.I.G.
