AIRWORTHINESS DIRECTIVE

- TYPES AFFECTED:** All DG-100 and DG-100 ELAN sailplanes fitted with an all moving tailplane.
- SUBJECT:** Inspection/modification of the main fitting (L4) of the all-flying tailplane.

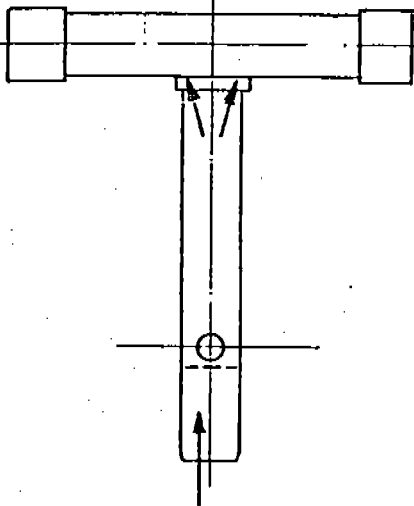
1. INSPECTION FOR WELD PENETRATION

- BACKGROUND** Overseas investigation after the failure of the main fitting of the all flying tailplane has found that the weld penetration was not complete. The manufacturers have issued TN 301/15.

Inspect the welding in the edges inside the tube by means of an Endoscope or an other suitable method.

If a plastic plug is glued into the tube, the plug is to be removed and to be glued into the tube after the inspection and repair by use of metal adhesive.
