**GFA AD 408**

**GFA AIRWORTHINESS DIRECTIVE**

**TYPE AFFECTED:** Grob G 109B from serial number 6200.

**SUBJECT:** Drain holes in the elevator and trim tab.

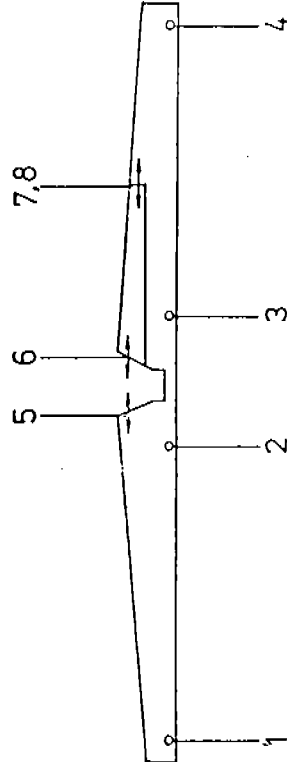
| <p><b>Subject:</b> Inspection of drain holes in the elevator<br/>(including trim tab)</p> <p><b>Concerning:</b> G 109B, as of S/N 6200</p> <p><b>Urgency:</b> 31 October 1992 at the latest</p> <p><b>Procedure:</b> A sufficient number of drain holes must be provided in the elevator including trim tab. Otherwise the laminate can be damaged by the water penetration, or weight and C.G. problems of the elevator may occur, and cause at the worst flutter tendency.</p> <p><b>Actions:</b> The following inspections must be performed:</p> <ol style="list-style-type: none"><li>1. Check for provided and open drain holes at the following positions (quantity: 8):</li></ol> <p><u>Elevator bottom side</u></p> <p>If drain holes are provided at these positions, check whether they are open.<br/>If so, no further action is required.</p> <ol style="list-style-type: none"><li>2. If drain holes are not provided at these positions, drill drain holes of <math>\phi</math> 6 mm or <math>\phi</math> 4 mm according to the figures shown on pages 3 and 4.</li></ol> <p><b>Caution:</b> Before drilling it is helpful to remove the horizontal tail according to the Flight Manual.<br/>While drilling take care not to damage the upper elevator shell!</p> | | |

**ACTION REQUIRED:** Before 31 May, 1995 the elevator and trim tab must be inspected for the correct number of drain holes and if necessary modified, per TM 817-35 which forms part of this AD.
