## GFA AIRWORTHINESS DIRECTIVE

- TYPE AFFECTED:** ASH 26 E up to Serial Number 26134.
- SUBJECT:** Inspection and possible replacement of the rotor cooling fan.
- BACKGROUND:** Service experience has shown that cracking of the cooling impeller is possible.

| <b>GFA AD 491</b> | <b>ISSUE: 1</b> | <b>7 October, 1998</b> | <b>Page 2 of 5</b> |

**ASH 26 E**Prüfung des Lüfterrads der Luftinnenkühlung  
*Checking the fan of the rotor cooling air system***Alexander Schleicher**

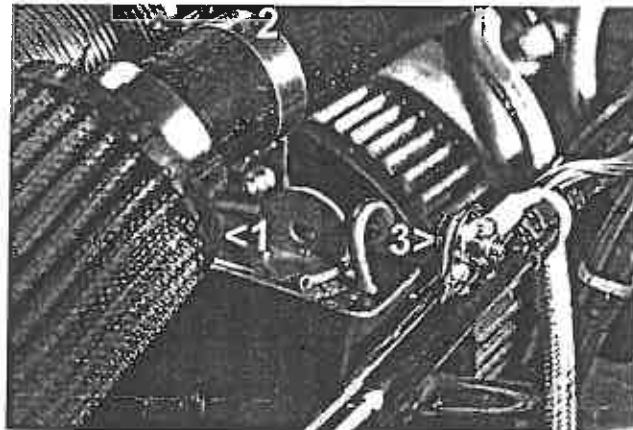
Fig. 1

**Gegenstand:** Kontrolle des Lüfterrades der Innenluftkühlung auf Beschädigungen**Subject:** *Inspection of the rotor cooling air fan for damage.***Betroffen:** ASH 26 E entsprechend den Angaben in TM 5**Serial number applicability:** *ASH 26 E corresponding to TN 5***Maßnahmen:**  
1. Hintere Befestigungsschraube (1) des Triebwerkes lösen. Diese Schraube führt durch den Öltank und kann nicht herausgezogen werden.  
2. Schele (2) des Ansaugrohres lösen.  
3. Öltank an der seitlichen Verschraubung (3) rechts lösen.**Action:**  
1. *Undo the rear mounting bolt (1) of the engine system. This bolt is running through the oil reservoir and can not be removed.*  
2. *Undo the clamp around the ram pipe.*  
3. *Undo oil tank reservoir at the screw(3) on the right side.*

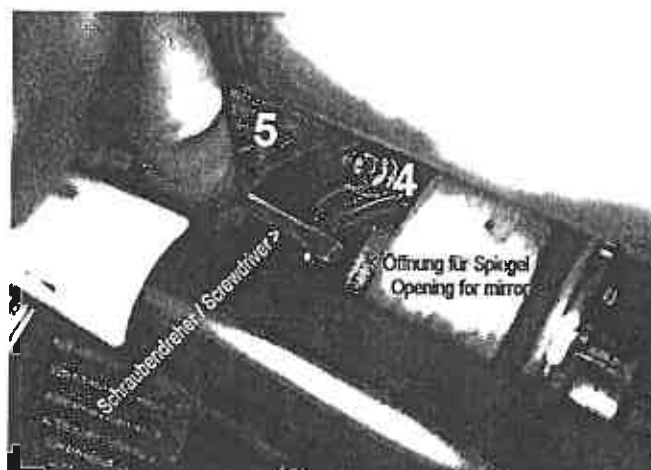
Fig. 2

4. Schelle (4) des Kühlluftfilters (5) lösen.
5. Öltank vorsichtig nach hinten schieben.
6. Kühlluftfilter (5) ebenfalls so weit wie möglich nach hinten schieben und mit einem Schraubendreher den Gummifansch am Filter wegdrücken, damit mit einem Spiegel, wie in Fig. 3 dargestellt, das Lüfterrad im Inneren des Lüftergehäuses kontrolliert werden kann.
4. *Undo the clamp (4) at the rotor cooling air filter.*
5. *Move oil reservoir carefully to the back.*
6. *Move rotor cooling air filter (5) backwards, as far as possible and press the rubber flange of the filter to the back by means of a screwdriver, as shown in fig. 3, so that the fan inside the cooling air fan assembly can be inspected.*
