# The Gliding Federation of Australia Inc

## Occurrence Summaries

01/01/2014 to 31/12/2014

The Gliding Federation of Australia Inc  
SOAR Accident and Incident Occurrences

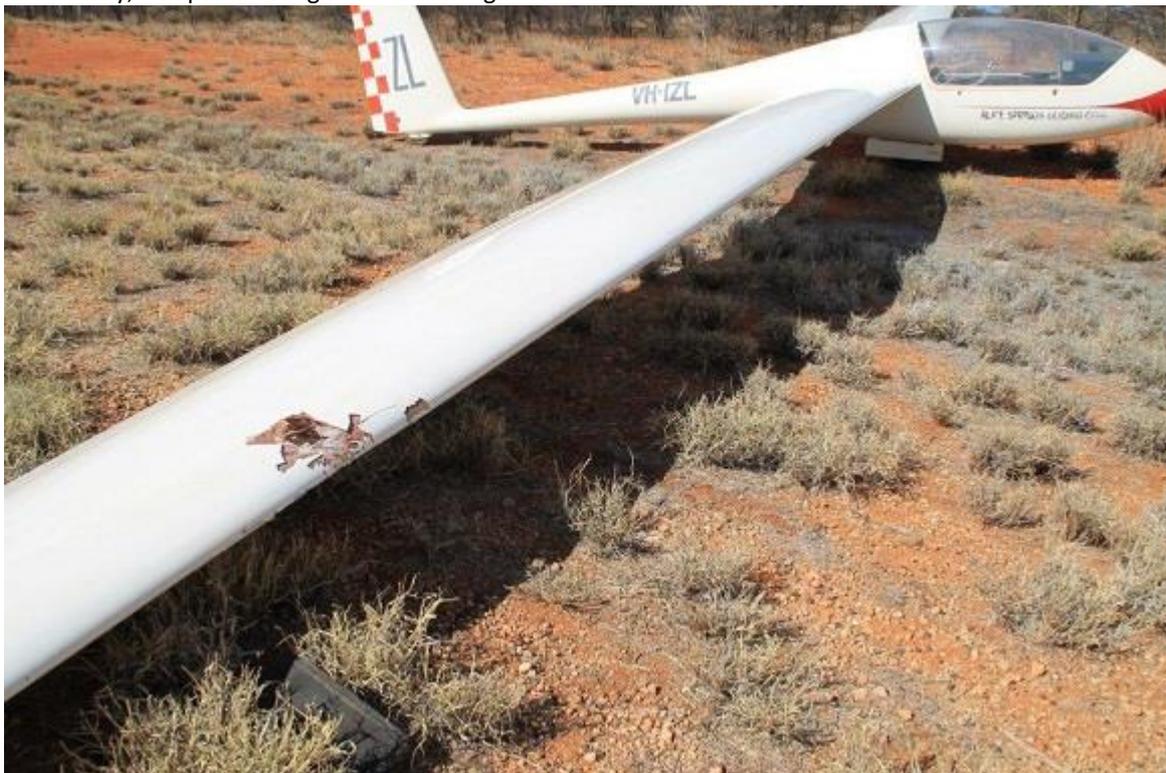
Date	11-Jan-2014	Region	SAGA	SOAR Report Nbr	S-0325
Level 1	Operational	Level 2	Terrain Collisions	Level 3	Collision with terrain
A/C Model 1		Astir CS		A/C Model 2	
Injury	Nil	Damage	Substantial	Phase	Outlanding
<p>PIC Age 30</p> <p>During a cross country flight the pilot got low and elected to land on the Stuart highway. The glider's right wing impacted a temporary road works sign and did substantial damage. This was the pilot's first outlanding and the road was the safest option. Contributing factors include stress brought on by inexperience and lack of currency, and possible cognitive tunnelling.</p>

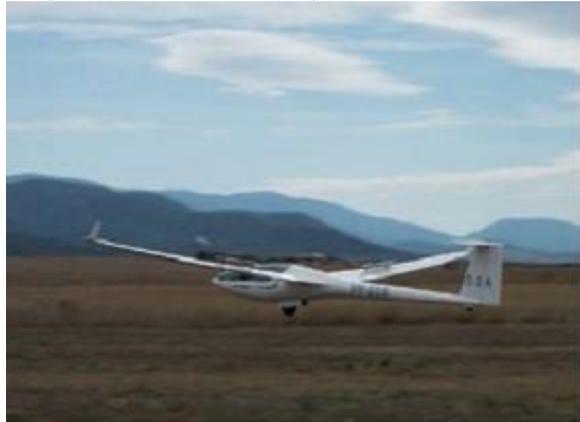
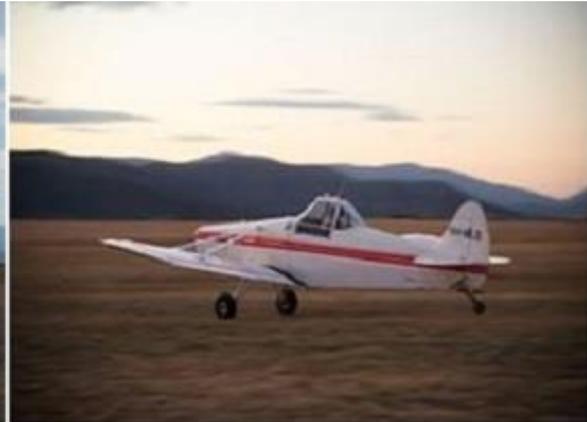
On 8 February 2014, at about 1500 Eastern Daylight-savings Time, the pilot of an AMS-flight DG-303 glider, registered VH- DGA (DGA), broadcast on the local gliding club radio frequency that he would return to land at Bunyan aeroplane landing area (ALA), New South Wales, following a local flight of about 90 minutes duration. The glider was about 5 NM east of the aerodrome and on descent from 10,000 ft above mean sea level (AMSL). About 10 minutes later, the pilot of a Piper PA-25, registered VH-MLS (MLS), broadcast a lining up and rolling call and took off from runway 33 at Bunyan to launch a glider from overhead the aerodrome. At about 1515, when at about 4,000 ft AMSL, in anticipation of the glider pilot releasing the tow cable, the pilot of MLS turned to look behind the aircraft. He confirmed that the glider had released successfully and, in accordance with standard operating procedures, he then commenced a descending turn to the left. The pilot of DGA sighted MLS release the glider and commence the turn. The two aircraft were at about the same altitude and he then observed MLS with the wings level, he assumed the aircraft would then track straight ahead. He commenced a right turn to increase separation between them, and to track towards the joining point for a right downwind for runway 27. He reported that he assumed the pilot of MLS had sighted DGA at that time, and that he did not see MLS again until it was on downwind. As the pilot of MLS rolled the aircraft's wings level from the turn, he saw DGA as a white flash passing about 30 ft below him, and reported that he could see the rivets on the glider's airbrakes. About 25 seconds later, the pilot of DGA broadcast joining downwind for runway 27 and the pilot of MLS responded that he had the glider visual. After landing, the pilot of MLS alerted the pilot of DGA to the incident that had occurred.

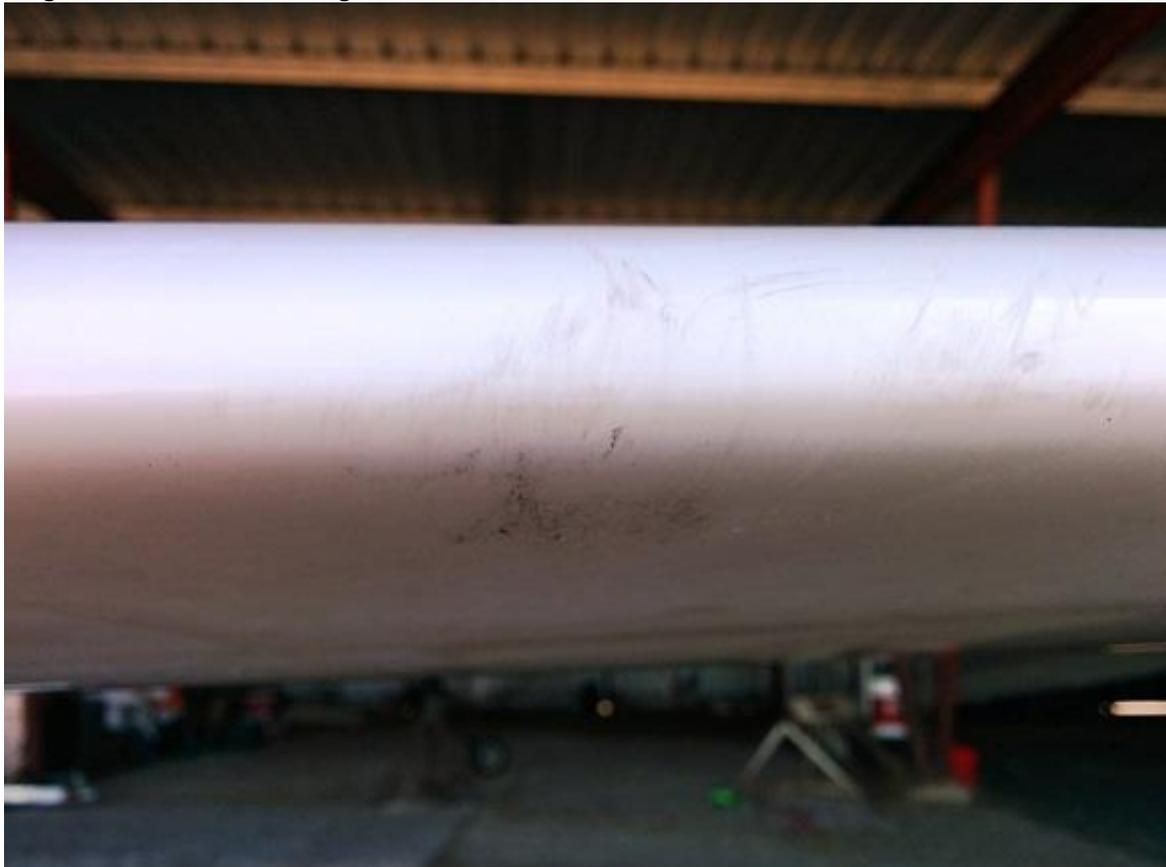
While thermalling on a cross-country flight about 38kms from home, the pilot heard a loud bang accompanied by the airframe shuddering and immediately knew something had collided with his aircraft. There were no Flarm indications and the pilot had not sighted another glider. After determining his aircraft was controllable, the pilot elected to return to his home airfield. The aircraft landed without further incident. Subsequent inspection of the airframe revealed signs of a bird strike 5 metres outboard of the left wing. The aircraft was undamaged.

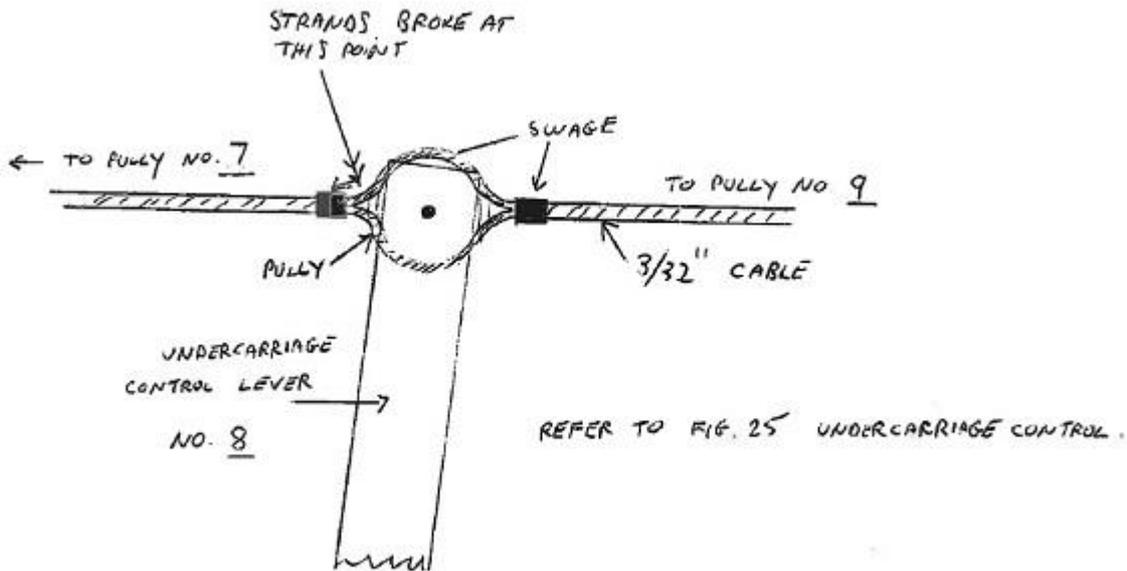
The glider's undercarriage collapsed on landing. Investigation revealed that the cable connected to the undercarriage actuating lever broke due to unidentified wear.

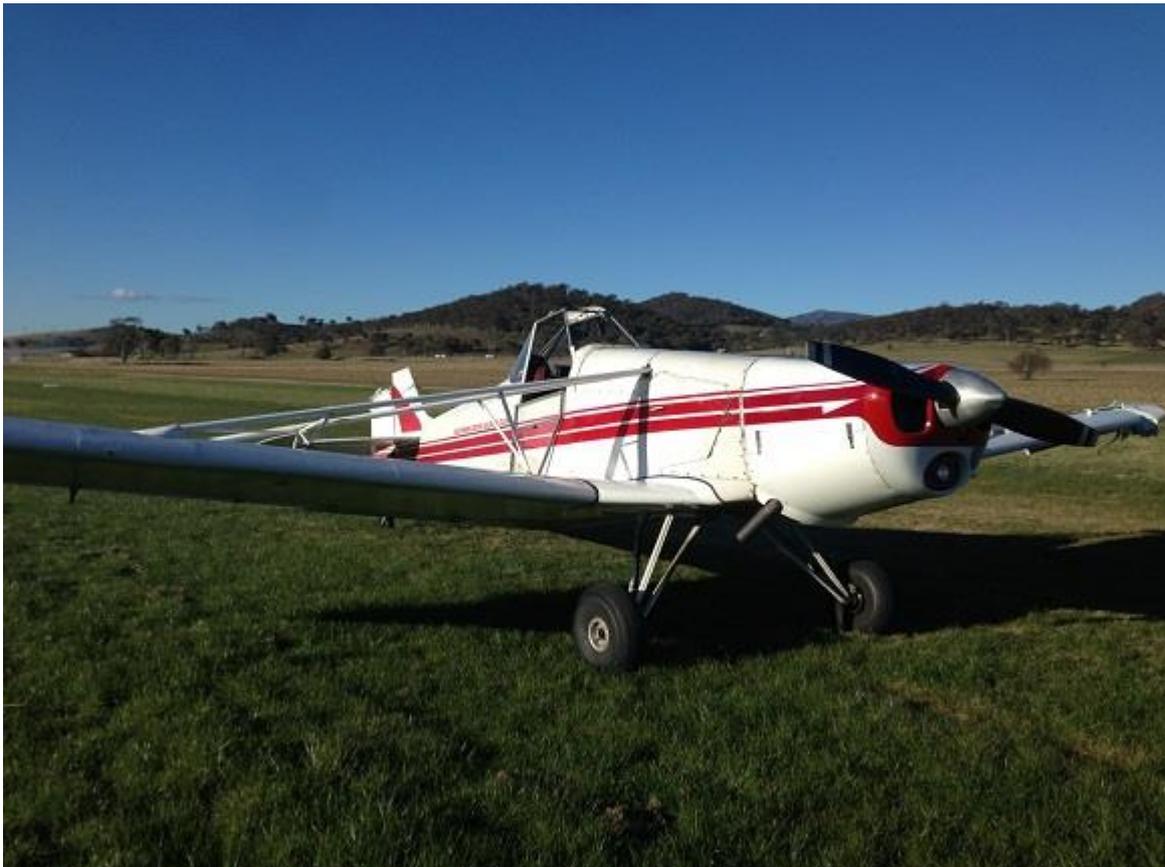
At about 1640 Eastern Standard Time on 20 September 2014, while conducting a positioning flight between Camden NSW and Bunyan NSW, the pilot of a Piper PA25 Pawnee aircraft decided to conduct a precautionary inspection of a private airstrip at Michelago, NSW. While flying above runway 18/36 on a southerly heading, the aircraft struck power lines suspended some 20 to 30 metres above ground and about 300 metres south of the threshold of runway 18. The aircraft was substantially damaged but controllable, and the pilot was able to complete a low circuit and land back on the airstrip. The pilot contacted the Canberra Gliding Club to notify them of the accident and the property caretaker called emergency services. The ATSB was advised of the accident but declined to attend.

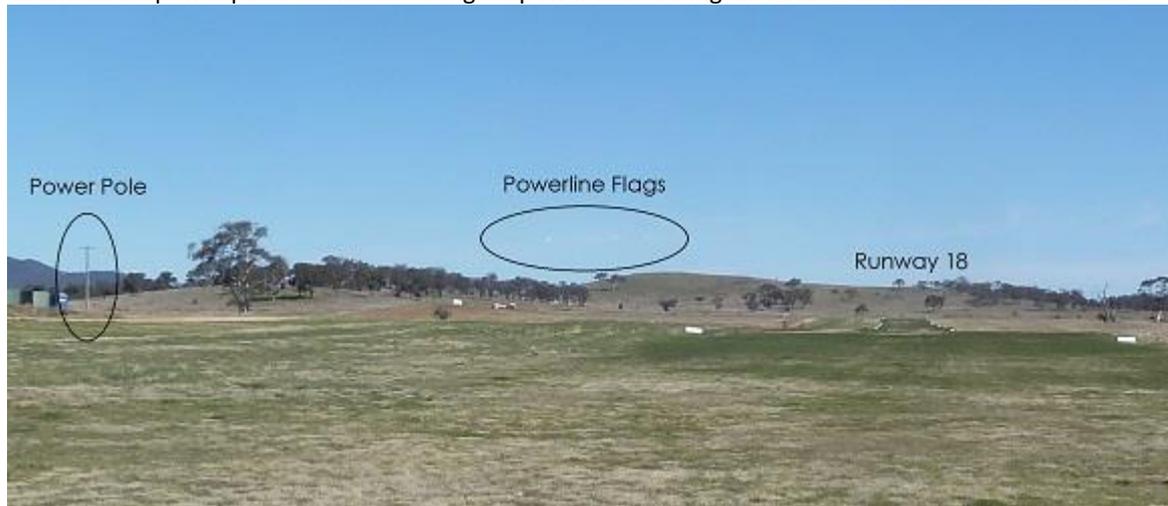
The airfield is well-defined, with edge markers, a wind sock and a mown grass runway. It is visible as an airfield from some distance away. The airfield is not marked on charts, nor is it in ERSAs. The airfield also has a power line hazard that pilots would not expect to encounter that is well inside the airfield boundary; with one pole east of the airstrip and the next pole atop a hill 800 metres away to the west. This power line configuration makes it potentially hazardous to aviators and is particularly unusual. The absence of intermediate power poles makes searching for power lines during an aerial search much more difficult.

6. The power lines were inadequately marked and were almost invisible to a pilot on approach.
7. The airfield operator did not comply with planning approvals that required the power line to be relocated or placed underground to provide protection from the possibility of an accident involving aircraft and the electricity supply line.

1. GFA to remind all pilots operating into an unfamiliar landing area to remain vigilant and ensure that all the necessary precautions are taken to reduce the risks. Precautionary searches should be conducted initially from a safe height, only working to low-level once risks have been identified.
2. GFA to remind tow pilots to ensure the owner of an airstrip or paddock has given permission to operate there and has been quizzed about power lines and other potential hazards.
3. GFA to recommend to all Gliding Clubs to fit passive wire-strike protection systems to tow planes, especially those used for paddock retrieves.

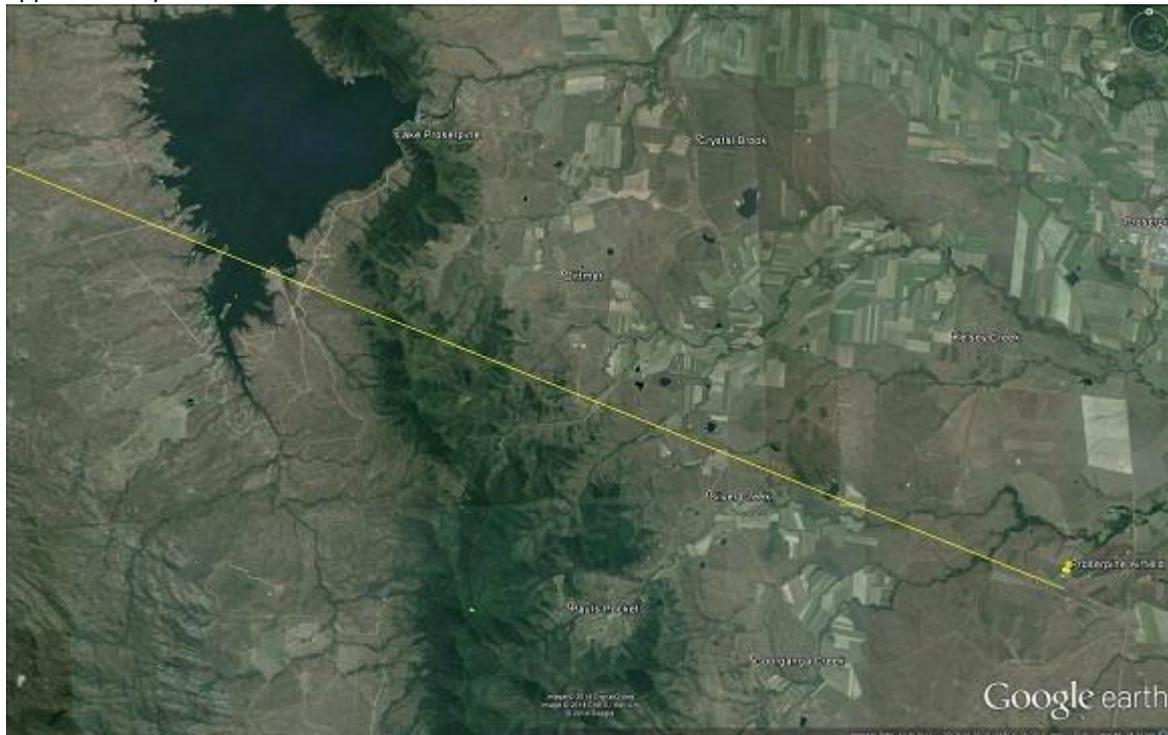
At around 4,000ft and about 20 minutes into the flight, an unusual smell was noticed that was not initially considered a threat because the engine was operating normally; the smell being attributed to recently installed heat barrier lagging on the exhaust pipes. However the smell intensified and was soon accompanied by visible smoke from the cowling joints. With smoke building in the cockpit, the pilot operated the canopy ejection mechanism but the canopy merely retracted rearwards and jammed open. The pilot then shut down the engine that was still operating normally. Shutting down the engine had no appreciable effect on the fire, which by now had started to breach the cowling on the upper right rear where the oil tank inspection hatch is located. By this time the aircraft was crossing Lake Proserpine at about

Damage to the engine and its systems was extensive. The four coolant hoses exiting the cylinder heads terminate at a small steel header tank situated centrally above the crankcase and this area sustained the worst of the damage. The return pipe to the radiator is also connected to this header tank. All five of these hoses were badly burned, the worst being the No. 2 cylinder head hose, which was completely destroyed. Hoses from numbers 1, 3 & 4 cylinders were burned to ash at the ends connecting to the header tank but were still intact nearer to the cylinder heads. The header tank, although not melted, had been subject to extreme heat, especially on the rear left adjacent to the left carburettor. There was no evidence of coolant in any of the upper hoses or the tank. The ignition coil packs and wiring to the right of the tank were severely damaged, as was the battery that is located centrally on the upper firewall behind the engine. The four hoses beneath the engine supplying coolant to the heads fared better and still contained coolant. Fire sleeving had been applied to these hoses to shield them from radiant exhaust heat and this protected them;

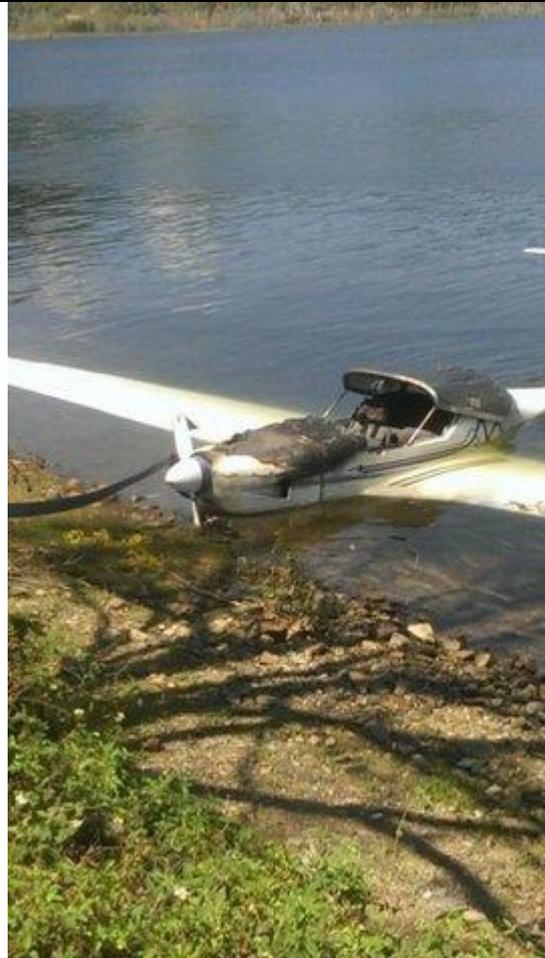
Investigation indicates the fire started near the front left of the engine, fuelled from the oil and mist leaking from the No. 2 cylinder inlet pushrod tube. The oil was most likely ignited by the adjacent hot exhaust pipe. Flames and heat were sucked upward and diagonally across the top of the engine, exiting initially via the gaps in the cowling around the oil tank inspection hatch and where the cowling attaches to firewall. Initially this fire was not severe but it intensified once the rubber components ignited. The pitch change relay lever was melted away at its outer end where it would have been in a direct path of the fire as it swept up past the front of the No. 2 cylinder. The failure of this lever prevented the pilot feathering the propeller, which resulted in the continuing rotation of the engine. This led to a continual flow of oil mist and petrol to the fire via crankcase pressurisation and the mechanical fuel pump. The cause of the oil leak was determined to be the incorrect assembly of the No, 2 cylinder head. During the process of aligning the pushrod tubes and the crankcase, the inlet side O-ring slipped out of position on the pushrod tube and was sheared off between the end of the pushrod tube and the crankcase aperture, thereby resulting in about one-third of the pushrod tube diameter remaining unsealed. The aircraft had flown on four occasions since the cylinder head installation but during this time no oil leaks or loss had been detected. The operator advised that he always removed the engine cowls when performing his Daily Inspection and that no evidence of oil leakage had been detected, nor was there any evidence of oil on the floor of the hangar where the aircraft was parked. Oil level in the tank was checked at each Daily Inspection and no oil usage/loss was seen. It is unclear why the oil leak did not become evident until after four flights, as the potential for the leak existed from the moment the O-ring was damaged on assembly.

3. O-ring failure the No. 2 cylinder inlet pushrod tube likely occurred as a result of inadequate engine maintenance procedures during re-assembly.
4. The fire started as a consequence of escaping oil at the damaged O-ring contacting the hot exhaust.

- The importance of maintenance personnel ensuring faults such as this do not result, especially in circumstances where a fault cannot be seen once assembled. This was an avoidable defect but it is understandable how the error could occur. Working in a poorly lighted hangar and assembling a complex component with an inexperienced assistant may have contributed. The maintenance engineer was a very experienced and qualified GFA member. More care was required to avoid the fault and engineers must identify potential problems and compensate.

- The burning coolant hoses contributed significantly to the fire, which reduced the time in which to land and increased the fire risk to the occupant. They were of a standard design and GFA will consider recommending the use of fire resistant hose or fire sleeving on similar gliders (mandatory action is not considered necessary as the occurrence rate is very low).

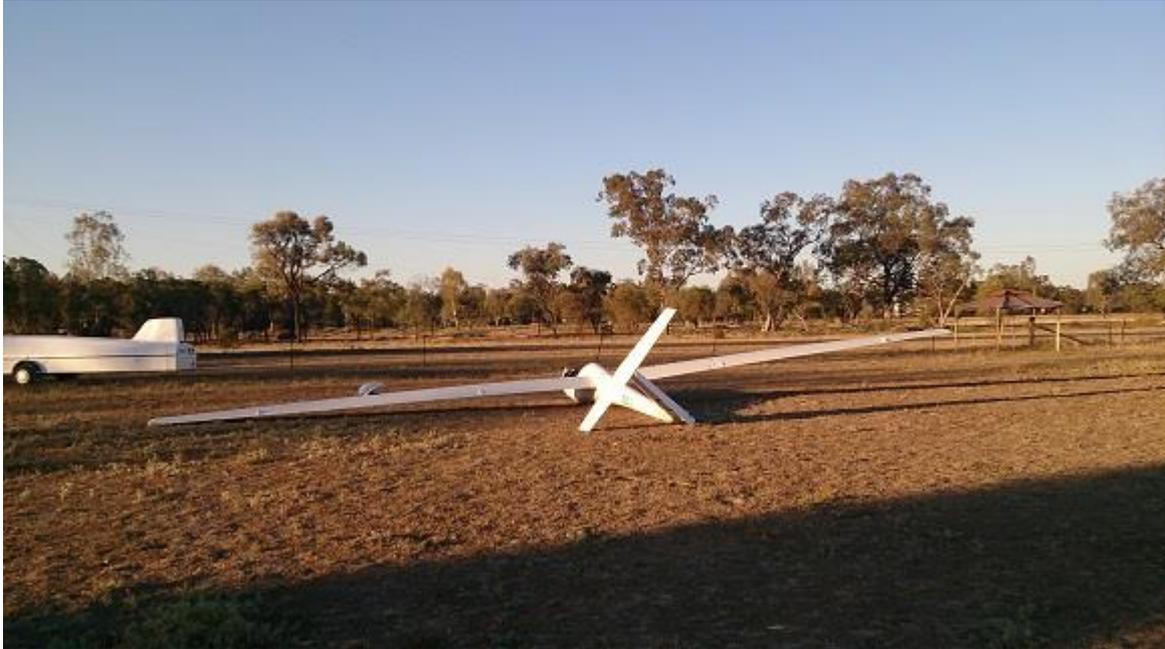
The aircraft struck the power line with the right wing, midway between the fuselage and the airbrakes. This resulted in the aircraft turning through 180 degrees and impacting the ground tail-first, and then the fuselage taking an impact. This accident geometry led to the pilot suffering only minor injury.
