The Gliding Federation of Australia Inc

Occurrence Summaries

01/01/2015 to 31/12/2015

The Gliding Federation of Australia Inc
SOAR Accident and Incident Occurrences

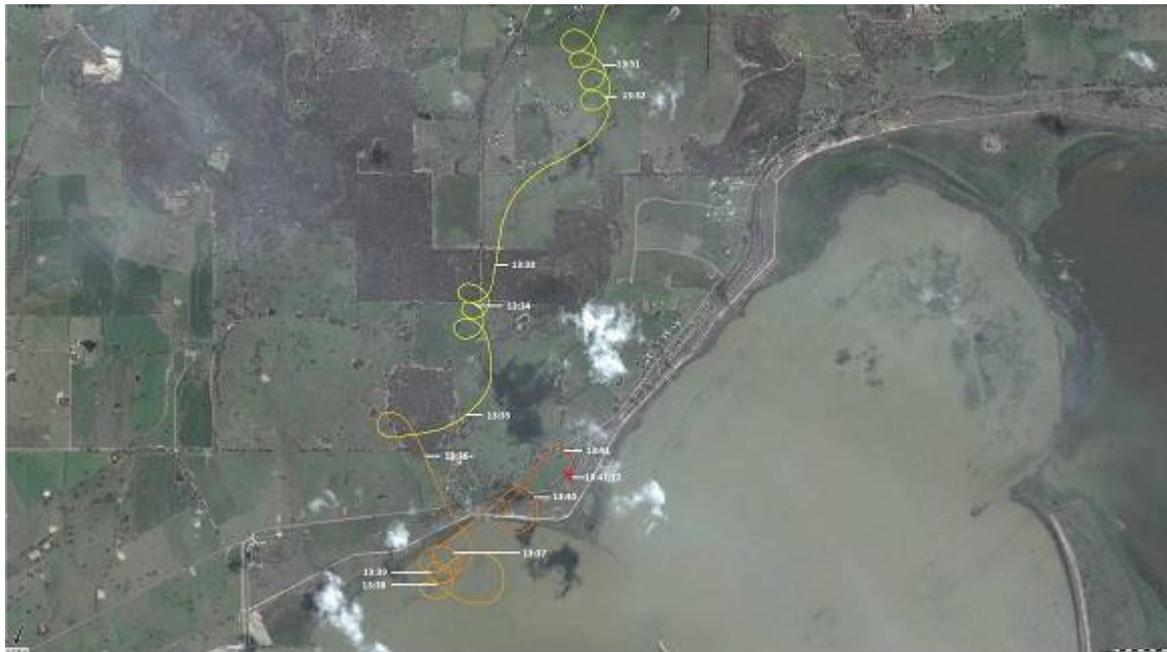
On 2 January 2015, at 1341 Eastern Daylight Savings Time, and while flying in the vicinity of Chesney Vale Victoria, a Schempp-Hirth Flugzeugbau Nimbus 2 glider departed controlled flight during a low-level right-hand turn and impacted the ground with the right wing and nose. The aircraft came to rest inverted and was substantially damaged. The pilot suffered fatal injuries.

Examination of the occurrence site and wreckage indicated that the glider was in a right-hand turn when it struck the ground in a right-wing-low, very steep nose-down attitude. The aircraft came to rest inverted on a westerly heading. The leading edges of both wings left ground scars and the nose left a shallow indentation in the ground. The fuselage forward of the wing leading edge, which includes the cockpit, was mostly destroyed at impact. The wings remained attached to the fuselage and the tail boom was broken just behind the wings and displaced slightly to the South. The rudder remained intact but the drag chute and container had deployed due to impact loads. There was no evidence of any pre-existing airframe or control surface defect. All flight control surfaces were accounted for at the accident site. While there were multiple overload failures of the flight control system in the fuselage and cockpit areas, control continuity was established. There was little damage to the airbrake arms in the wings, which is indicative of them being in

the closed position prior to impact and that they deployed when control circuit integrity was lost. The flaps were in the landing configuration, but as the flap retention mechanism was destroyed it is unclear whether they were set by the pilot or forced into that position by impact. The undercarriage was down and locked prior to impact. The hand grip from the control column had come off and was in the pilot's left hand post-accident. There was no evidence of water ballast being released when the tanks ruptured on impact, which indicates the pilot had drained the water much earlier in the flight. This is consistent with normal practice when the need to optimise climbing performance is evident.

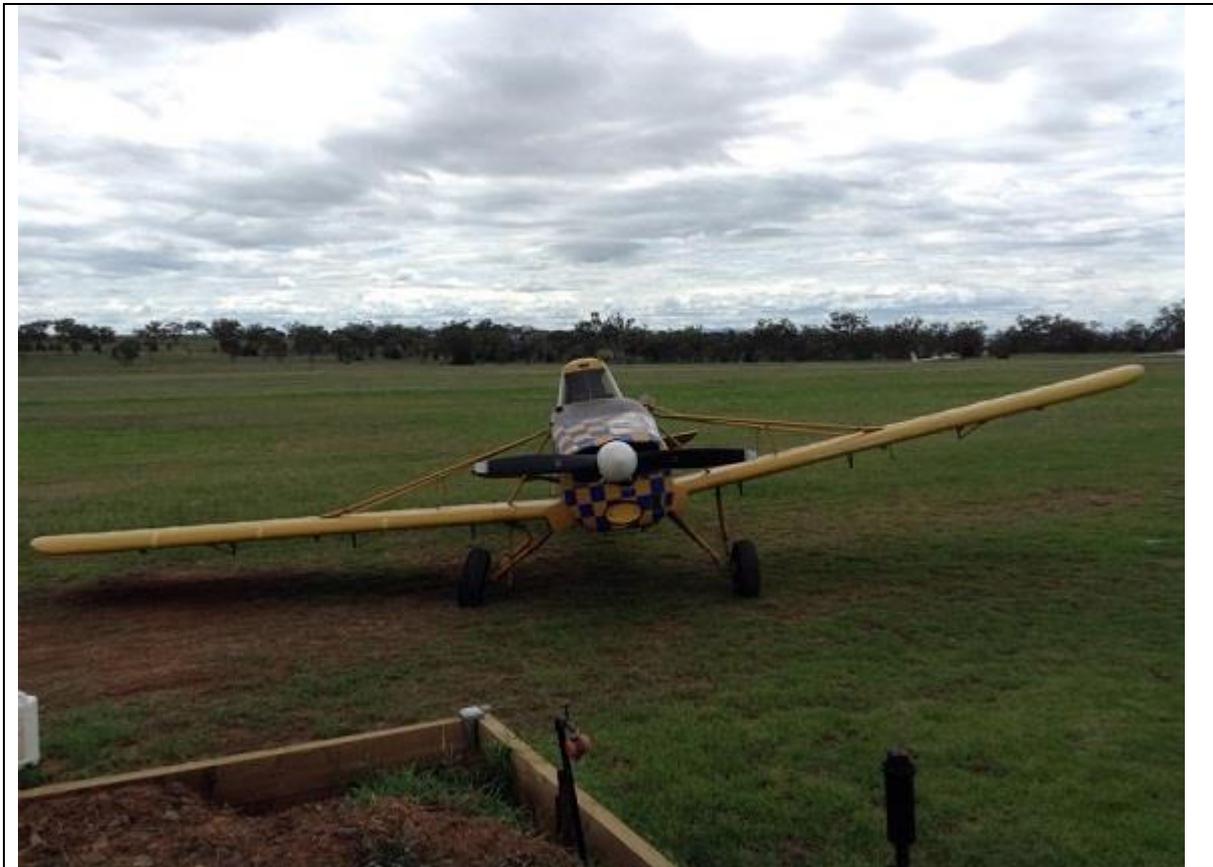
Just after touch down the pilot flying applied the wheel brake resulting in the aircraft nosing over and the forward fuselage contacted the ground and suffering minor damage. The pilot could not raise the nose and the aircraft came to rest with the tail in the air. Tail ballast was not fitted to compensate for the heavier pilots as the aircraft was awaiting a replacement door for the trim ballast compartment located in the fin that was lost on an earlier flight. It is important to note that a forward CG location increases the need for greater back elevator pressure, and that too forward a CG could result in the elevator no longer being able to oppose any increase in nose-down pitching. A glider will also stall at a higher speed with a forward CG location because the stalling angle of attack is reached at a higher speed due to increased wing loading. Flying a glider outside its forward CG limit may also make it difficult to flare the glider on the landing and, more seriously, it could also result in the maximum calculated flight loads on the tailplane being exceeded. Pilots must always ensure weight and balance calculations are rigorously completed before each flight.

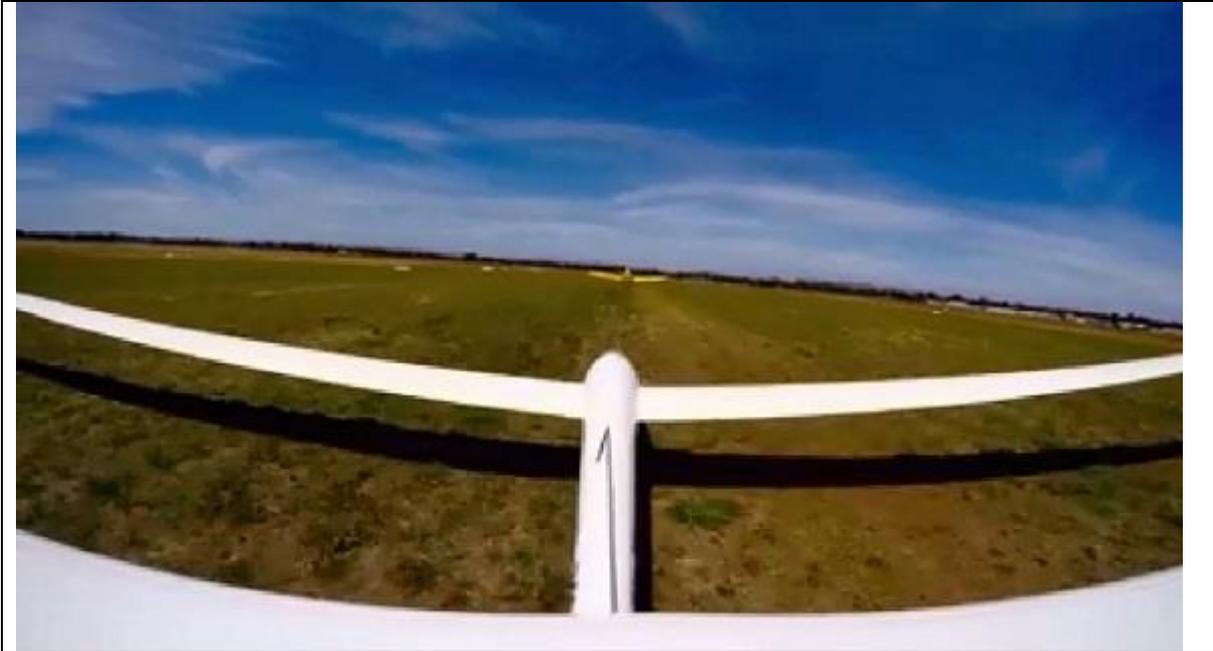
The pilot fitted Go Pro cameras to the tailplane and starboard wingtip of the aircraft without formal engineering approval or Technical Standing Order. Under CASR 21.M, a CASA authorised person has to approve the installation against existing airworthiness standards before the aeroplane can be flown. The pilot concerned was counselled by his CFI. NOTE: In June 2012 an ASK21 experienced elevator flutter caused by disturbed airflow coming from a wing-mounted GoPro camera.

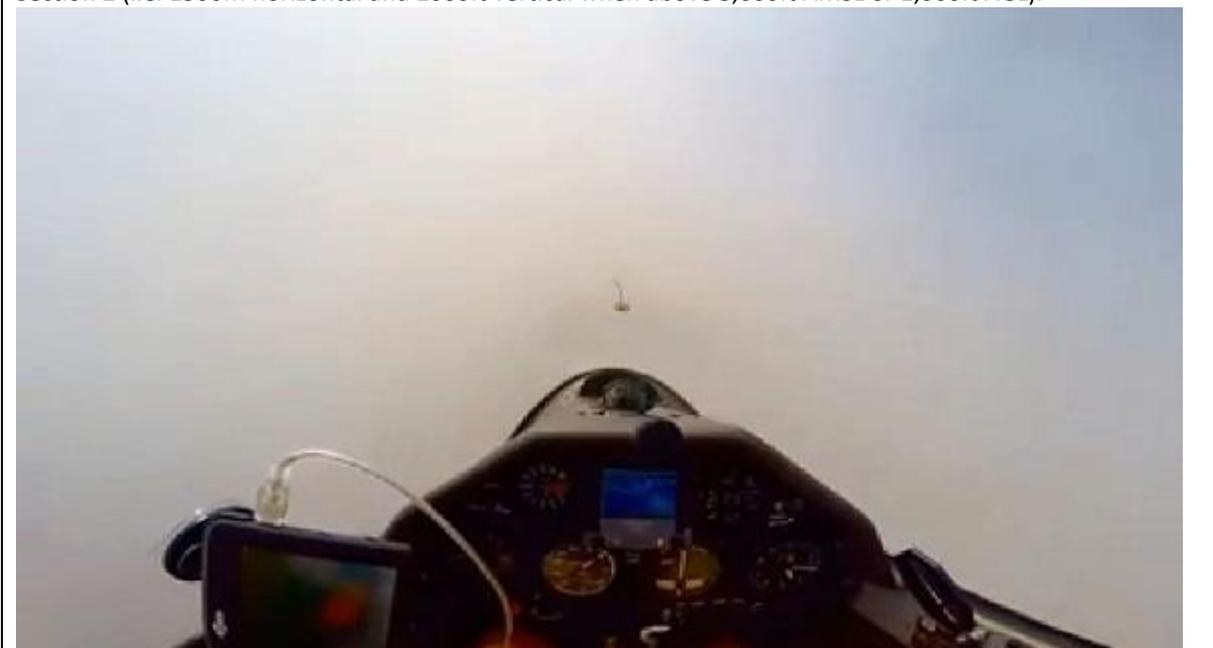
During a cross-country soaring flight the pilot flew through cloud and posted video of the flight on Facebook. The pilot concerned was counselled by his CFI. While it is tempting to fly close to cloud when conditions allow, pilots need to comply with the VFR visibility and distance from cloud criteria stipulated in ENR 1.2 Section 2 (i.e. 1500M horizontal and 1000ft vertical when above 3,000ft AMSL or 1,000ft AGL).

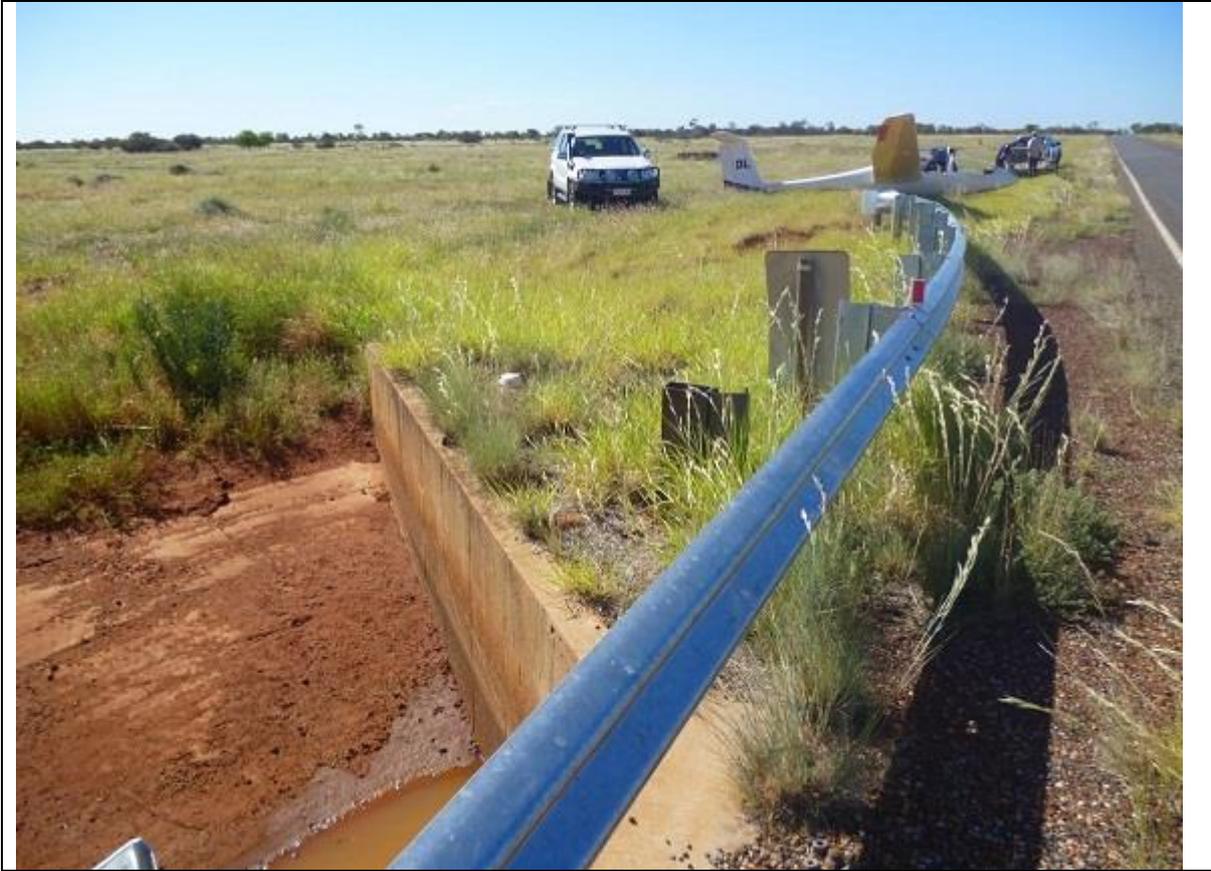
After a normal aerotow launch into a 5 to 10 knot headwind and at about a height of 200 to 300ft AGL, the combination flew through some strong lift causing the glider to climb above the tow plane. The pilot lost sight of the tow plane and released in accordance with proper practice. The pilot lowered the nose to maintain airspeed and flew a turn that to land back on the same runway as the take-off, rather than landing in a suitable paddock. The pilot managed to complete the turn but was too low to make the runway and landed in scrub. After touchdown the left wing dropped to the ground and the aircraft turned through 90 degrees with the nose wheel was on the ground and skidded to a halt in a cloud of dust. The aircraft was substantially damaged but the pilot was unhurt. The pilot, who was experienced but had not flown much in the last five years, was solo subject to daily check flights. The pilot had completed a satisfactory check flight earlier. Investigation by the pilot's CFI revealed that the pilot was sitting low in the seat, which when flying in what would be a normal high tow position may have placed the pilot in a position where she could not see the tow aircraft. The decision turn back was inappropriate for the height and an off-field landing ahead was preferred. The pilot has been made aware of landing options and the actions to take in an emergency. This accident highlights the importance of always being aware of landing options during the early stages of the launch. As demonstrated here, the main risk is trying to get back to the airfield. It is much safer to make a controlled arrival into a field ahead than risk low turns, catching a wing tip, stalling or spinning. Remember, the less you have to turn, the safer you will be.

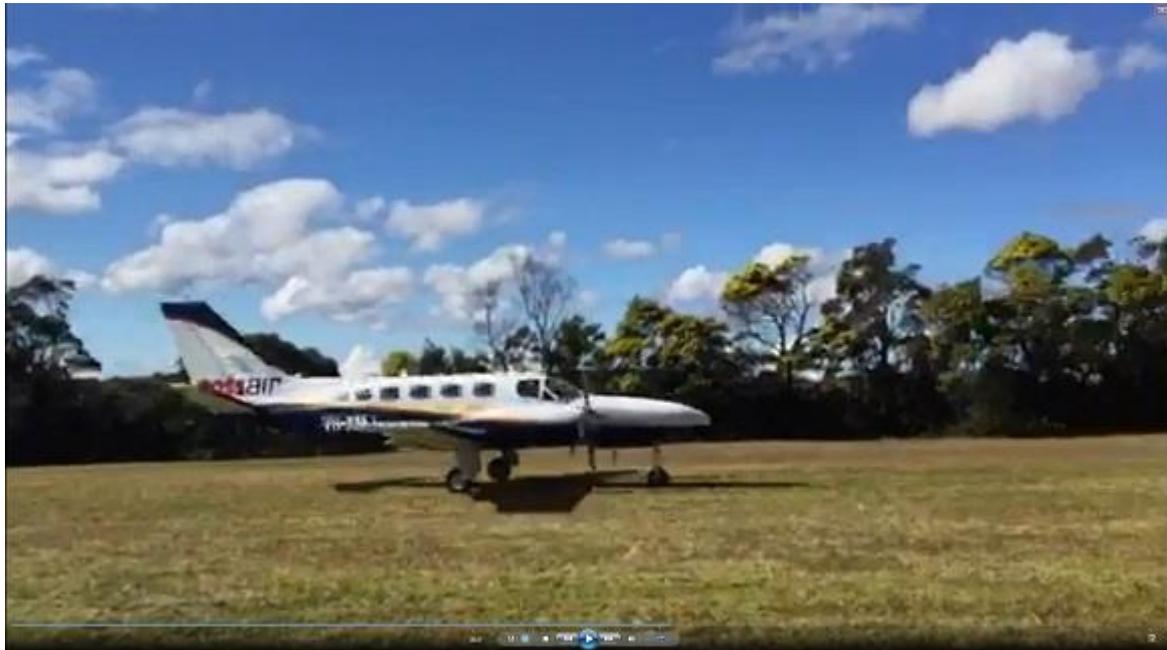
A corporate owned Cessna Conquest twin engined aircraft did a low pass of the gliding winch operation and then conducted an unauthorised landing. Radio calls on the appropriate frequencies were not made. In addition, the airfield is not suitable for heavy aircraft and the council prohibits powered aircraft operations. The company's Chief Pilot has advised the pilot will be unavailable for flight duties pending his investigation. The gliding airfield is located in busy airspace and there is a significant potential for conflict between transiting powered aircraft and gliders. The GFA AA&A Officer has worked with the Gliding Club CFI to have the airfield included in ERSA and for AirServices to identify it as a CTAF on the Sydney VTC and Newcastle VNC. The Club is also pursuing a proposal to have the boundaries of a proposed Broadcast Area adjusted to include their airfield.

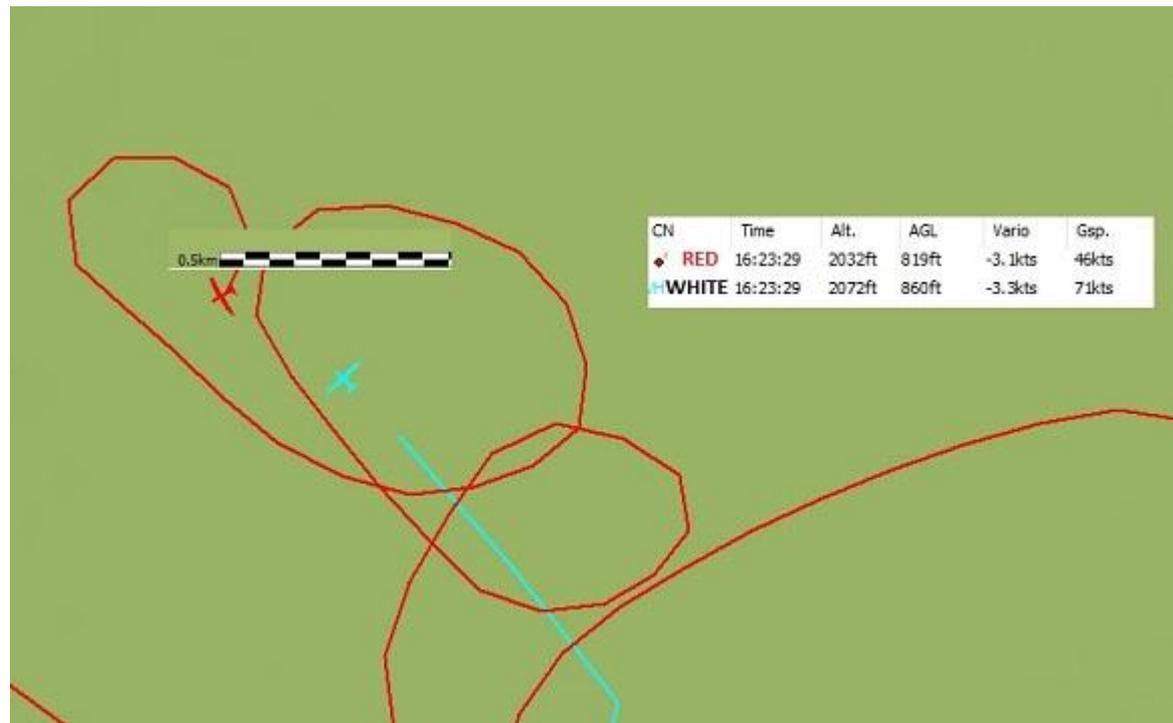
The canopy Perspex detached from its frame at about 500ft AGL during a winch launch and shattered against the tailplane. The pilot released the cable shortly thereafter at a height of 800ft AGL and assessed his options. The pilot commenced a descending turn with the intention to position for a landing on the duty runway but modified the decision due to the glider's high rate of descent and positioned for a downwind landing on the cross-strip. The pilot landed with a higher than normal airspeed and rolled across the duty runway, whereupon the pilot taxied clear. Examination revealed that sections of the Perspex had cleanly separated from the frame, with little to no glue attached to the Perspex. The sailplane was manufactured in 1988 and the canopy was an original factory fit. At the time of the occurrence, the aircraft had logged 3,130 hours and 7,268 landings. Examination of sections of the Perspex showed a clean separation with little to no glue attached - most of the glue was left on the frame. Investigation suggests the glue failure is age-related. The Type Certificate (TC) holder has informed GFA that this is the first reported occurrence of this kind. GFA has issued Airworthiness Alert 2015-3 to all SZD series sailplane owners requesting a detailed inspection of the glue bond between the canopy Perspex and frame and, to repair and report any defects found.

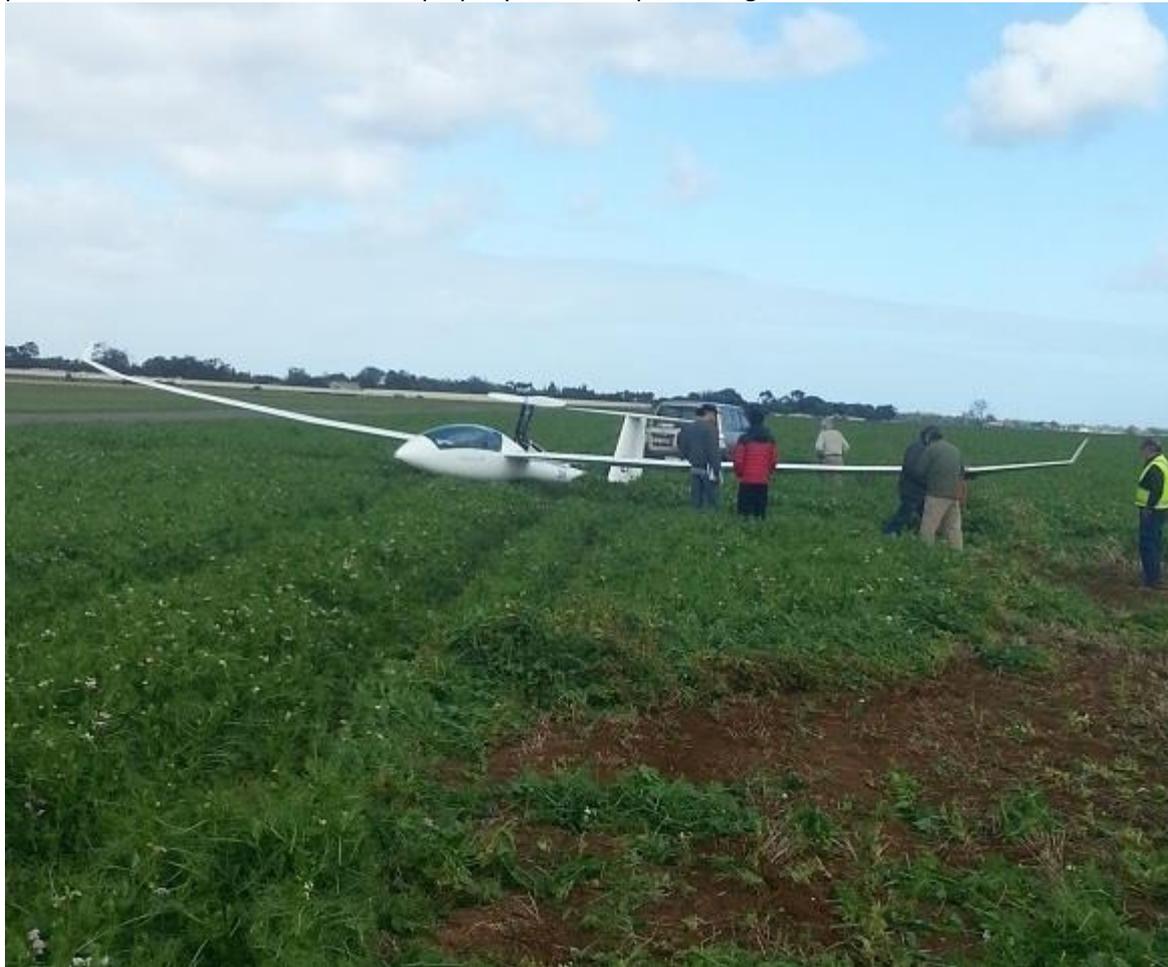
Date	7-Sep-2015	Region	SAGA		SOAR Report Nbr	S-0583	
Level 1	Technical		Level 2	Powerplant/Propulsion		Level 3	Engine failure or malfunction
A/C Model 1	Arcus M			A/C Model 2	N/A		
Injury	Nil	Damage	Substantial	Phase	Launch		PIC Age 66

as for take-off and did not use airbrakes. A decision was also made not to land on the cross-strip as the crosswind would have added to the already high workload. The command pilot flew a steep turn onto final but the long-winged aircraft was slow to recover to wings level flight and drifted over a pea crop. While banking to realign with the runway into wind, the left wing caught in the crop causing the aircraft to ground loop to the left and land heavily. The aircraft was substantially damaged. Engine damage was discovered on an earlier occasion and involved a failed bearing and injectors. The engine was sent away for repairs and it is possible the drive belts were either improperly tensioned prior to flight or defective.

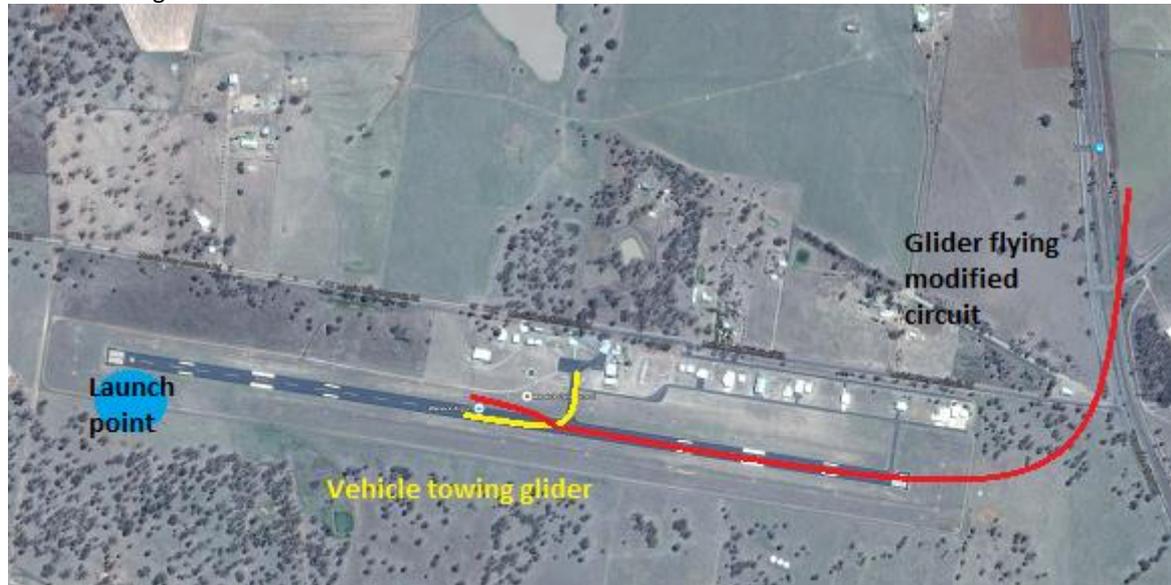
Date	20-Sep-2015	Region	GQ	SOAR Report Nbr	S-0596		
Level 1	Operational	Level 2	Runway Events	Level 3	Runway incursion		
A/C Model 1	LS 1-f		A/C Model 2	PW-6U			
Injury	Nil	Damage	Nil	Phase	Ground Ops	PIC Age	55
While towing a glider to the launch point, the driver (an experienced pilot) entered the runway as another

glider was on a base leg for landing. The driver entered the operational runway from the main apron, using the taxiway situated about midway along the runway. The driver stopped at the holding point, confirmed there was no aircraft on approach and then made an entering and backtracking call on the CTAF. Unknown to the driver, a glider that had got low upwind of the airfield was conducting a modified circuit onto the reciprocal runway from behind and was unsighted. The driver did not hear any circuit calls and, as he was taxiing to the launch point on the main runway, the glider landed behind him, pulling off the runway to one side as it went past the vehicle. Investigation later revealed that the driver's radio was unserviceable due to a flat battery. The pilot of the landing glider unnecessarily overtook the vehicle and landed alongside, when a safer option was to land much shorter and further away. This incident highlights the importance of clearing the airspace in all directions of potential conflict when entering a runway to achieve the required situational awareness. As the primary tool of alerted see-and-avoid is the radio, it is also important that the radio is on the correct frequency and functioning. Pilots should also make a straight approach and landing run parallel to the runway and must not taxi off the runway unless operationally required and only if no other aircraft can land alongside in the direction of taxi.

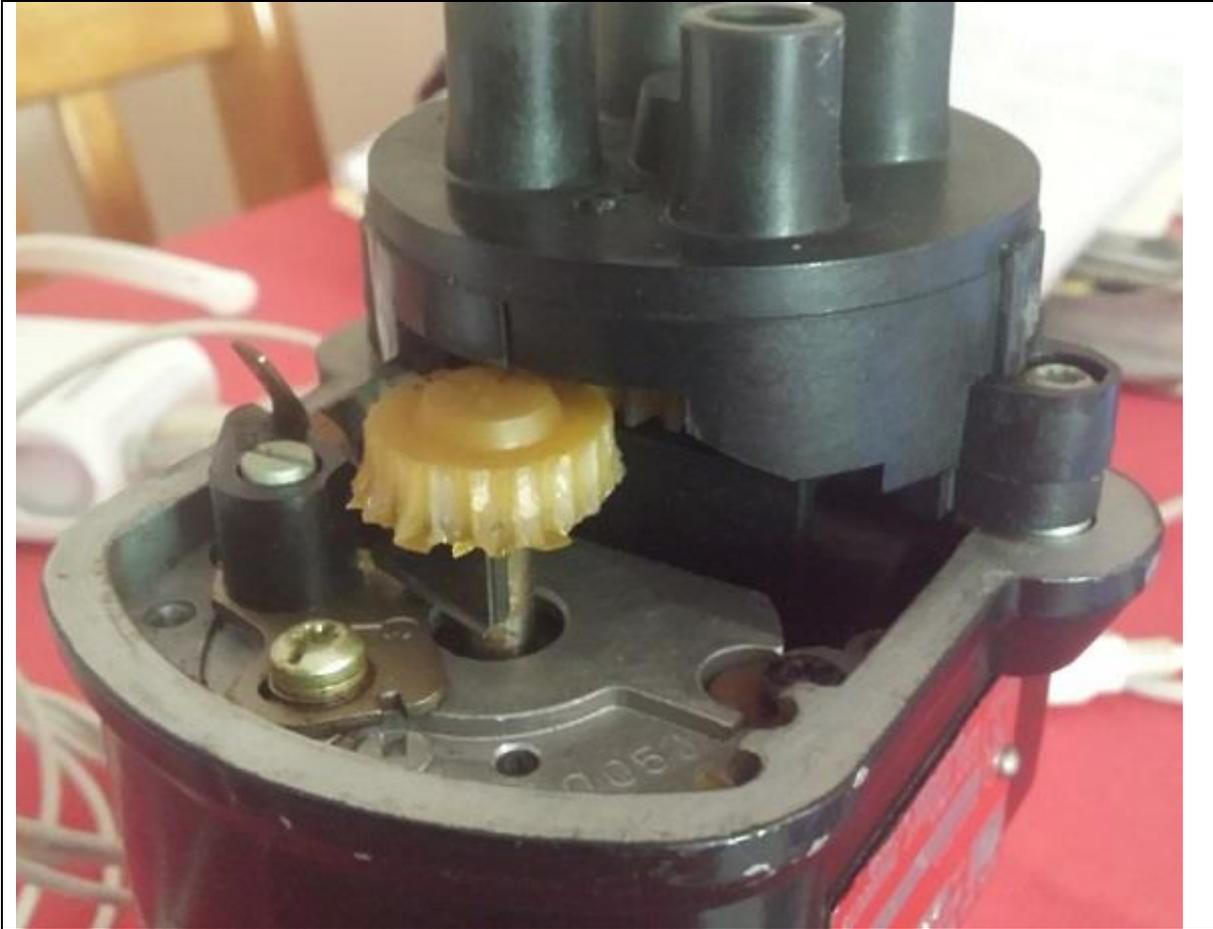
Date	26-Sep-2015	Region	WAGA		SOAR Report Nbr	S-0591	
Level 1	Technical		Level 2	Powerplant/Propulsion		Level 3	Other Powerplant/Propulsion Issues
A/C Model 1	Stemme S10			A/C Model 2	N/A		
Injury	Nil	Damage	Minor	Phase	In-Flight	PIC Age	57
<p>The powered sailplane was being used on a trip from Perth WA to Burketown Qld flying via Alice Springs. While readying the aircraft for an early morning flight at Burketown, the command pilot was unable to start the engine. Upon examination, it was found that the plastic distributor gear teeth on the magneto were stripped. No apparent reason for failure could be determined but it is likely related to the high shock loads from the impulse unit while starting that morning (the aircraft flew in and taxied under power the day prior). The Limbach engine is a single magneto arrangement that is common to many powered sailplanes, and this incident highlights just how easy it is for a terminal failure to occur without warning. Unlike a powered aircraft that is started while on the ground, the engine of a powered sailplane is usually turned off in flight and only restarted if needed. For this reason, a failure to start poses a greater risk to a powered sailplane than with a powered aircraft, and this incident supports GFA guidance that pilots should not fly powered sailplanes where they wouldn't go with a normal glider.</p>

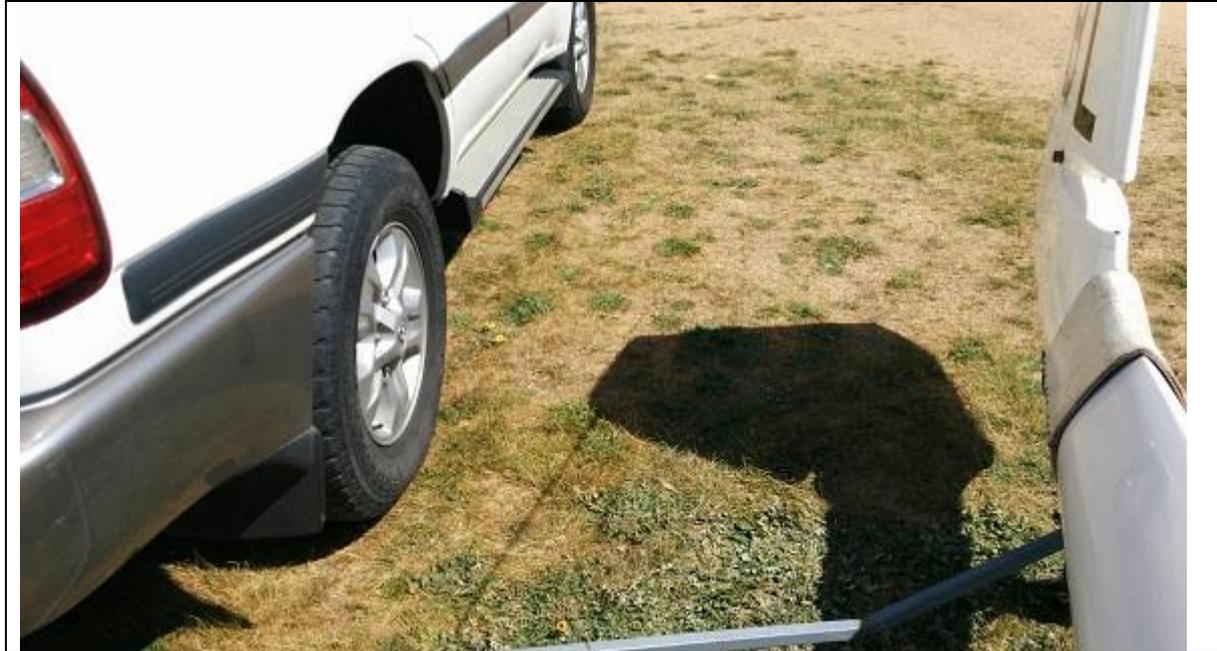
Date	27-Sep-2015	Region	VSA	SOAR Report Nbr	S-0597		
Level 1	Operational	Level 2	Ground Operations	Level 3	Ground handling		
A/C Model 1	Standard Libelle 201 B		A/C Model 2	N/A			
Injury	Nil	Damage	Substantial	Phase	Ground Ops	PIC Age	62

The glider was being towed back to the hangar using a rigid bar and wing dolly at the end of the day's flying. The driver was towing at excessive speed, which caused the tail dolly wheel to oscillate. A number of members witnessed the event and called/motioned to the driver to stop. The driver braked heavily in response and the inertia of the glider resulted in it colliding with the car. The tailplane and elevator were substantially damaged. Investigation revealed that the towing bar in use was not approved for the aircraft. The CFI also noted that the driver was inattentive to the task and that his situational awareness may have been degraded by fatigue. Drivers using a rigid bar must never tow at faster than walking pace, and should always use the tow-out equipment designed for use with the glider. When towing gliders, never brake heavily and always allow a greater distance to slow or stop than the distance you would allow with only the car.

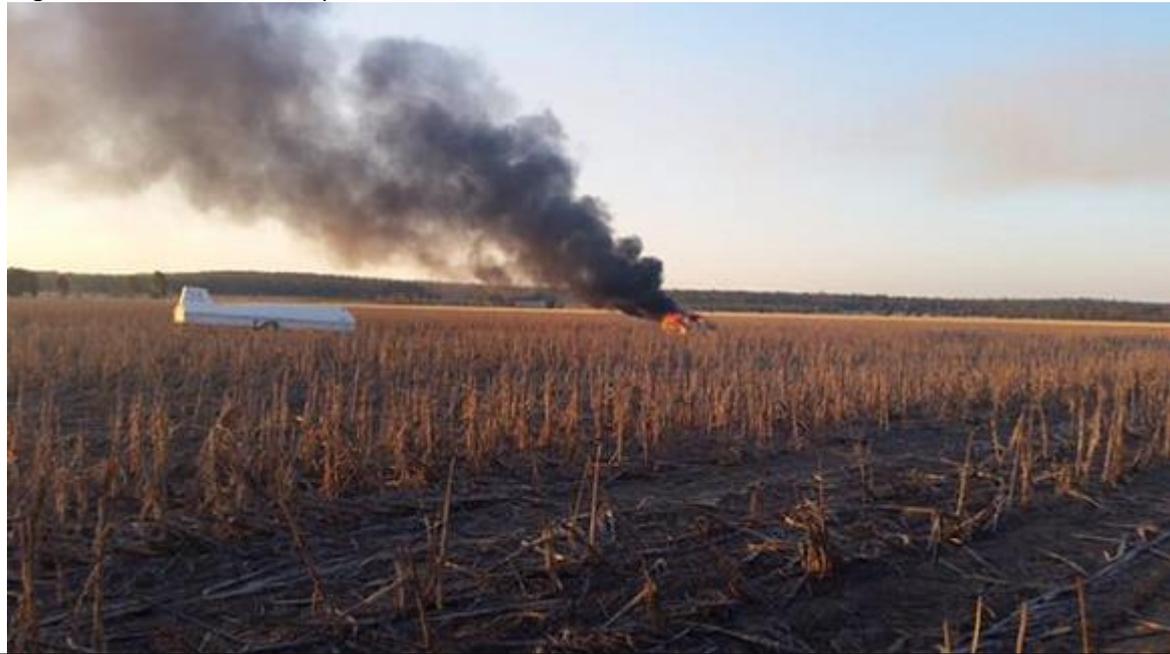
Date	4-Oct-2015	Region	GQ	SOAR Report Nbr	S-0879		
Level 1	Operational	Level 2	Ground Operations	Level 3	Other Ground Ops Issues		
A/C Model 1	HPH Glasflugel 304 C		A/C Model 2	N/A			
Injury	Nil	Damage	Nil	Phase	Ground Ops	PIC Age	54
<p>Day 1 of the 2015 Queensland state gliding competition being held at Kingaroy, Qld, The pilot had conducted a safe outlanding in a sorghum stubble field on the Darling Downs to the west of the Kingaroy valley. A fellow competitor on a lay day volunteered for the retrieve and hitched the pilot's trailer to his car, a two-year-old Nissan X-Trail petrol-engine 4WD, and set off. The trip was uneventful and the pilot was picked-up up at the entrance to the paddock. As the vehicle was driven across the paddock towards the waiting glider, the driver noticed a trail of small spot fires behind them. The driver stopped the car and the two occupants extinguished the fires by stamping on them. On continuing their slow progress across the field the smell of burning appeared to be increasing and spot fires were again noticed behind them and smoke was slowly drifting up from around their feet. The car was stopped again and the spot fires were extinguished. As the last one or two smoldering stubble patches were extinguished, the crew person turned toward the car and noticed it was visibly on fire, with acrid smoke pouring from the engine compartment and flames rising a metre high. The pilot and crewman ran back to the vehicle, unhitched the empty trailer and man-handled it out of the way. The plume of acrid, black smoke had alerted the young farmer, who turned up in his truck with wife and kids in tow. A little later, the farmer's brother turned up with a water truck and put out the last of the flames. The pilot originally thought that a sorghum stalk had ruptured a fuel line, which would</p>

account for the spot fires. However, it was most likely caused by radiated heat from the car's catalytic converter igniting the flammable sorghum. As the accumulated flammable material burns, small amounts of burning material falls to the ground periodically causing spot fires. It is quite common in rural Australia for the ignition of flammable vegetation to occur when it is caught in a vehicle's hot metal exhaust pipe, muffler or catalytic converter and shield when driving through dry grass or crop paddocks. Under normal running conditions any motor vehicle exhaust can become hot enough to start a fire in dry grass. The amount of heat radiated from a hot exhaust may also be sufficient to ignite flammable vegetation if it is located too close. Where possible avoid driving a vehicle across paddocks of long dry grass or crop stubble and parking in vegetation on roadsides and paddocks.

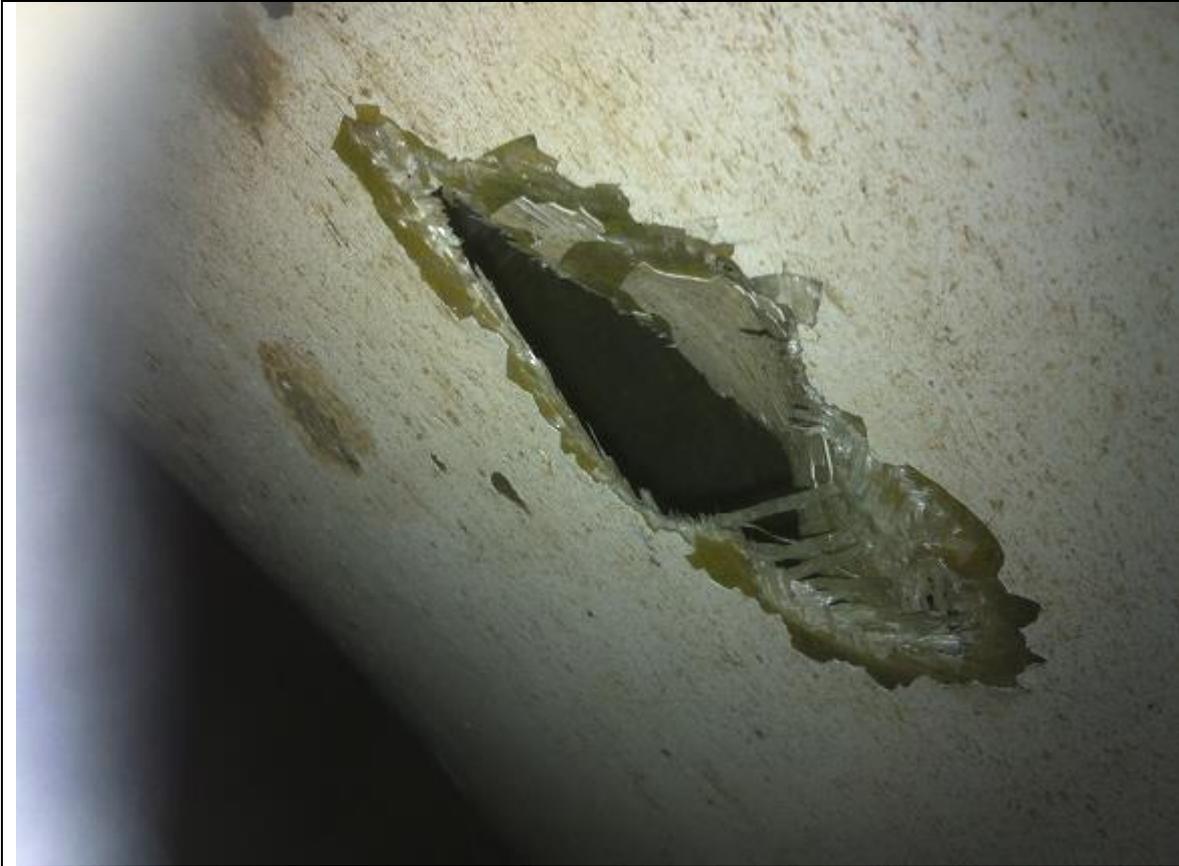
Date	4-Oct-2015	Region	VSA		SOAR Report Nbr	S-0610	
Level 1	Operational		Level 2	Miscellaneous		Level 3	Rope/Rings Airframe Strike
A/C Model 1	SZD-50-3 Puchacz			A/C Model 2			
Injury	Nil	Damage	Substantial	Phase	Launch	PIC Age	49
<p>During a winch launch the rope between the drogue parachute and the weak link broke, catapulting the weak link into the lower fuselage between the winch release and the undercarriage resulting in substantial damage. Investigation revealed the trace had elastic properties and was covered by hose pipe of only half its length. The ropes used between the drogue chute and the rings should be of a non-elastic type to prevent springing back when tension is released (e.g. wire or sisal). Where hose pipe is used, it should enclose the entire trace. The Club has replaced its rope traces with braided cable fully covered by hose pipe.</p>

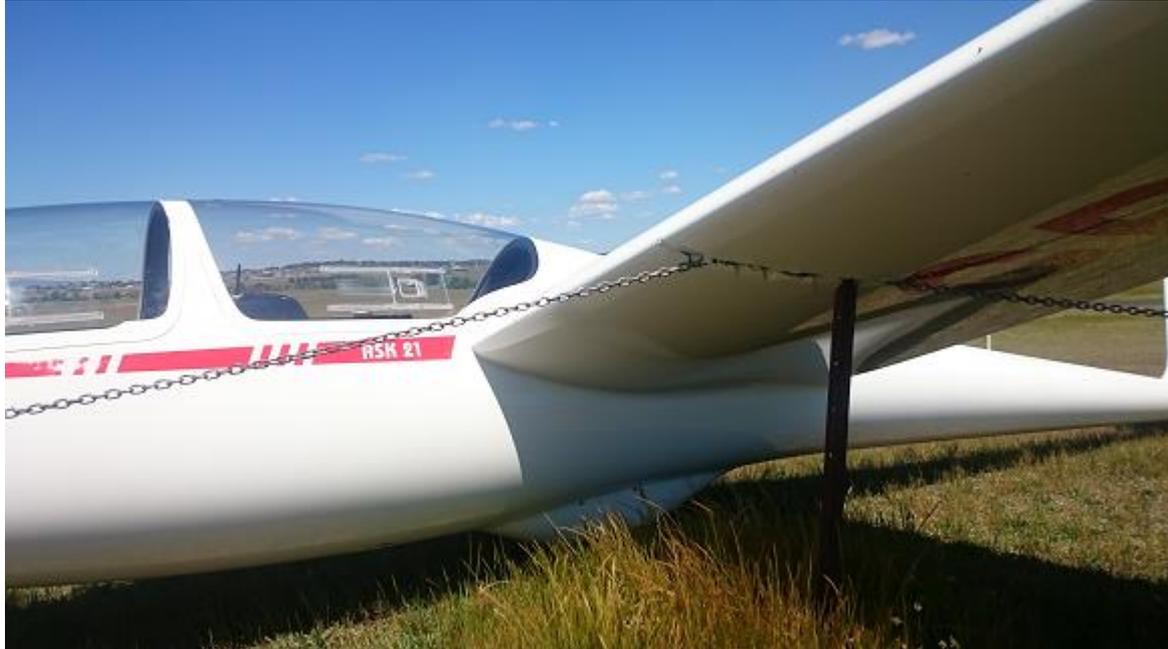
Date	16-Oct-2015	Region	NSWGA	SOAR Report Nbr	S-0606		
Level 1	Operational	Level 2	Terrain Collisions	Level 3	Collision with terrain		
A/C Model 1	ASK-21		A/C Model 2	N/A			
Injury	Nil	Damage	Substantial	Phase	Landing	PIC Age	60
<p>Pilot on first solo lost directional control while landing downwind and uphill. The glider turned left through 90 degrees and collided with a picket and chain fence causing substantial damage to the port wing. The pilot, who commenced gliding in late 2014, was participating in an ab-initio gliding course. The aerodrome runways are on a slope and it is usual for the club to launch downhill into wind and land uphill, providing the tailwind component is not excessive. The pilot was familiar with this procedure, having flown 19 flights during the course. The pilot was sent solo on her 20th flight on the course by the same instructor who had flown with her on her nine previous instructional flights. The take off, aero-tow, free flight, circuit joining, downwind, base, and approach phases of flight were all observed by the instructor to be well executed. The pilot was landing with a 5 knot tailwind and mentioned the crosswind component was stronger than earlier. The pilot approached at a shallower angle than previously and did not use much airbrake. With the aiming point moving up the canopy, the pilot eased away more airbrakes. The pilot subsequently over controlled the flare causing the glider to balloon slightly and immediately closed the airbrakes and flew parallel to the ground for a short period. The glider initially touched down at flying speed and a small bounce occurred. The pilot overcorrected the nose down attitude and the glider bounced a number of times from nose to tail. The pilot was unable to maintain directional control during the bounces and the glider turned left through 90 degrees with the wings level. The pilot did not deploy the airbrakes and wheel brake until late in the ground roll when the glider was heading towards the boundary fence. The port wing struck a picket and chain fence at low energy resulting in substantial damage but no injury to the pilot. These incidents usually occur when the</p>

pilot does not maintain a stable approach, allows the glider to touch down at flying speed, and mishandles the subsequent bounced landing. Bounced landings and subsequent 'pilot induced oscillation' can be reduced by flying a stable approach at the correct airspeed and using about half airbrake, rounding out at the correct height without adjusting the airbrakes unnecessarily, holding off a few feet above the ground and then allowing the glider to gradually settle as the speed decays. Potential causal factors include low experience, upward sloping runway and tailwind component.

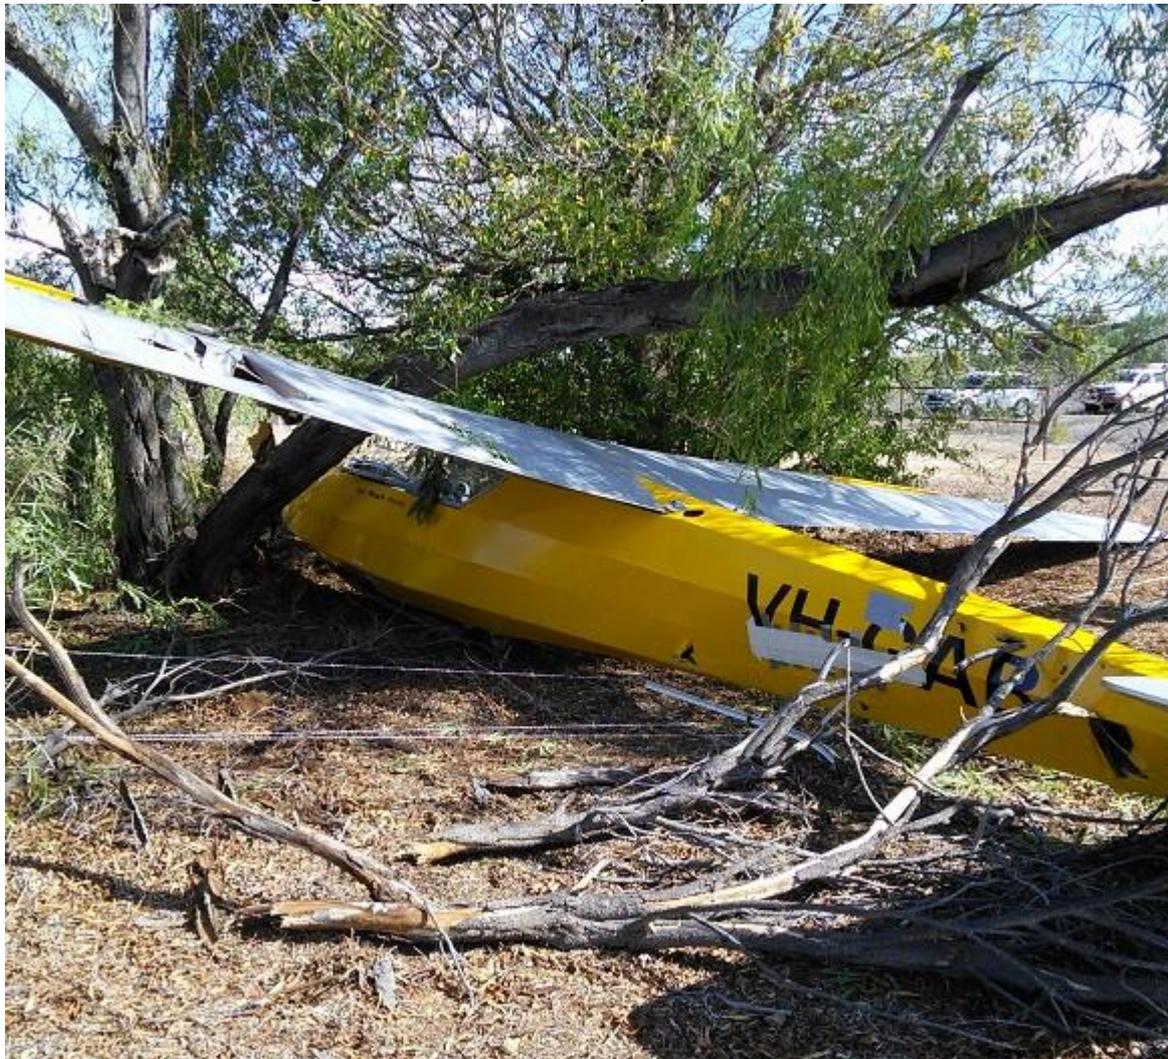
Date	8-Nov-2015	Region	GQ	SOAR Report Nbr	S-0614		
Level 1	Operational	Level 2	Terrain Collisions	Level 3	Controlled flight into terrain		
A/C Model 1	K 7		A/C Model 2	N/A			
Injury	Minor	Damage	Write-off	Phase	Landing	PIC Age	76

The low hours pilot flew too far downwind, undershot the runway and collided with a wire fence and tree. The aircraft was substantially damaged and the pilot suffered minor injuries. The Club had only operated on eight occasions in the previous 12 months as the CFI had moved residence to another State. As a consequence its members lacked both currency and proficiency. To maintain a minimum level of competency in a specific task, it is important to perform the task on a regular basis. The new CFI noted that contributing factors included low currency, misjudged circuit angles, strong sink on final approach and unsuitable terrain for landing short of the airfield boundary.

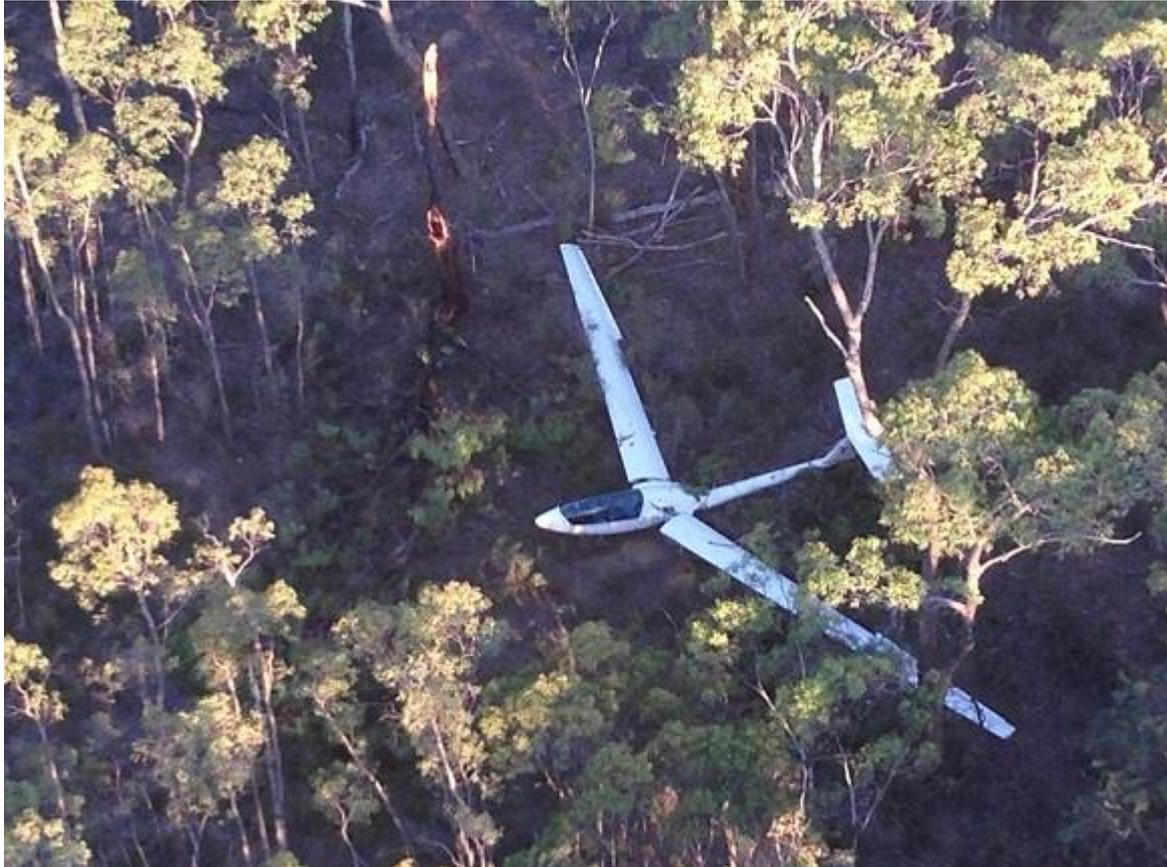
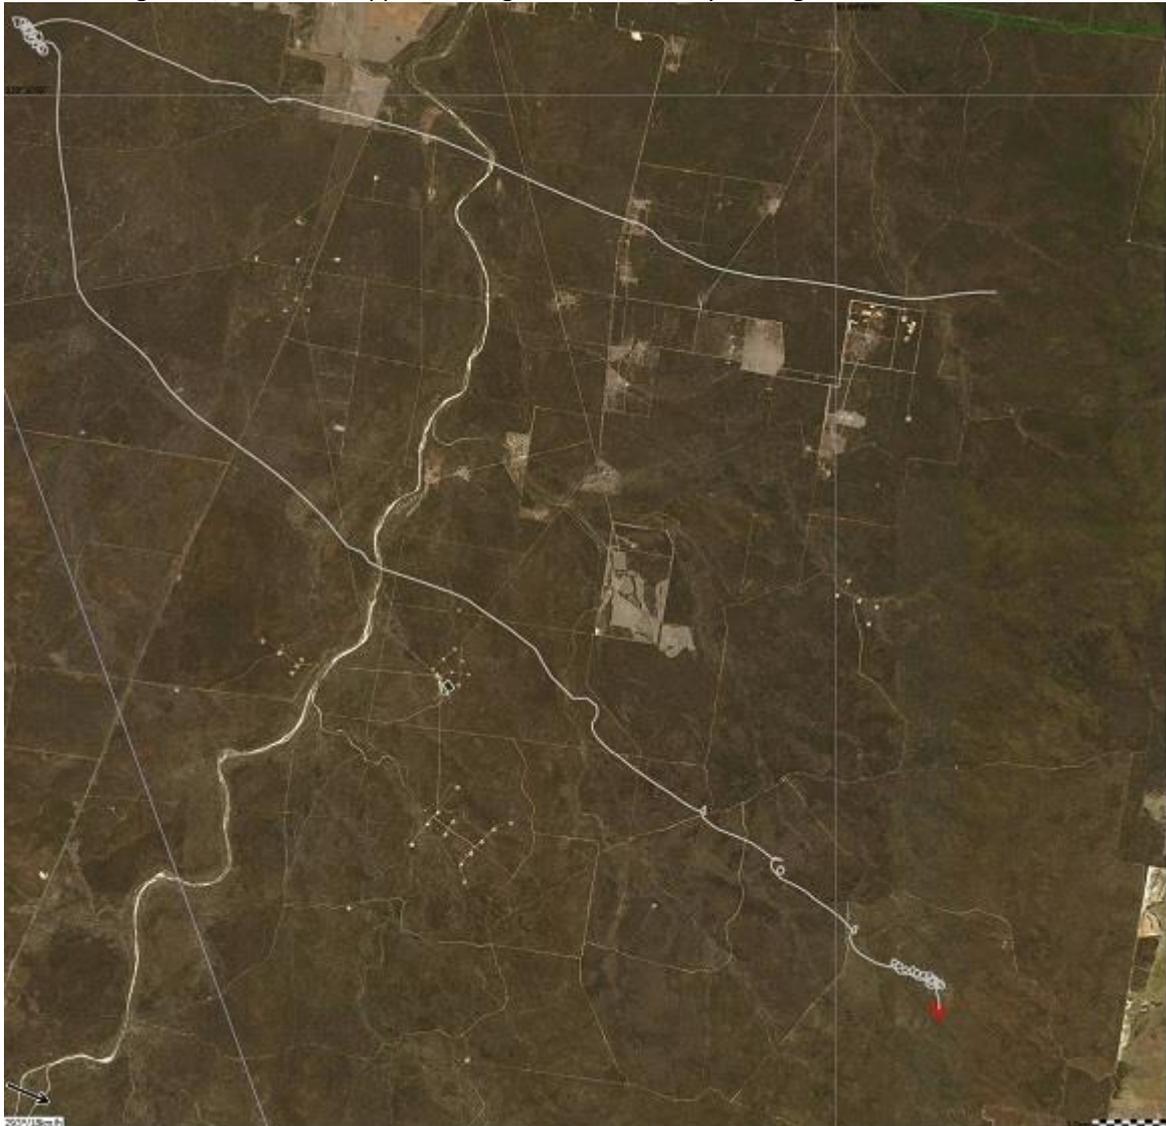
the pilot got low over the Pillaga Forest and was unable to glide clear. The pilot conducted a controlled crash into the tree canopy and suffered only minor injury. He was able to communicate with a passing aircraft, whose pilot relayed back to the gliding base and the emergency services were contacted. The aircraft descended to the forest floor and the pilot was able to extricate himself from the wreckage. The Newcastle-based Westpac Rescue Helicopter was deployed to the scene to rescue the pilot because the terrain was inaccessible for emergency crews on the ground. The pilot did not require hospitalisation and was flown back to the airfield from which he had departed earlier that day.

cumulus on track and assessed he could glide to the far side of the forest at best LD if he did not encounter any lift. The pilot flew over the forest but was unable to connect with any lift and found himself in a position where he was unable to glide clear. Buoyed by the presence of working cumulus in the distance, the pilot pushed on and applied himself to working lift and assessing his landing options. Between 2,000ft and 600ft AGL the pilot encountered weak lift but found himself pushing on. At a height above ground of about 300ft the pilot encountered a weak thermal. After trying to climb in it for five minutes, the pilot made the decision that continuing was futile. The pilot broke off the flight, lowered the undercarriage and flaps, and executed a controlled crash between the trunks of two trees at low energy. The glider came to a jarring halt, 20 feet or so from the ground, and then dropped to the ground in a sideways sliding motion.
