The Gliding Federation of Australia Inc

Occurrence Summaries

01/01/2015 to 31/12/2015

The Gliding Federation of Australia Inc
SOAR Accident and Incident Occurrences

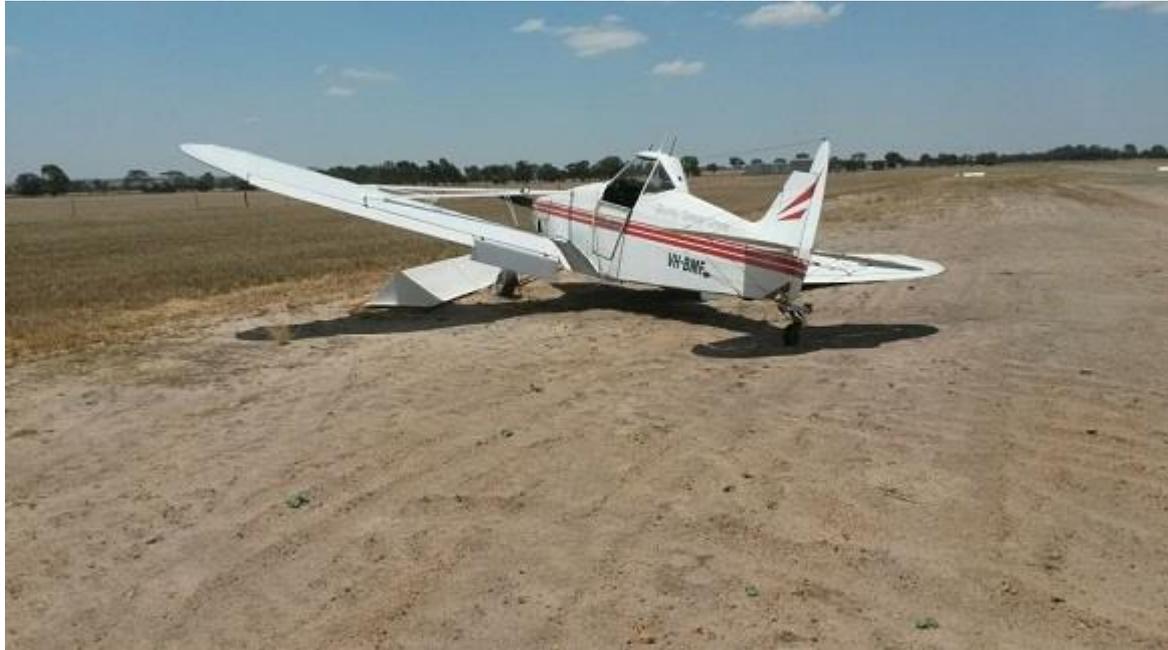
aircraft slid off the runway. During the later stages of the ground slide the aircraft nosed over, suffering a prop strike. The pilot reported strong thermal conditions, with gusting winds and a crosswind component varying up to 90 degrees.

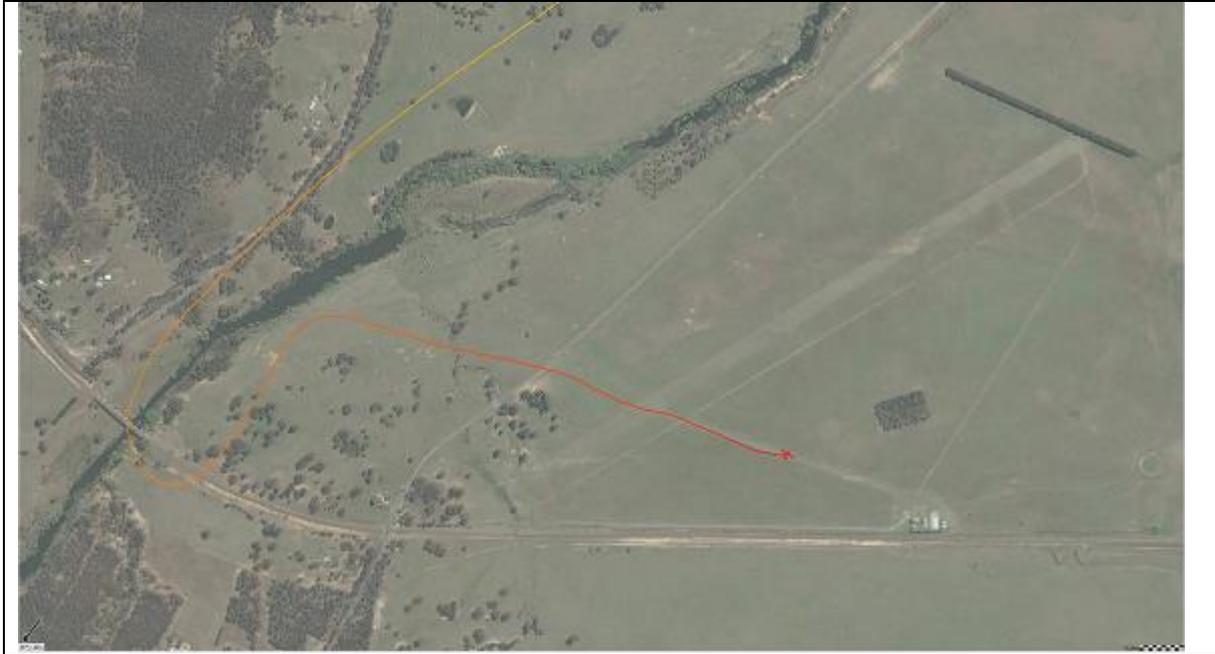
Date	28-Nov-2015	Region	NSWGA	SOAR Report Nbr	S-0627		
Level 1	Operational	Level 2	Aircraft Control	Level 3	Hard landing		
A/C Model 1	Astir CS		A/C Model 2	N/A			
Injury	Minor	Damage	Substantial	Phase	Landing	PIC Age	65

The glider launched in relatively benign weather conditions for a short local flight that was well within the capabilities of its pilot. After about one hour, the pilot decided to break off and land on the operational runway. On late downwind the pilot was advised by the Duty Pilot that his aircraft was not required for further flights, so he made a broadcast that he would land on the cross strip to be close to the hangar. The pilot executed a 180degree turn and rolled out on a short base for the cross strip. Upon turning final the pilot saw a glider being towed onto the right-hand side of the runway in the area he planned to finish his landing roll. He assessed that his best option was to land shorter as there was a risk of ground looping in long grass if he landed off the runway. With his focus on the glider and vehicle on the ground ahead the pilot did not adequately monitor his airspeed, Flight recorder data indicates the aircraft slowed to between 40 to 45kts soon after the final turn when the airbrake was deployed and remained in this speed range for most of the final approach. When the pilot commenced his round-out, the aircraft stalled and rapidly descended several metres to the ground. The pilot did not close the airbrakes in response to the high descent rate and the aircraft landed heavily. The aircraft was substantially damaged and the pilot suffered minor injury. Causal factors include: high workload; inadequate airspeed monitoring; distraction in the circuit from non-operational radio calls; the pilot's decision to change runways for convenience at a late stage in the circuit; potential low level wind shear; and landing on an occupied runway.

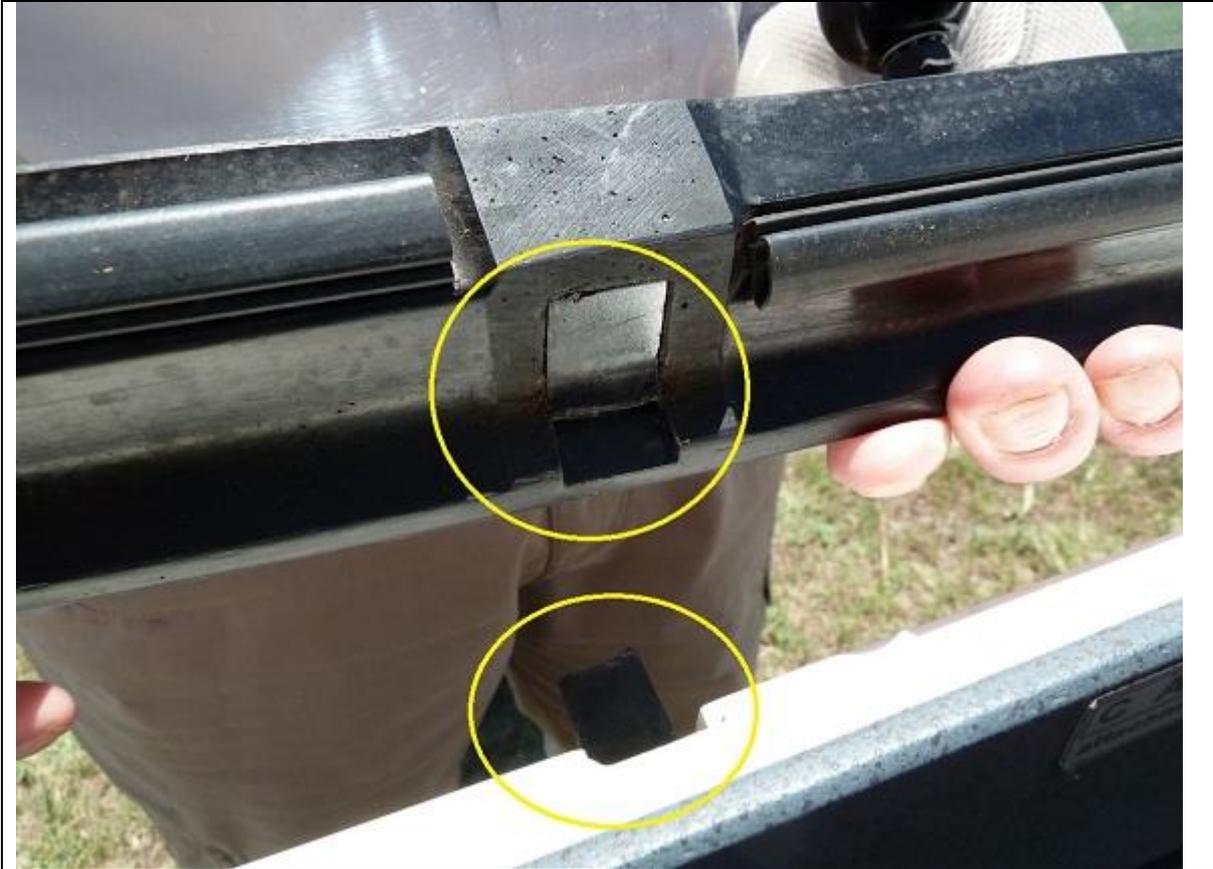
Date	30-Nov-2015	Region	VSA	SOAR Report Nbr	S-0641		
Level 1	Technical	Level 2	Powerplant/Propulsion	Level 3	Propeller malfunction		
A/C Model 1	Arcus M		A/C Model 2	N/A			
Injury	Nil	Damage	Substantial	Phase	In-Flight	PIC Age	67

After shutting down the engine it was noted that the propeller did not stop as usual and the pilot was unable to 'park' the propeller in the vertical position manually. After an uneventful landing with the engine fully extended, it was found that the propeller brake drum had disintegrated. A forensic examination of the failed drum is currently being undertaken by a Forensic Engineering Team at Defence Science and Technology Group, Aerospace Division. The preliminary investigation indicates fatigue occurred near the hub and progressed either side towards the rim, with final rupture starting relatively close to the rim. Minor corrosion was found on the fatigue fracture surfaces, indicating more than a short time from crack initiation to final failure. The Type Certificate holder has been advised and is in receipt of the preliminary report. While no other failures of this kind have been reported through the GFA reporting system, Airworthiness Alert 2015-4 has been issued alerting operators of Arcus aircraft to examine the brake system after each engine cycle for signs of failure.

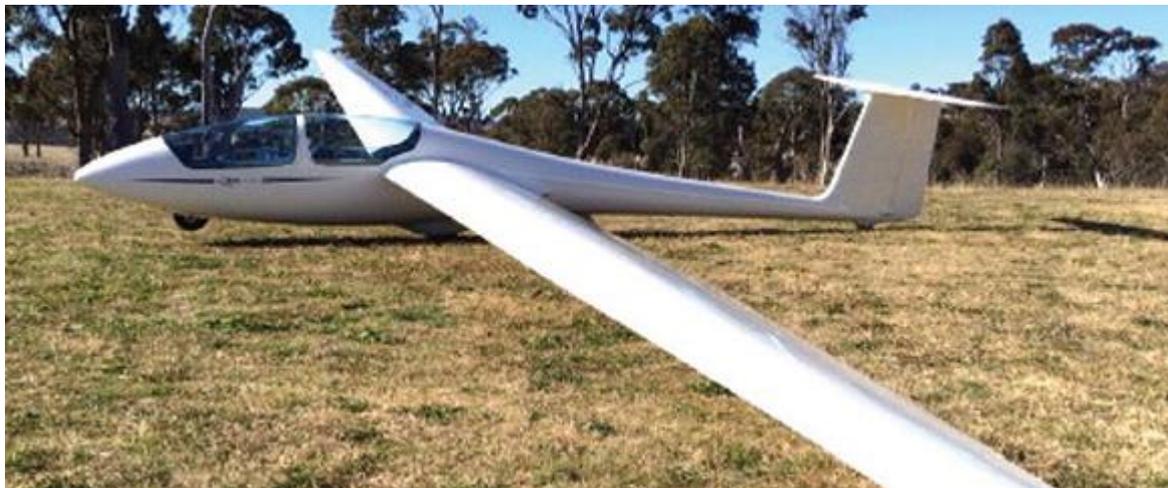
Date	19-Dec-2015	Region	GQ	SOAR Report Nbr	S-0645		
Level 1	Operational	Level 2	Aircraft Control	Level 3	Hard landing		
A/C Model 1	ASK-21Mi		A/C Model 2	N/A			
Injury	Nil	Damage	Minor	Phase	Landing	PIC Age	56

The glider bounced on landing and pitched forward onto the nose wheel incurring minor damage to nosewheel steering fork and mount. The CFI noted that this type of aircraft has minimal clearance between the ground and nose/tail wheel, which enhances the tendency for the aircraft to oscillate if the recovery from a bounced landing is misjudged. Another contributing factor was rough ground. The pilot was briefed on the issues.

File image - for illustration purposes only,
