26 May 2009

CANCELLED 14 OCT 2022
REFER GFA AN 0170
AIRWORTHINESS ALERT 2009-2. SZD-50-3 PUCHACZ

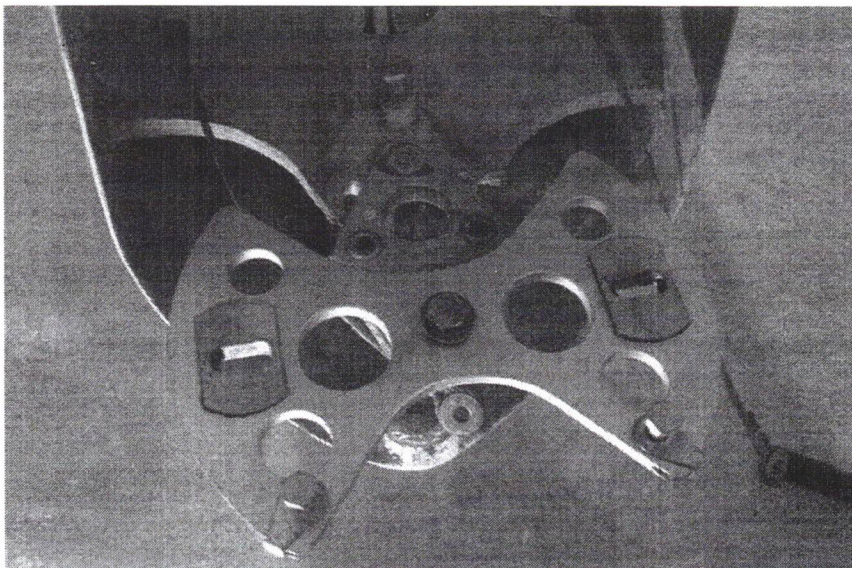
During an Annual Inspection the ply plate in the base of the fin which supports the rudder drive quadrant mounting bracket was found to be broken. Inspection of a second aircraft revealed similar damage.

The drive quadrant pivots on a steel bracket fabricated from two diamond shaped plates with side gussets & is attached to the plywood by three tubular rivets and an 8 mm bolt at the forward end. A nylon bush attached by this bolt serves as a rudder overtravel stop by limiting rotation of the drive quadrant. There are lightening holes in the upper & lower metal plates, through which the ply is visible.

The failures occurred spanwise between the tubular rivets on the left & right of the bracket, and may be visible in the lightening holes. It could be difficult to detect during a Form II and would be virtually impossible to detect during a normal DI.

When the rudder cable circuit & pedal stops are correctly adjusted the quadrant does not contact the rear stop, but incorrectly set pedal stops could permit significant foot loads to be applied to the rear stop. Violent deflection of the rudder in strong wind could also cause the quadrant to come in contact with the rear stop. This would be exacerbated by loose rear cables.

Before further flight the integrity of the plywood within the metal bracket must be checked.

4. Check the ply for damage by gentle up & down movement of the bracket while observing in the area of the lightening holes above & below. Also apply a firm rearward pulling load (by hand). Cracks may be visible in the edges of the ply, but these could well be hidden by the gussets on the sides of the bracket too. (See diagrams on Page 1)

5. If damage is detected in the ply the aircraft is not to be flown until repairs have been carried out. Contact the GFA Airworthiness office for repair instructions.

6. If no damage is found the aircraft may be returned to service. When adjusting cables ensure correct tension is applied & check rudder deflections after refitting. Deflection limits are adjusted at the pedals & if correct the rudder drive quadrant will not contact the rear stop.
