The Gliding Federation of Australia Inc

Occurrence Summaries

01/01/2018 to 31/12/2018

The Gliding Federation of Australia Inc Accident and Incident Occurrences

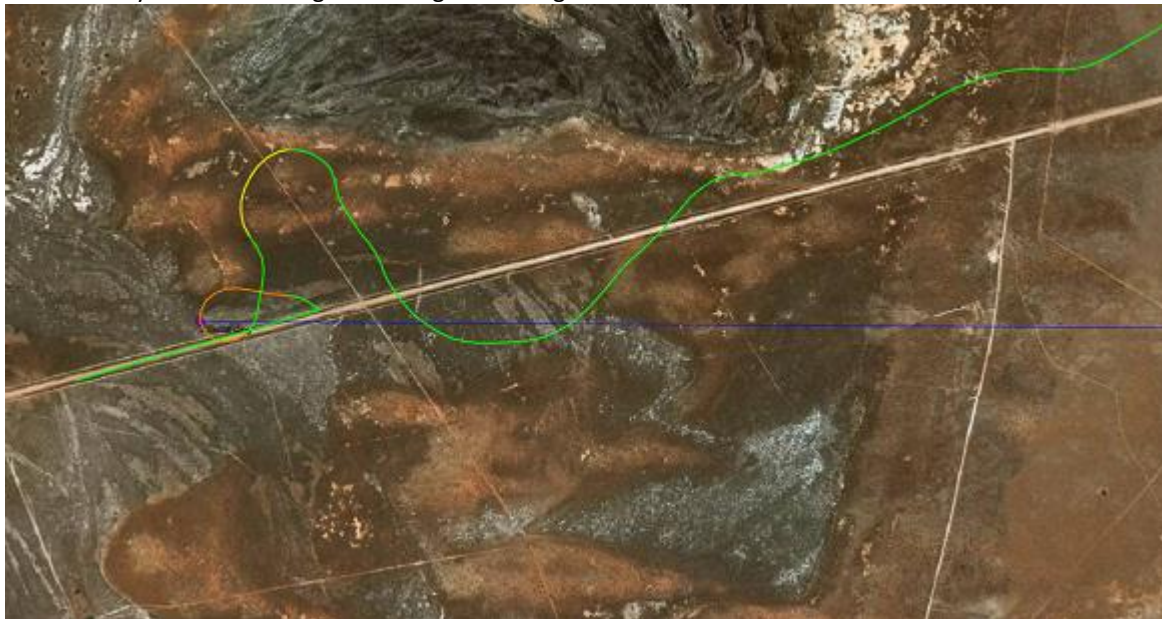
The pilot reported that dense shadow moved in quickly from upper level clouds and height was lost fairly quickly. Dust being raised from a couple of cars and caravans indicated the wind at ground level was about 5 to 10 kts from the north, almost at right angles to the main road with a crosswind from the right. The vehicles were travelling fairly fast, so the pilot knew the road must have been graded fairly recently. At around 1,000ft AGL the pilot attempted to start the jet engine to self-retrieve but was unable to raise the engine as they had inadvertently set the master switch to the circuit where the battery was not connected. The pilot stated: *"There are 8 electric switches. Four on a panel that I would call Master switches and four on an adjoining panel that selected Left, Right, or (unfitted) Centre batteries for different circuits. I had only a few flights in the glider and 2 engine starts previously. The jet "Master switch" was not an OFF/On switch (as I assumed subconsciously at the time) but an OFF/L/R switch. The up position being L = Left Battery which gave no power because I suspect it was not plugged in properly. The middle, Right, position did not occur to me and so I fiddled with the other 4 circuit, 3 position switches, to no avail."* With the ability to self-retrieve

The aircraft suffered significant damage to the lower fuselage, the undercarriage box and to the main frame immediately behind which carries the rear wing lift pins. The uncommanded retraction of the main gear also resulted in the tailwheel retracting as they are interconnected. The tailwheel retracted with vigor, over rotating the frame and punching two holes into the base plate of the tail tank. After the flight the pilot noted *"there is no question of my hydration state as I super hydrate prior to takeoff, connect myself to a catheter for flight, and pee about 1½ to 2 litres during the flight as a result of very regular drinking in flight. I also eat mixed nuts, and fruit in flight very regularly. I do believe that I was pretty peeved off with the glider – and to a lesser extent myself for letting it distract me during an unexpected out landing."* The pilot also noted that they spent the 2 weeks prior to the competition rectifying problems to get the glider ready, which eliminated planned practice and familiarity flying with the glider.

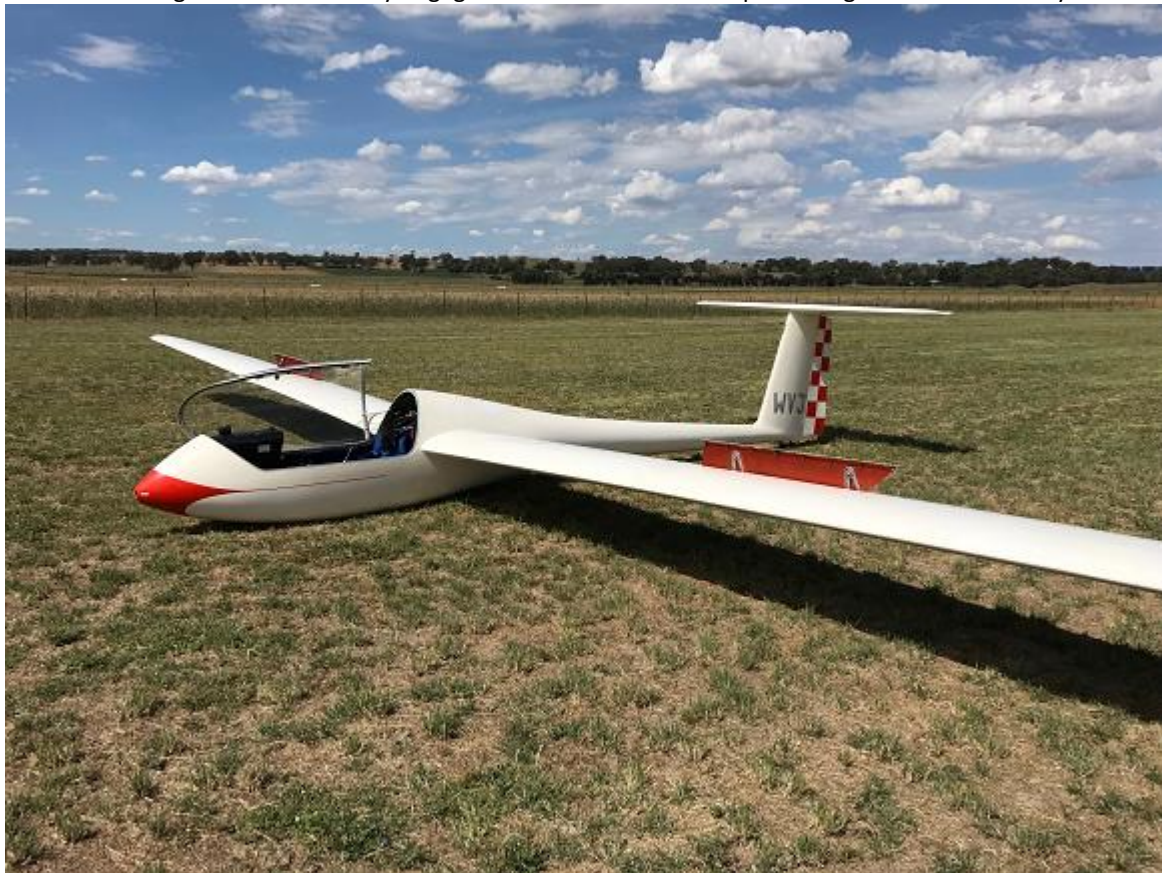
Date	13-Jan-2018	Region	VSA	SOAR Report Nbr	S-1145
Level 1	Operational	Level 2	Airframe	Level 3	Doors/Canopies
A/C Model 1	SZD-50-3 "Puchacz"			A/C Model 2	
Injury	Nil	Damage	Substantial	Phase	In-Flight
					PIC Age
					54

The pilot was conducting a private passenger flight that included some basic aerobatics comprising a spin, a loop, and a chandelle/wingover to the right. Just as a chandelle/wingover to the left was commenced, and at a height of about 2,000ft AGL, the canopy opened and the Perspex shattered. The pilot regained level flight, declared an emergency, and simultaneously headed back to the airfield. The pilot then checked on the well-being of the passenger and returned the canopy frame to the closed position. The incident occurred about 3.5 Kms south-west of the operational runway (RWY 27), and about 2 kms from RWY 01. The pilot joined downwind for RWY 27, but due to the increased drag and the high speed at which the aircraft was flying, a high sink rate ensued, and it became obvious to the pilot that a landing on the operational runway was not possible. Having flown beyond reach of RWY 01, the pilot conducted a safe outlanding in a paddock parallel to, and about 500 metres from the operational runway. No injuries were sustained.

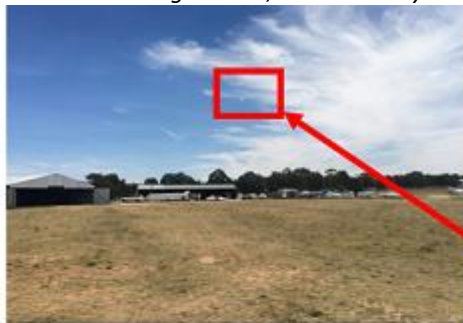
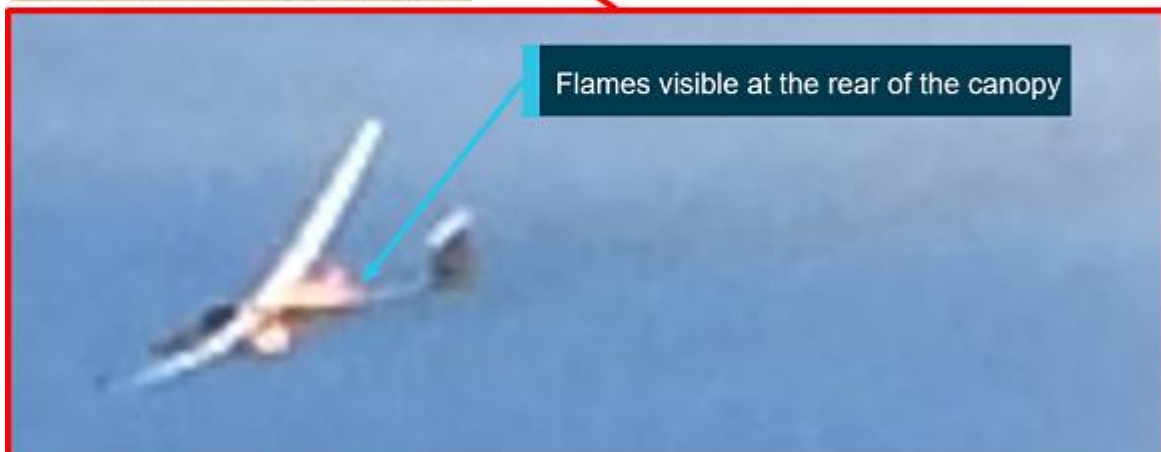
Figure 3: Photograph of GOA after the front canopy was jettisoned. Source: Witness photograph, modified by ATSB.

At this stage, GOA was seen maintaining a steep nose-down attitude and high speed with a bank angle of about 15°. Witnesses also recalled that there did not appear to be any discernible control inputs after the

canopy was jettisoned and by the time the glider descended to about 500 ft AGL, more of the fuselage was engulfed in fire. At about this time, at least one of them called emergency services. The soaring club's closed-circuit television camera recorded that the glider banked left just prior to impact (Figure 4). A witness similarly reported that the glider's left wing tip impacted the ground first, before it came to rest in an inverted position. The wreckage continued to burn after impact, and a fire spread to the surrounding grass. Some witnesses moved to the accident site with handheld fire extinguishers to control the fire. About 10 minutes later, fire services arrived on the scene and extinguished the fire before it spread to neighbouring properties. The pilot received fatal injuries and the aircraft was destroyed.

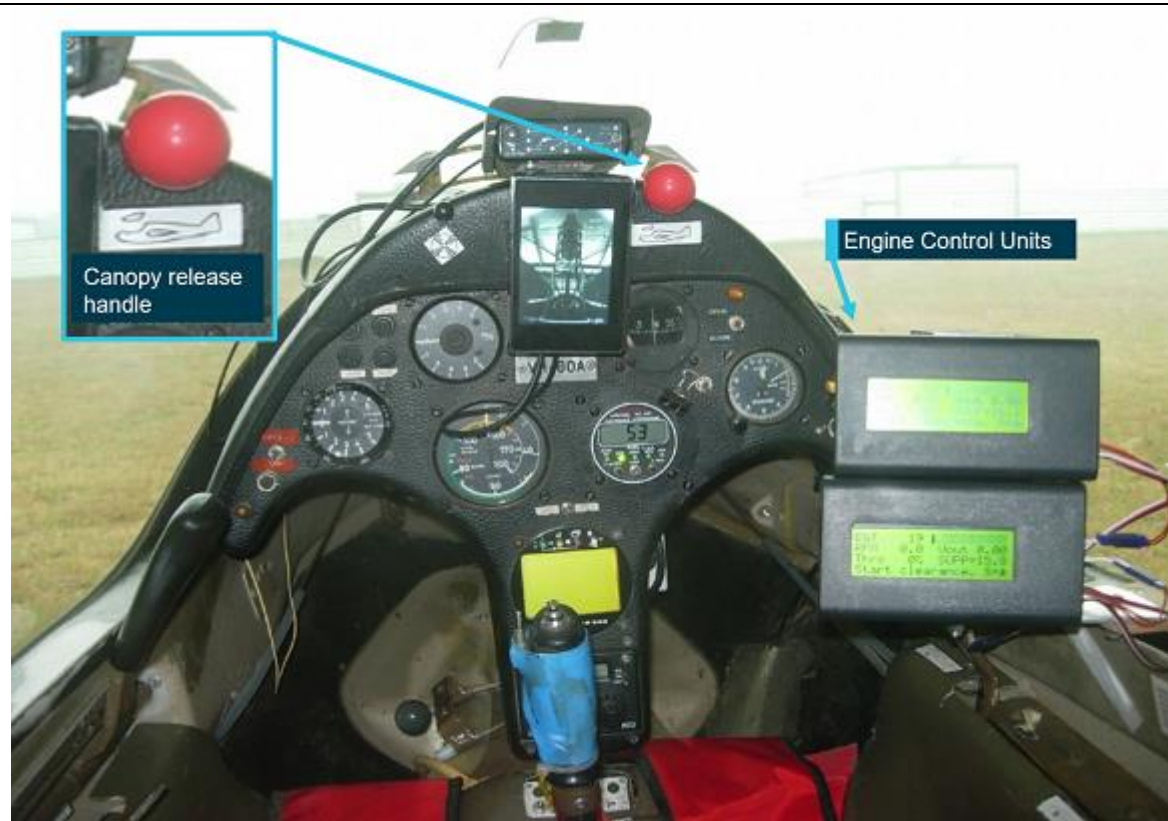
Figure 5: View from front seat in GOA's cockpit. Source: Flight Manual, amended by the ATSB

The cockpit of GOA contained two seats, one behind the other. The pilot operated the glider from the front seat on solo flights. In addition to the standard instruments, installed equipment included two engine control unit (ECU) displays, a rear-facing camera (to see the engines when operating) and an 'LxNav' flight recorder. A placarded canopy jettison release handle was positioned on the top right side of the instrument panel (Figure 5).

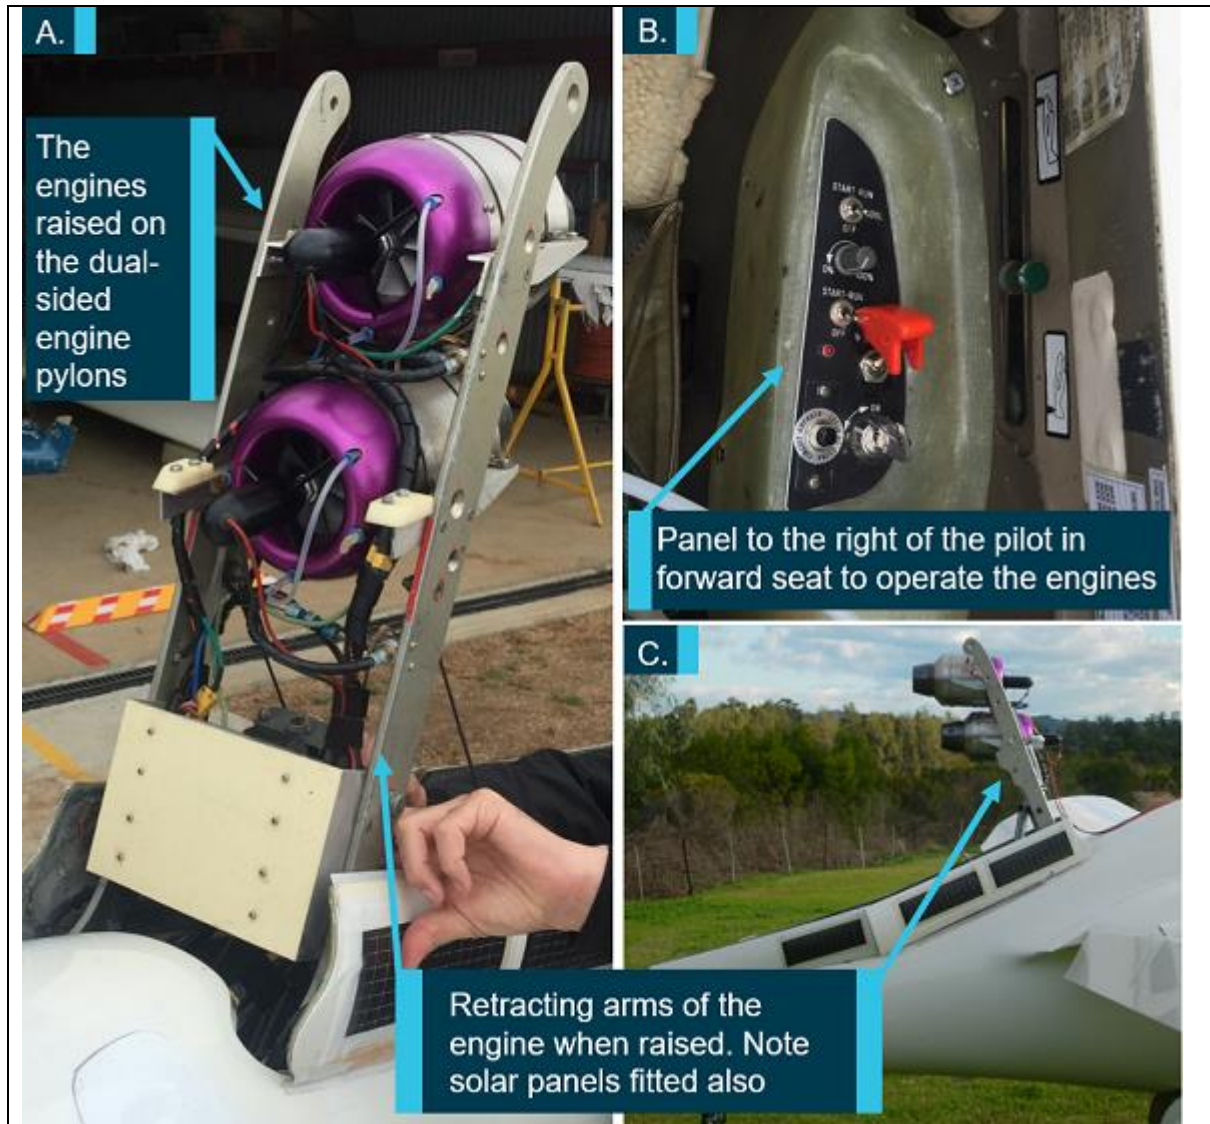
Figure 6: Images of the engines fitted to GOA. Source: ASH-215J Flight Manual

The two vertically-aligned Titan AMT Netherlands gas turbine engines were installed on the existing dual-sided pylon. The Titan was constructed from a single radial compressor and an axial flow turbine stage (Figure 6). Fuel attachments on the front cowl of the engine, with Teflon tubing and push-in Polytetrafluoroethylene (PTFE) fittings were used. The engines were housed in the engine bay when not in use, and were raised as part of the one-switch start sequence. The Titan engines' fuelling and operating speed were controlled by the two electronic control units (ECUs), which also regulated performance, and were each powered by a lithium polymer battery. The ECU displays were fitted inside the cockpit (Figure 5). The engines' ignition system was designed in a manner to prevent start-up when the pylon was lowered. In the event of an emergency, the flight manual recommended lowering the pylon, which would cause the fuel flow to stop immediately. The ignition system for the engines comprised a disposable propane gas bottle installed in the engine bay. The specially developed ASH-25J Flight Manual for GOA contained further information on the propane system:

The ATSB conducted a bench test on the fuel system plumbing, constructed from plastic tubing to confirm the product was fire-resistant. The test results showed that the tubing had high temperature resistance and did not support combustion.

Following the occurrence, the Gliding Federation of Australia published an Airworthiness Directive and Airworthiness Advice Notice, both entitled Engine Compartment Fire Containment and Retardation, which provide guidance regarding fire safety. The Airworthiness Directive requires all powered glider operators to inspect and repair fire retardant paint, fit 'in case of engine fire' cockpit placards, and ensure there is no flammable material on the cockpit side of any firewalls.

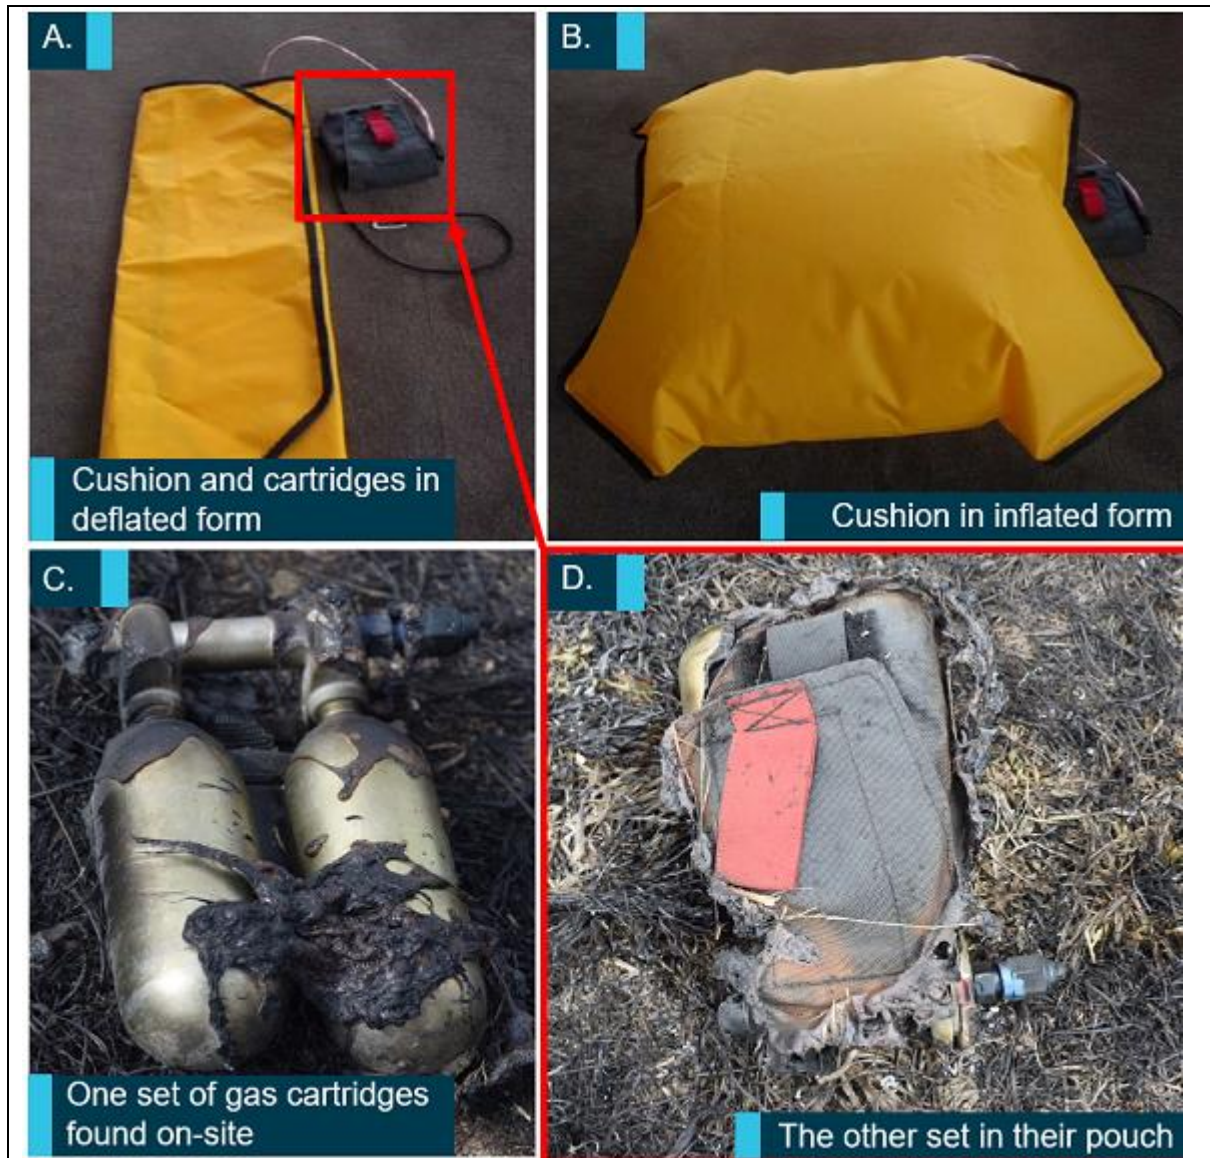
Figure 9: The components of the egress assist cushion. Source: ATSB

The pilot had designed his own egress assistance cushion to allow an easier inflight exit from the glider, particularly if the occupants needed to egress in the case of a mid-air collision. It consisted of two hermetically-sealed carbon dioxide cartridges from commercially-available life jackets that fed the gas through to an inflatable bag via a manifold and flexible hose (Figure 9). Using it required both hands – one to steady the pouch, and the other to manipulate a lanyard. In the case of an emergency that required abandoning the aircraft, the pilot would jettison the canopy first, undo the seat harness, open the flap of the pouch to reveal a lanyard attached to the actuators, and then pull the lanyard to activate the flow of gas. Due to the extent of fire damage, it could not be determined whether the pilot deployed the egress assistance cushion.

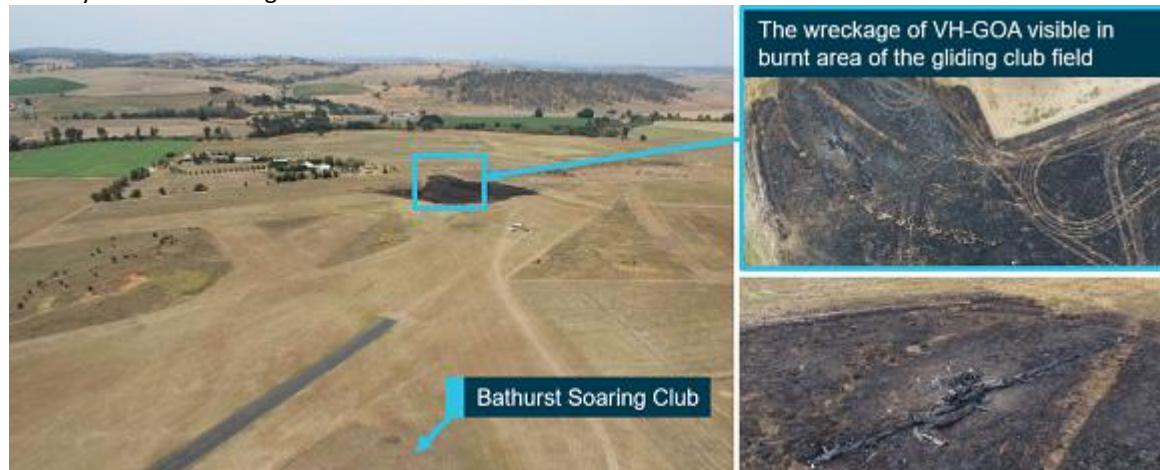
Figure 10: Location of the wreckage on the Bathurst Soaring Club property. Source: ATSB

The aircraft wreckage was located in a large burnt patch of grass on the property of Bathurst Soaring Club, about 445m away from the threshold of airstrip runway 03. The wreckage trail was spread across about 125m. Ground scars and evidence from the wreckage indicated that GOA impacted the ground in a nose-down, left wing configuration in a northerly direction, then rolled or tumbled after the initial impact and came to rest inverted. It was determined that the impact sequence was likely not survivable. The in-flight

fire continued and spread to the surrounding area (Figure 10). The shattered components of the canopy, as well as the GPS unit and flight recorder, were found on private property adjacent to Piper's Field, about 440 m away from the fuselage.

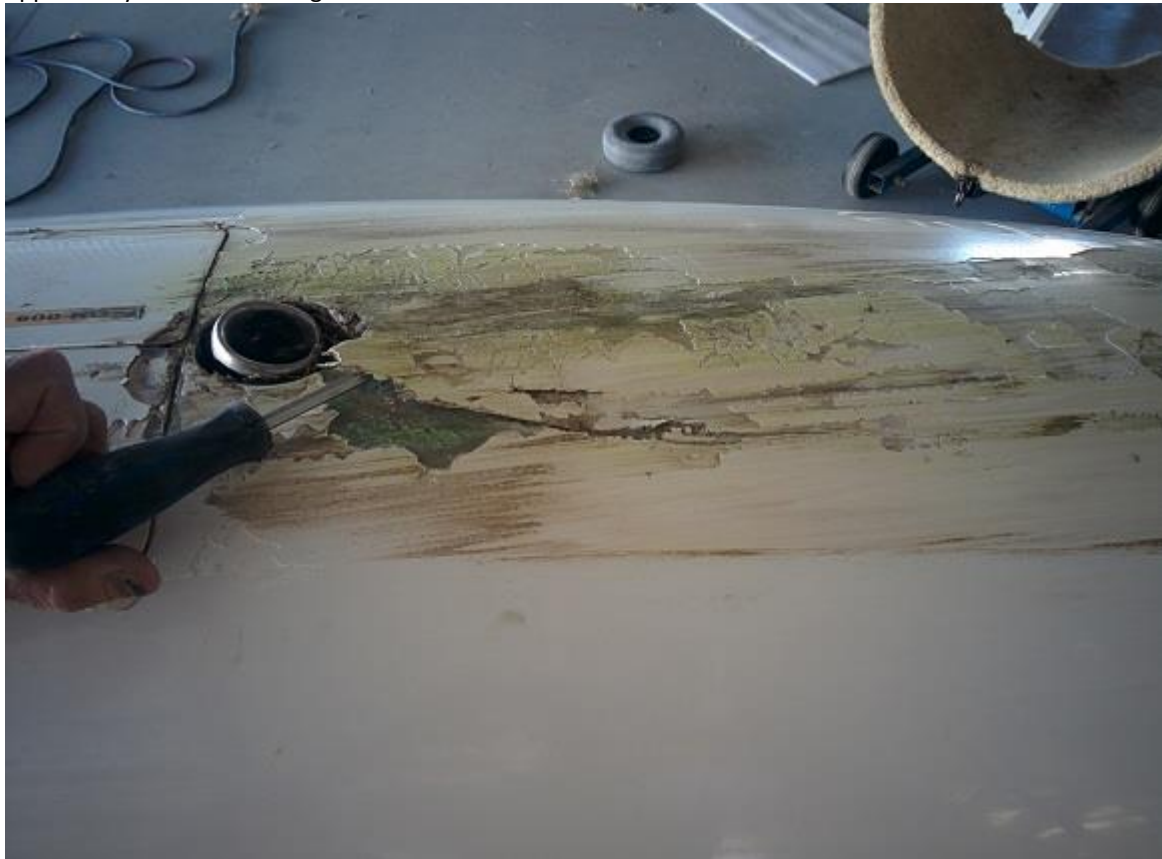
Level 1	Operational	Level 2	Aircraft Control	Level 3	Wheels up landing
A/C Model 1	DG-300 Elan			A/C Model 2	
Injury	Nil	Damage	Substantial	Phase	Outlanding
				PIC Age	65

While returning from a 300km cross-country flight, and when about 17kms from the home airfield, the pilot landed in a paddock with the undercarriage retracted. Although the pilot was unhurt, the aircraft suffered substantial damage to the fuselage due to small rocks. The flight trace showed the pilot joined a downwind leg for a low and tight circuit into the paddock at about 500ft AGL. Despite going mentally through the pre-landing check, the pilot did not physically check the position of the undercarriage lever. The pilot stated: *"I identified the wheel lever early on but decided to leave the wheel up ...to keep performance up a bit longer. When I did my (pre-landing) checks I identified the wheel lever again but thought I had lowered it already."* The pilot's failure to extend the undercarriage was consequent of a high workload following a late decision to select a suitable landing area due to task fixation. It was also noted that despite the pilot's aim to finish the task at the minimum height for a safe circuit, investigation revealed the pilot had been using a '0' McReady setting and had not properly set-up their navigation device or added a margin for circuit (arrival) height. Review of the flight log also revealed the navigation device had been indicating the glider was close to a final glide for some time, and that the pilot passed through weak lift and did not avail themselves the opportunity to take advantage of the tailwind home.

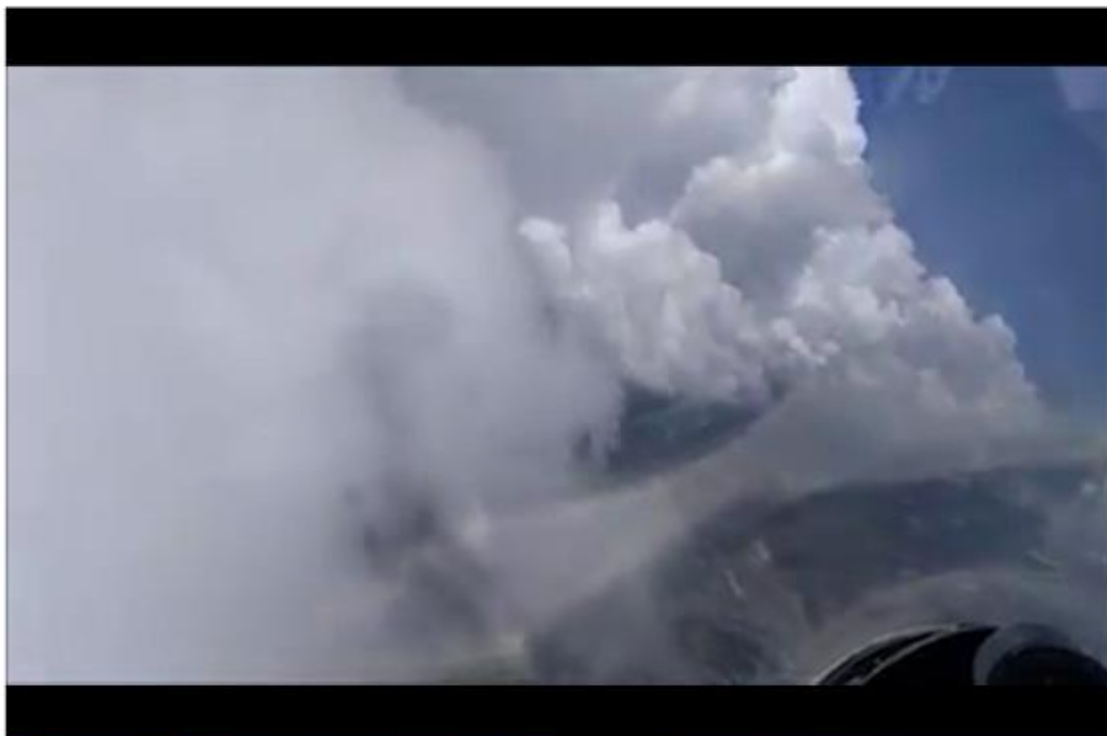
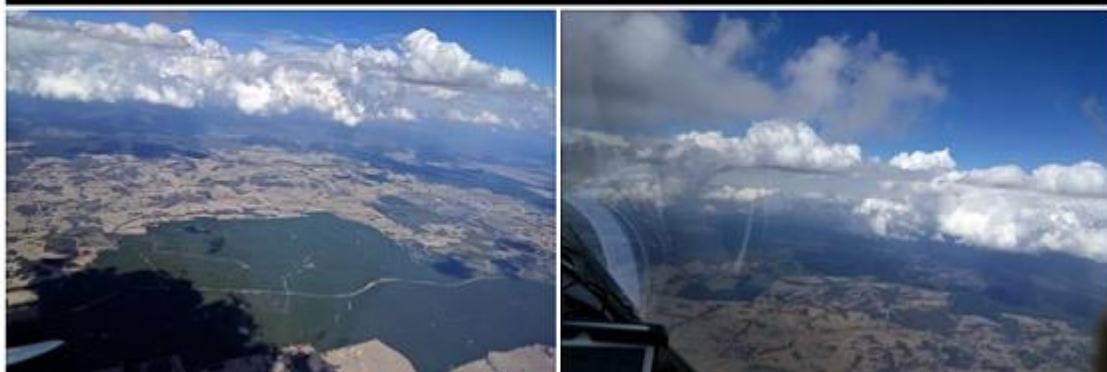
Date	4-Mar-2018	Region	NSWGA	SOAR Report Nbr	S-1222
Level 1	Operational	Level 2	Flight Preparation/Navigation	Level 3	VFR into IMC
A/C Model 1	Mosquito			A/C Model 2	
Injury	Nil	Damage	Nil	Phase	In-Flight
				PIC Age	57

The pilot failed to maintain flight in VMC and flew near and through cloud in contravention of the Visual Flight Rules. The incident was identified via the pilot's posts to social media. the pilot was counselled by their CFI.

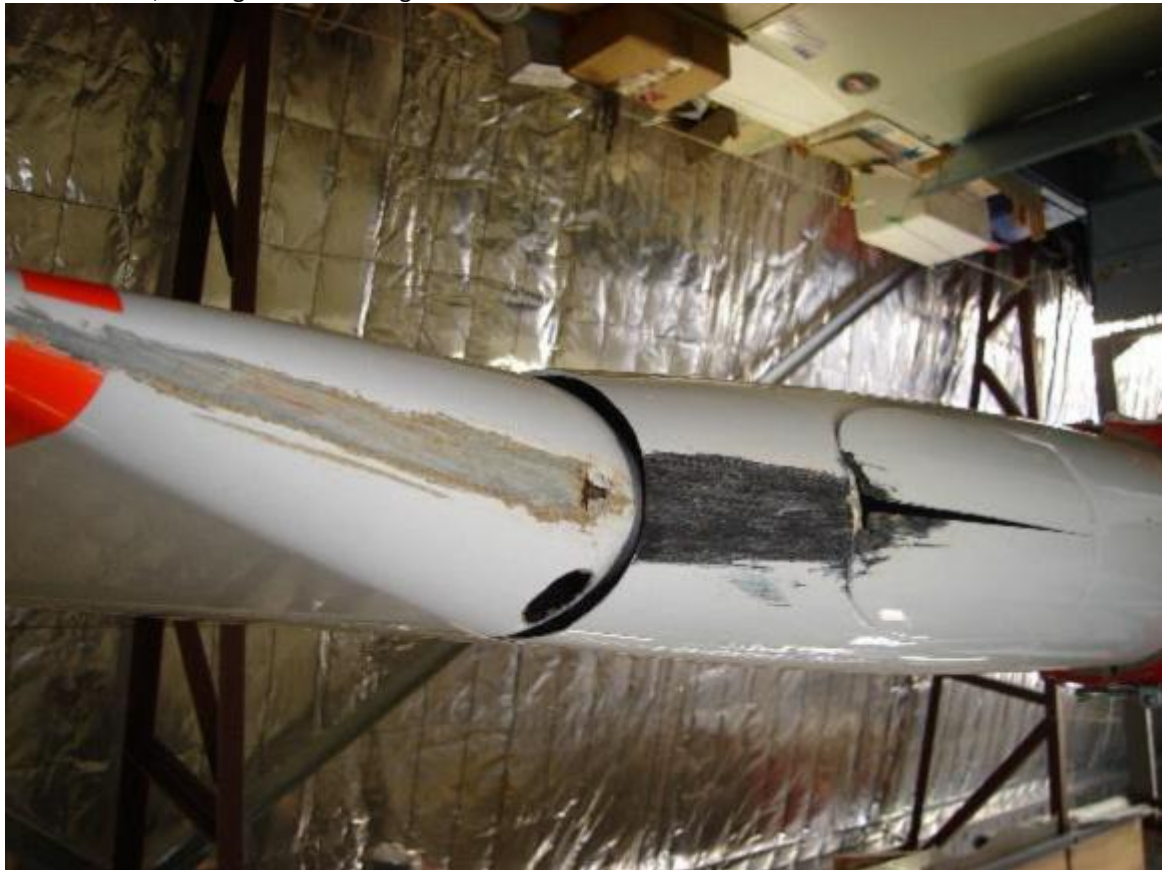
Date	17-Mar-2018	Region	WAGA	SOAR Report Nbr	S-1205
Level 1	Operational	Level 2	Airframe	Level 3	Landing gear/Indication
A/C Model 1	JS3			A/C Model 2	
Injury	Nil	Damage	Minor	Phase	Landing
				PIC Age	56

The pilot reported the tailwheel retracted during landing, resulting in minor damage to the rear fuselage and rudder. Investigation revealed retraction resulted from incorrect assembly, rigging and setting of the swages in the retraction system leading to failure of the actuating cable. The local agent, in conjunction with the manufacturer, redesigned the cabling to the tail wheel and increased the overcentre on the tail wheel.

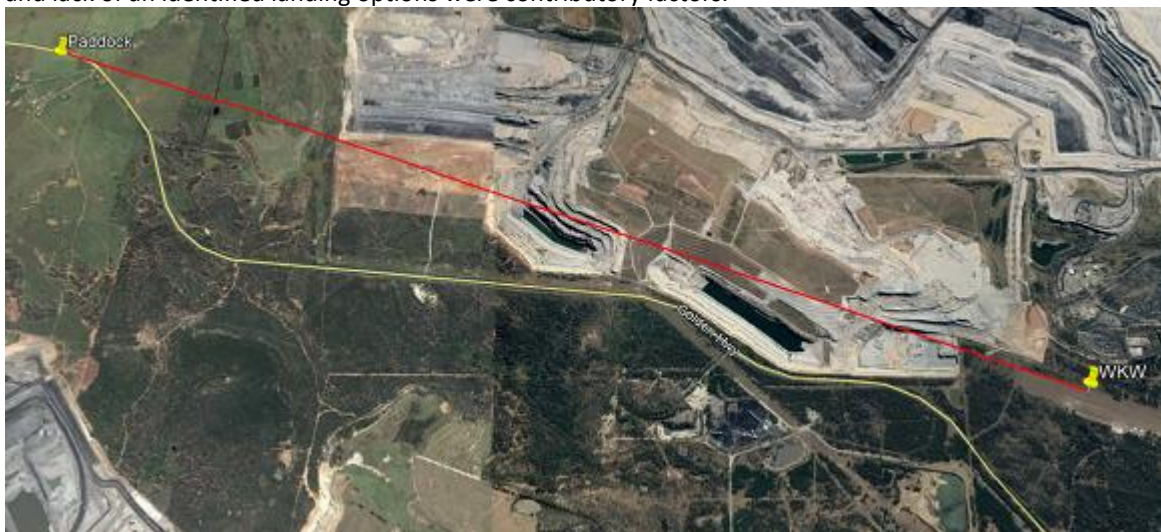
Date	22-Apr-2018	Region	NSWGA		SOAR Report Nbr		S-1242	
Level 1	Operational		Level 2	Runway Events		Level 3	Runway incursion	
A/C Model 1		Apis M			A/C Model 2			
Injury	Nil	Damage	Substantial	Phase	Outlanding		PIC Age	70
<p>The pilot reported ground-looping the glider during an outlanding when the engine failed to start. The pilot had been on a cross country flight was returning to the home airfield. At a height of around 1700' AGL some 5kms from the destination, the pilot realised they were below glide slope unlikely to make it back, and so attempted to start the engine. Although the engine started it would not continue to run. The pilot kept trying to start the engine to no avail, during which time the glider flew past the only suitable landing paddocks. Running out of height and with no landing options ahead, the pilot turned through 180 degrees and landed downwind in the nearest landable paddock with the engine still extended. During the ground roll the pilot initiated a ground loop to the left to avoid running into the end fence. The glider slid sideways for about 20 meters before coming to rest about 10 meters from the fence and facing 90 degrees to the direction of landing. The glider was substantially damaged, with cracks in at least three places on the fuselage just aft of the port wing trailing edge. The CFI reported that the pilot had not conducted an outlanding for over 10 years and that this lack of currency, coupled with the late decision to start the engine and lack of an identified landing options were contributory factors.</p>

A common reason for powered sailplane outlandings going wrong is the pilot's mindset of expecting the engine to start first time and not having any other plan. GFA training requires all glider pilots to remain

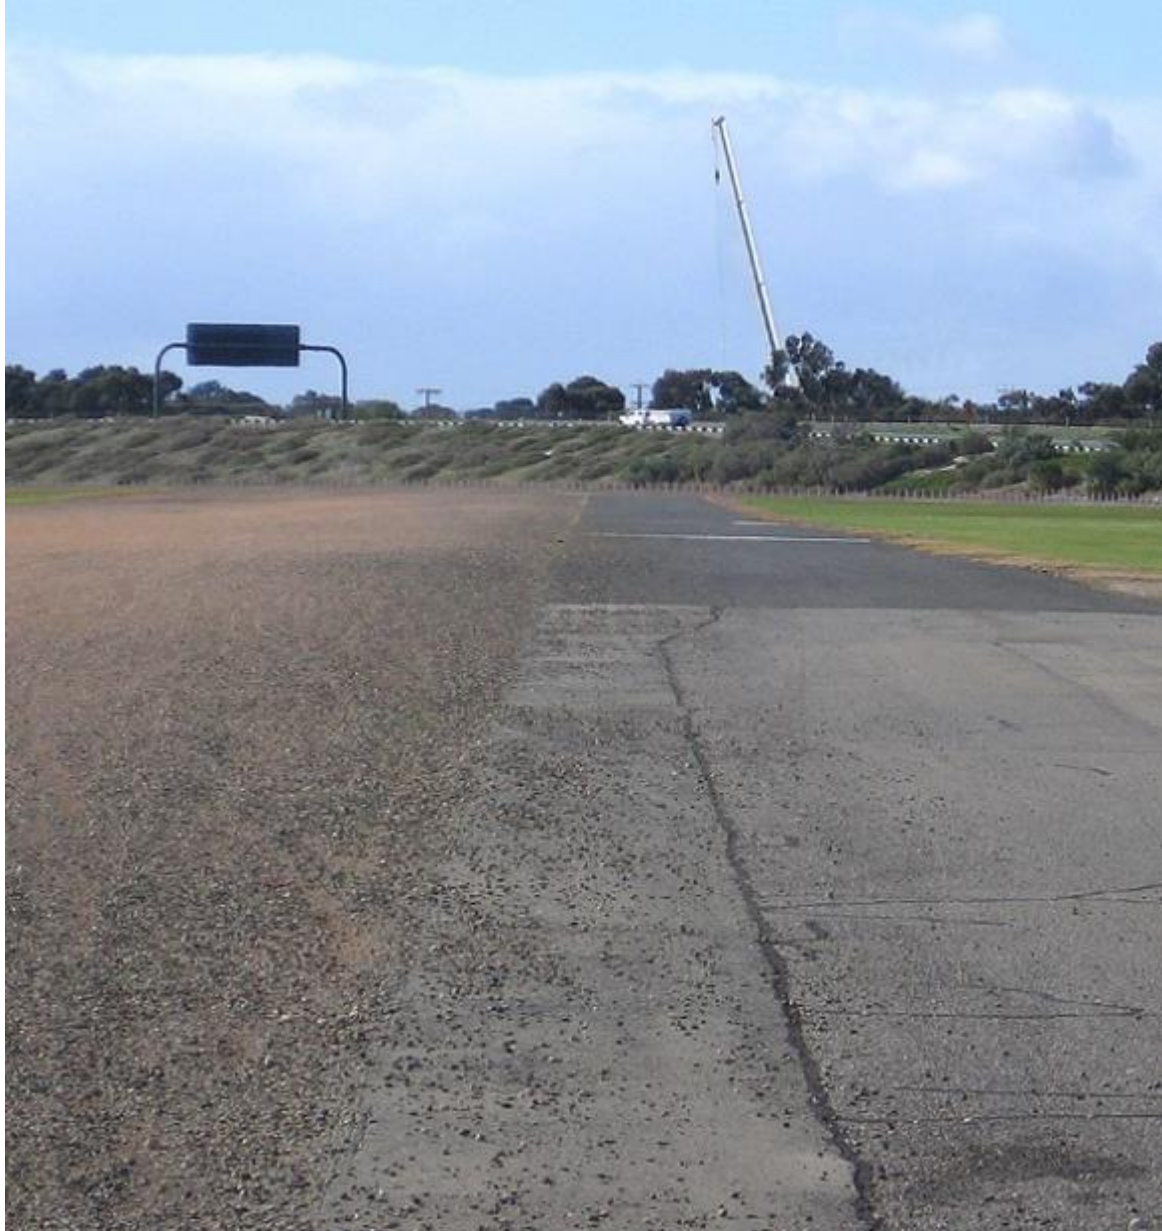
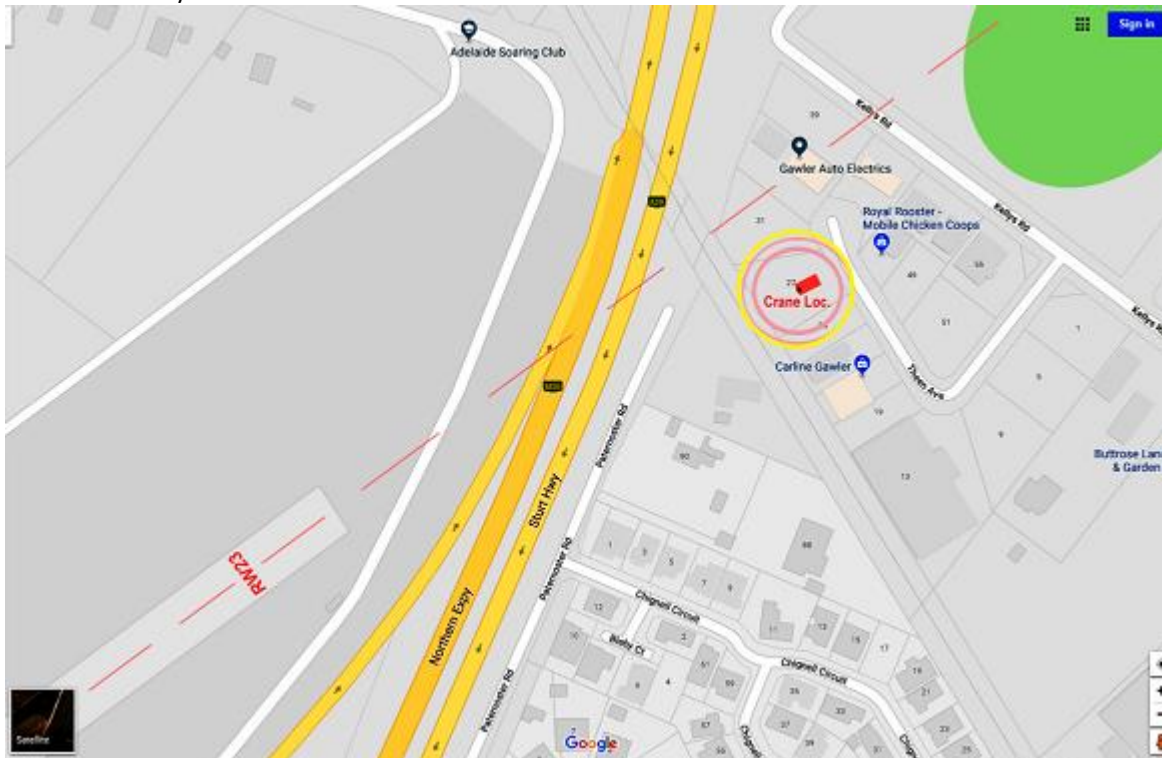
At Gawler aerodrome a mobile slewing crane was observed operating up to a 30-metre height within 100 metres of the runway 23 threshold and displaced 20 meters to the south east of runway 23/05 centre-line.

As the operation of the crane posed a hazard to aircraft landing and taking off, the aerodrome manager met with the construction team and crane operator. Despite voicing concerns and being given undertakings that the operating height would be reduced, the crane continued to be operated at 30-metres for the next two-and one-half days.

- Safe Work SA;
- CASA Airports Inspection;
- The Airports Act 1996;
- The Airports Regulations 1997; and
- CASR 139.265 Registered aerodromes. It was determined that there were no rules or regulations preventing the operation of the crane in that location. Two weeks later the crane operator returned but this time spoke with the aerodrome manager beforehand and some risk management measures were put in place. After some pushback because Gawler was not a certified aerodrome, the aerodrome Manager arranged with CASA to issue a FIR NOTAM advising of the hazard.

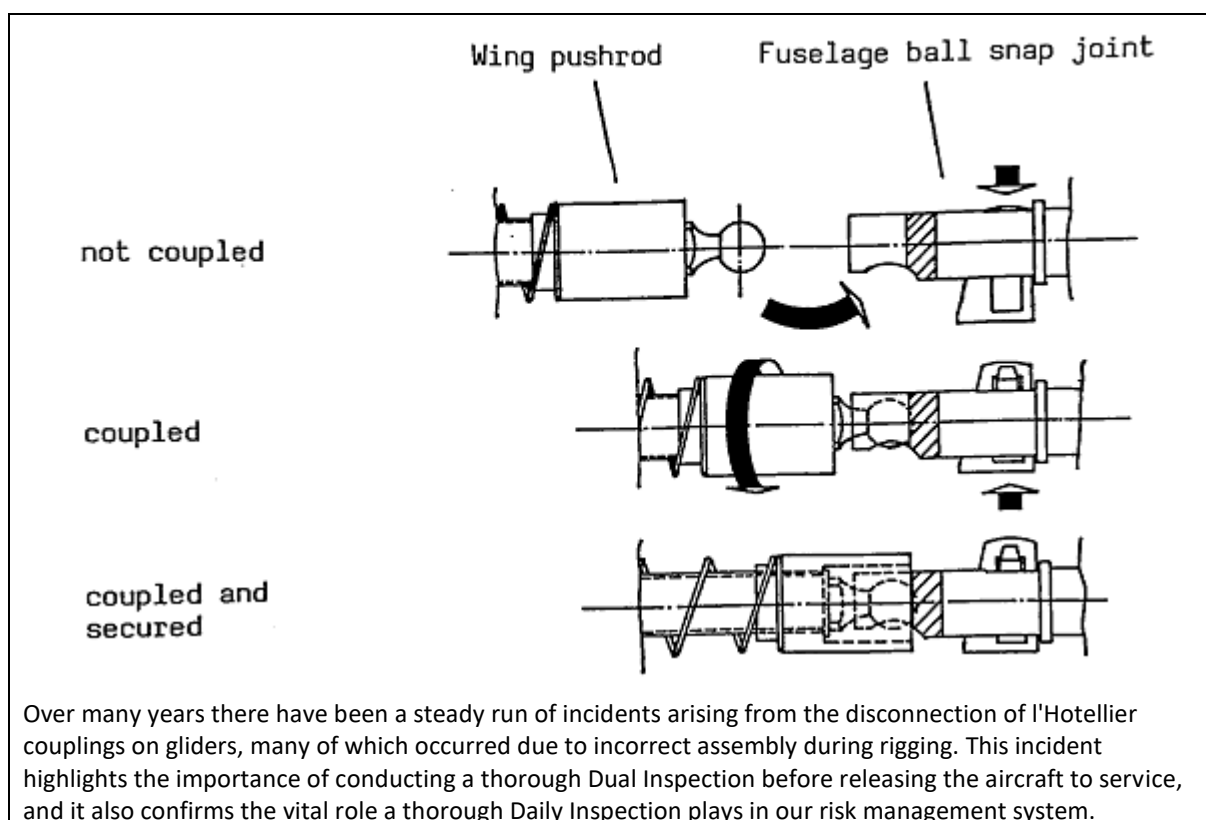
Date	28-Jul-2018	Region	GQ	SOAR Report Nbr	S-1292
Level 1	Operational	Level 2	Aircraft Control	Level 3	Loss of control
A/C Model 1	LS 6			A/C Model 2	Piper PA-25-235
Injury	Nil	Damage	Minor	Phase	Launch
<p>During take-off the pilot had trouble maintaining wings level and aborted the launch. The aircraft came to rest after a moderate ground-loop. Investigation revealed that:</p> <ul style="list-style-type: none"> one of the aileron ball snap joints was not properly secured and had disconnected; and a dual-check post rigging was not undertaken. The aircraft owner had completed the Daily inspection that morning but neglected to have the L'Hotellier couplings independently inspected. The lack of a dual certification in the aircraft Maintenance Release went unnoticed by the pilot. The ball snap joints of the aileron system are secured by turning the LS-sleeve over the joint as far as possible (see the drawing below).

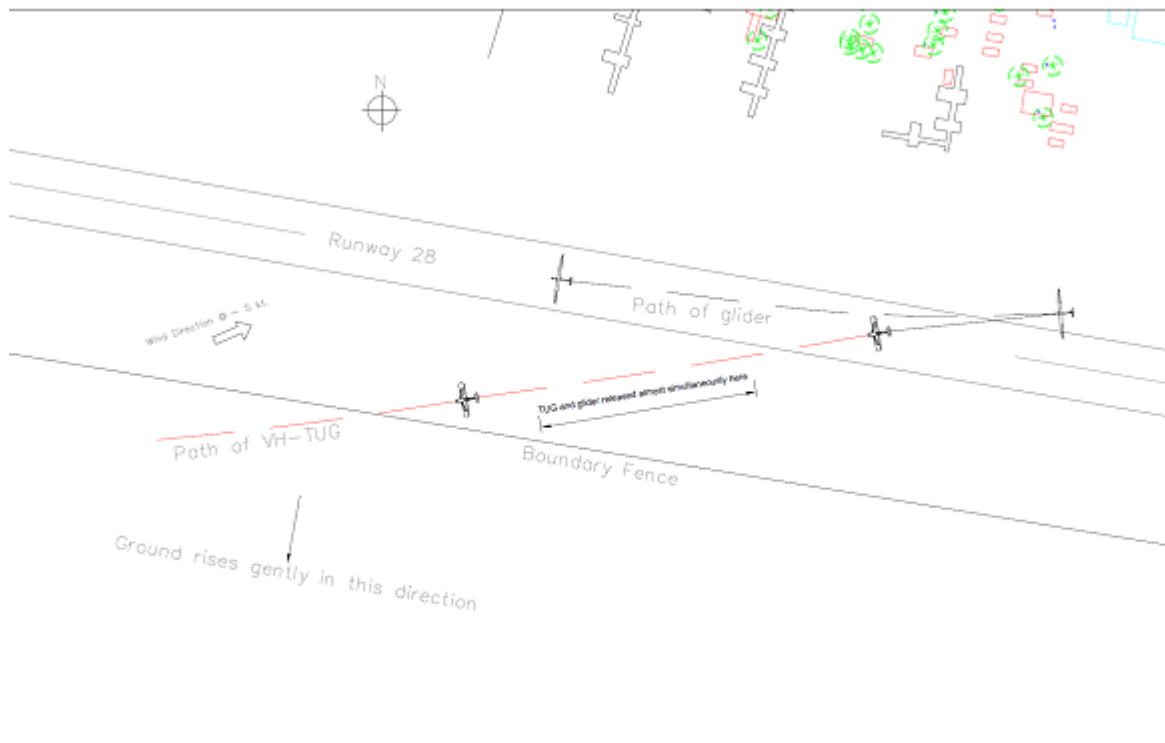
airborne and crossed the boundary fence at low level, and the glider pilot taxied to a stop along the runway centreline. The tow pilot conducted a modified circuit and landed safely onto the operational runway. Investigation identified the following factors contributed to the tow plane's lack of directional control during the take-off run:

- The two rope was line-astern with the tow plane, resisting the effects of any rudder application.
- The wind, from the SW, was tending to weathercock the tow plane to the left.
- The "asymmetric blade effect" (P factor) would have been tending to yaw the tow plane to the left.
- The angle of the combination to the normal take off path was more obtuse than normal. Witnesses described the tow plane's position as being well out onto the bitumen when the launch commenced. The tow pilot was counselled about the correct procedure for lining-up in such conditions.
