The Gliding Federation of Australia Inc

Occurrence Summaries

01/01/2018 to 31/12/2018

The Gliding Federation of Australia Inc Accident and Incident Occurrences

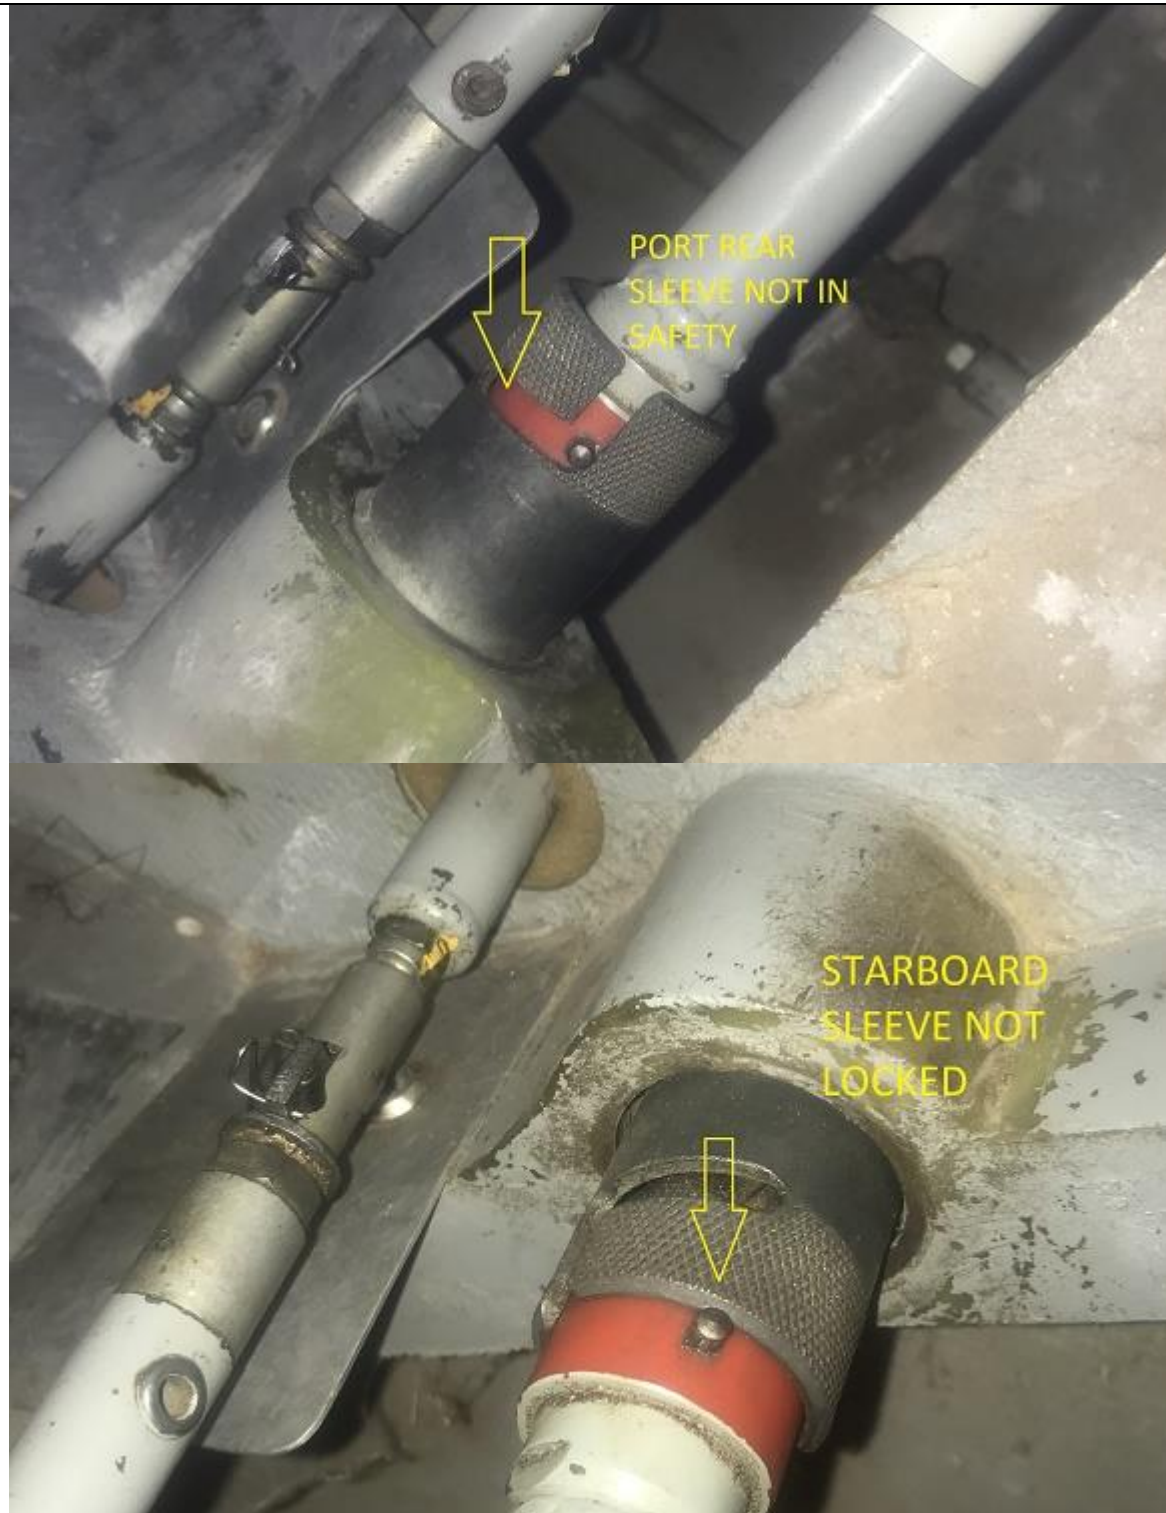
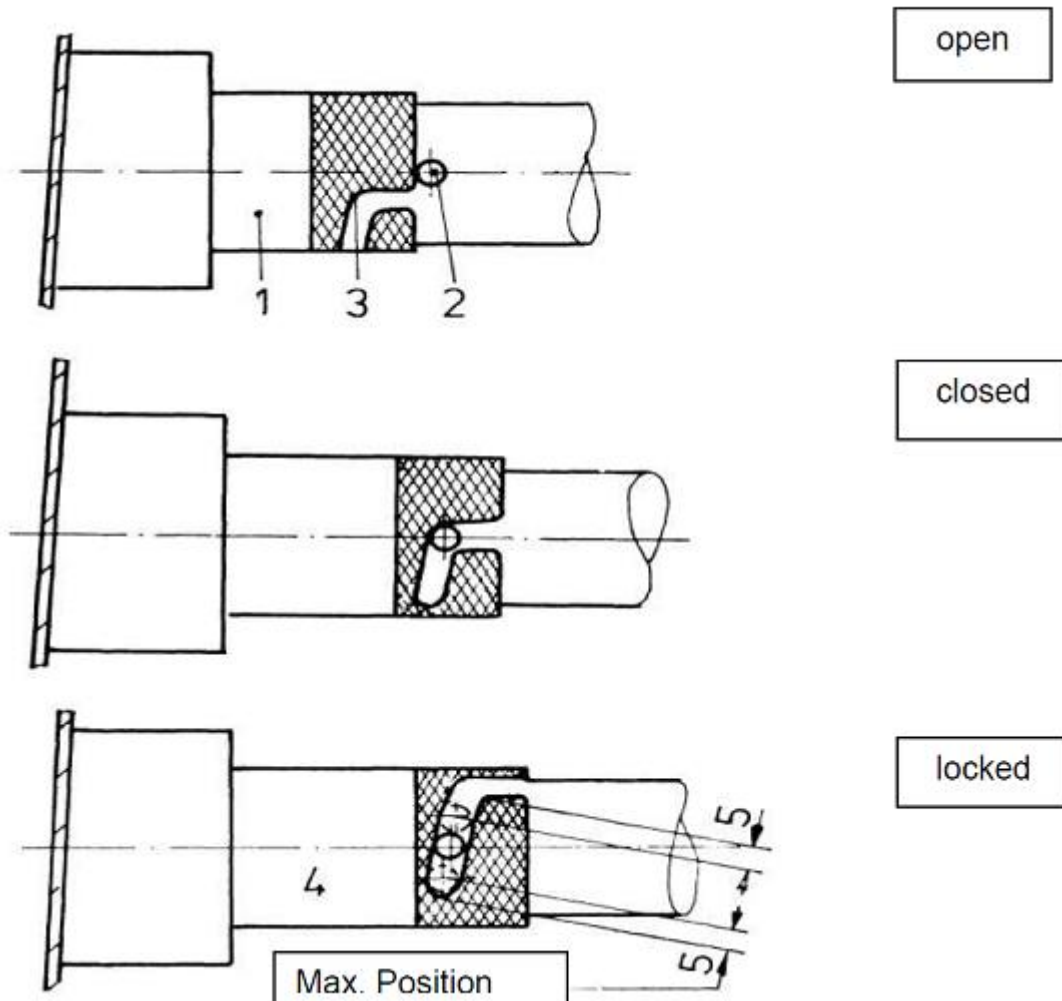
Date	10-Nov-2018	Region	SAGA	SOAR Report Nbr	S-1352
Level 1	Operational	Level 2	Airframe	Level 3	Fuselage/Wings/Engine
A/C Model 1	Astir CS 77			A/C Model 2	
Injury	Nil	Damage	Nil	Phase	Ground Ops
				PIC Age	
<p>During the daily inspection the access hatch in the top of the fuselage behind the wing spars was removed in order to confirm the control connections and wing attachments were secure. The inspector identified that the three of the safety catches on the four main wing fittings in the fuselage were locked but not secured, and one was unlocked. The aircraft had been flown on three occasions in this configuration.</p>

Investigation revealed some inspectors lacked familiarity with the rigging requirements in the Aircraft Flight Manual, and one inspector may have suffered a memory lapse (this inspector has since relinquished their authority). It was also identified that inspectors would seal the access hatch with tape once the post rigging inspection had been completed to remove the need to inspect inside once an initial inspection had been performed and signed off, and it would also hold the cover on during all kinds of flight. While taping the hatch down is necessary to prevent loss on some aircraft, the hatch must be removed to facilitate the Daily Inspection. In the case of Grob Astir types, it is also common for the locking collars to move out of safety during flight or ground handling, so periodical inspection is needed to return them to safety.

independent duplicate check of the structure and control system by Daily Inspector following rigging. However, the check relies on the person completing it to be familiar with the aircraft, which appears not to have been the case in this instance. Similarly, unfamiliarity or inadequate attention to detail by subsequent Daily Inspectors also led to the error going undetected. Pilots and inspectors should ensure that rigging is directed by a person experienced on the type, in accordance with the flight manual and without interruption or distraction. The Daily Inspection must also be conducted by a person experienced on the type and without interruption or distraction. It is worth remembering that well-meaning, motivated, experienced people can make mistakes: fatigue, distraction, stress, complacency, and pressure to get the job done are some common factors that can lead to human errors. Pilots and inspectors can minimise the risks by adhering to sound risk management practices.

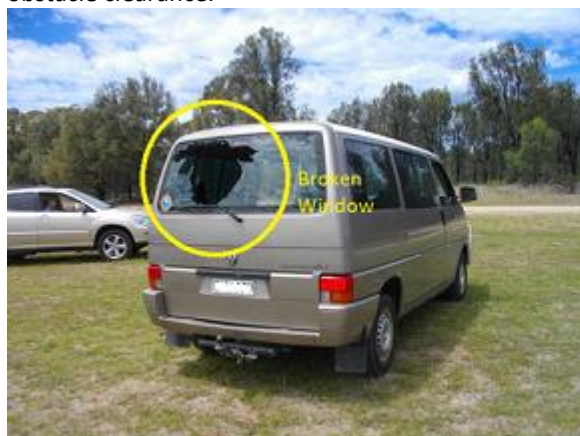
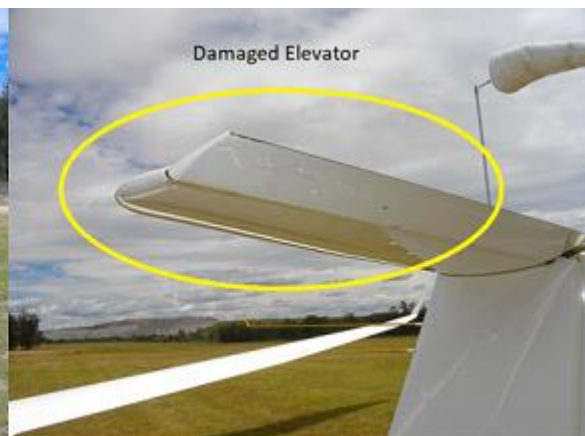
Date	25-Nov-2018	Region	NSWGA	SOAR Report Nbr	S-1372
Level 1	Operational	Level 2	Ground Operations	Level 3	Taxiing collision/near collision
A/C Model 1	Duo Discus			A/C Model 2	
Injury	Nil	Damage	Substantial	Phase	Ground Ops
				PIC Age	82
<p>The aircraft had been rigged near the main hangar and was being towed to the flight line. As a launch was about to proceed, the vehicle driver moved off the airstrip with the intention of driving between the windsock and a shed. When the driver moved off, the glider's right wingtip struck the windsock pole causing the aircraft to pivot and the left elevator tip contacted the rear window of the tow vehicle. The driver stopped, but not before the rear window of the towing vehicle was broken and the glider substantially damaged. The glider damage included: creases in the fin running from the leading edge diagonally down towards the tailwheel; scratches and punctures to the left tip of the elevator, and minor damage to the right wingtip. Contributing factors included inattention by the vehicle driver and not seeking external assistance when manoeuvring in a tight space. When taxiing gliders, drivers need to pay particular attention to obstacle clearance.</p>

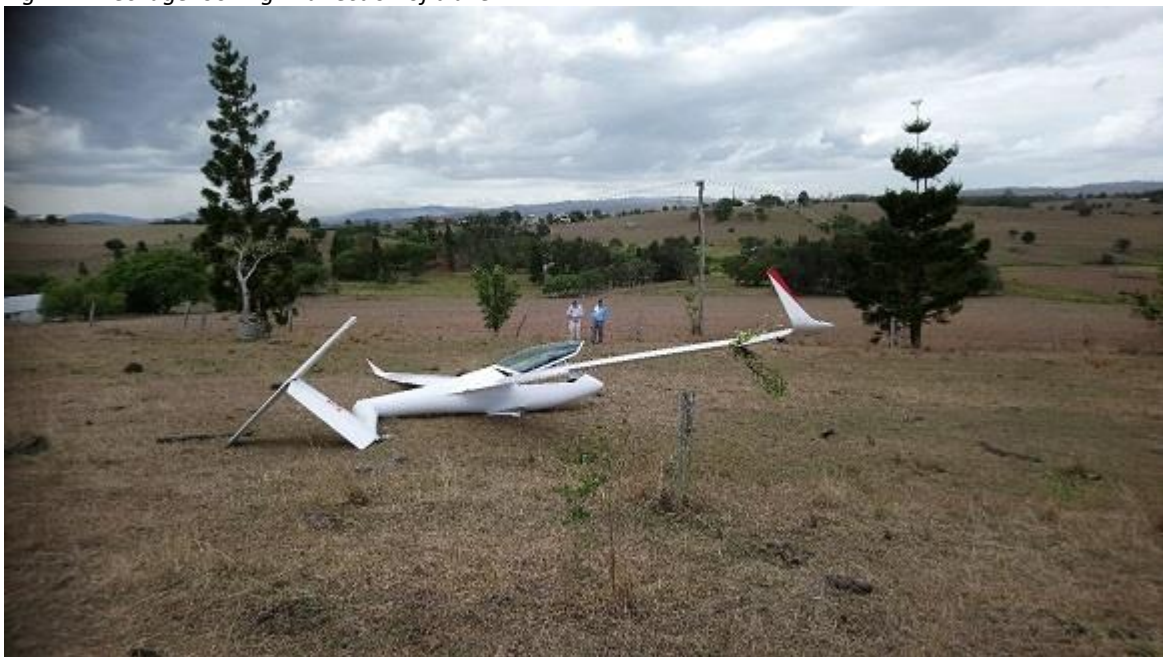
Fig 2. Wreckage looking towards the approach path.

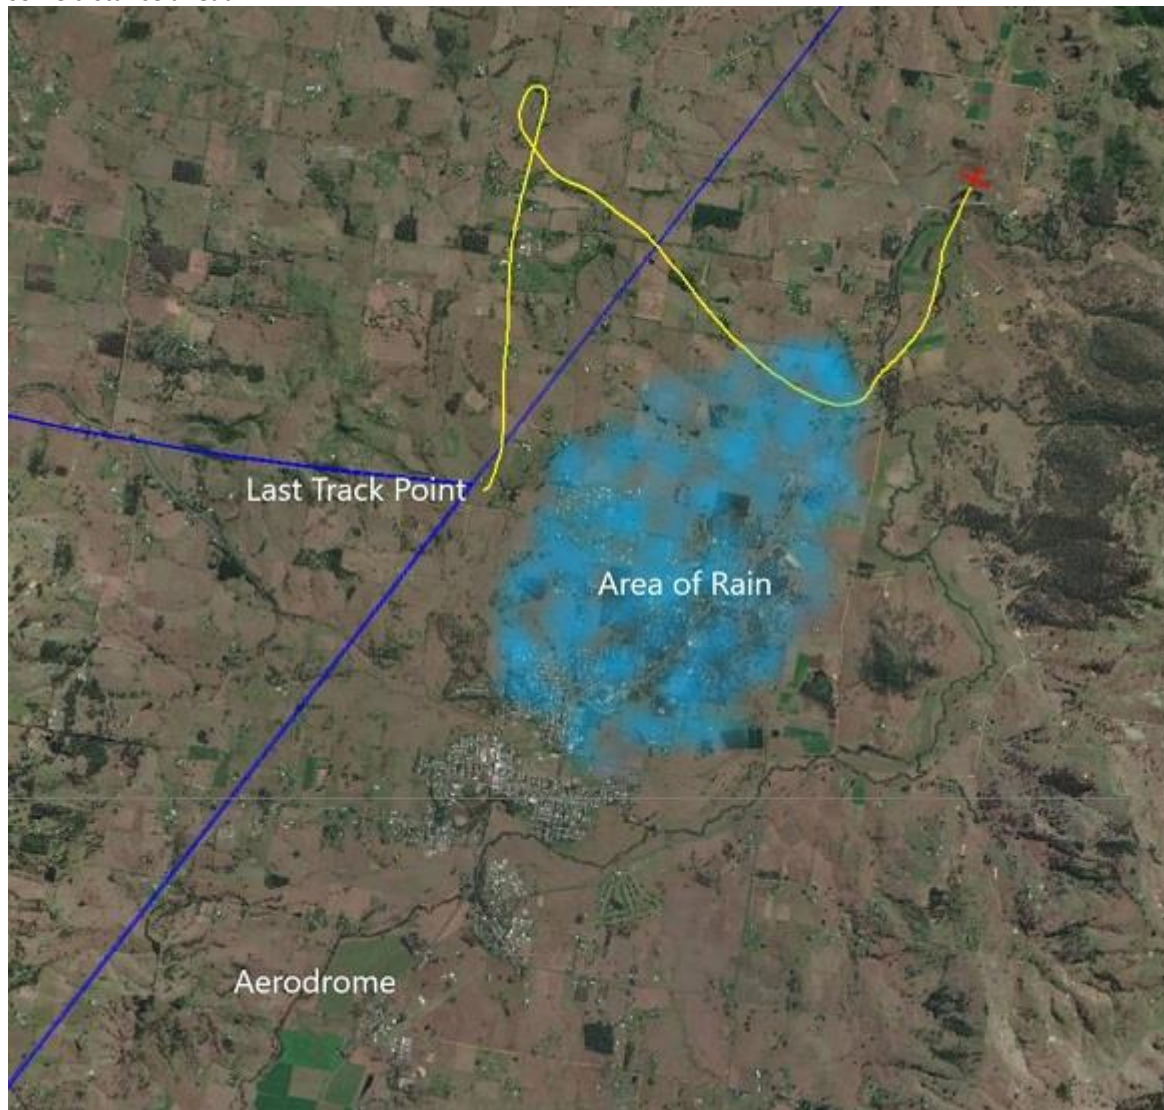
pilot noticed spots of rain appearing on the canopy from a small rain shower from the south-east and altered heading North into clear skies. The pilot continued to search for lift but was unsuccessful. When down to 3000ft about 10 kilometres to the north-east of the aerodrome, the pilot elected to return. The pilot noted: *"at that point I was in the position of flying over unfamiliar terrain and I think that the small shower that went by earlier was now obscuring the township."* The pilot initially tracked on a south-westerly heading towards the aerodrome but after a couple of minutes turned to the north-west into clear air and to avoid the rain shower that was passing to the north of the township (see Fig. 5). At this point the pilot became disoriented and continued to fly further away from the aerodrome. By the time the pilot realised his error and identified the aerodrome, the glider was at about 1200ft (900ft AGL) with 9kms to run. The pilot stated: *"After changing course again to head back in the right direction shortly after, I realised that I wasn't going to make it back. The terrain was rolling landscape with not many options."* The return track was over some difficult terrain with numerous small and undulating paddocks. A few suitable paddocks either side of track were overlooked as the pilot attempted to reach what appeared to be a more suitable landing area some distance ahead.

Fig 5. Graphic of return flight path showing approximate area of rain shower.

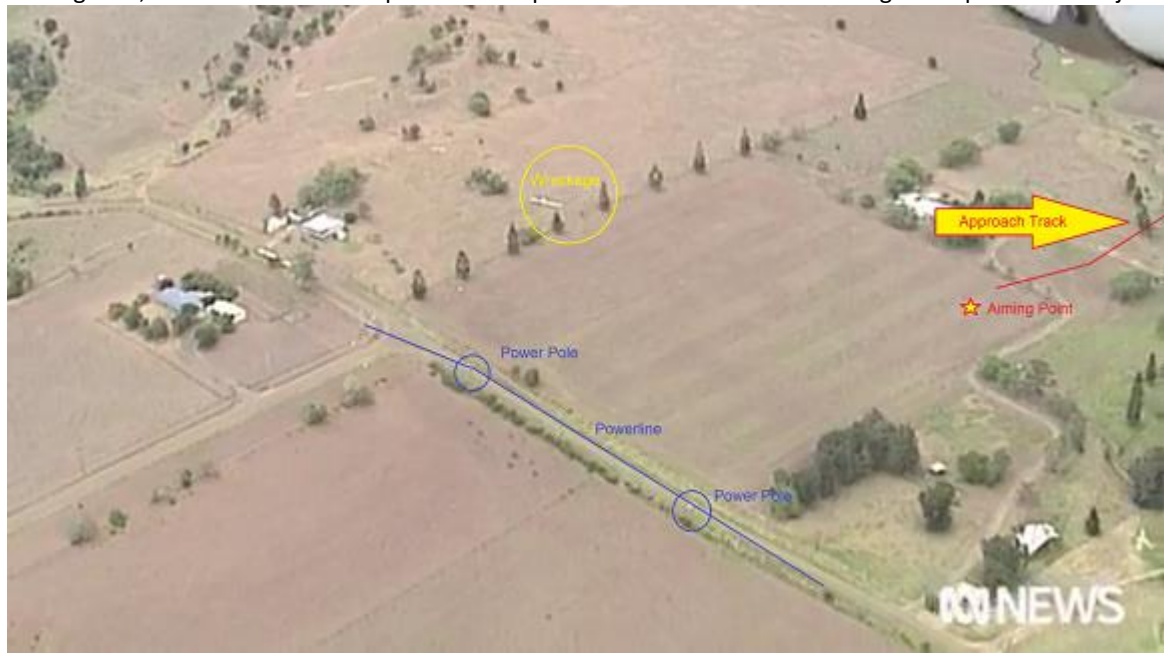
paddock beyond was also unsuitable as it had powerlines running across its approach that the pilot did not believe the glider would clear. A late decision was then made to land uphill in an adjacent paddock to the right (see Fig 6). The pilot stated: *"on getting closer I then saw multiple power lines in my path, to the left were trees and the right a small uphill paddock. As I turned right there was a single line either power or telephone that I had to fly under."* The glider flew underneath the powerline, between the power pole and a tall tree (see Fig 7), whereupon its starboard wing struck a fence post and shrub (see Fig 8). The glider turned through 270 degrees before striking the ground going sideways. The main wheel was sheared off by the fencing wire, and the tail boom tailplane and tailplane suffered substantial damage. The pilot was uninjured.

Fig 6. The selected paddock and aiming point.

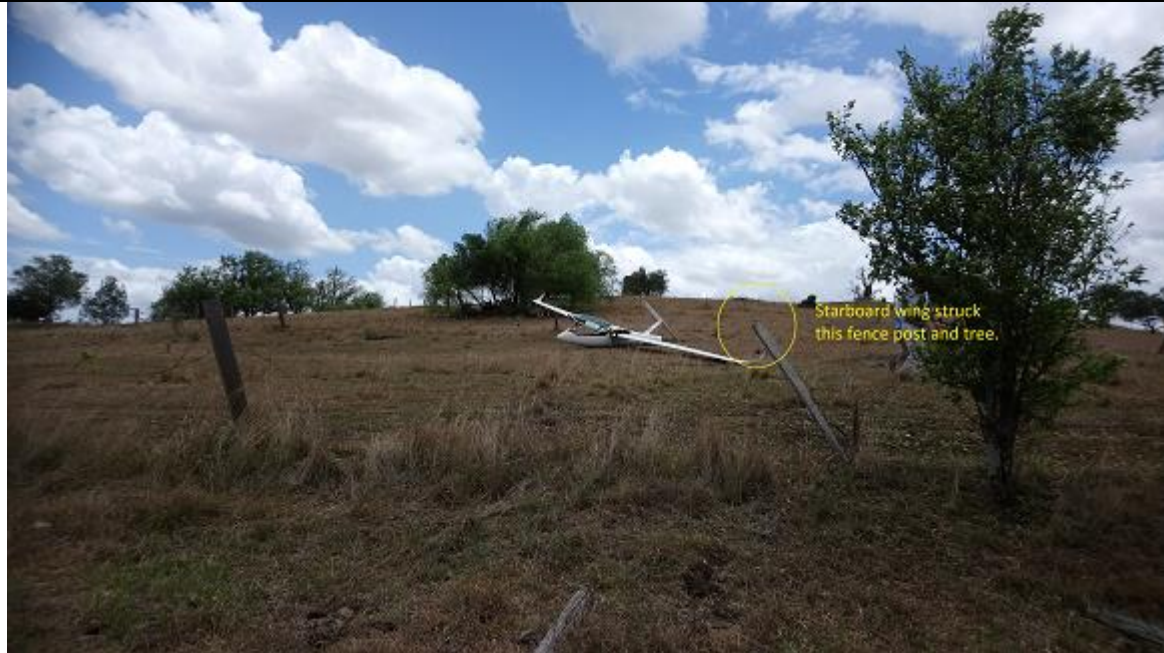
Fig 8. The glider struck the marked post and shrub in the right foreground, and the top two strands of fencing wire.
