**Civil Aviation Authority**  
**SAFETY NOTICE**  
**Number: SN-2020/003**

**Version 2: Issued: 30 April 2021**

## **Carbon Monoxide Contamination Minimisation and Detection in General Aviation Aircraft**

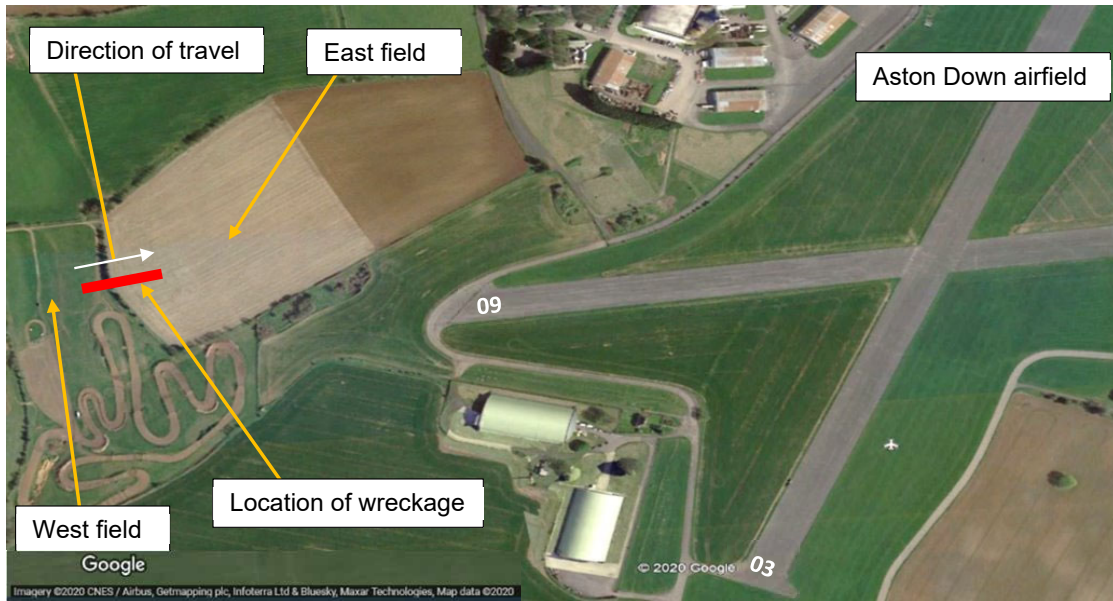
**Figure 1**

Location of the accident site on the western boundary of Aston Down airfield

The wreckage of G-KDEY stretched across two fields to the west of Aston Down airfield (Figure 1).

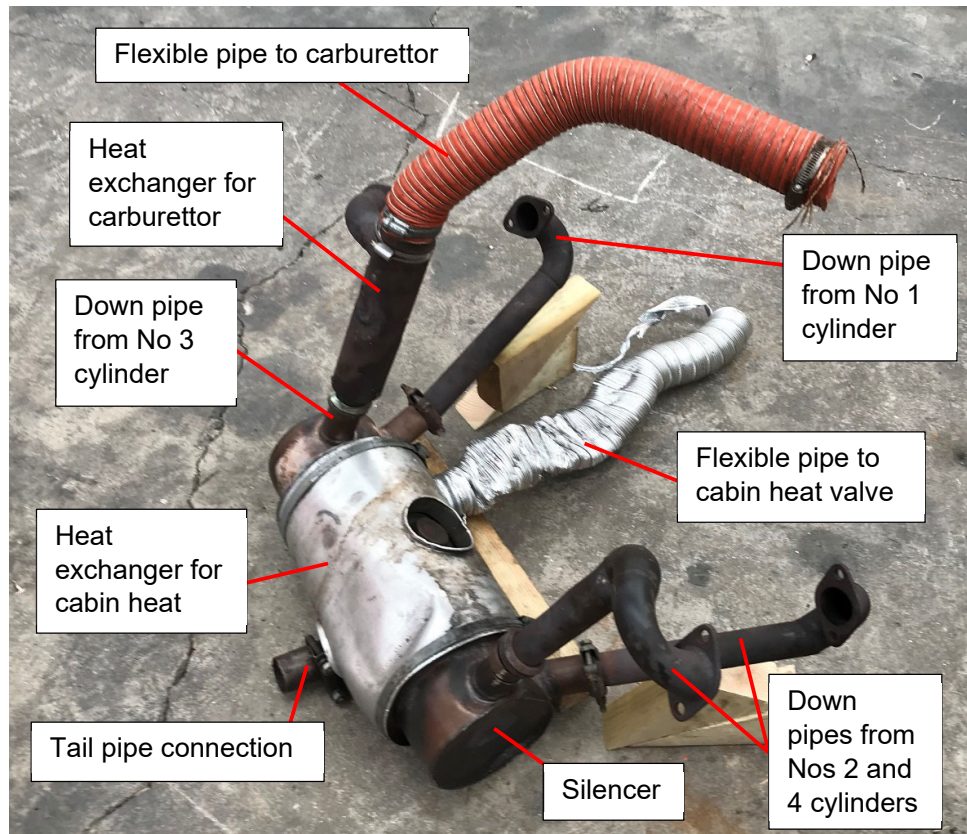
**Figure 6**  
G-KDEY exhaust system

The exhaust consists of a silencer positioned directly under the engine and connected to each of the engine's four exhaust ports by down pipes. Exhaust gasses pass from the piston combustion chambers, through the down pipes to the silencer and are vented rearwards to atmosphere underneath the aircraft by a tail pipe. To make use of the heat from the exhaust, a heat exchanger is fitted around the silencer. Atmospheric air from the front of the engine cowling passes into the heat exchanger and is warmed by the silencer (Figure 6).

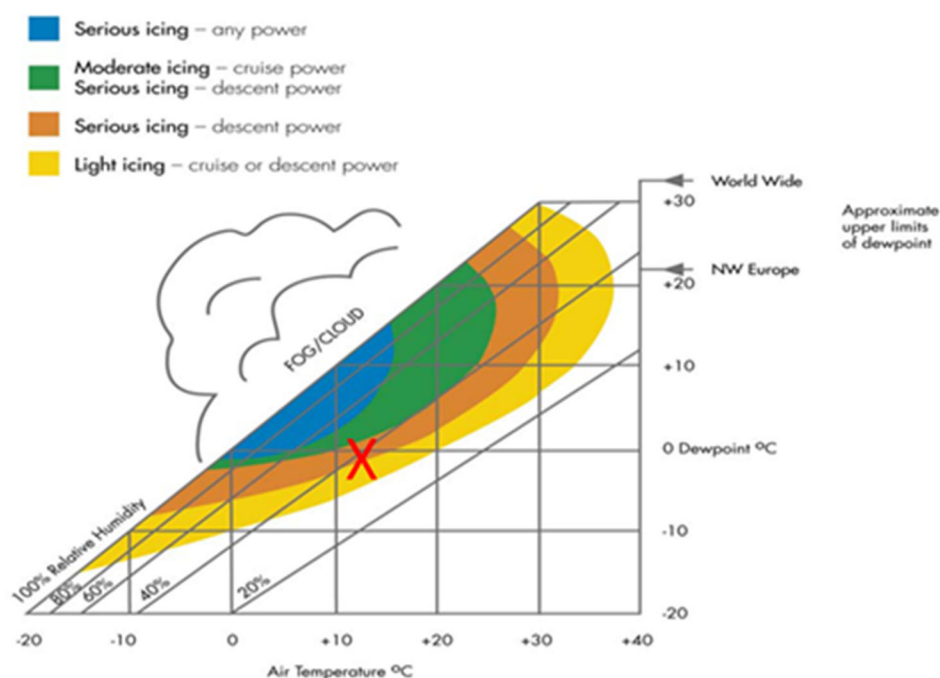
**Figure 12**  
Carburettor Icing Chart

Observations at Gloucestershire Airport, approximately 11 nm north of the accident site, at the time of the accident indicated that the wind was from 140° at 5 kt. The visibility was in excess of 10 km, the temperature was 13°C and the dew point -1°C. The atmospheric pressure was 1024 hPa. When plotted on the CAA's carburettor icing chart they indicate that there was a likelihood of serious icing with descent power (Figure 12).
