THE GLIDING FEDERATION OF AUSTRALIA INC

Airworthiness Alert 2021-3 **IS-28B2 Wing Rigging Failure**

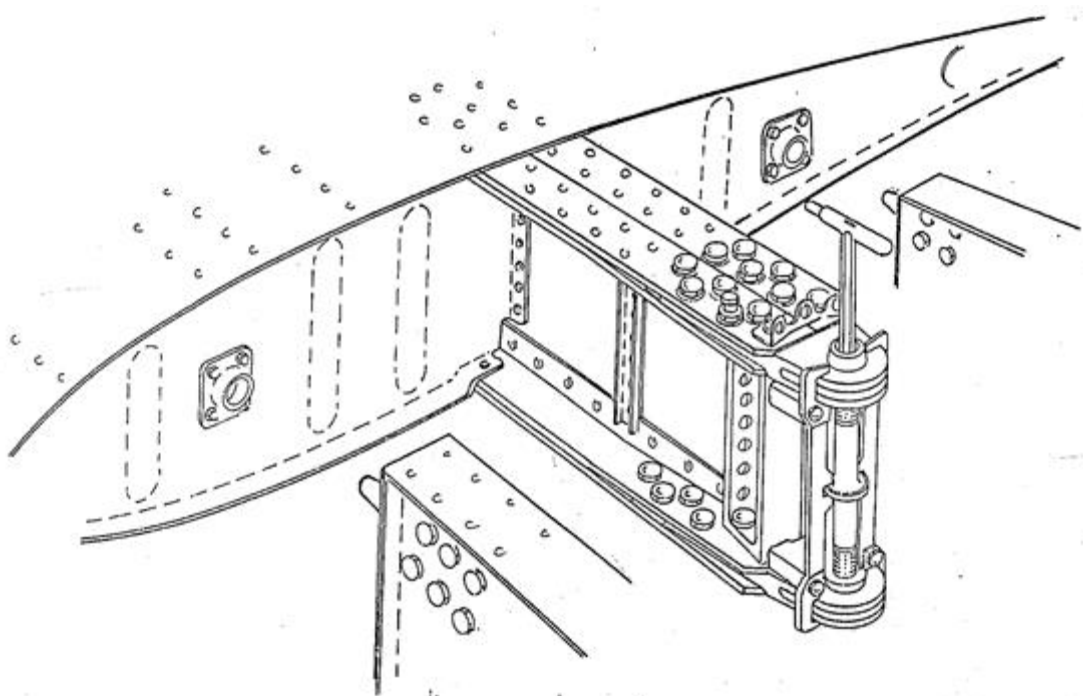
The fuselage-wing junction consists of four cylindrical guiding bolts located on fuselage and of two central, tapered, undismountable bolts, located on the right wing (see fig.6-1) which are actuated simultaneously by a special wrench.

Prior to rigging, the slot in the guide plates for the collar should be inspected for undue wear.

Prior to rigging, the tapered bolt assembly must be inspected and confirmed to be in good condition, fully functional and serviceable. Worn bolt assemblies must be replaced.

The tapered bolts and collar should be visually inspected after rigging (including using a torch and mirror) to ensure upper and lower tapered bolts are fully engaged and collar is retained in its slot. Check the exposed threads are roughly equal on the upper and lower surface and approximately 25 mm of thread is exposed. Wear / contact surfaces on both tapered bolts should not be visible.
