# The Gliding Federation of Australia Inc

## Occurrence Summaries

01/01/2022 to 31/12/2022

**The Gliding Federation of Australia Inc**  
**SOAR Accident and Incident Occurrences**

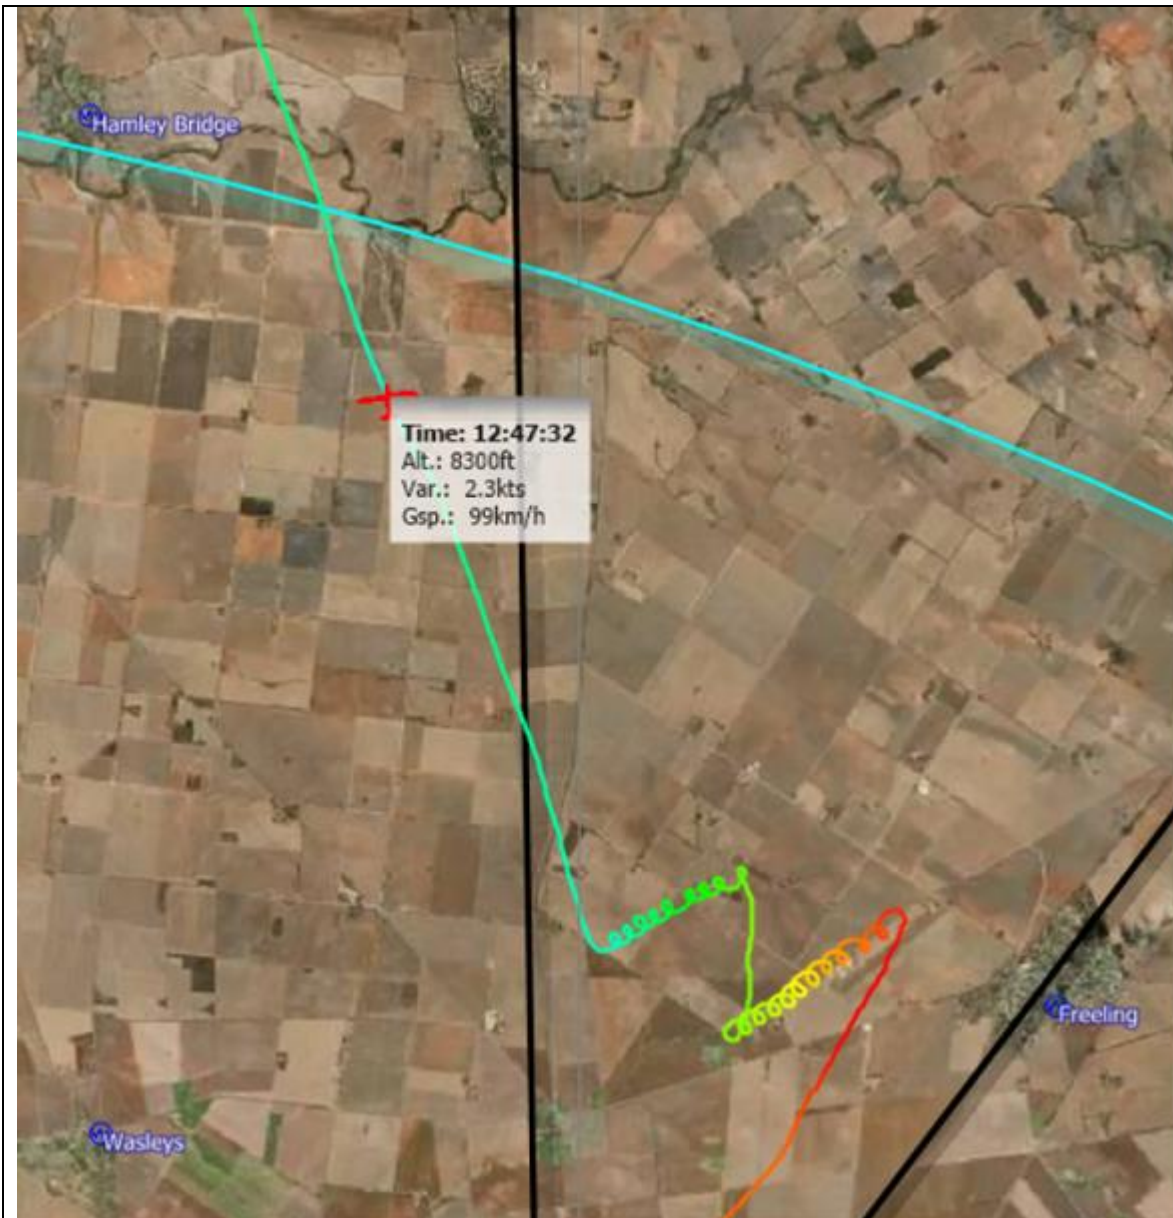
Date	6-Feb-2022	Region	SAGA	SOAR Report Nbr	S-2010
Level 1	Airspace	Level 2	Airspace Infringement	Level 3	Airspace Infringement
A/C Model 1	Mosquito			A/C Model 2	
Injury	Nil	Damage	Nil	Phase	In-Flight
				PIC Age	59
<b>What Happened</b> The pilot reported violating Class C airspace by about 1.7 kms laterally and 3,800ft vertically.					
<b>Analysis</b> Review of the aircraft flight logger trace file revealed the pilot traversed through Class C airspace at up to 8,300 ft and 1.7km from the boundary in an area where the Class C lower limit is 4500f (refer image below). On that day gliders had access to D206 up to 10,000 ft (east of the black line), however the pilot flew to the west of this airspace for some of the time, on a north westerly track. After some distance the pilot reached the 8500ft CTA LL step (as shown north of the cyan line). The breach occurred because the pilot failed to track far enough to the north (withing D206) before heading out to the northwest and thus entered controlled airspace. The pilot was counselled and undertook refresher training with the Club's Airspace officer

Violations of controlled airspace can be avoided by remaining situationally aware. Situational awareness is having an accurate understanding of what is happening around you and what is likely to happen in the near future. By being aware of what is happening around you and understanding how information, events and your own behaviour will affect your own goals, you have situational awareness. Having situational awareness doesn't happen by accident, it is a cognitive skill. You need to build and maintain situational awareness to ensure that you can stay ahead of a situation and avoid being caught off guard or unprepared. To build a mental model of the environment, it is necessary to gather sufficient and useful data by using our senses of vision, hearing and touch to scan the environment. We must direct our attention to the most important aspects of our surroundings and then compare what we sense with the experiences and knowledge in our memory. It is an active process and requires significant discipline, as well as knowing what to look for, when to look for it and why. For further information, refer to

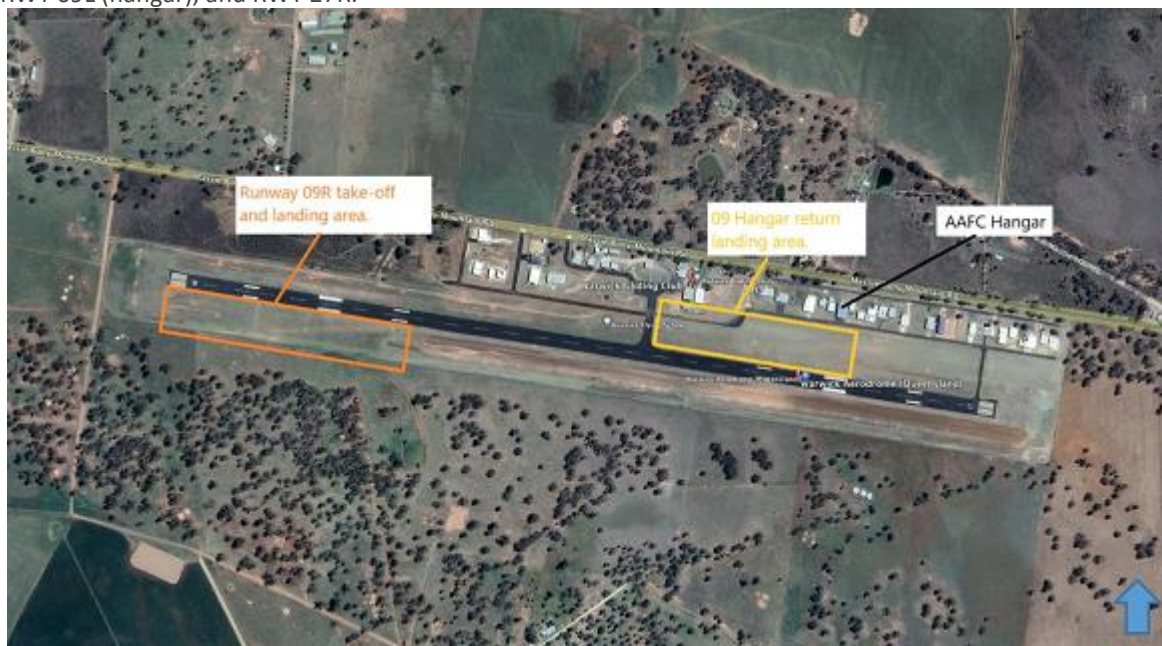
To execute a nominally "ideal" glider circuit, pilots will cross a rejoin position approximately 1000 m abeam the upwind threshold at 1000 ft AAL and a speed in the vicinity of 60kts. At Warwick this equates to approximately 2500 ft indicated. A circuit pattern is then flown with the pilot using cockpit-to-runway angles to determine the base turn point. Final approach is normally joined at between 400 ft and 600 ft AGL and air

brake deployed as required to achieve the desired touch down point. On the last flight of the day pilots usually land on the grass area close to the AAFC hangar, in order to expedite aircraft retrieval and hanging. This is called a “hangar flight”. Gliders usually use serviceable grass areas either side of the bitumen runway to take-off and land, in Warwick’s case RWY 09R, RWY 09L (hangar), and RWY 27R. Final approach is normally joined at between 400 ft and 600 ft AGL and air brake deployed as required to achieve the desired touch down point. On the last flight of the day pilots usually land on the grass area close to the AAFC hangar, in order to expedite aircraft retrieval and hanging. This is called a “hangar flight”. Gliders usually use serviceable grass areas either side of the bitumen runway to take-off and land, in Warwick’s case RWY 09R, RWY 09L (hangar), and RWY 27R.

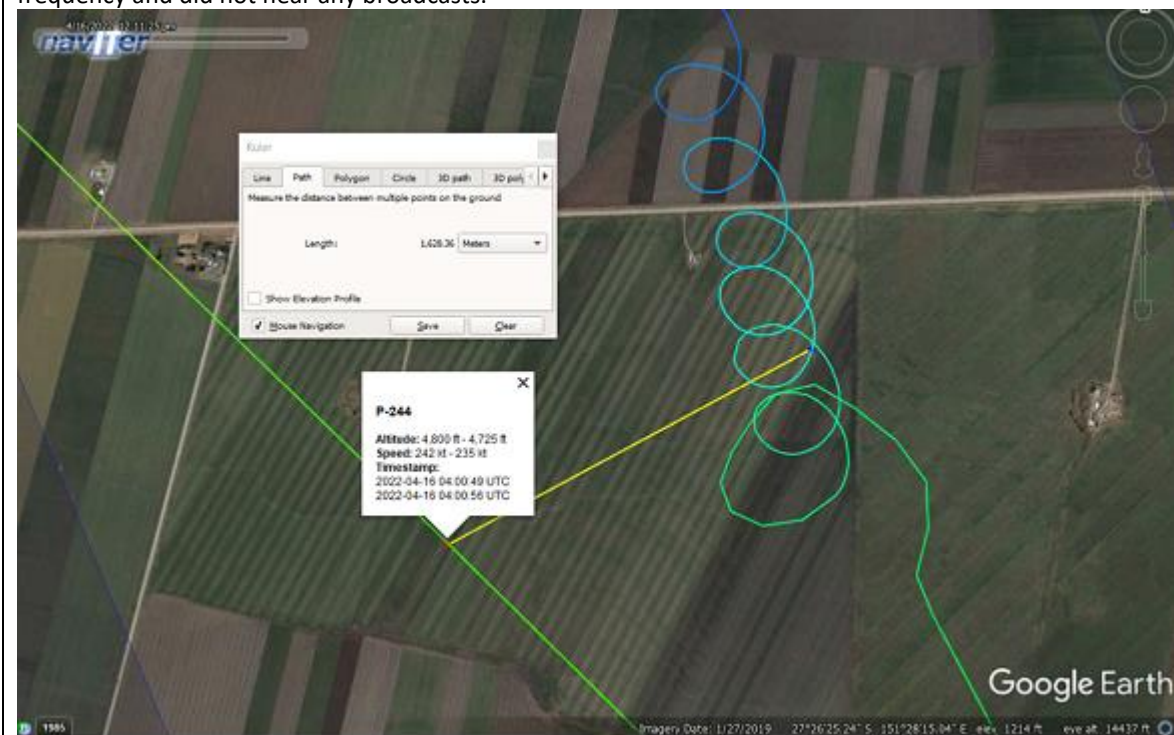
Date	16-Apr-2022	Region	GQ	SOAR Report Nbr	S-2036
Level 1	Airspace	Level 2	Aircraft Separation	Level 3	Aircraft Separation Issues
A/C Model 1	Discus B			A/C Model 2	Embraer ERJ 170-100 LR
Injury	Nil	Damage	Nil	Phase	In-Flight
				PIC Age	55

Under investigation. During a cross-country flight and while thermalling near the known IFR route for Wellcamp airport, the glider pilot received a Alarm alert warning of a fast-moving target approaching the glider's position. The pilot observed that the target would pass with sufficient horizontal separation as to avoid a collision, although the distance was not known. The other aircraft was a small passenger jet enroute to Wellcamp airport. A post-flight review of the two flight traces identified the passenger jet passed about 1200 meters horizontally from the glider at the same height. The glider pilot was monitoring the glider safety frequency and did not hear any broadcasts.

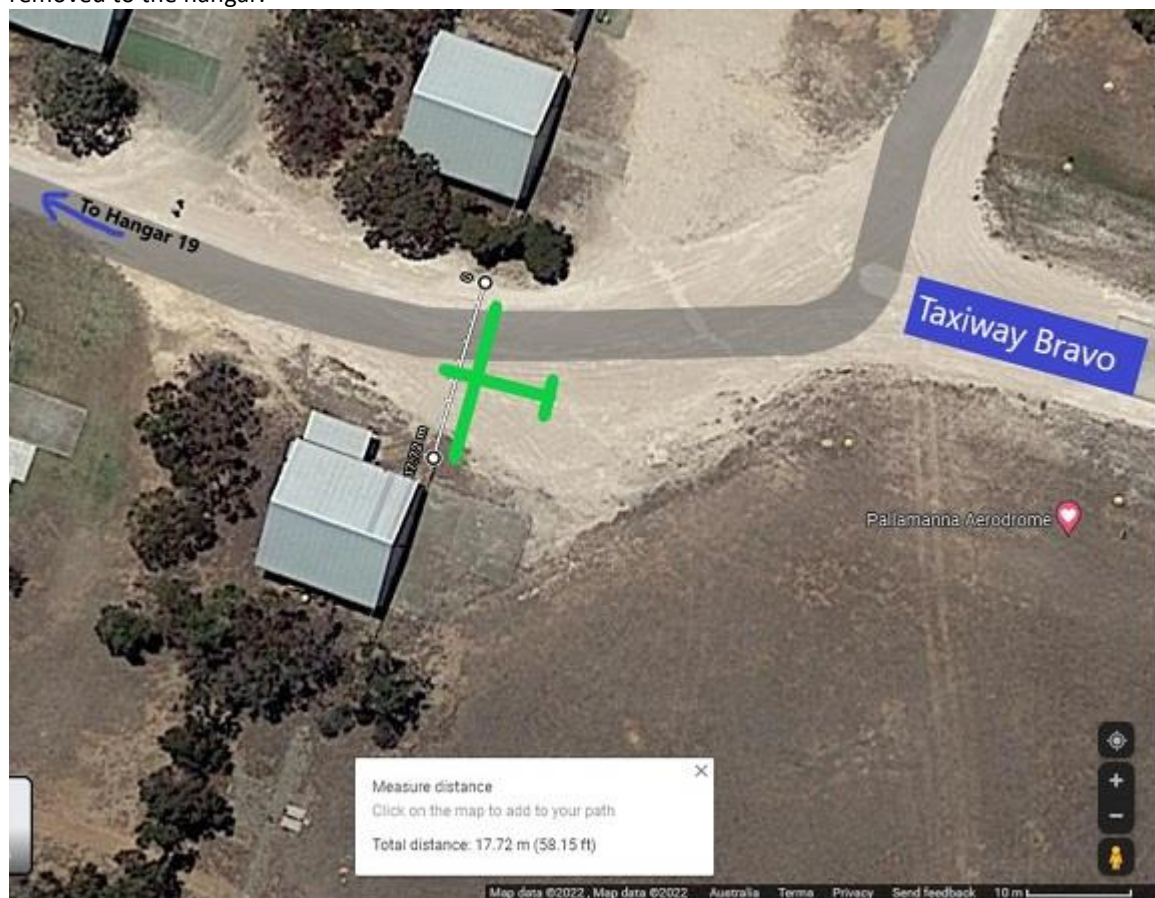
the pilot entered and backtracked the runway for the taxiway towards the hangars. The pilot reported that as the aircraft got close to the first hangars, he judged that the port wingtip was close to the hanger door outrigger post, so he reduced power, but the wingtip contacted the outrigger post at low speed before he could apply the brakes. The pilot stated *"taxying a 15 metre wingspan aircraft (the aircraft has a 17.4 metre wingspan) between these hangars is a tight fit and wind gusts can affect the steering when passing hangars. I was well aware of that and have practiced for it. I wasn't overly concerned this time as the wind conditions were favourable and didn't have any adverse effect. Looking back at the incident, I think I didn't pick up the presence of the outrigger post when estimating my distance to the hangar on the port side, and I must have overestimated the distance to the tree on the starboard side."* The pilot notified the local traffic that the aircraft was stuck on the taxiway, and then with the assistance of the Duty Instructor the aircraft was removed to the hangar.

This incident highlights the importance of aircraft operators conducting a thorough risk assessment where ground movement is confined, particularly movements involving narrow taxiways. Effective risk assessments ensure that hazards are clearly identified and well understood, and that the associated risks are appropriately managed. To manage clearance in congested areas, pilots should, where possible, seek marshalling or wing walking assistance. Airport authorities should consider removing obstacles such as trees and bushes to accommodate larger span aircraft.

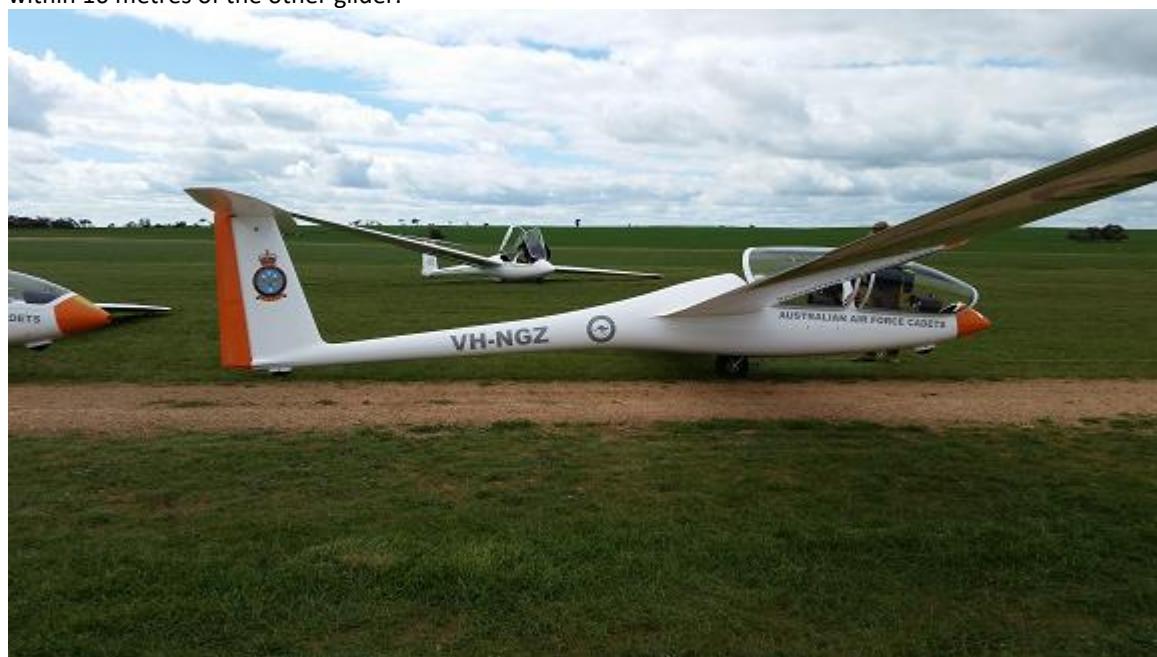
Date	3-Sep-2022	Region	SAGA	SOAR Report Nbr	S-2077
Level 1	Operational	Level 2	Runway Events	Level 3	Other Runway Events
A/C Model 1	ASK-21			A/C Model 2	DG-1000s
Injury	Nil	Damage	Nil	Phase	Landing
					PIC Age 54
Under investigation. A glider landed short of the flight line. During the ground rollo the left wing contacted the ground causing the glider to turn towards a glider awaiting a launch. The landing glider came to rest within 10 metres of the other glider.

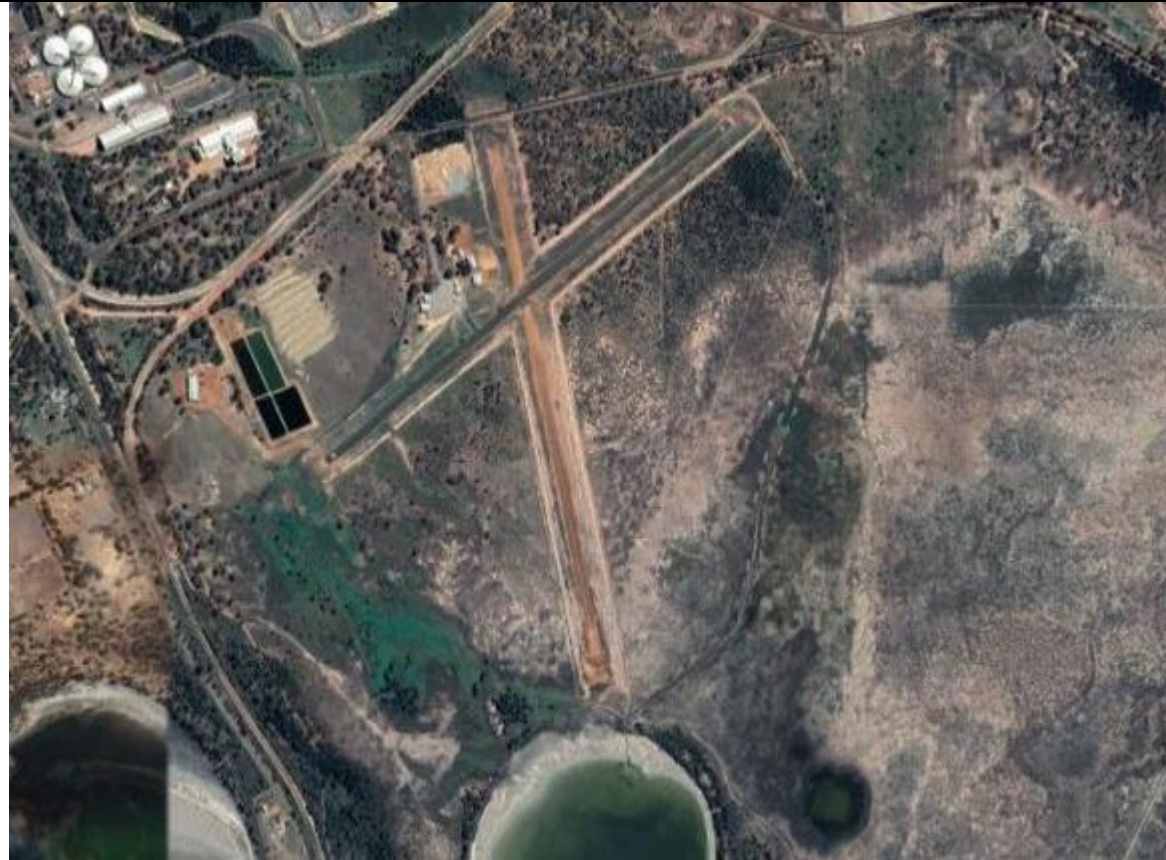
The pilot reported "A lefthand circuit was initiated and during the circuit whilst flying over the dried dark brown clay lakebed to the South of the airfield, some turbulence was felt. Turbulence was also felt on the base leg, but this reduced once over the green fields whilst turning onto finals." The approach was conducted with the engine idling and the propellor in fine pitch. The pilot stated the aircraft touched down mid runway and he noted the ground speed was very high. Due to the high speed, the pilot had difficulty maintaining directional control. The pilot reported "...Full main wheel brake was applied with full backstick to try and maintain control with the tail wheel. The aircraft veered to the right off the runway and the right undercarriage fibreglass wheel fairing contacted a white cone shaped fibreglass light marker." As the glider slowed, the pilot was able to steer the glider back onto the runway. While taxiing to the parking area at the end of RWY 24, the pilot observed the primary windsock was now indicating a strong East-North-Easterly wind, confirming the aircraft had landed downwind with a slight crosswind component. The secondary windsock was noted to be still hanging limp and may not have been serviceable. Discussion with other pilots revealed the lakes and surrounding terrain often generate a microclimate different to that in the surrounding areas. The aircraft was inspected by authorised inspector, who conformed the damage was isolated to the fibreglass wheel fairing.

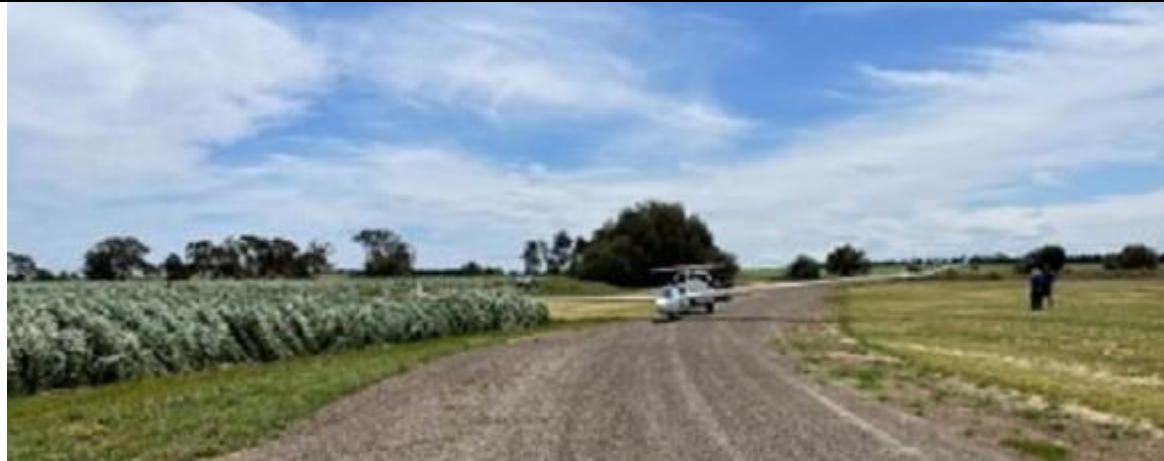
The Club share farms the land around the runways to obtain extra income. The edge of the crop is about 10 metres from the centre of the taxiway. However, in the area where this incident occurred the crop is a lot closer to the taxiway centreline. Compounding matters, the usual wheat and barley crops in past years, which do not grow high enough to normally be an obstacle, were replaced by beans that have grown to about 1.2 metres in height. Although the pilot was aware of this hazard, which had been discussed during the morning briefing in the context of emergency options around the field and places to land, the pilot did not pay sufficient attention to the position of the crop, and the glider's wing penetrated 3 metres into the crop before the yawing force became too much for the tow bar. Due to the forces needed to dislodge the tow bar and the damage to the tailplane, the aircraft was taken to the workshop and derigged to inspect for any damage. After careful examination, the only damage was to the underside of the tailplane, with scratches on the paintwork and damage to the zigzag tape. The glider was returned to service and the crop was slashed.

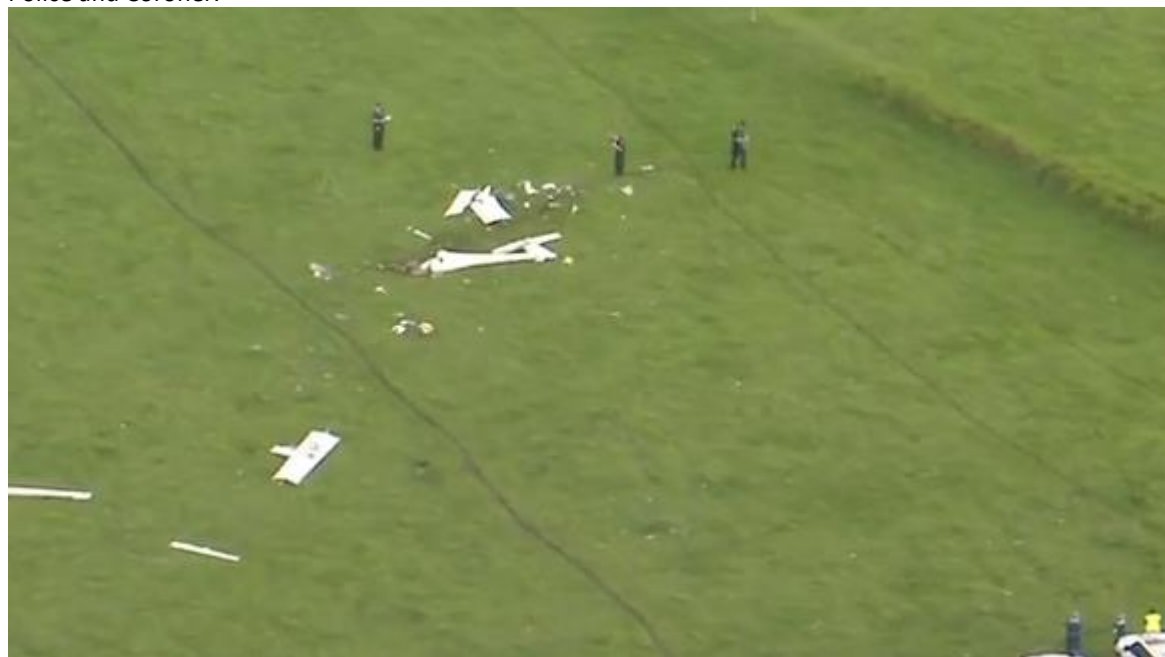
Date	9-Nov-2022	Region	GQ	SOAR Report Nbr	S-2095
Level 1	Airspace	Level 2	Aircraft Separation	Level 3	Collision
A/C Model 1	Astir CS			A/C Model 2	KP-2U Sova
Injury	Fatal	Damage	Write-off	Phase	In-Flight
				PIC Age	80

Under investigation. A powered aircraft listed with RAAus and an Astir CS glider were involved in a mid-air collision approximately 2NMs South-West of Gympie aerodrome at a height of about 2,500ft. Both aircraft spiralled to the ground and their pilots were fatally injured. The accident is being investigated by the Qld Police and Coroner.

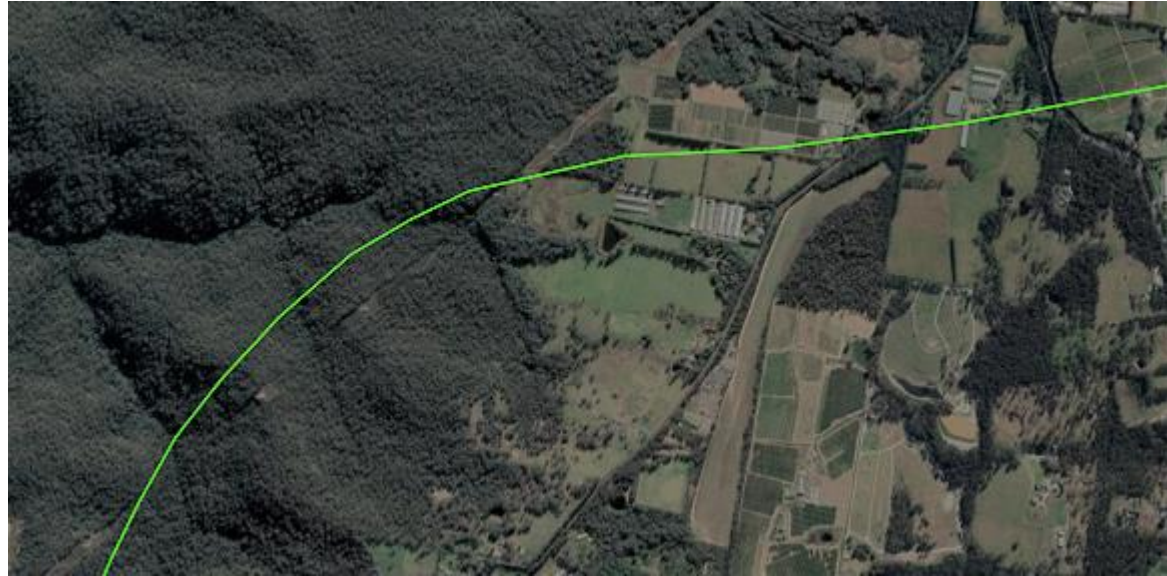
During a winch launch on RWY 01 a powered aircraft flew across the end of the runway unannounced at the same height as the glider. The powered aircraft's track was obtained from FlightAware, which showed it approached the airfield from the Northeast at a speed of about 133 kts and passed the glider on launch at the same height but displaced about 200 metres. The airfield is marked on the AIP Charts with the gliding and winch symbol and has a designated CTAf. There is also an entry in the Airfields database in the Electronic Flight Bag apps advising of gliding operations, with cables up to 3,000ft. The CFI reported the launch crew were unaware of the presence of the powered aircraft when the launch commenced, and heard no radio calls despite making all operational launch broadcasts (i.e. the pre-launch broadcast, take-up slack

and all out) on the CTAF. The CFI and GFA AAAO contacted the aircraft operator (Flying School), whose Head of Flying Operations apologised for the incidents and advised will raise awareness and use this as a learning opportunity.

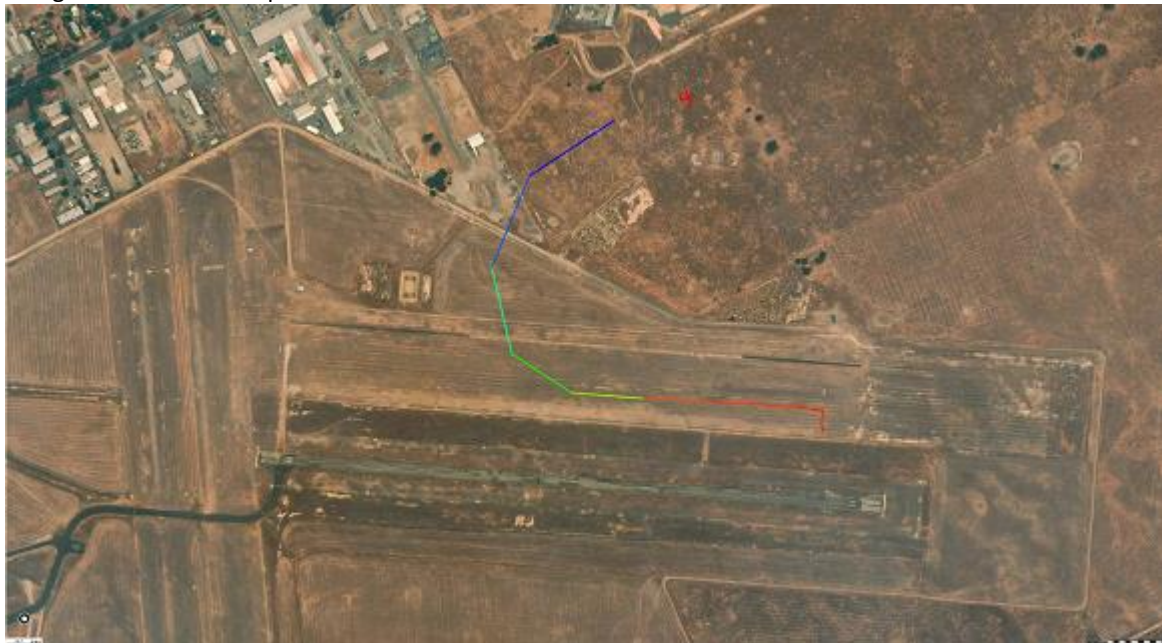
During the third aerotow for the day and at approximately 50ft AGL, the tug commenced an uncommanded rapid roll to the right resulting in the tug turning sharply to the right. The tug pilot released the tow rope and initiated an unusual attitude recovery. The glider pilot simultaneously released the tow rope and landed straight ahead. The tow pilot flew a modified circuit and landed.

The launch was being conducted without the assistance of a wingtip runner, so the glider was taking off from a wing down position. The slack in the rope was taken up uneventfully and the combination became airborne. The tow pilot reported that shortly after becoming airborne and at a height of about 50ft, the tug "...went from straight and level to nearly 90 degrees within less than a second". The pilot attempted to reduce power but inadvertently pulled the mixture control. Observing the glider passing on the left, the tow pilot pulled the release, and then applied full power to climb away. The glider pilot also released from tow and landed heavily straight ahead. The tow pilot completed a modified circuit and landed safely. The tug was inspected by a LAME and no issues or defects were identified. The glider was undamaged. The trace from the tug's Flarm unit verified the pilot had sufficient airspeed at the time of the upset. The Club Tugmaster believes the occurrence was consistent with the tug having been caught by a thermal gust.

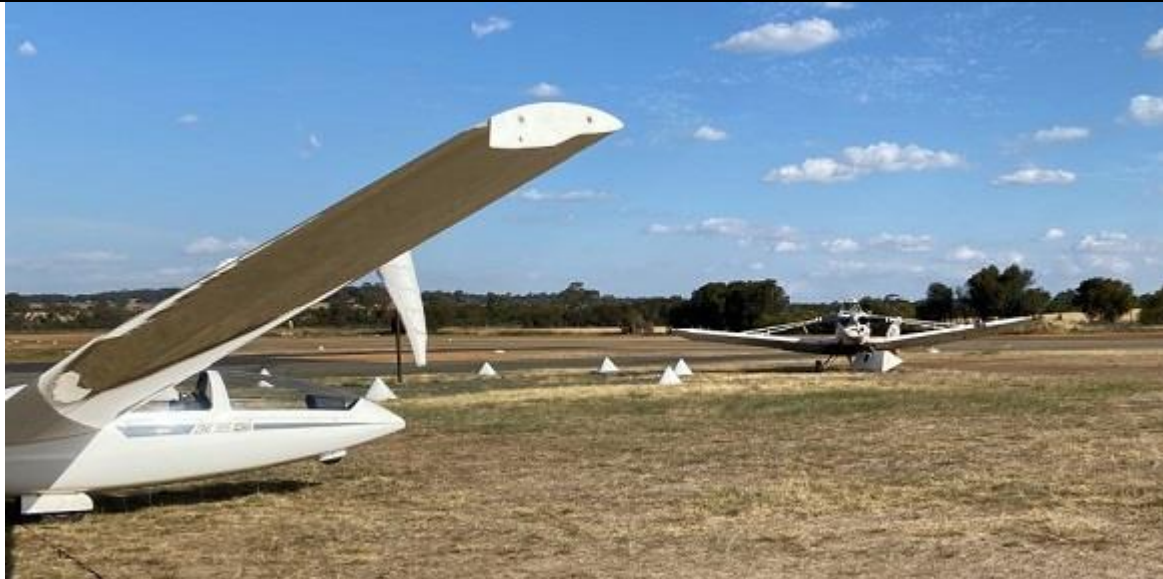
Date	3-Dec-2022	Region	WAGA		SOAR Report Nbr	S-2108	
Level 1	Operational		Level 2	Terrain Collisions		Level 3	Collision with terrain
A/C Model 1	Piper PA-25-235				A/C Model 2	N/A	
Injury	Nil	Damage	Nil	Phase	Ground Ops	PIC Age	82
<b>What Happened</b> After refuelling the tow plane and while taxiing back towards the hangar, the pilot made a sharp turn to avoid some gliders parked nearby and the aircraft collided with a gable runway marker.

The tow pilot was current and had conducted 19 tows over the period of the day, which was not abnormal. At the time of the incident a 15-knot crosswind was blowing across the runway but was not considered a factor in the incident. The pilot had just refuelled the tow plane prior to putting it closer to the main hangar for the end of day. While taxiing back towards the hangar the tow pilot elected to take an abbreviated path that was shorter than the originally intended. This may have been a contributing factor, as the pilot became distracted by focusing on avoiding two gliders that were parked nearby. To avoid the gliders, the pilot elected to turn sharp into an area that he had not properly surveyed, and the presence of the gable marker was not noticed until the aircraft collided with it. The pilot immediately shut down the engine and disembarked to survey the scene. Fortunately, only the left undercarriage struck the marker and the aircraft did not suffer any damage other than a scratch on the undercarriage leg. The towplane was subsequently put in the main hangar, where it was inspected and cleared for flight. Following this incident, the Club Tugmaster reminded tow pilots about the increased risk involved when suddenly changing direction without prior planning.

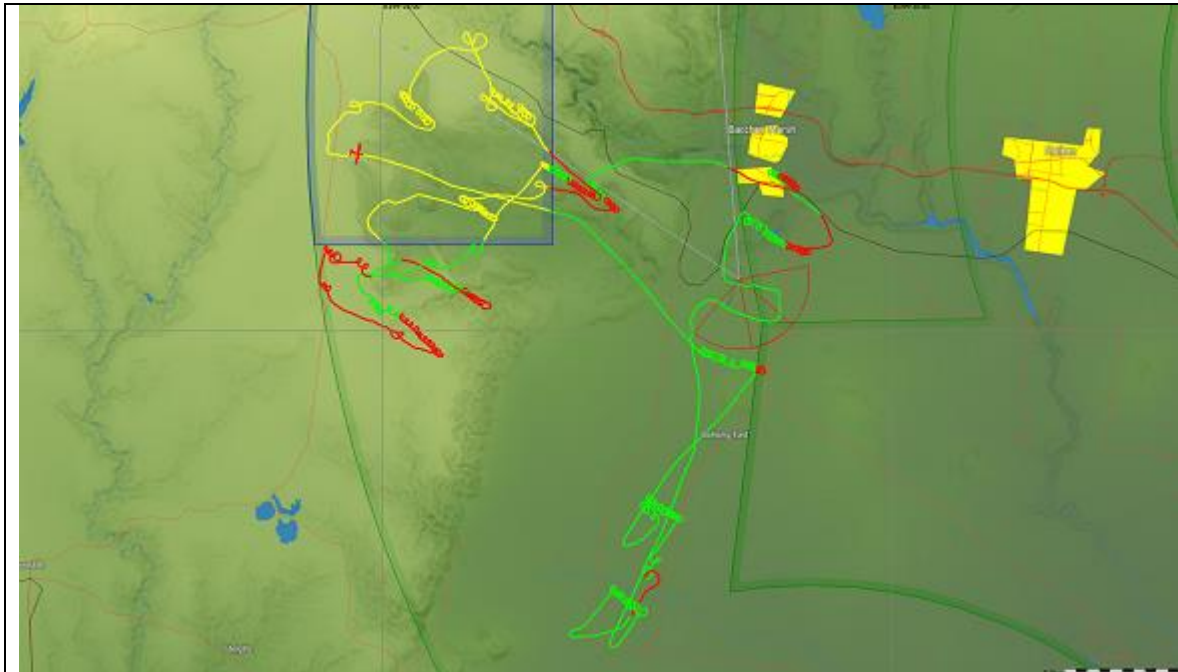
Date	4-Dec-2022		Region	VSA		SOAR Report Nbr		S-2112	
Level 1	Airspace			Level 2	Airspace Infringement		Level 3	Airspace Infringement	
A/C Model 1			SZD-48-1 Jantar Standard 2			A/C Model 2		N/A	
Injury	Nil		Damage	Nil	Phase	In-Flight		PIC Age	61
<b>What Happened</b>									
During a single flight of 2½ hours, the pilot entered Class C airspace without a clearance on seven occasions.

The experienced pilot was aware of the airspace restrictions, having operated at this site for over a decade. On this local flight he was navigating by memory, as he did not have a flight computer with airspace loaded nor did he carry any charts. The pilot was counselled by their CFI.

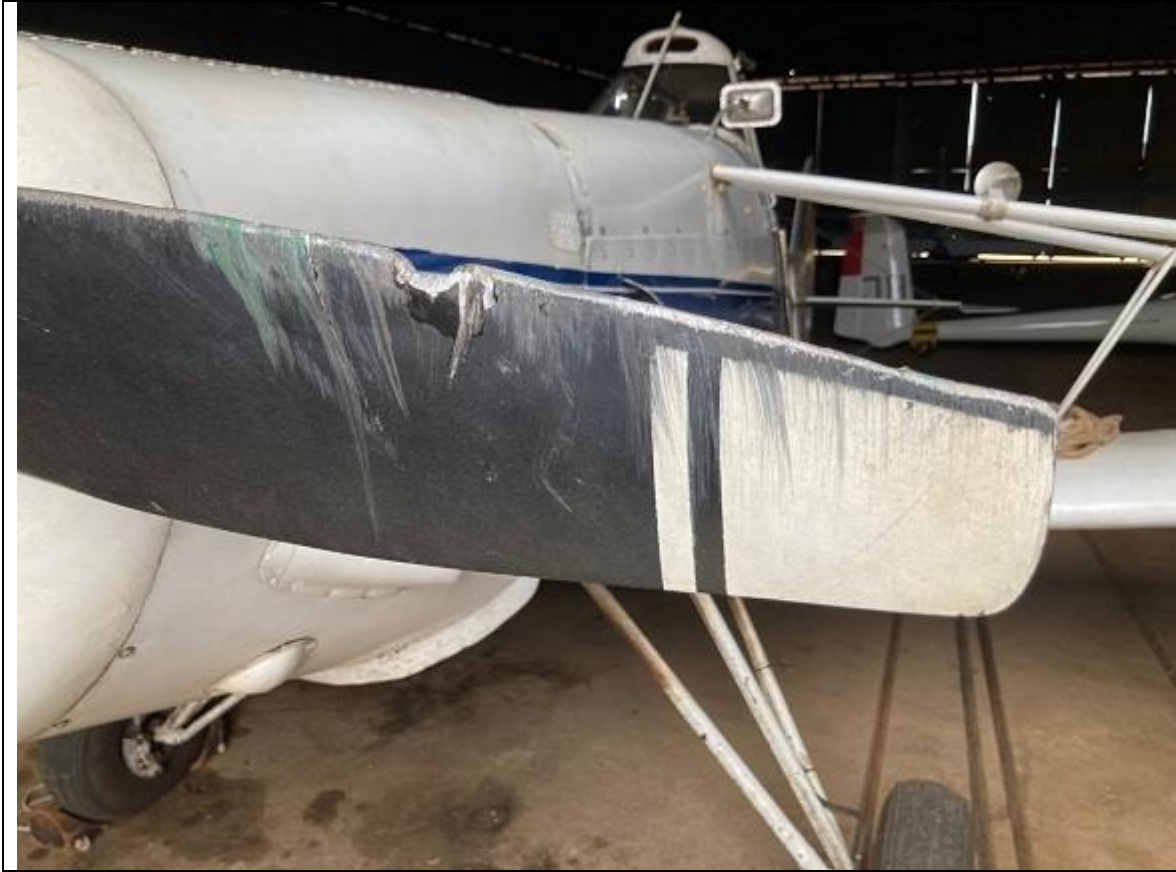
Injury	Nil	Damage	Substantial	Phase	Ground Ops	PIC Age	75
<p>Under investigation. Due to runway works being in progress, gliding operations were being conducted from a taxiway entering the RWY 23. Two gliders were parked behind the holding point on the 30-metre-wide taxiway awaiting to be pushed onto the runway for launch. One of the gliders still had the wing dolly fitted to the port wing. As the first pilot was ready for launch, the tow plane, which had been parked on the Southern side of the taxiway, entered the taxiway to commence a glider launch. As the tow pilot manoeuvred around the parked gliders, the towplane's propellor struck the port wingtip and wing dolly of the rear glider. The wing dolly was destroyed, and about 1 metre of the glider's port wingtip was removed.</p>							
<p><b>2: Accident sequence</b></p> <p>VH-GCK calls entering runway and prepares to be pushed onto runway by ground crew</p> <p>VH-GWK</p> <p>VH-PXI taxis forward to enter runway and tow VH-GCK</p>

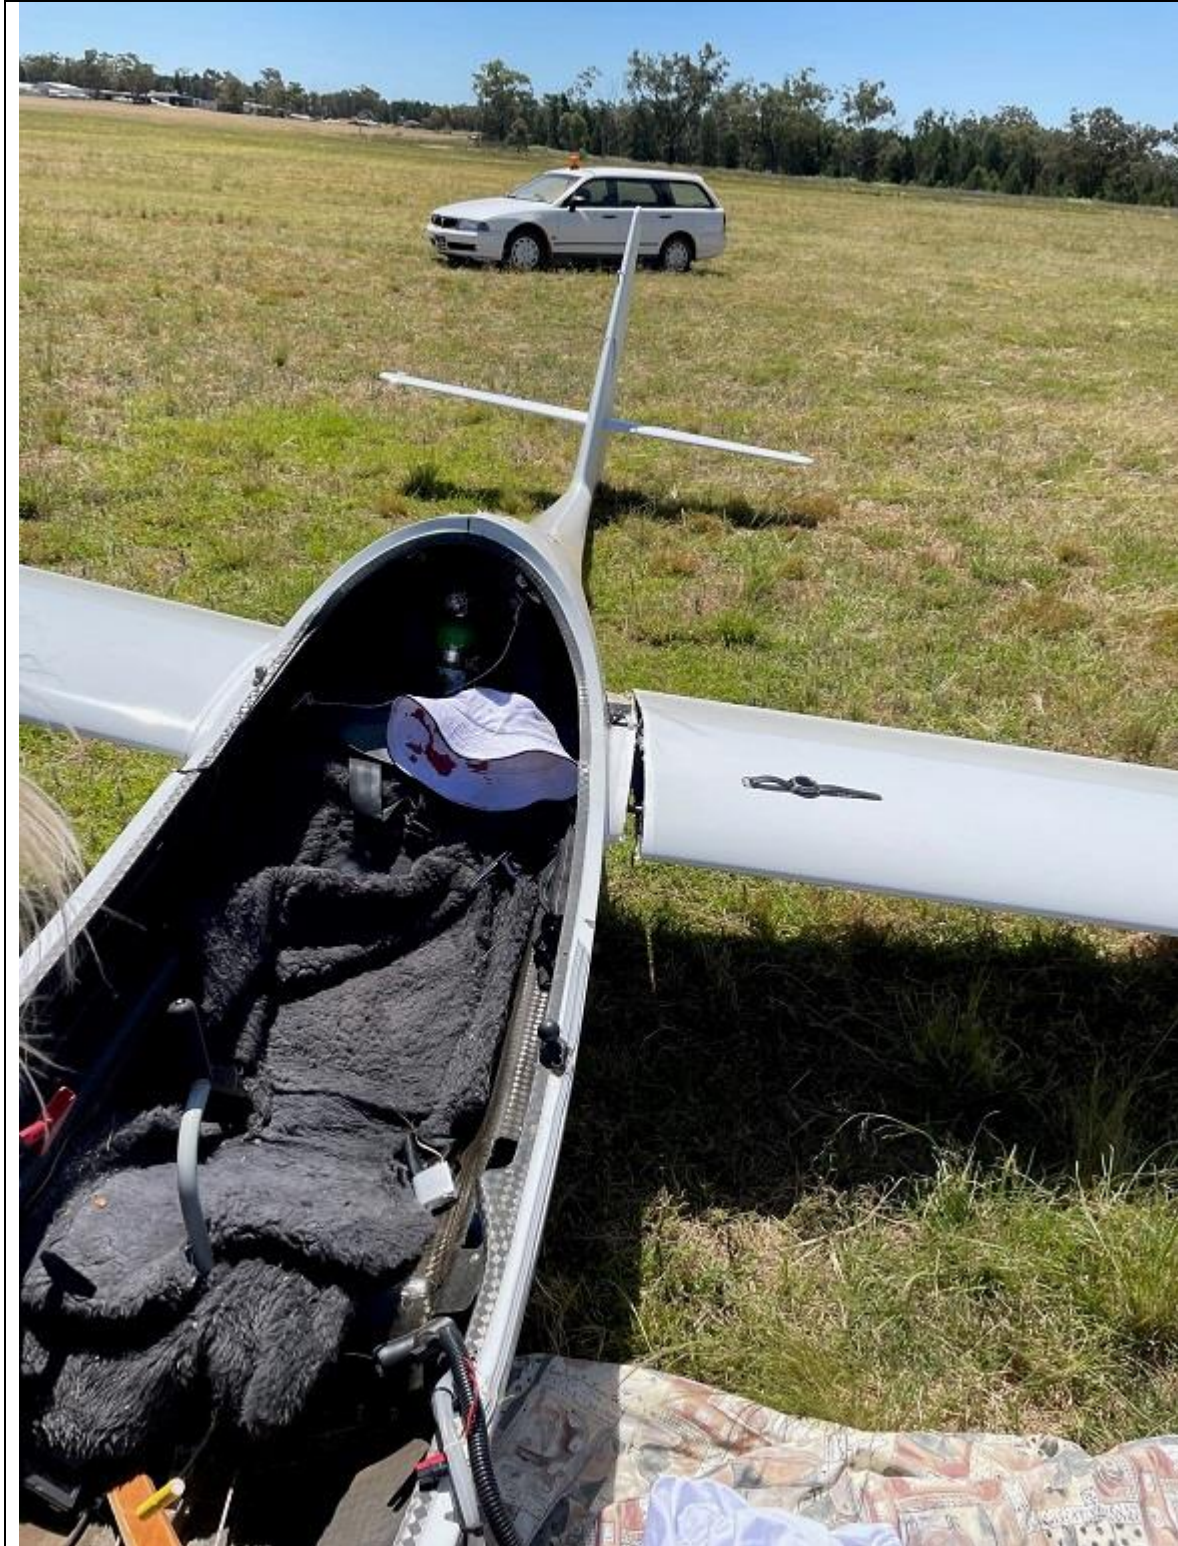
Date	8-Dec-2022	Region	NSWGA	SOAR Report Nbr	S-2109
Level 1	Operational	Level 2	Terrain Collisions	Level 3	Collision with terrain
A/C Model 1	Sparrow Hawk			A/C Model 2	
Injury	Serious	Damage	Write-off	Phase	Launch
				PIC Age	63
<p>Under investigation. During the initial stages of an aerotow launch, and shortly after the glider became airborne, witnesses observed the glider move into the high tow position and, when at a height of about 50ft AGL, the glider was observed to suddenly pitch up steeply to the right, and then the left wing and nose dropped. One witness observed the tow rope was still attached as the glider pitched down but believed the pilot must have activated the tow release because the tow plane climbed away while the glider departed controlled flight. As the glider's left wing dropped, the wingtip struck the ground followed by the fuselage striking the ground in a nose down attitude while pivoting around the wingtip. The glider was substantially damaged, and the pilot suffered serious injury. Police and emergency services attended, and the pilot was transported to hospital by ambulance. The pilot has no recollection of the launch or accident.</p>

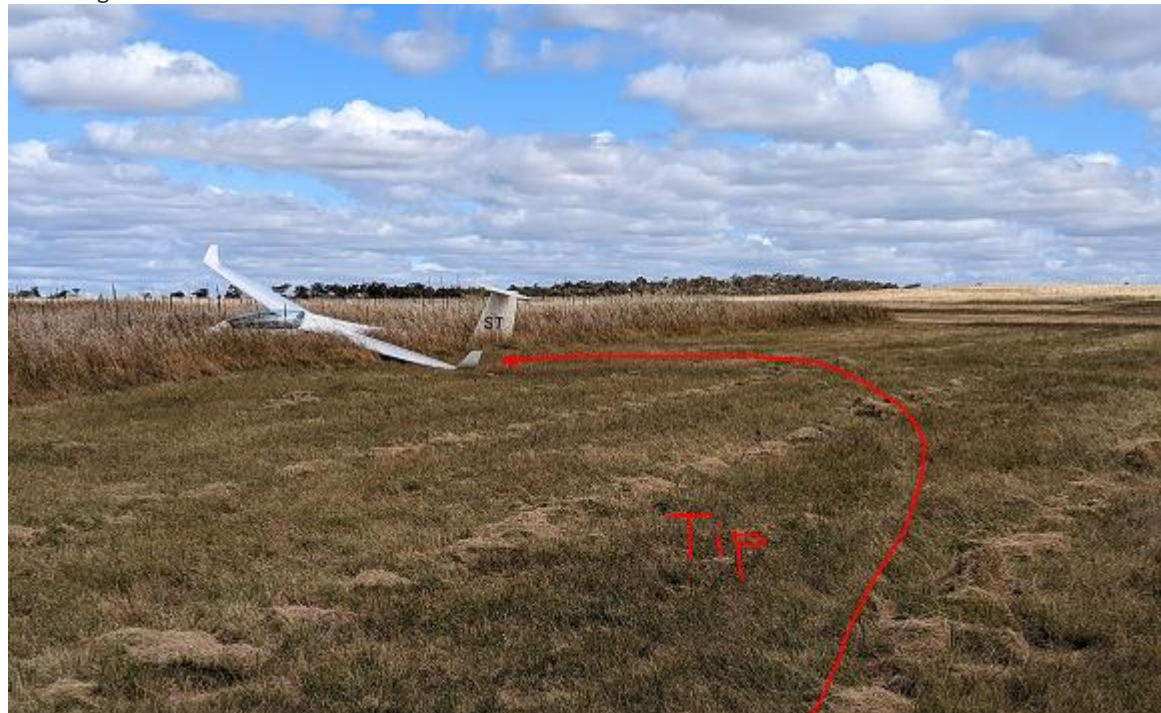
approach with 10 deg of flap and with ambient wind of 178 deg and 8 knots. The glider touched down gently in high grass about 30 metres before the area of RWY 16 that had been cut to a lower level. The touchdown was gentle and straight, but the glider's left wingtip wheel either caught on the relatively long grass, or on a clump of cut grass on the runway. The glider turned rapidly to the left through 120 degrees and came to rest about 3 metres into the long grass and weeds on the Eastern edge of RWY 16. The pilot reported the deviation happened so quickly that *"I was simply along for the ride. I had no reactions quick enough to apply opposite rudder or move the stick forward to raise the tail."* Subsequent inspection revealed the glider to be undamaged.

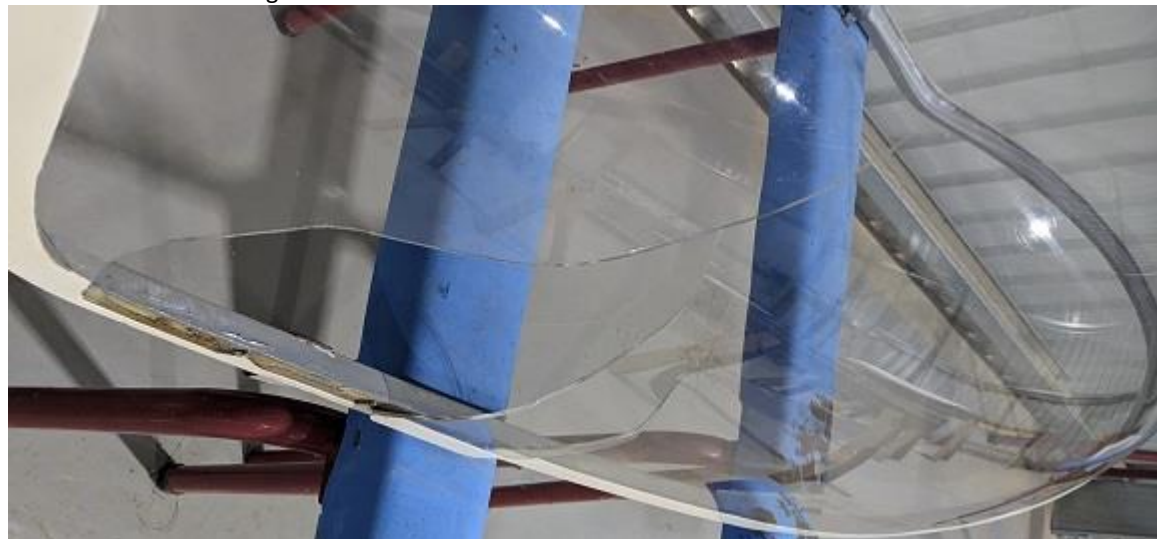
The pilot had just landed after a successful cross-country flight. After opening the canopy to alight the aircraft, the pilot placed his right hand on the cockpit fuselage and lifted his weight. His right hand slipped, and his right elbow impacted the rear right-hand side of the cockpit. The canopy Perspex cracked, and a part broke away. The pilot was uninjured. The CFI reported that the pilot had surgery on his back, which may have been a contributing factor.
