COMMONWEALTH OF AUSTRALIA  
DEPARTMENT OF TRANSPORT

AIRWORTHINESS DIRECTIVE - GLIDERS

GFA/AD104 LET KUNOVICE 13

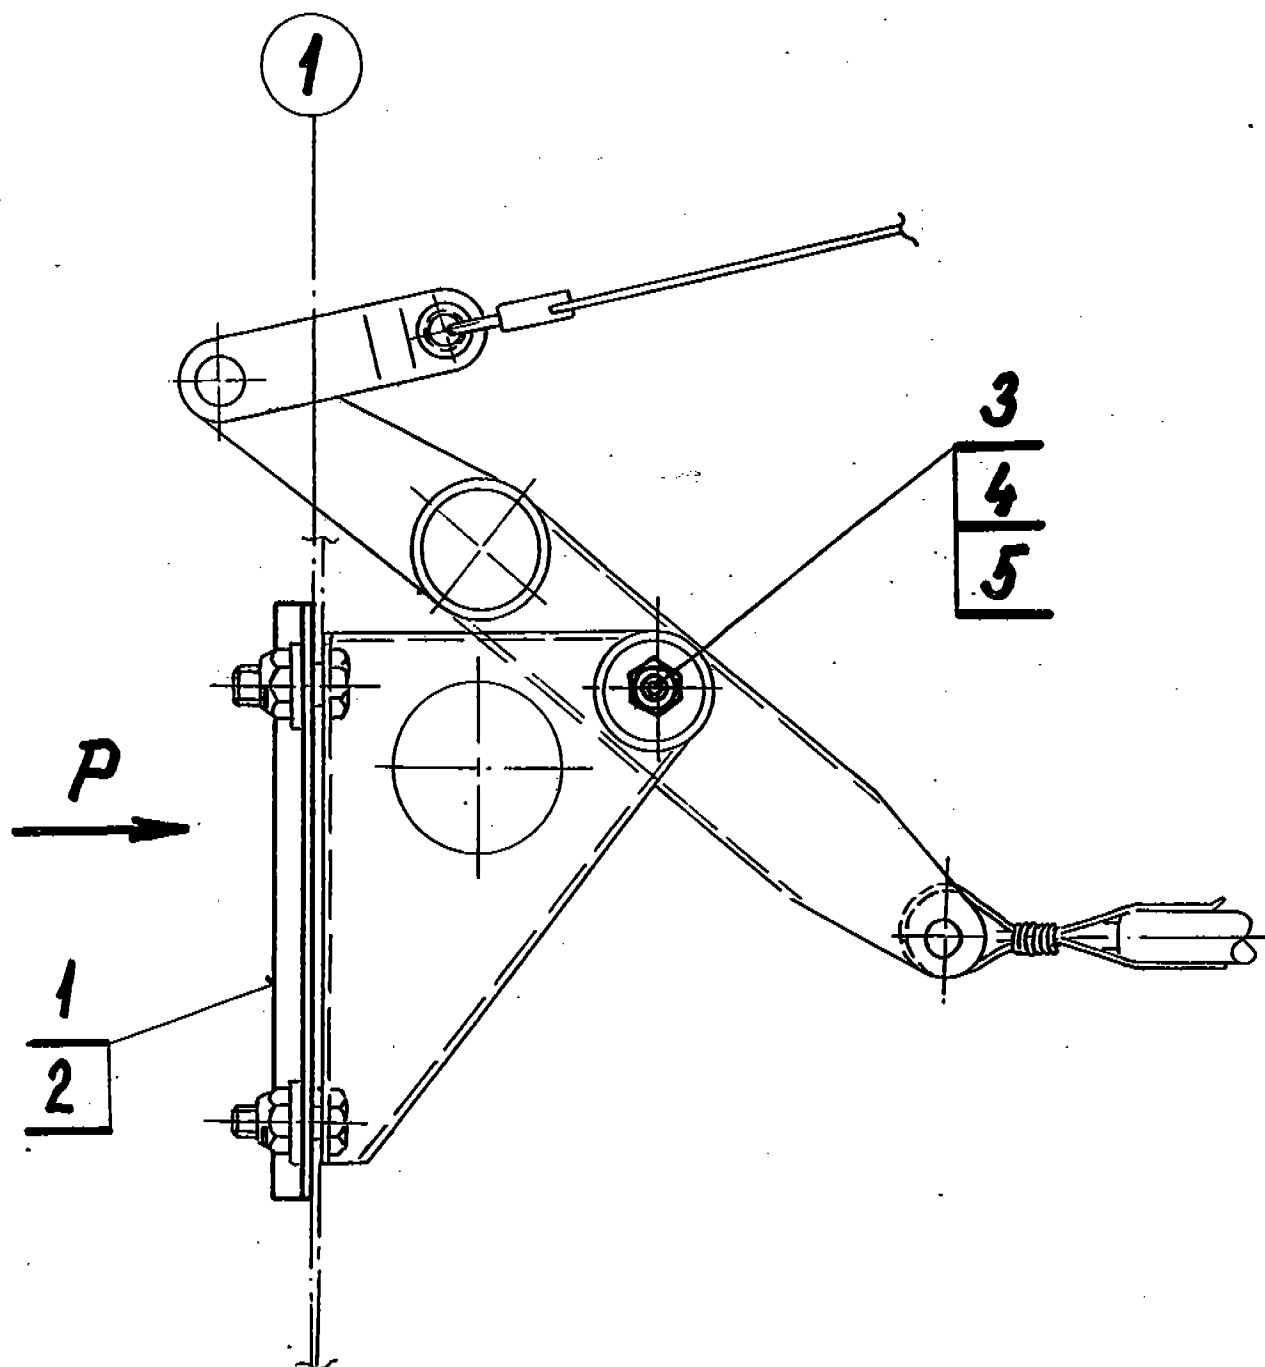
1.

- A. To increase rigidity of No 1 bulkhead at the location of tow rope hook control system countershaft bracket.
- B. To secure tow rope hook control system countershaft (by means of bolts nuts and washers) against accidental sliding out of the bracket bearings.

A.Reinforcement of bulkhead No 1:

B. Securing of countershaft:
