AIRWORTHINESS DIRECTIVE

Centrair 101, 101A, 101 AP, 101P

Centrair Service Bulletin # 101-4 asks for immediate inspection of the top rudder hinge, for cracking or failure in some form.

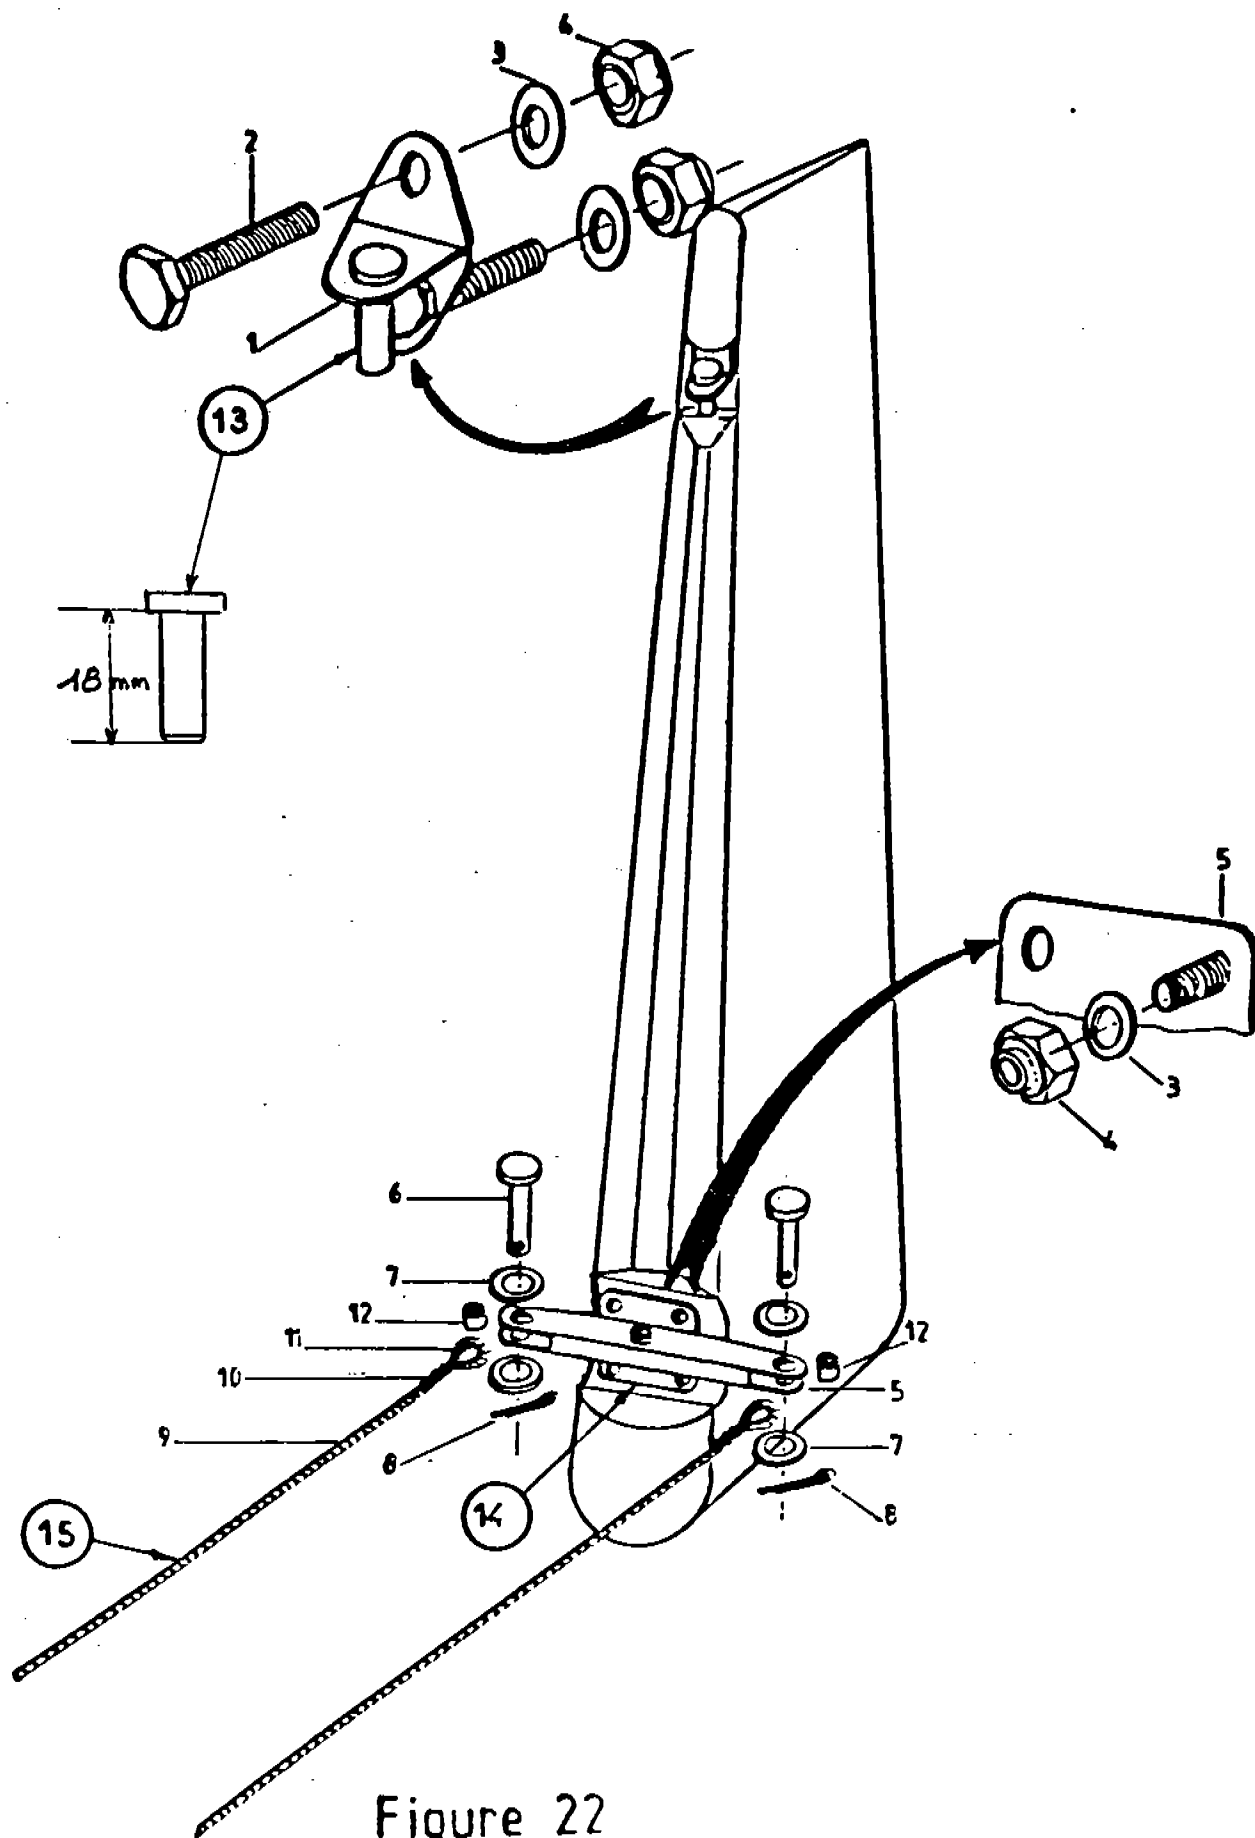
Figure 33

Following the discovery of two failures of the upper rudder hinge pivot, it is imperative to immediately check the upper rudder hinge pivot by disassembling the rudder :

In the case of a failed pivot or seized pivot the aircraft must be grounded until repair kit number one (1) is installed. This repair kit consisting of upgraded parts must be ordered from the manufacturer CENTRAIR immediately.

1. Remove the rudder control cables (rep.15 fig.22)
2. Remove the bottom rudder hinge retaining bolt (rep.3 fig.33)
3. Pull the rudder back slightly (to clear the bottom rudder hinge) then lift rudder to disengage it from the vertical fin.

If nothing abnormal is found, grease the pivot and reassemble the rudder.
