## AIRWORTHINESS DIRECTIVE

ASTIR CS from Serial No. 1001 to 1536 inclusive  
ASTIR CS77 from Serial No. 1601 to 1844 inclusive  
ASTIR CS Jeans from Serial No. 2001 to 2248 inclusive  
CLUB ASTIR 11 and STD ASTIR 11 from Serial No. 5001 to 5061 incl.

Inspection/replacement of divebrake system cast bellcranks

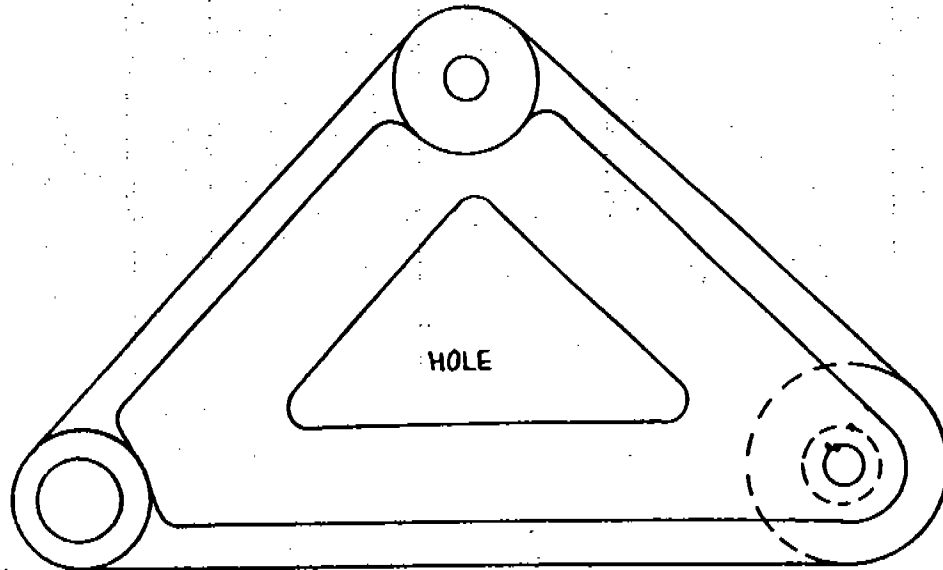
Technical Information  
TM 306-26

- 1.4. If a solid constructed lever of aluminium casting without hole is found, further actions are not applicable until the 3000-hours-check (see instruction 4.4.)

- 1.5. If a lever of aluminium casting with facilitating hole is found, the following instructions have to be carried out.
2. Instruction: Installation of an inspection hole with sight-window into the wing underside in the region of the airbrake locking levers. (See repair instruction 306-26/1).

- 2.1. Temporarily, the control of the levers according to instruction 3 can be carried out through the opening in the root rib. In order to facilitate the control and especially to avoid the daily disassembly it is urgently recommended to install the inspection openings in the wing underside at short notice.
