GFA AIRWORTHINESS DIRECTIVE

- TYPE AFFECTED:** Twin Astir (including Trainer) All Serial Numbers
G 103 Twin II All Serial Numbers
G 103 Twin II Acro All Serial Numbers
- SUBJECT:** Ultrasonic Inspection and possible replacement of the spar spigots.

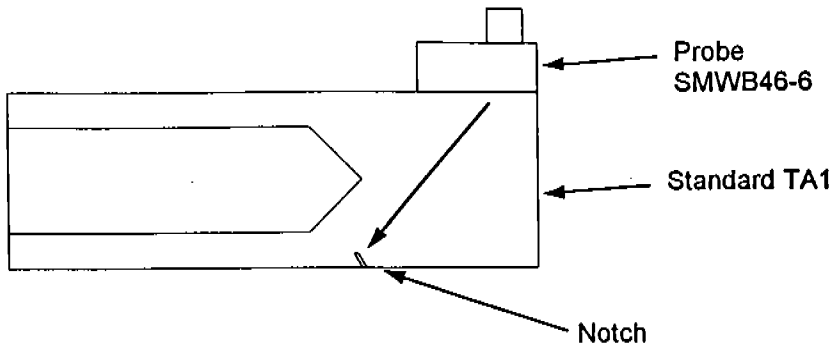
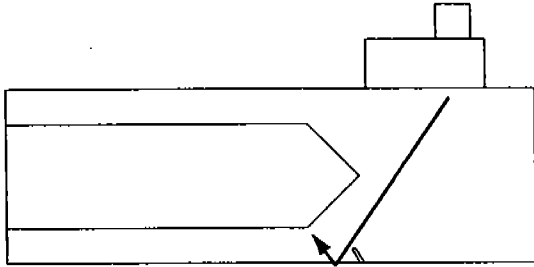
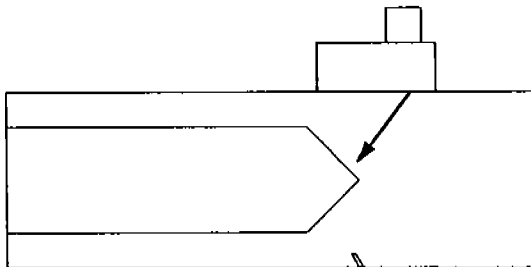
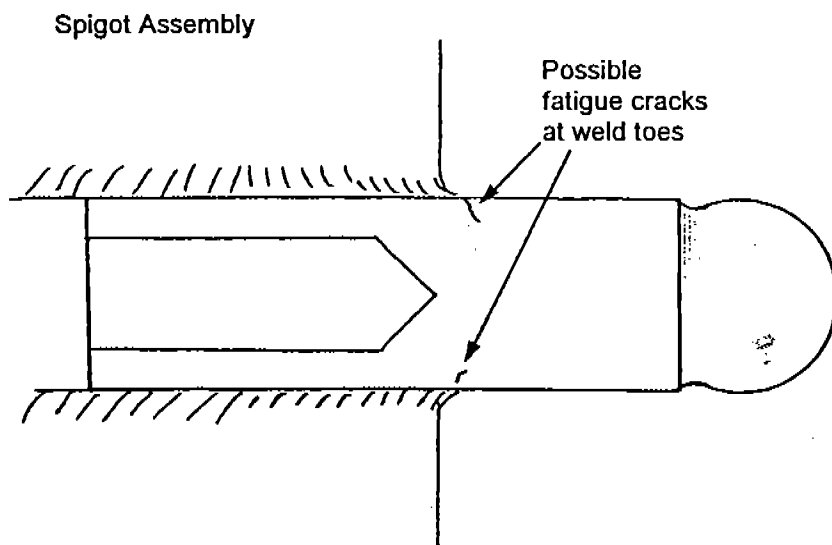
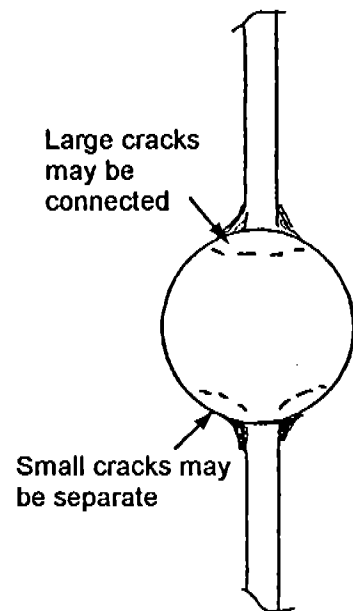
ULTRASONIC INSPECTION PROCEDURE.

EQUIPMENT:	<p>Krautkramer ultrasonic flaw detector USM2 or equivalent. Probe SMWB45-6 Serial number 55996. Test Standard TA 1.</p>
CALIBRATION/SET UP:	<p>Connect probe to instrument and calibrate the screen for 50 mm metal travel distance.</p> <p>Set the indication from the 45° notch at 50% horizontal position and 80% full screen height - no reject used.</p> <p>Shift the probe forward to show the reflection from the end of the counter bore and note the position shift.</p> <p>Scan further forward to show the reflection from the top of the counter bore and note the position.</p>
PREPARATION:	<p>Clean all dirt and foreign material from the spigot and apply couplant. Use SAE 30 oil or equivalent.</p>
INSPECTION:	<p>Carefully scan the spigot at the 12 and 6 o'clock positions identifying the counter bore and weld root from each side of each plate.</p>
DISPOSITION:	<p>All indications from cracks require further investigation.</p> <p>Correlation between cracks and the reference standard have been such that the standard represents a crack approximately 0.020" deep.</p> <p>Report crack sizes by length of circumference and \pm gain in dB compared to standard.</p>
