AIRWORTHINESS ADVICE NOTICE

TYPE AFFECTED: Whisper Motorglider

1.1 NUMBER: WA SB 0006

TITLE: CANOPY LATCH LEVER LOCK

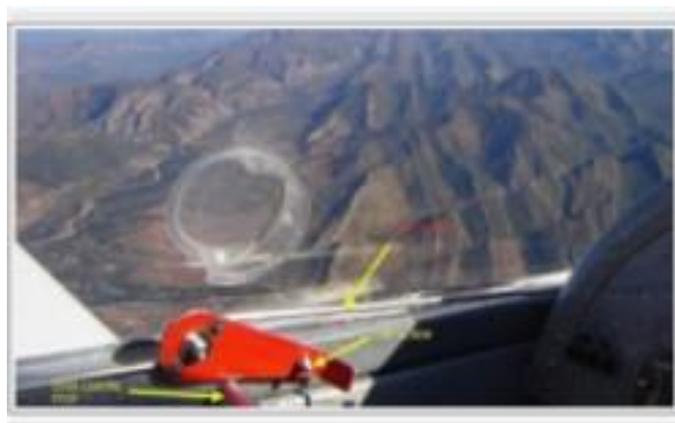
2) It has also been noted that some latch levers have been installed incorrectly (left and right levers reversed). The correct installation is on the image below.

lever to permit the head of the capscrew to just pass the latch rod. A further stop should be installed to prevent the lever rotating downwards to an over centre position where the latch pins start to retract. See picture below for further explanation. Between the two limiting positions the latch pins should remain extended such that they engage at least 32mm into the bushes in the fuselage.

Check correct installation of left and right levers. Reverse if necessary. Drill a 6mm hole through the latch lever and install an M6 capscrew such that the capscrew head strikes the canopy latch rods and prevents accidental opening. Add washers as required to ensure adequate contact for positive locking. Installation should be such that canopy opening is still possible by the pilot by flexing the

The person signing off this SB should endorse in the airframe logbook that the canopy lever locks have been checked and are satisfactorily preventing accidental opening and that the levers are installed in the correct orientation as per the image below.
